**2007/2008 Annual Inspection
Report**

**CAMERON/CREOLE
WATERSHED HYDROLOGIC
RESTORATION PROJECT
(CS-17)**

State Project Number CS-17
Priority Project List 1

December 12, 2007
Cameron Parish

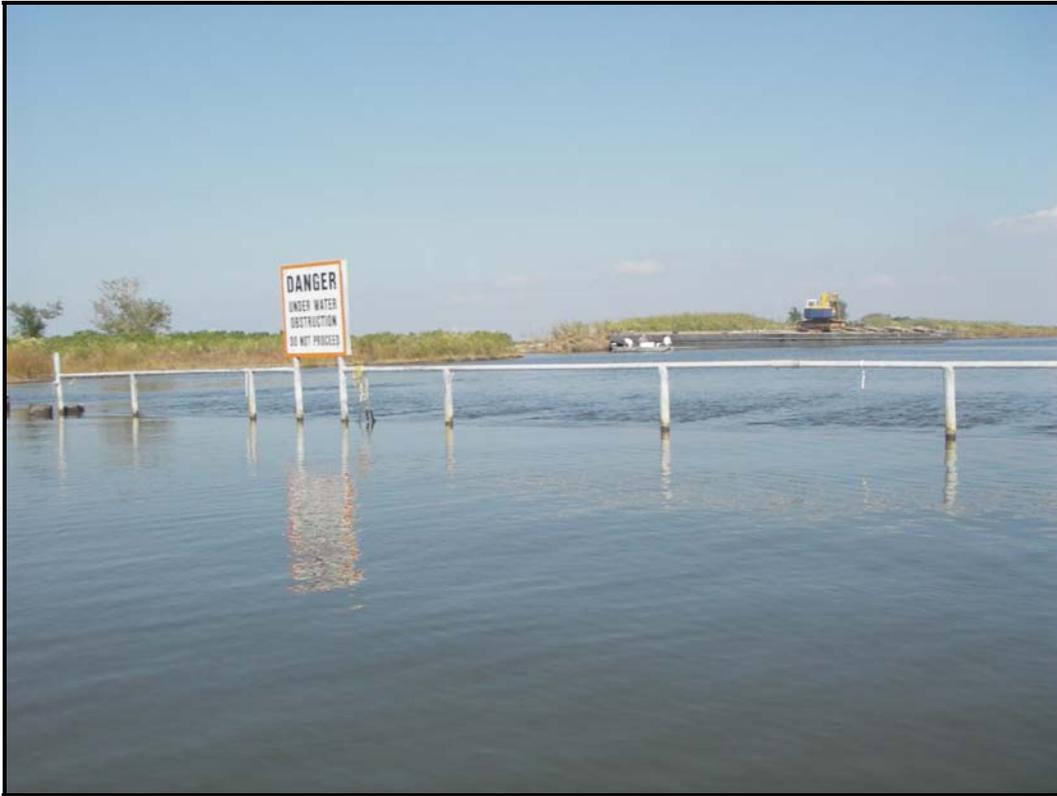
Photo 1, Grand Bayou Structure

The structure is in fair condition since the maintenance repair project in 2005; however there is bank erosion on both ends of the sheet pile wall which will need to be addressed with rock rip rap. Water is beginning to circumvent the structure on the east side. This bank should be hardened with rip rap. The structure has been vandalized. Two (2) sections of 8"x12" Seatimber Composite Marine Timber have been removed from the boat guide and need to be replaced along with the stainless steel Hardware. (Photos: Appendix B, Photos 1 & 2).

Item	Condition	Pysical Damage	Corrosion	Photo #	Observations and Remarks
Steel Bulkhead / Caps	Fair			1	
Steel Grating	N/A				
Stop Logs	N/A				
Hardware	Fair				
Timber Piles	Good				
Timber Wales	N/A				
Galv. Pile Caps	Fair				
Cables	N/A				
Signage /Supports	Good			1	
Rip Rap (fill)	N/A				
Eathern Embankment	Poor			2	Erosion occuring on both ends of the sheet pile wall.

- Grand Bayou structure – repair bank erosion with rock rip rap on both ends of the structure and harden the bank on the east side of the structure. Replace the boat guide marine timbers.
- Mangrove Bayou structure – repair bank erosion with rock rip rap on both ends of the structure, harden the bank on the east side of the structure and replace the boat guide marine timber.

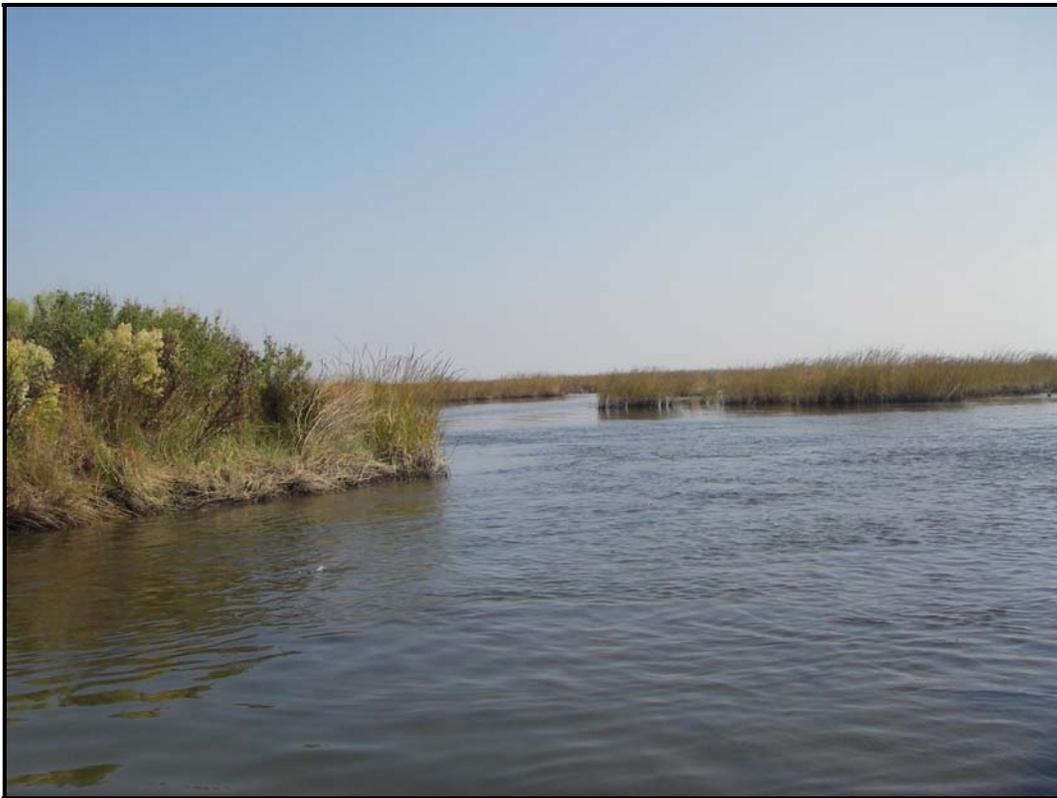
Photo 2, Erosion at east end Grand Bayou Structure

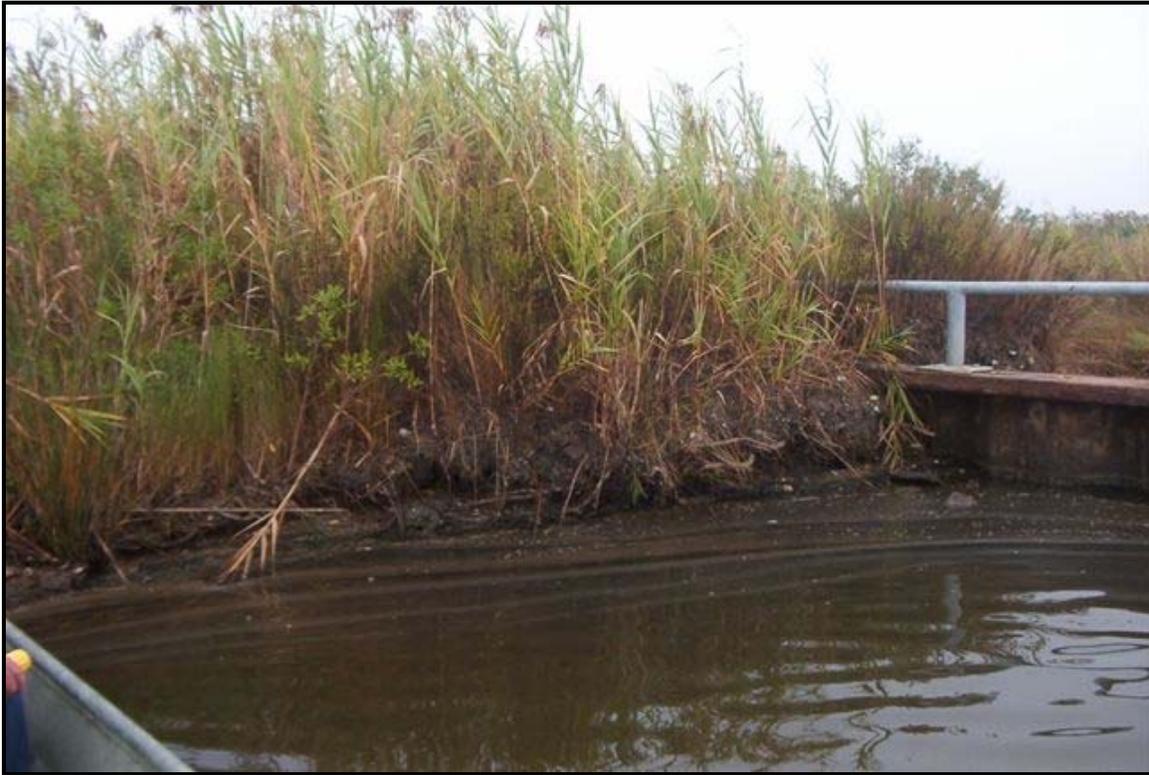
This structure is also in fair condition. There is bank erosion on both ends of the sheet pile wall which will need to be addressed with rock rip rap. Water is beginning to circumvent the structure on the east side. This bank should be hardened with rip rap. (Photos: Appendix B, Photos 3 & 4).

Photo 3, Erosion at West End Of Mangrove Plug

Item	Condition	Physical Damage	Corrosion	Photo #	Observations and Remarks
Steel Bulkhead / Caps	Fair			3	
Steel Grating	N/A				
Stop Logs	N/A				
Hardware	Fair				
Timber Piles	N/A				
Timber Wales	N/A				
Galv. Pile Caps	Fair				
Cables	N/A				
Signage / Supports	Good			3	
Rip Rap (fill)	N/A				
Eathern Embankment	Poor			4	Erosion occuring at both ends of sheetpile wall.

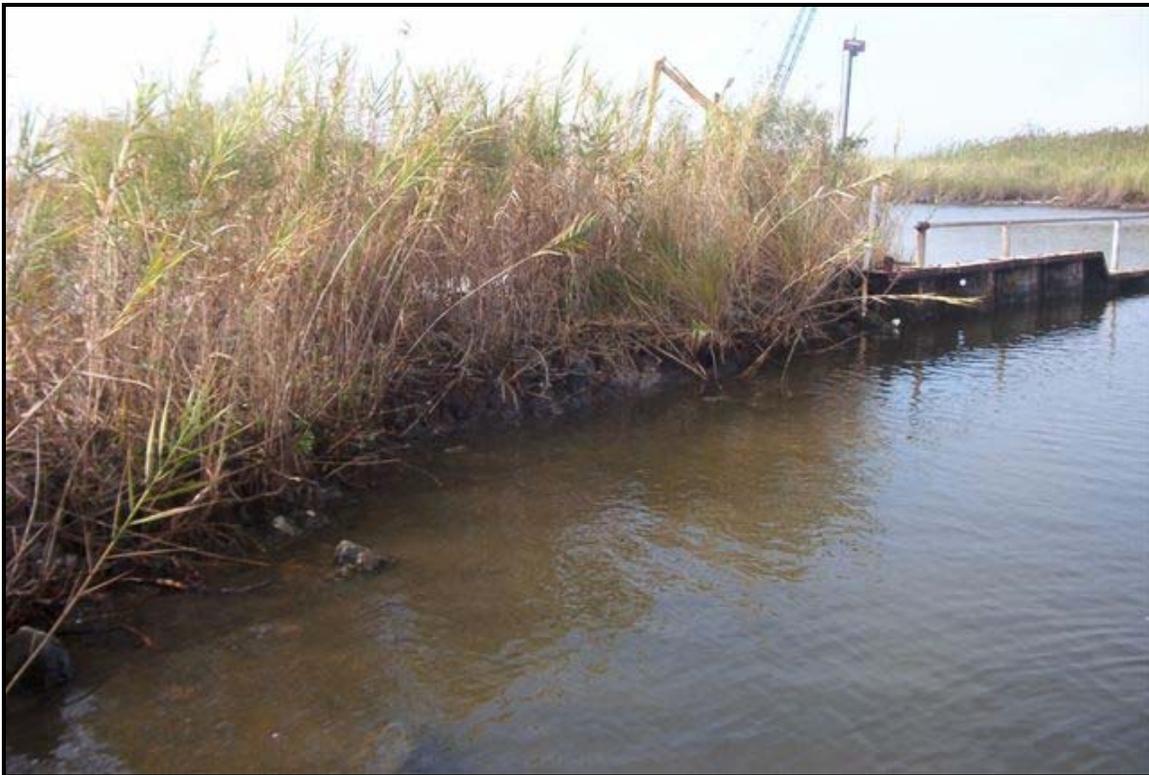
Photo 4, Erosion at East End Of Mangrove Plug
