## **Coastal Protection and Restoration Authority of Louisiana**

## **2007/2008 Annual Inspection Report**

## **SABINE REFUGE PROTECTION PROJECT (CS-18)**

December 6, 2007  
Cameron Parish

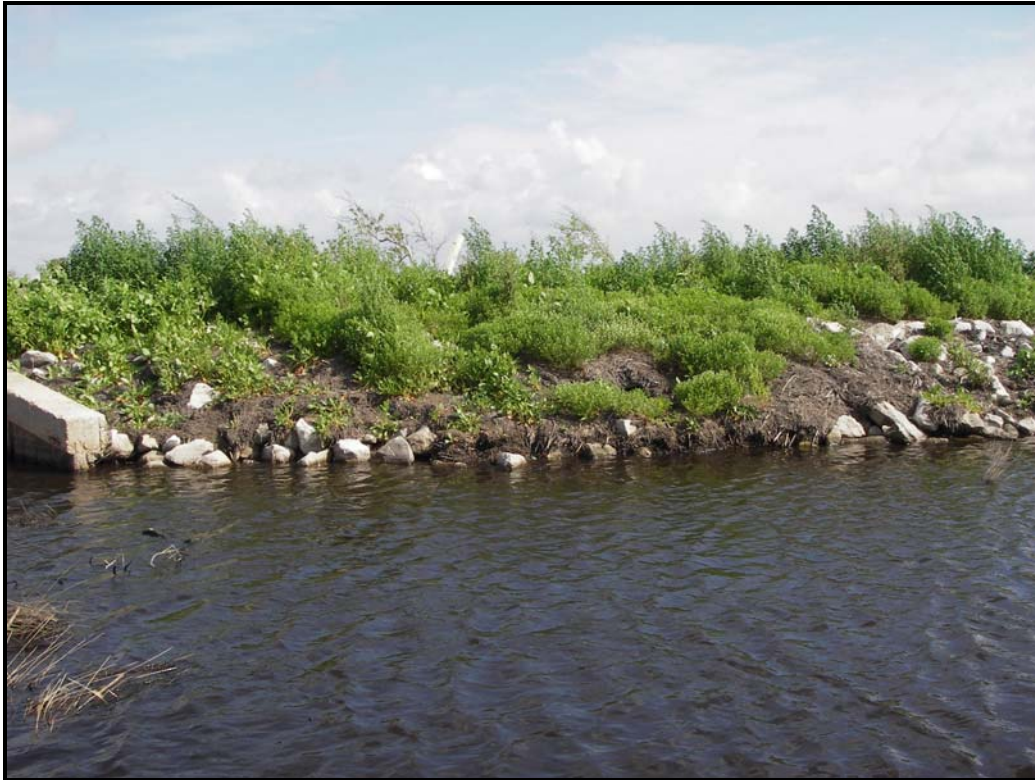
The weirs at Beach Canal Structure No. 2, Northline Canal Structure No. 3, and Stark's Central Canal Structure No. 4 were inspected for rock reinforcement at each wingwall. No maintenance required at any of the structures at this time. (Photos: Appendix B, Photos 3-8).

Photo 7 – eastern wingwall rock on Stark's Central Canal Structure No. 4 (Dec. 6 2007)

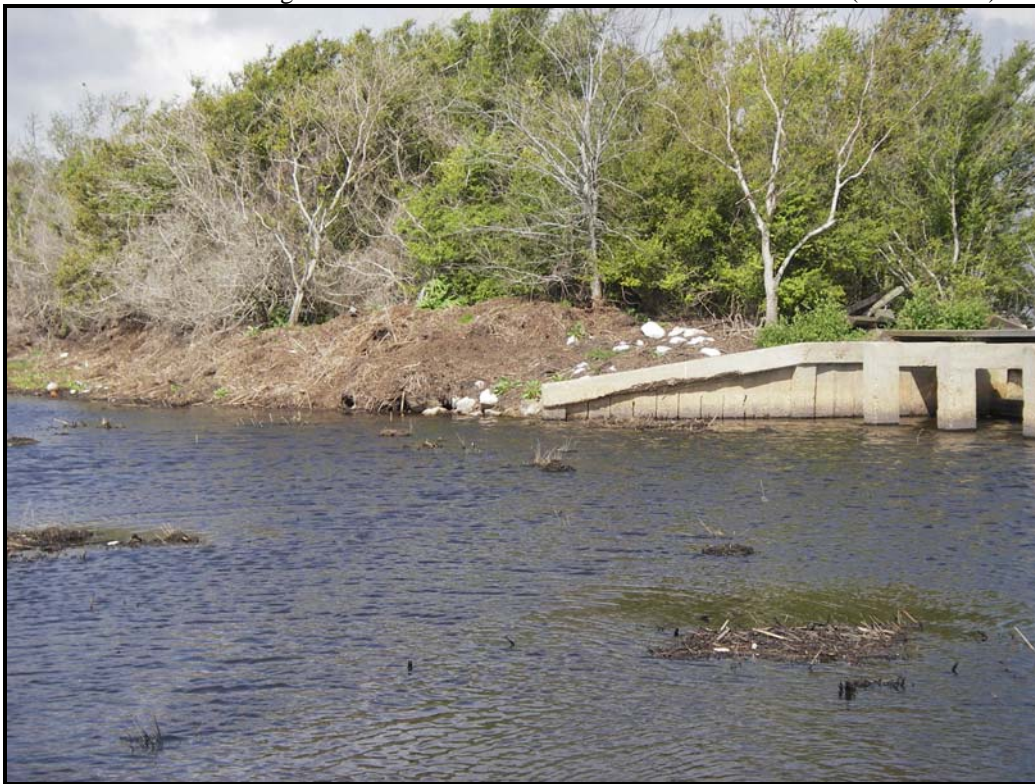
Photo 8 – western wingwall rock on Stark's Central Canal Structure No. 4 (Dec. 6, 2007)
