**2007/2008 Annual Inspection
Report**

**HWY. 384 HYDROLOGIC
RESTORATION PROJECT
(CS-21)**

State Project Number CS-21
Priority Project List 2

February 12, 2008
Cameron Parish

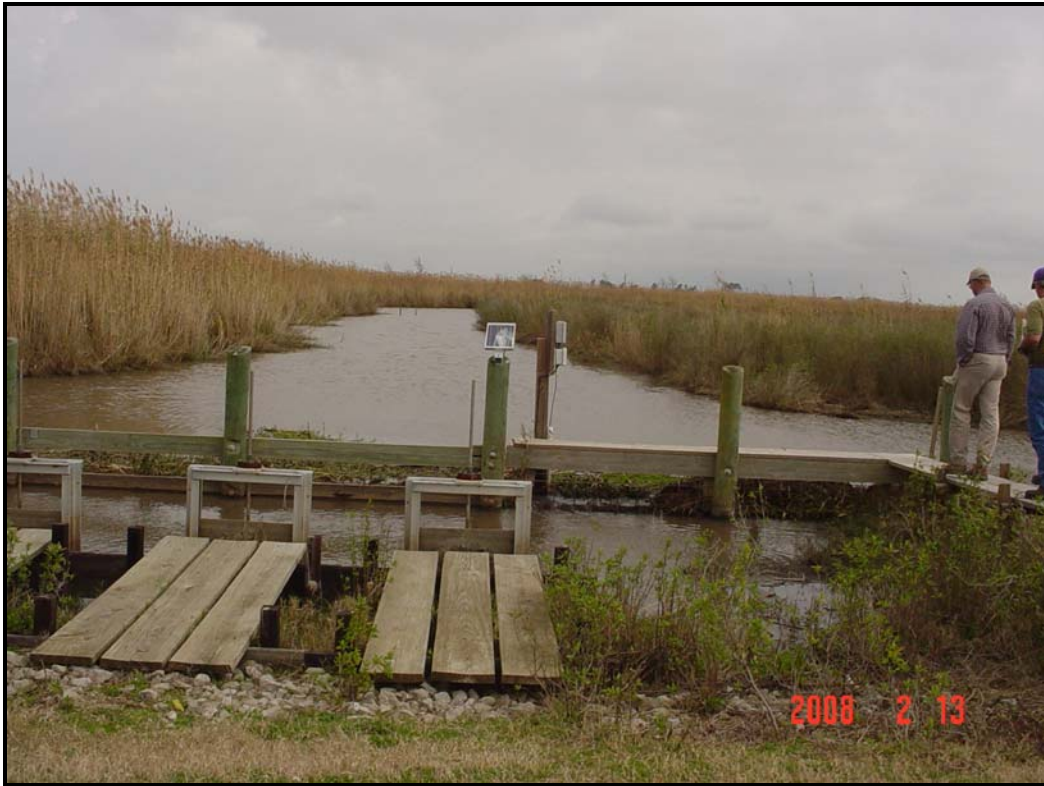
Photo 1, View showing hyacinth fence and sluice gates at Structure No.1

Item	Condition	Physical Damage	Corrosion	Photo #	Observations and Remarks
Steel Bulkhead / Caps	N/A				
Flapgates/Outlet Pipe	Good			3	
Stop Logs	N/A				
Hardware/Sluiceways	Good			1	
Hyacinth Fence	Fair			2	Trash accumulating on outside of hyacinth fence.
Timber Piles	N/A				
Timber Wales	N/A				
Galv. Pile Caps	N/A				
Cables	N/A				
Signage /Supports	N/A				
Staff Gages	Poor				Staff gage outlet side of structure not readable.
Rip Rap (fill)	Good				
WQ Troll 9500 - 29r	Good			2	
Earthen Embankment					
Access Roadway	Good

- Structure No. 1 – install bird excluder device on solar panel, replace staff gage, remove trash from outside of the hyacinth fence.
- Structure No. 12 – replace metal pile cap covers, install bird excluder device on solar panel.
- Structure No. 8 (Rock Plug) – install staff gauges both lake and marsh sides.

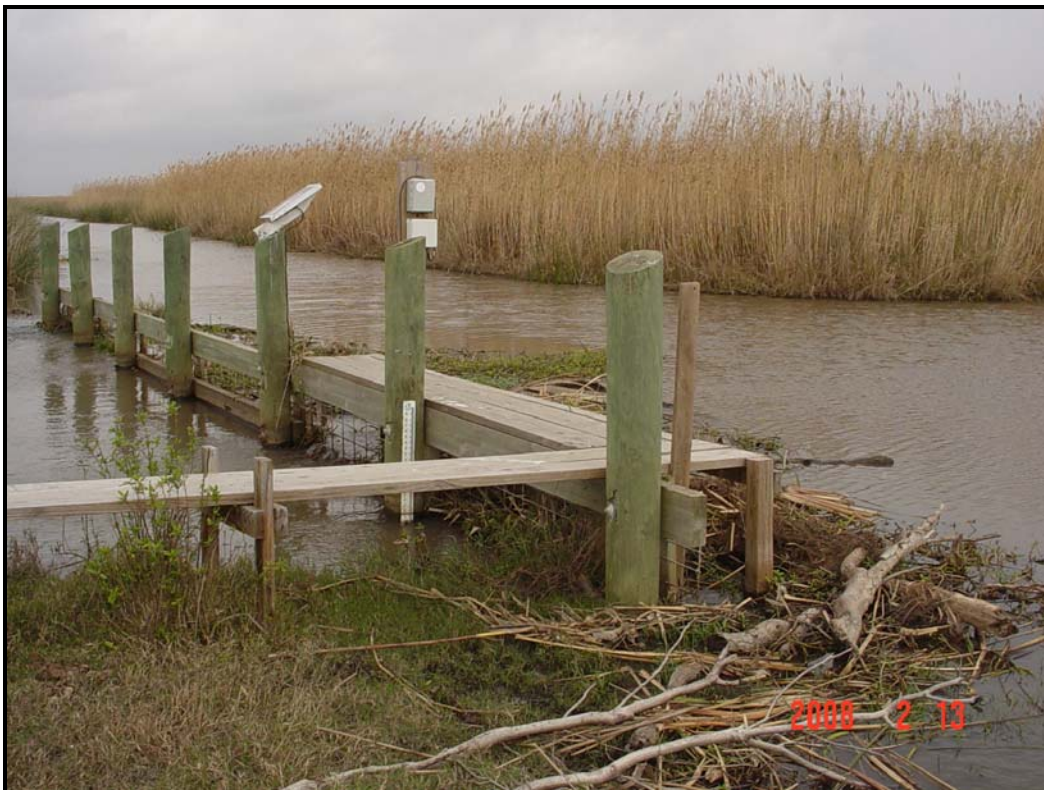
Photo 2, View showing Portable Multi-Parameter Water Quality Troll 9500 (29r) with wooden boardwalk at Structure No. 1 and trash accumulated against the hyacinth fence.

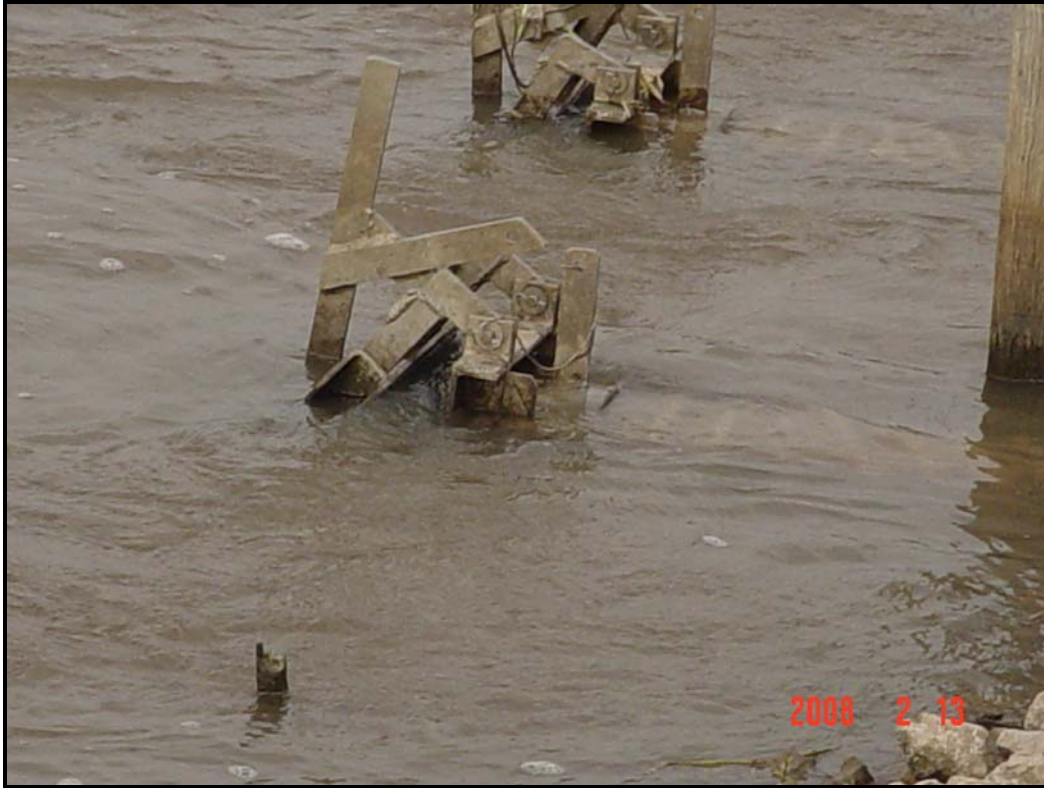
The structure is in good condition. Water level on the outside was elevation +1.0 NAVD88 and the level inside could not be determined because the staff gage was not readable. The inside staff gage will need to be replaced. Rock placed on the bank during the maintenance event of June 2002 is stable and in no need of repair. The hyacinth fence is in good condition; however there is trash accumulating on the outside of the fence which needs to be removed. The road/levee leading up to the structure is in good condition since it was repaired in June 2006. The recently installed Portable Multi-Parameter Water Quality Troll 9500 – 29r is in good condition and operating properly. The solar panel should be cleaned and bird excluder devices installed. (Photos: Appendix B, Photos 1-3).

Photo 3, Outlet side of Structure No. 1.

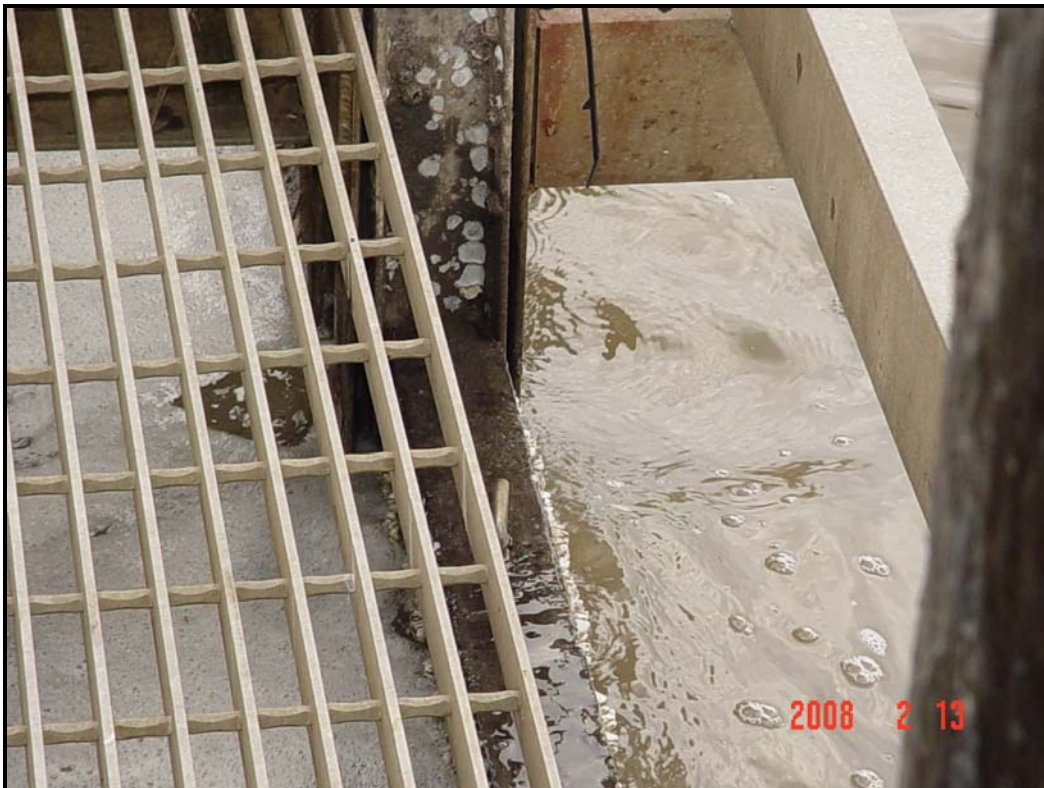
Photo 4, Inlet side of Structure No. 12.

Item	Condition	Physical Damage	Corrosion	Photo #	Observations and Remarks
Steel Bulkhead / Caps	N/A				
Steel Grating	Good			4	
Stop Logs	Good				
Hardware/Flapgates	Good				
Timber Piles	Good				
Timber Wales	N/A				
Galv. Pile Caps	Good			5	Pile caps on outlet structure are corroded and will eventually need to be replaced.
Cables	N/A				
Signage /Supports	N/A				
Staff Gages	Fair				Staff gage on inlet side not readable.
Rip Rap (fill)	Good				
WQ Troll 9500 - 15r	Good			6	
Earthen Embankment					
Access Roadway	Good			7

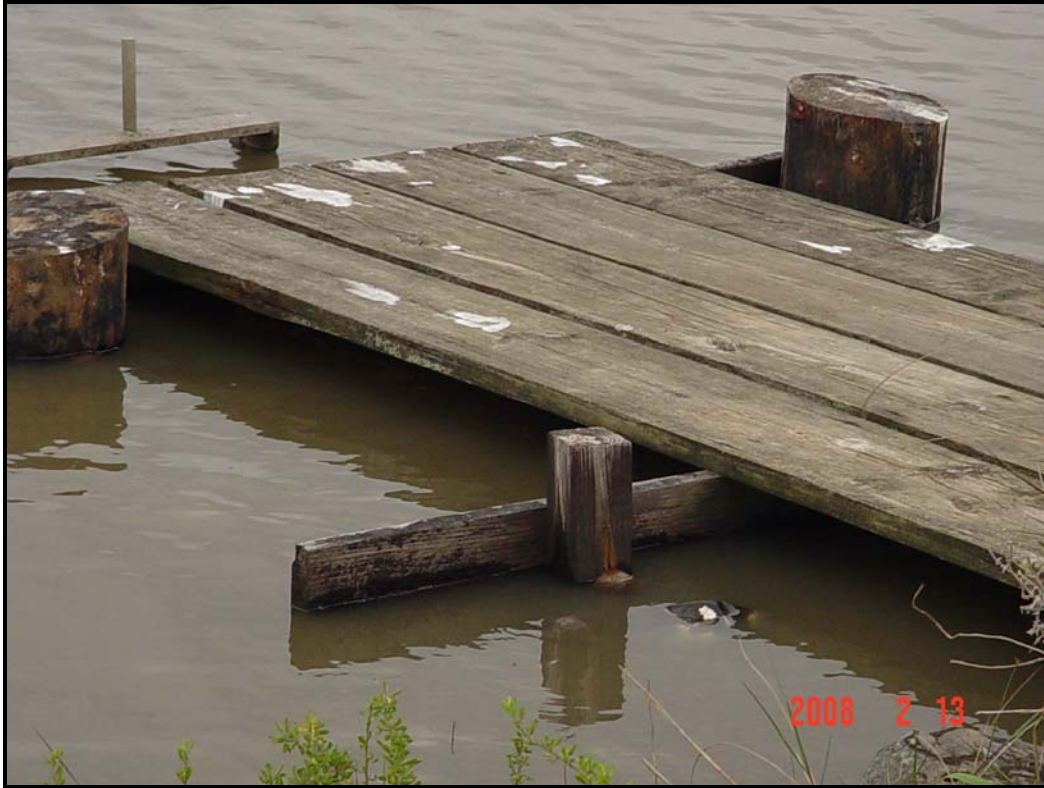
Photo 5, Outlet pipes for Structure No. 12.

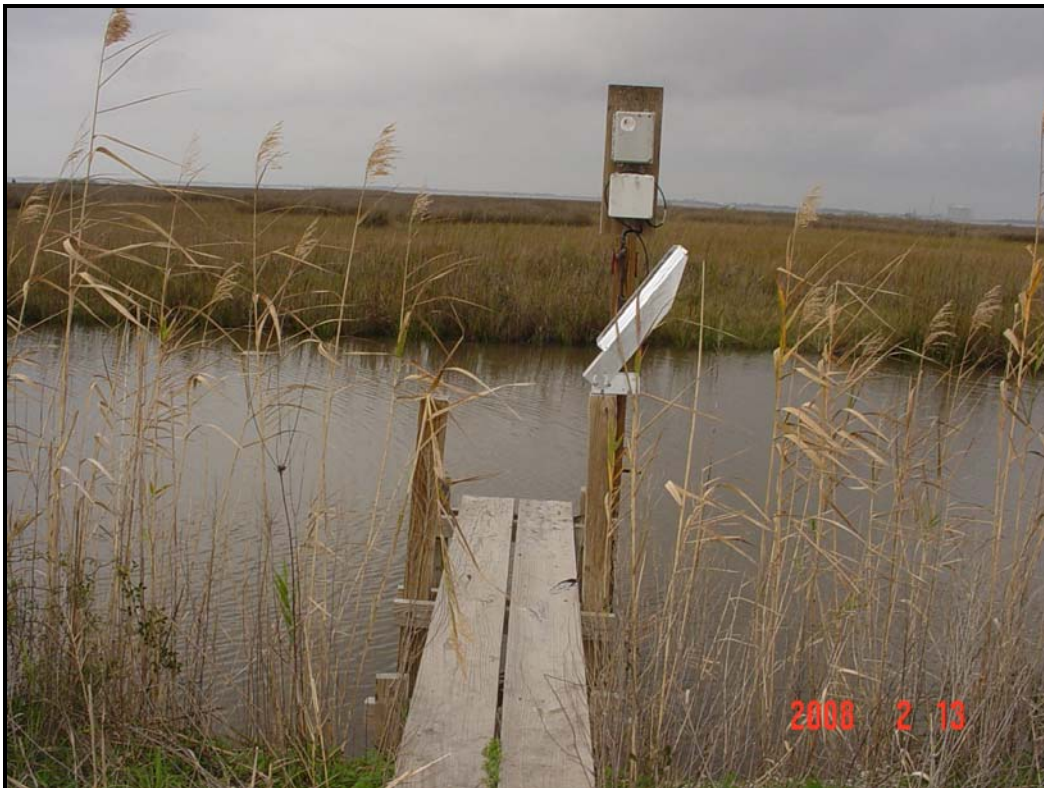
Photo 6, View showing Portable Multi-Parameter Water Quality Troll 9500 (15r) with wooden boardwalk near Structure No. 12.

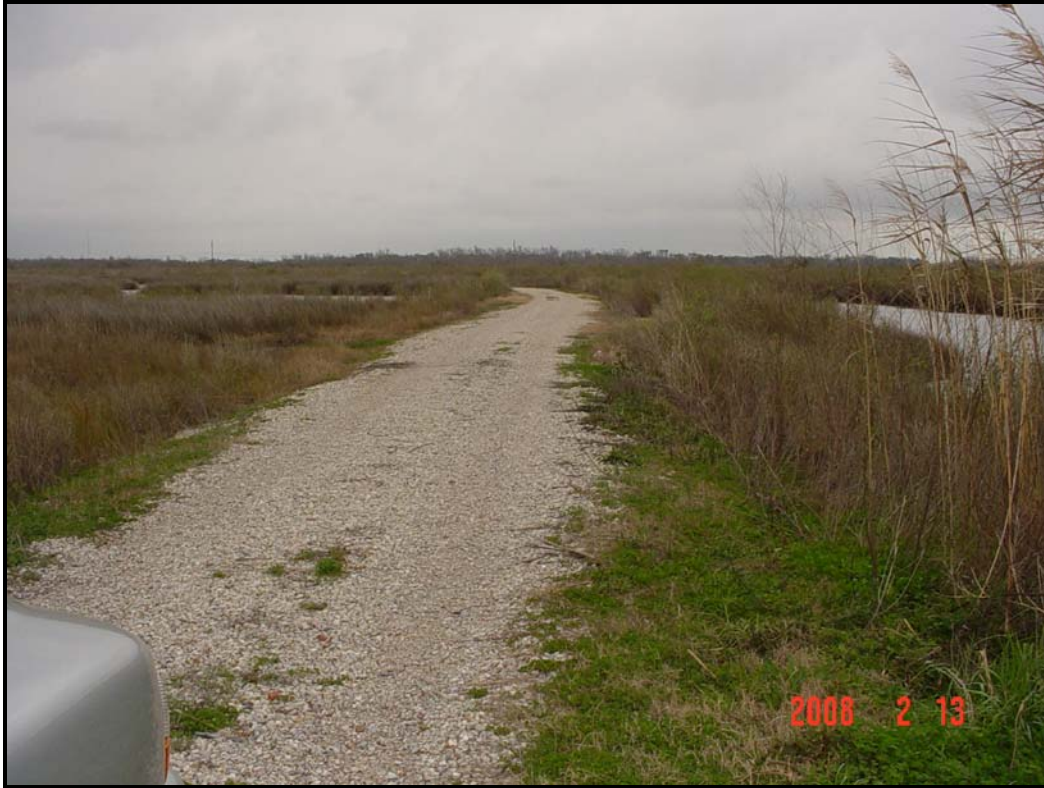
Photo 7, Access roadway to Structure No. 12, recently repaired with recycled concrete.

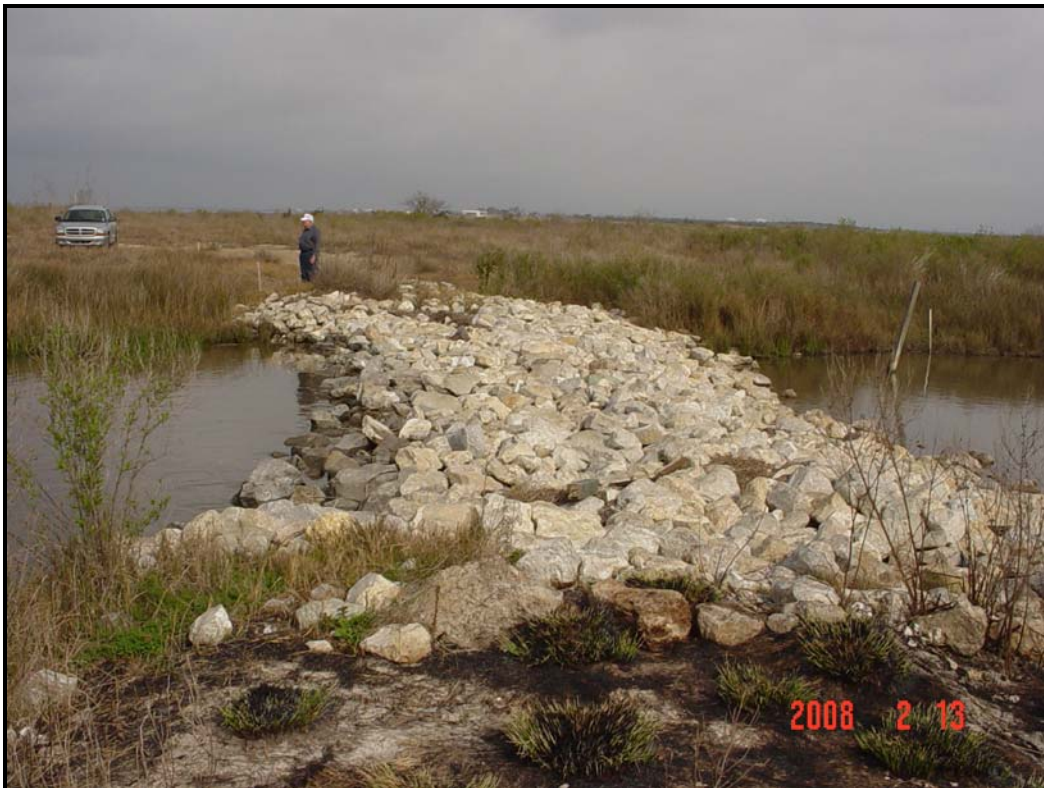
The rock plug is in good condition. Water levels could not be determined because the outside staff gage is missing and the inside staff gage was leaning and not readable. Both staff gages will need to be replaced. The recently completed maintenance work in May 2005 to repair the plug from vandalism held up well under the high storm surge waters. The interior area of the rock plug is showing signs of new vegetative growth in locations that were previously open water. (Photos: Appendix B, Photos 8-10).

Photo 8, Rock plug at structure No. 8.

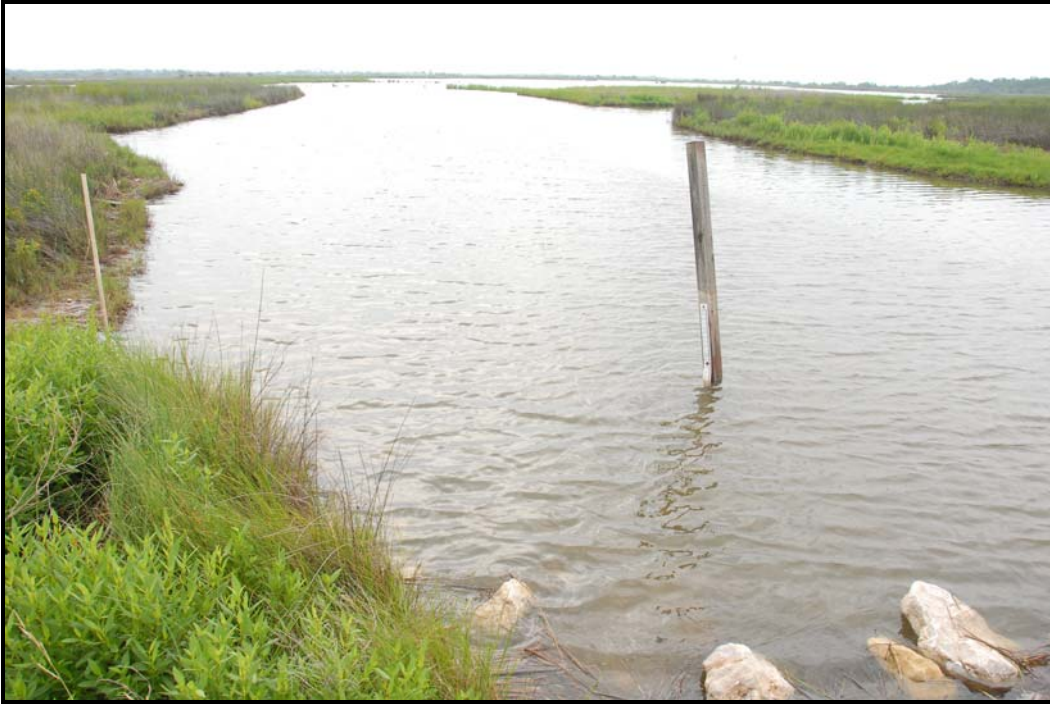
Photo No. 9, View showing open area on the interior of Structure No.8 (Picture courtesy of Lane LeFort, June 2006).

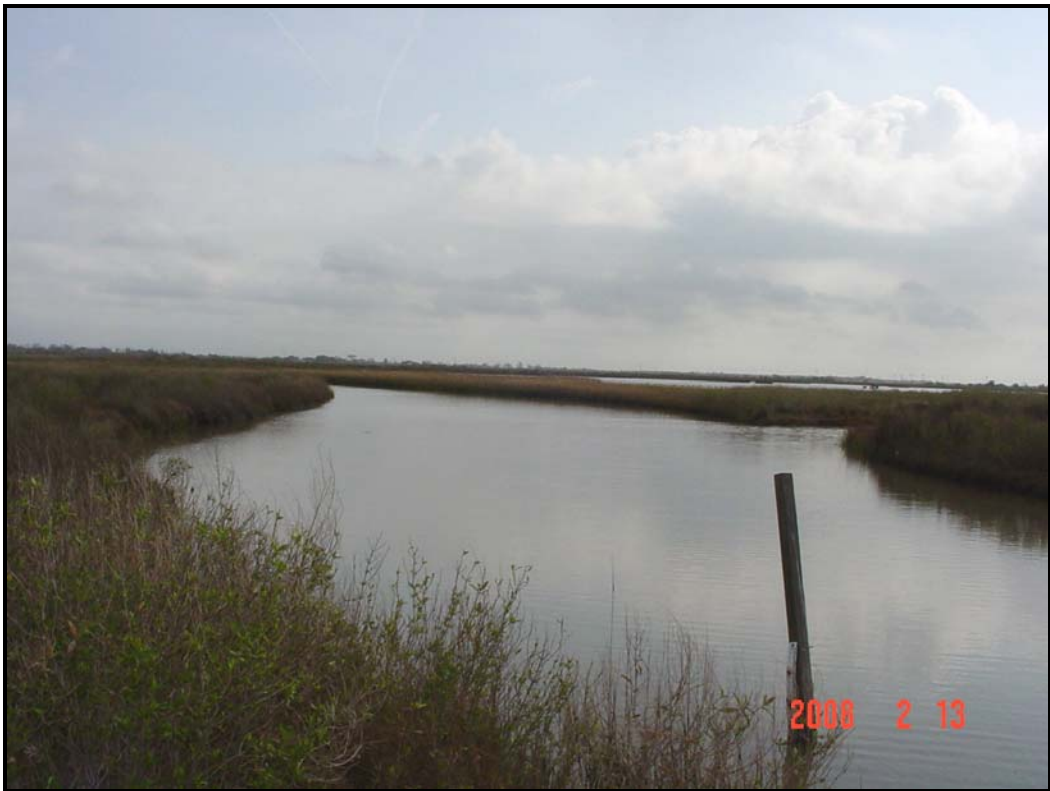
Photo No.10, View showing vegetative growth on the interior of Structure No. 8, same location as Photo No. 9 above.

Item	Condition	Physical Damage	Corrosion	Photo #	Observations and Remarks
Steel Bulkhead / Caps	N/A				
Steel Grating	N/A				
Stop Logs	N/A				
Hardware	N/A				
Timber Piles	N/A				
Timber Wales	N/A				
Galv. Pile Caps	N/A				
Cables	N/A				
Signage / Supports	N/A				
Staff Gages	Poor			10	Outside staff gage missing, inlet staff gage not readable.
Rip Rap (fill) (foreshore dike)	Good			8 & 9	The plug appears to be in good shape.
Earthen Embankment					The earthen levee that was rebuilt as part of the May '02 maintenance is in excellent condition beyond the limits of the channel.
