TIMBALIER ISLAND PLANTINGS (TE-18)

TE-18-MSPR-0697-4

PROGRESS REPORT NO. 4

December 9, 1996 to June 8, 1997

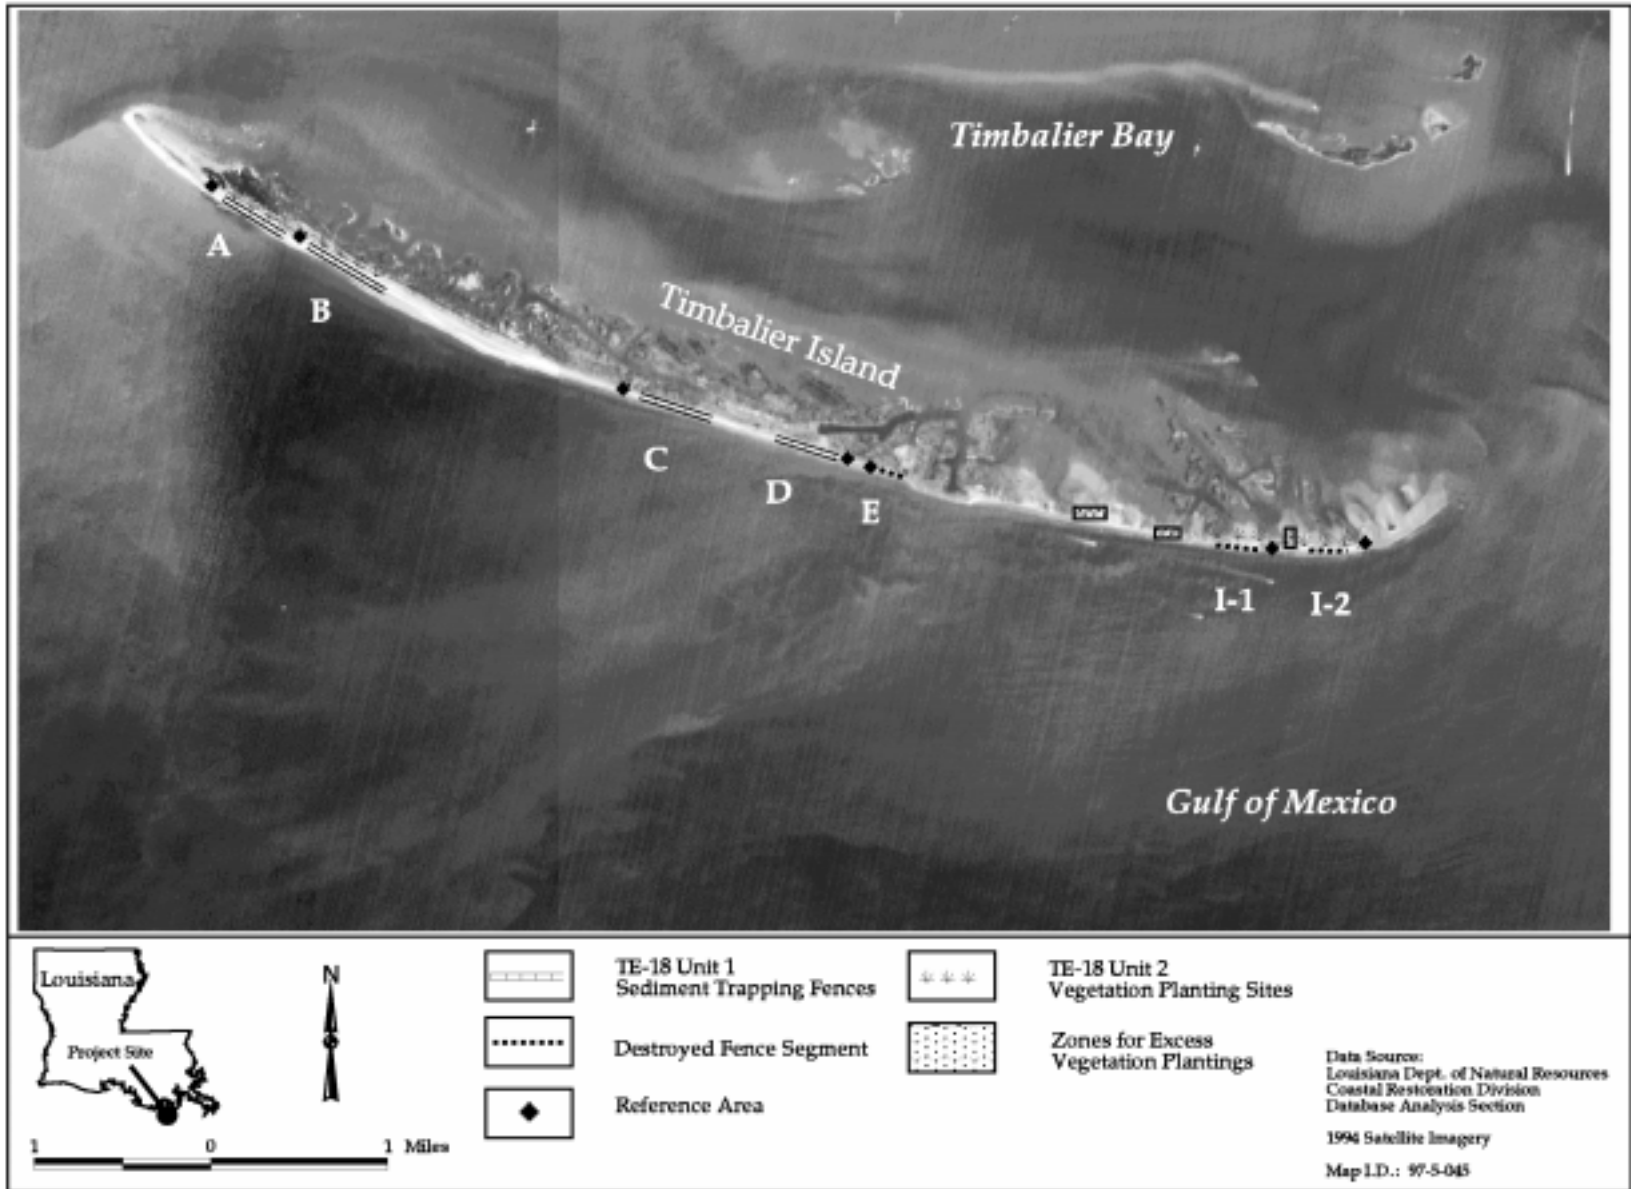
During the storm season of 1995, several tropical storms impacted the Louisiana coastal area, including Timbalier Island, causing damage to the fencing installed by the Natural Resources Conservation Service (NRCS) for the Timbalier Island Plantings project. In June 1996, the fencing damage was repaired except for segments E, I-1, and I-2, which remained unfenced (figure 1).

Plots I-1 and I-2 had been previously devastated by tropical storm Josephine in October 1996. The impact from the winter storms ranges from minimal to devastating among the remaining plots with damage to both vegetation plantings and fencing. Based on NRCS observations made from the gulf side of the island, plot D is 75% destroyed or damaged. The damage to the east end of plot B (plot BE) is approximately 50% including both vegetation and fence damage. The remaining two plots, A and C, appear to have suffered minimal damage.

Figure 1. Timbalier Island Plantings (TE-18) project elements. Letters (A-I) represent fence segments.

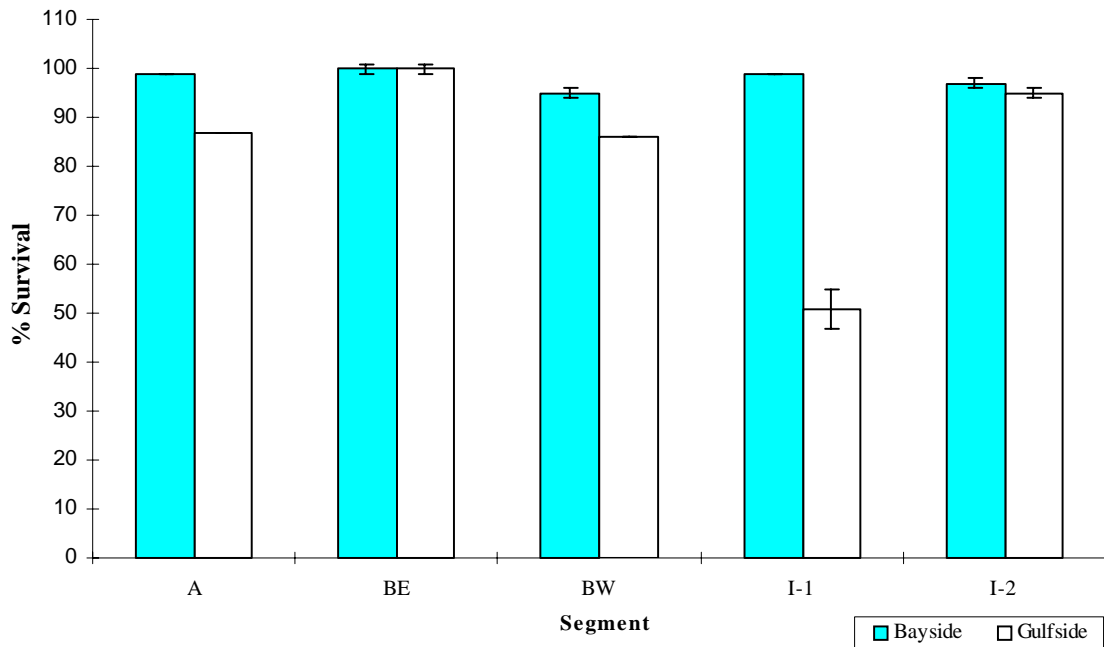
Percent survival of the planted vegetation (figure 3a) was significantly higher ($p < 0.05$) bayside than gulfside at all segments except BE and I-2. The bayside had near 100% survival at all segments while the gulfside plant survival ranged from a low of 51% at I-1 to near 100% at BE.

Figure 3a. Timbalier Island Plantings (TE-18) project percent survival for vegetation plantings (July-August 1996). Bars represent the mean percent survival of both planted species \pm 1 SE.

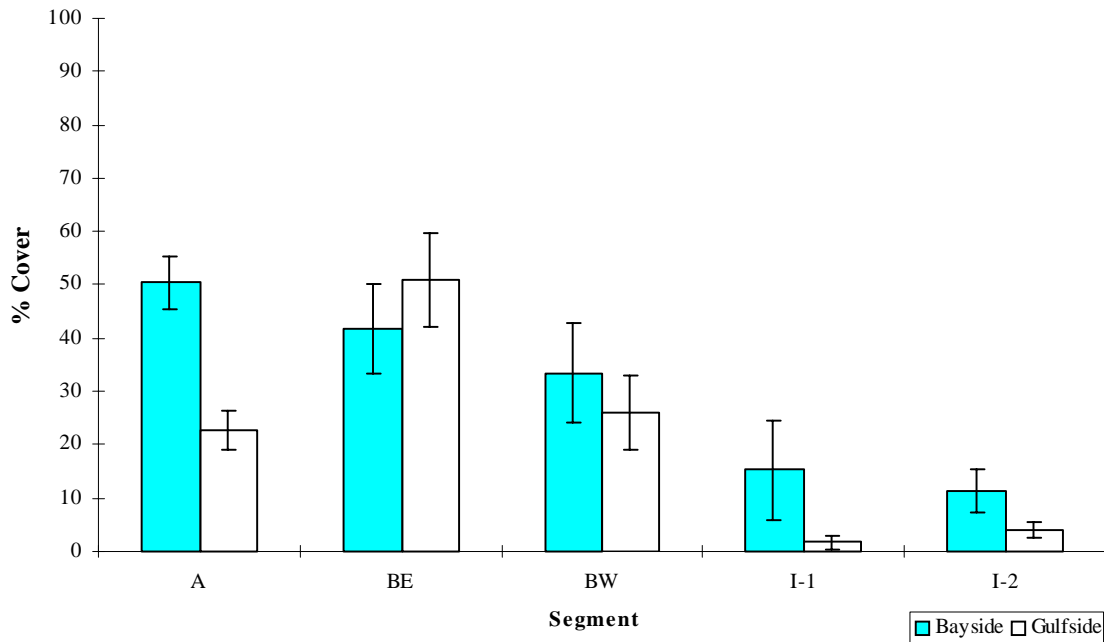
Plant cover (figure 3b) was significantly higher ($p < 0.01$) at the bayside than the gulfside of all segments except BE and BW, where there was no significant difference. Segments I-1 and I-2 had less plant cover than the other three locations, which was likely due to the absence of fences at those segments and direct exposure to wave action and submergence by the Gulf of Mexico. Percent plant cover of *P. amarum* naturally exceeds that of *S. patens* in most of the segments measured (table 1). This difference in percent cover between species may be attributed to the width of *P. amarum* leaves being two to five times greater than that of *S. patens* leaves. Naturally colonizing vegetation accounted for less than 5% of the plant cover in three bayside segments (A, BE, and BW) and three gulfside segments (A, BW and I-2) and was nonexistent in the remaining segments.

Figure 3b. Timbalier Island Plantings (TE-18) project percent cover for vegetation plantings (July-August 1996). Bars represent the mean percent cover of all plant species \pm 1 SE.
