**State of Louisiana  
Department of Natural Resources  
Coastal Restoration Division and  
Coastal Engineering Division**

**2005 Operations, Maintenance,  
and Monitoring Report**

**Sabine Refuge Protection**

State Project Number CS-18  
Priority Project List 1

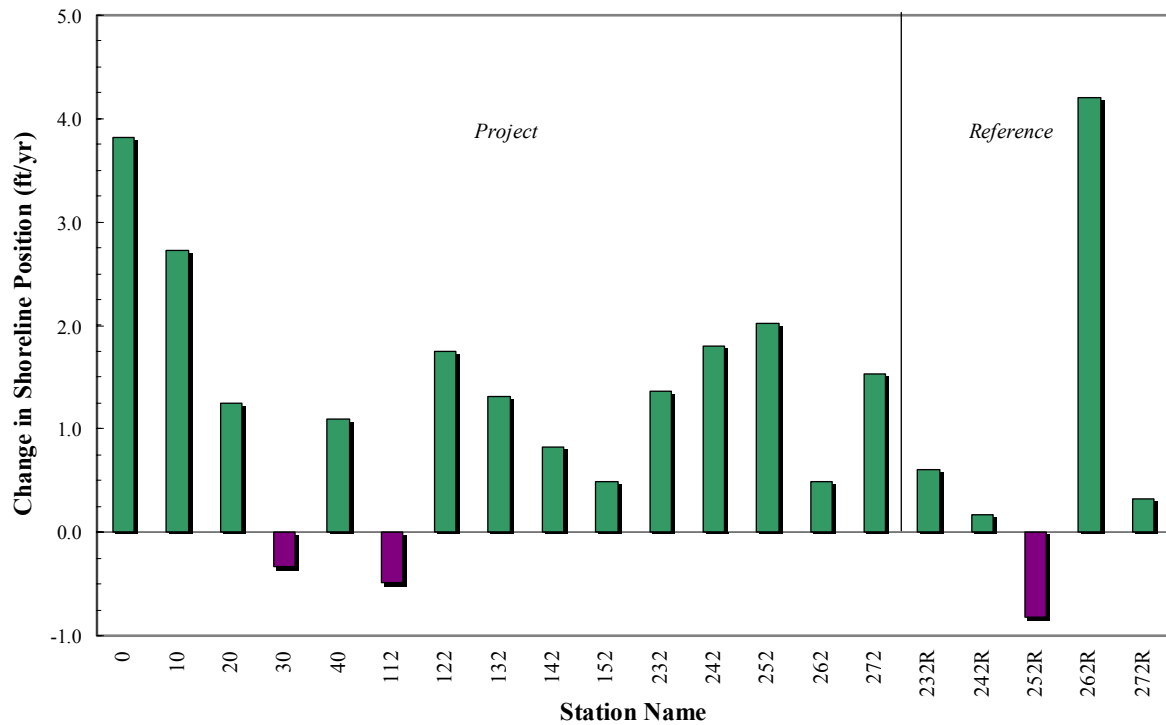
**Figure 5.** Sabine Refuge Protection (CS-18) shoreline change for the project and reference area from 1995 to 2000. Rates are calculated in ft/yr.

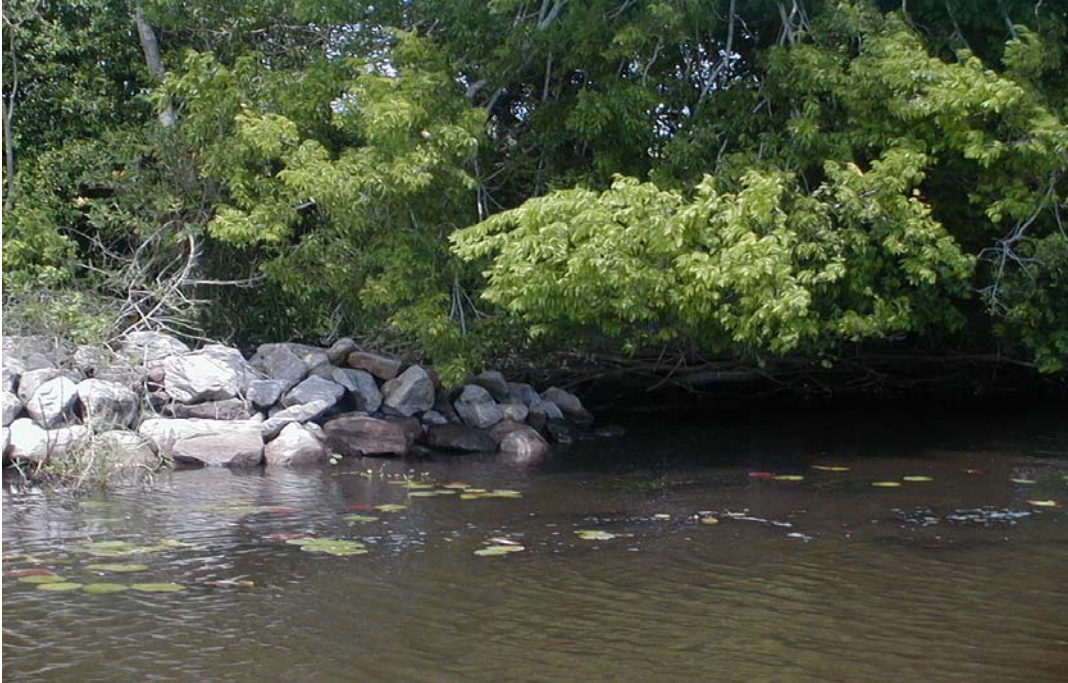
The dikes are in excellent post construction condition. No need for any maintenance in the foreseeable future. (Photos: Appendix A, Photos 1–2.)

Photo 1—southern tie-in on the Burton-Sutton Canal

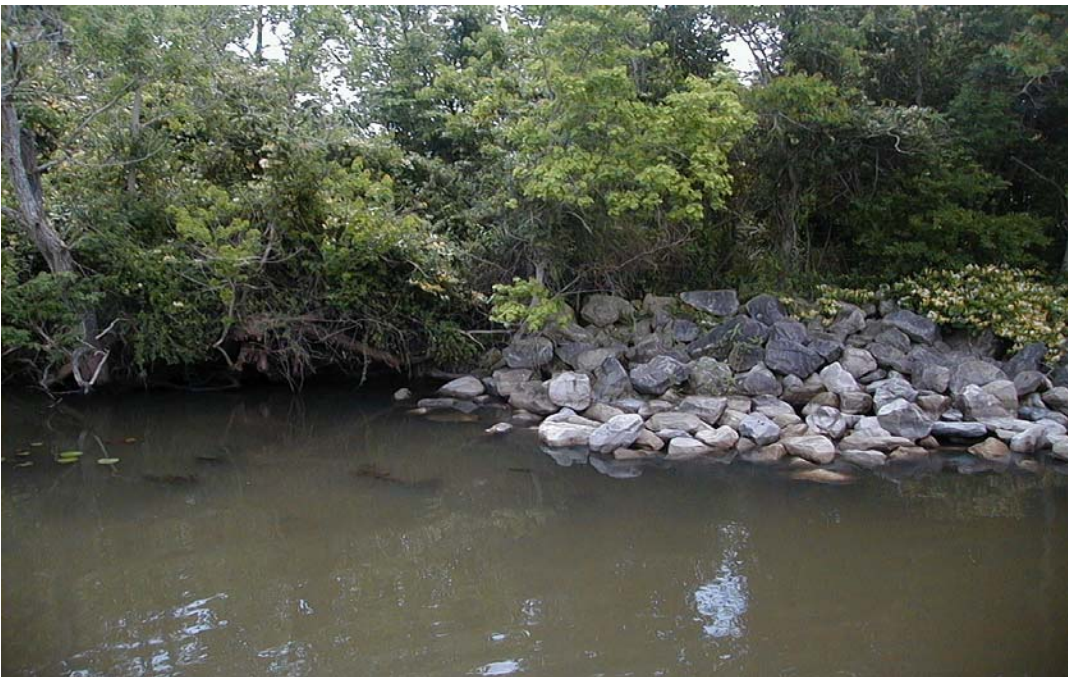
Photo 2—northern tie-in
