# **2005 Operations, Maintenance, and Monitoring Report**

# Perry Ridge West Bank Stabilization

State Project Number CS-30 Priority Project List 9

June 2005 Calcasieu Parish

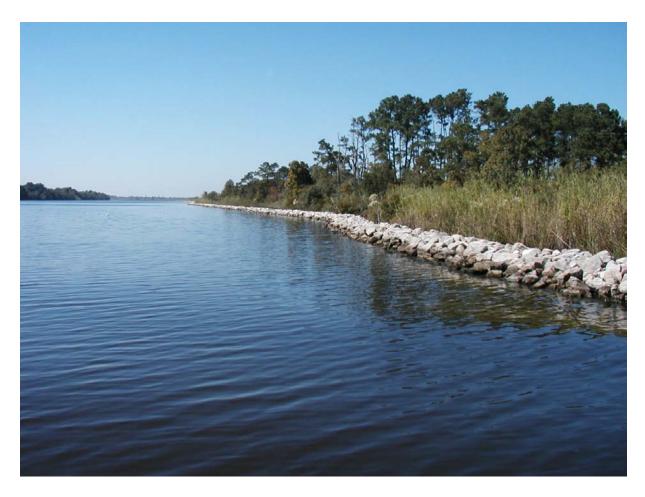
**Figure 5.** View of the Perry Ridge West rock dike taken October 21, 2003. The photograph is facing west. Photographs from the 2005 inspection are included in Appendix A.

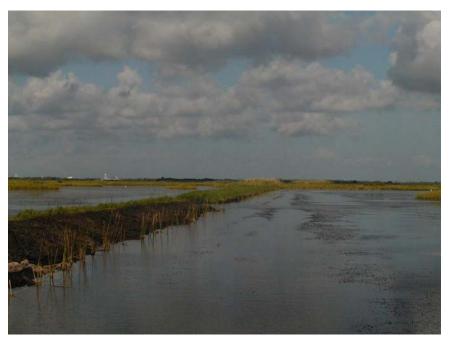
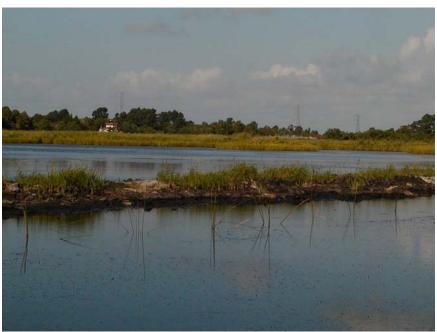
**Figure 6.** Views of the *Schoenoplectus californicus* plantings taken July 2002. The photograph on the top is facing southwest, and on the bottom is facing south. Photographs from the 2005 inspection are included in Appendix A.

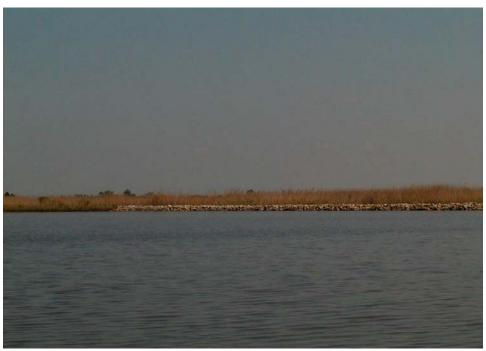
Photo 1—west tie in (April, 2005)

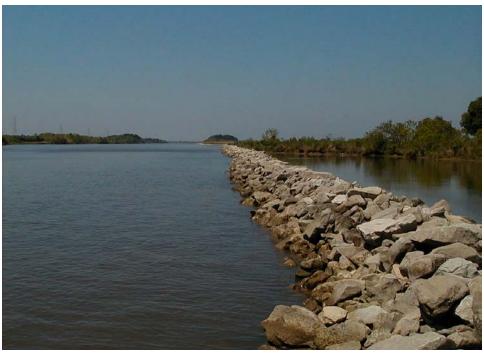
The dike is in excellent condition. No apparent need for any maintenance at this time.

Photo 2—typical section of dike (April, 2005)

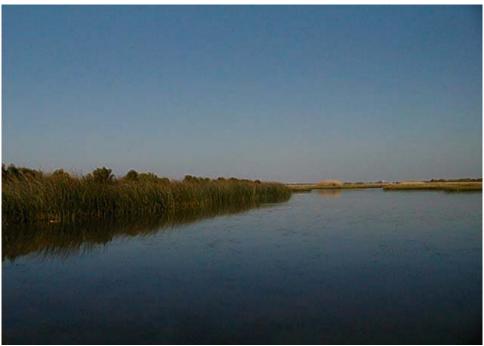
Approximately 800 linear feet (243.8 m) of the earthen terraces was experiencing little to no establishment of vegetation on the terraces. The area will be monitored to determine if a small vegetation maintenance project is necessary in the future. The remaining 22,152 linear feet (6752 m) is in excellent condition with dense vegetation noted throughout.

Photo 3—typical terrace (April, 2005)

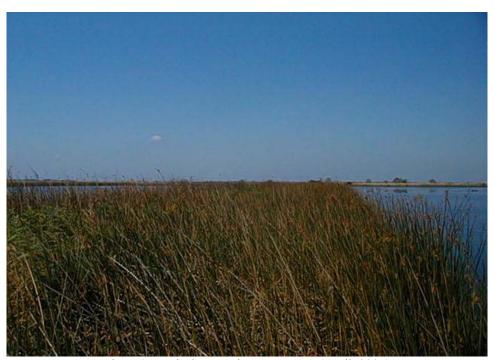
Photo 4—typical vegetation on terraces (April, 2005)
