**2005 Operations, Maintenance,
and Monitoring Report**

Cameron Prairie Refuge Protection

State Project Number ME-09
Priority Project List 1

June 2005
Cameron Parish

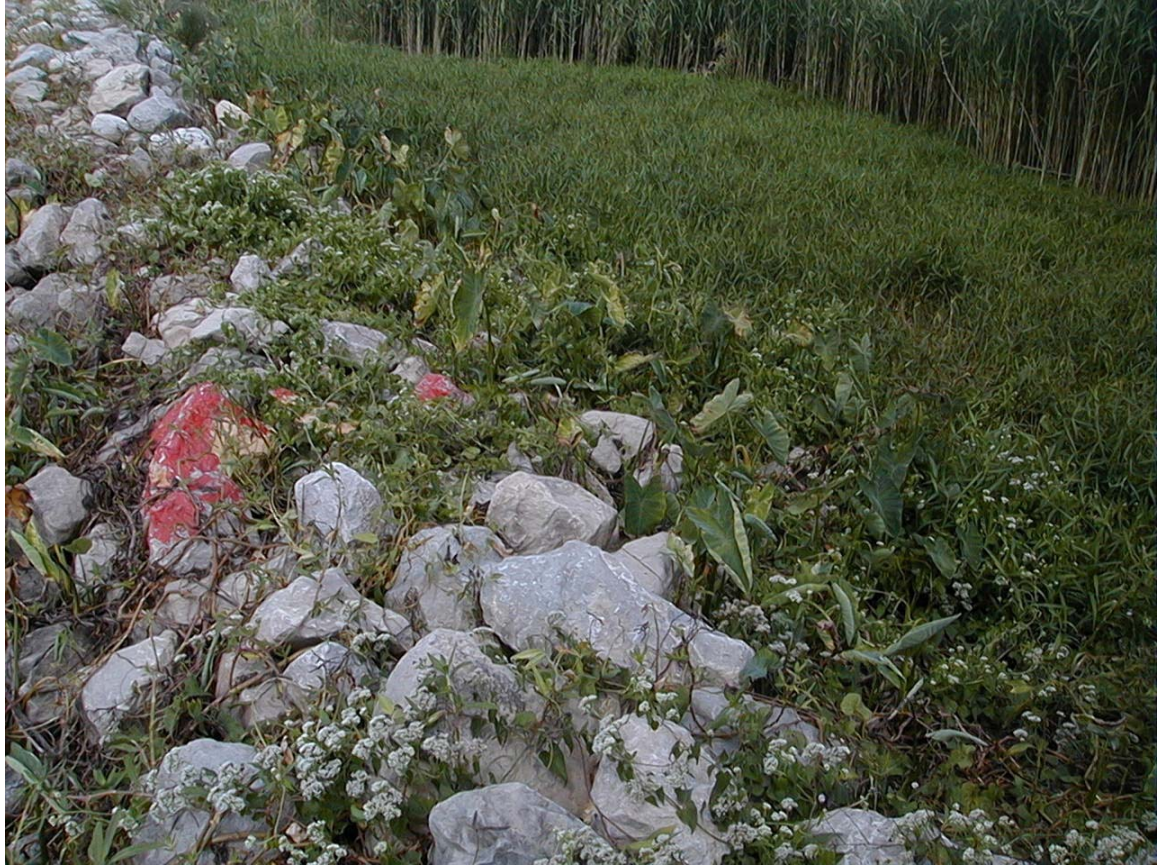
The project has been effective at preventing shoreline erosion at all project area stations and has caused progradation of the shoreline at many stations (figures 6-7). There is no evidence of shoreline progradation at the reference stations, and most show shoreline retreat. Visual observation indicates vertical accretion of the wetland area at many locations between the foreshore rock dike and the shoreline

As a result of the accretion occurring behind the rock dike, natural freshwater vegetation has colonized behind and over the rock dike. The colonization of the vegetation created a navigation hazard for marine vessels traveling the GIWW at night and during low visibility situations. In 2001, the U.S. Army Corps of Engineers addressed the hazard by installing pilings with navigation warning signs. In the future, similar projects implemented in freshwater areas should include navigation warning signs in the initial construction contract.

Figure 7. View of the Cameron Prairie rock dike showing naturalized vegetation colonizing the dike itself and the accreted marsh behind the dike. The red paint was used to mark the location of the shoreline marker for the DGPS survey.

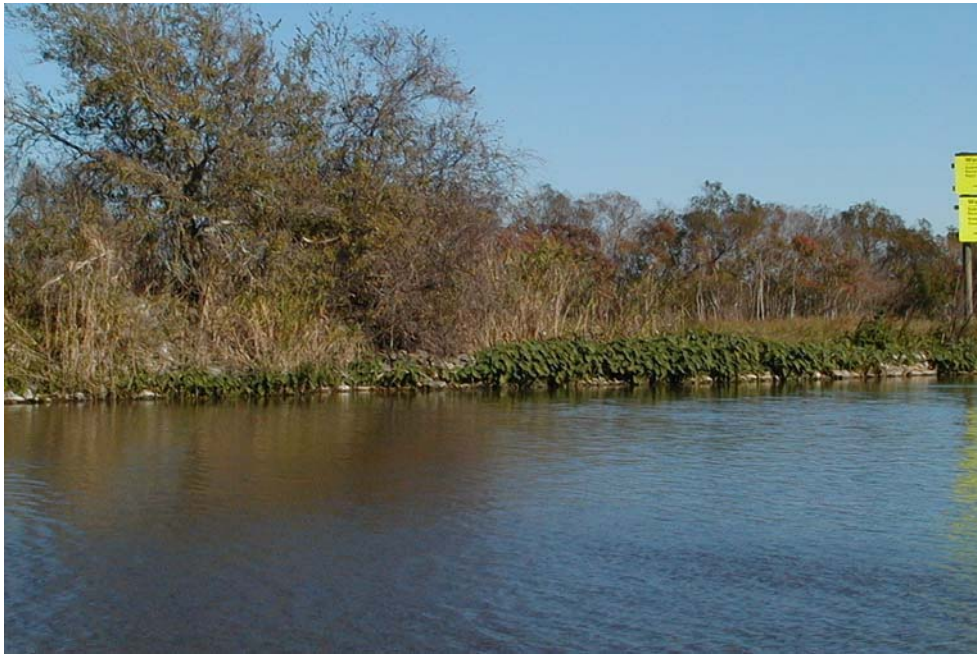
The dike is in excellent post construction condition. No need for any maintenance in the foreseeable future. (Photos: Appendix A, Photos 1 - 5)

Photo 1—west tie in

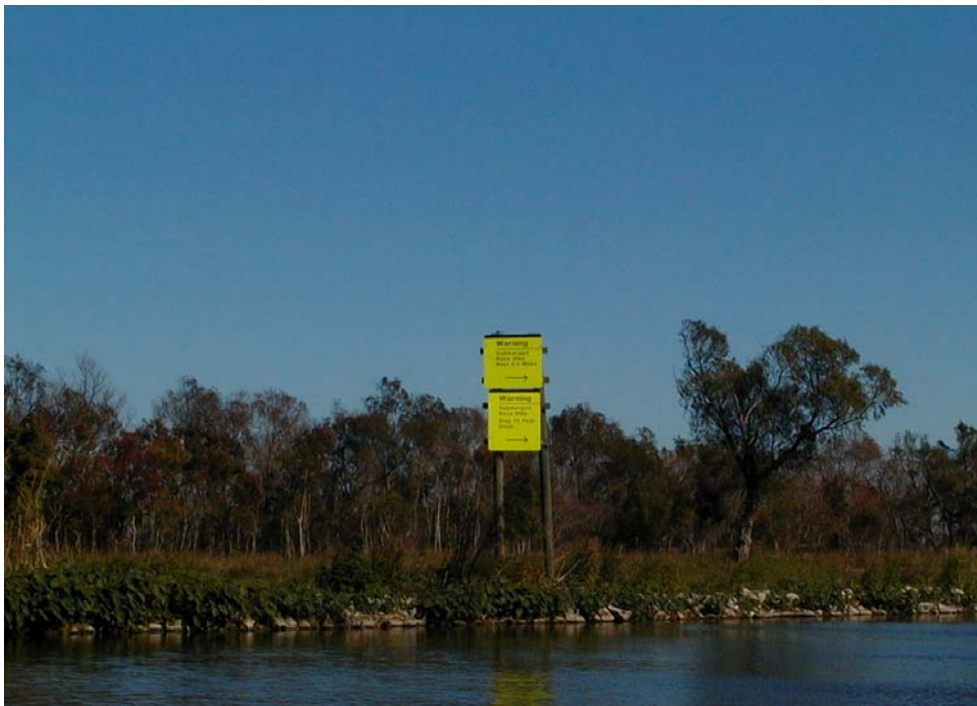
The U.S. Army Corps of Engineers (USACE) added warning signs along the northern boundary of the project in August 2001 in response to complaints from the commercial traffic traveling along the GIWW. This is not a project feature to be maintained through the Coastal Wetlands Planning, Protection and Restoration Act (CWPPRA).

Photo 2—signs installed by USACE

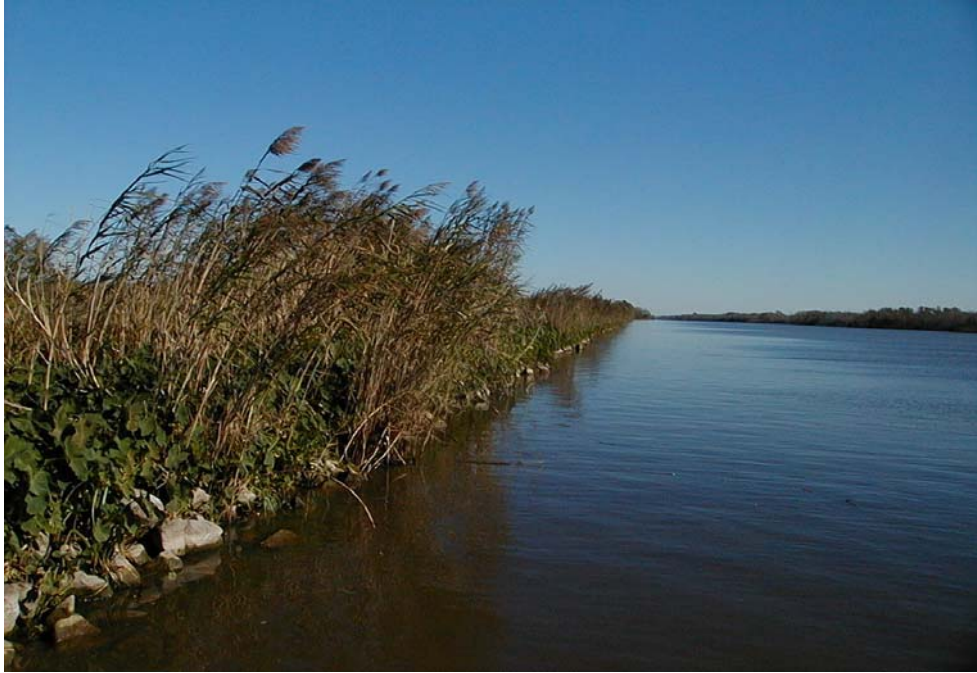
Photo 3—typical section of dike covered in vegetation

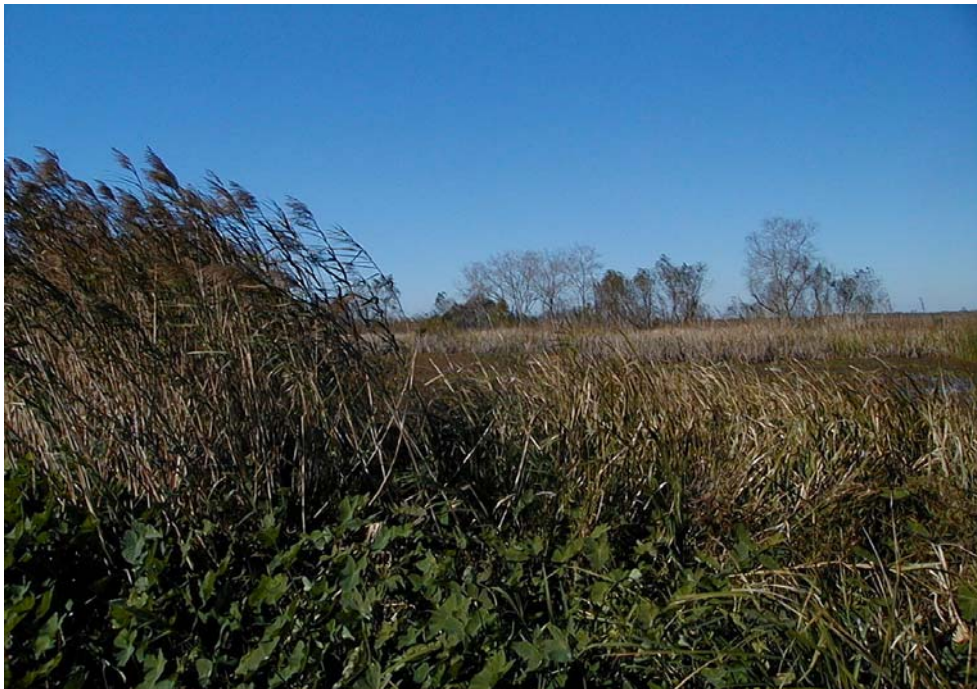
Photo 4—build-up behind dike

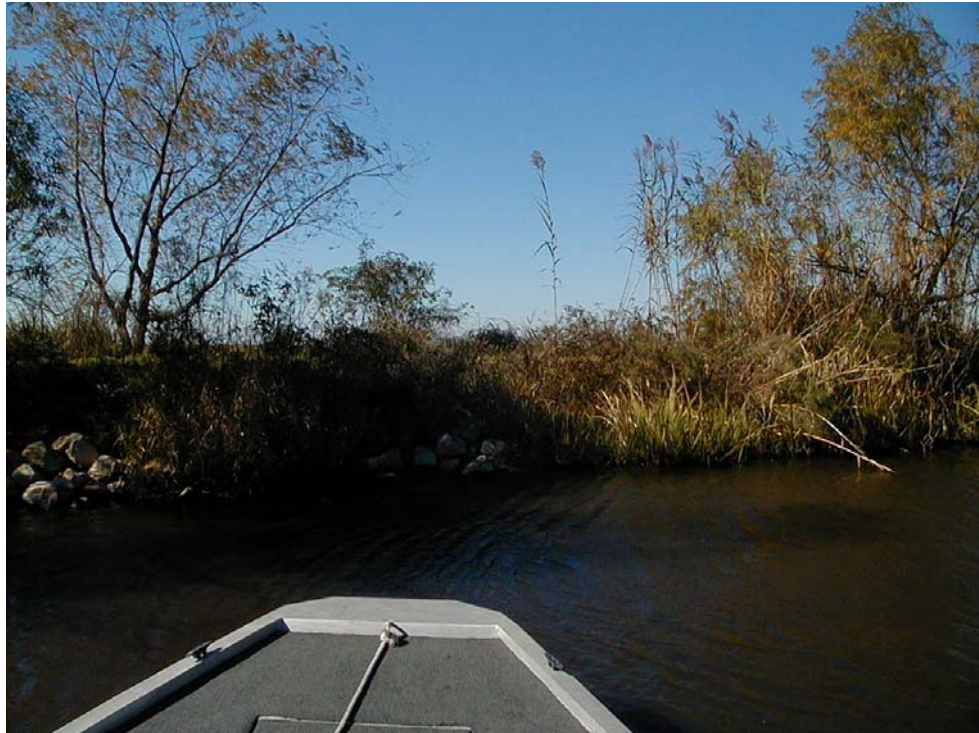
Photo 5—tie in on North Prong Canal
