**2005 Operations, Maintenance,
and Monitoring Report**

**POINT AU FER ISLAND
HYDROLOGIC RESTORATION**

State Project Number TE-22
Priority Project List 2

August 2005
Terrebonne Parish

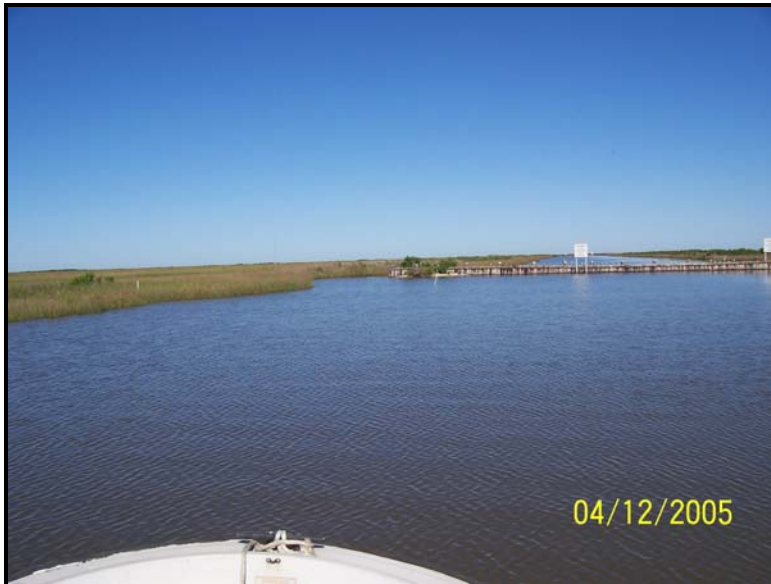
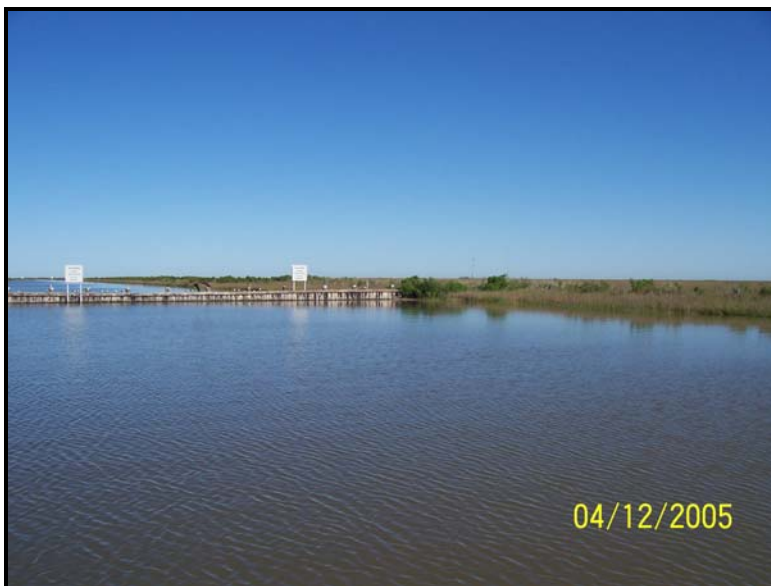
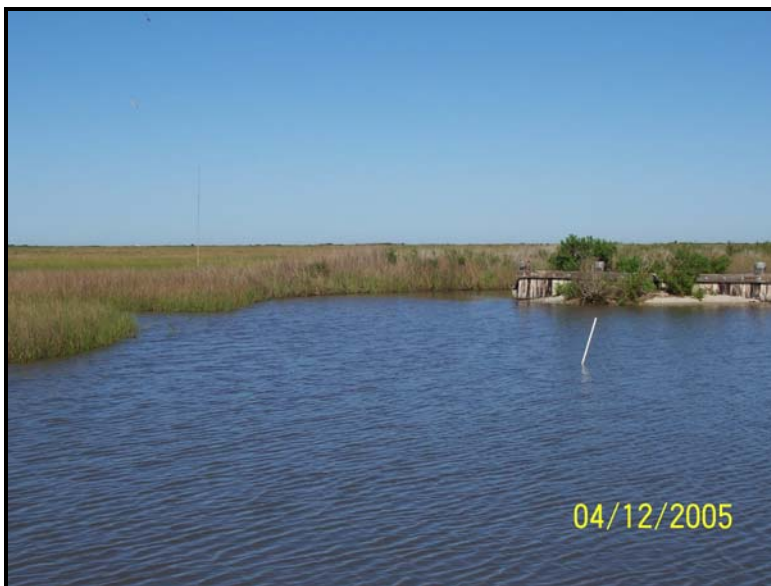
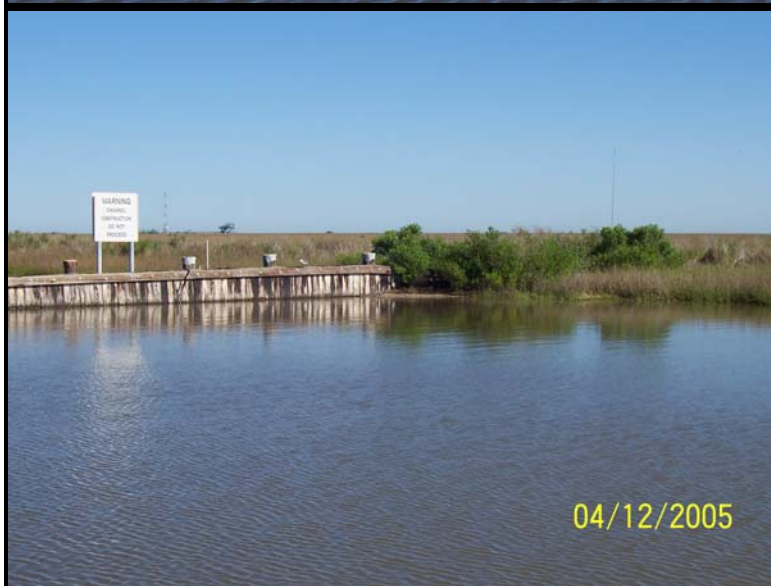
The timber bulkhead plug across Hester Canal east of Transco Canal appeared to be in good condition with no noticeable structural defects. The breach around the south tie-in is still active and may have become a little larger since last year's inspection. The north tie-in at the canal bank had no apparent signs of erosion. The warning signs and supports were in good condition. The breach around the south side has been surveyed, and a breach repair is being designed as noted earlier. No other maintenance will be required at this site. Pictures acquired during the inspection are in Appendix A, Photos 1 - 4.

The Point Au Fer Island Hydrologic Restoration (TE-22) - Breach repairs project has been designed and construction is scheduled to begin some time this summer (2005). Included in this project is the extension of the Plug No. 8 bulkhead (approximately 60 LF [18.2 m]) to close off an existing breach; the capping of approximately 400 ft (122 m) of articulated mats on the east side of Plug No. 4A with limestone rip rap and a marsh tie-in to prevent the possible breaching from the gulf into Transco Canal; and a marsh tie-in using limestone rip rap from the east end of the Area 4 rock dike to close off an existing breach from the gulf into Mobil Canal.

Photo 3. *Plug No. 8 – View of south tie-in, date: 4/12/05. Breach to be repaired under TE-22 O&M Project.*

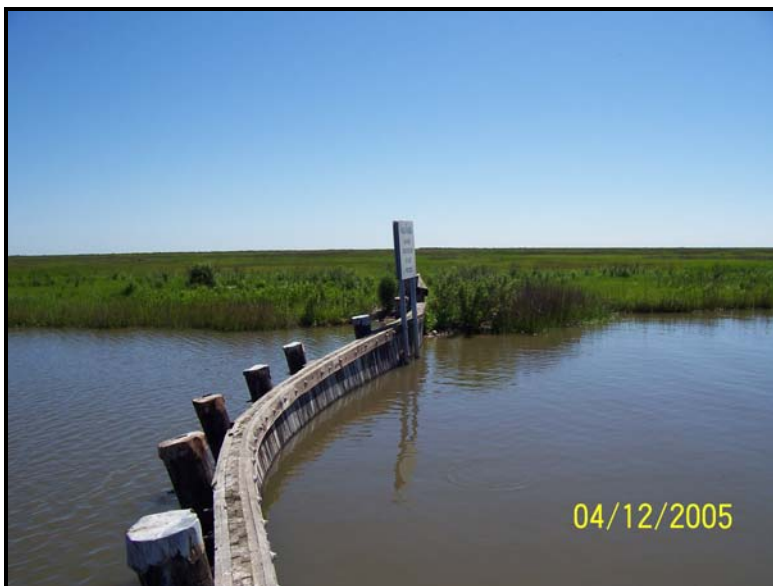
The timber bulkhead plug located across Transco Canal south of Hester Canal appeared to be in fair condition. The timber bulkhead was bowed in the center, off alignment approximately 6 to 7 feet. The tie-ins at the banks had no apparent signs of erosion. The warning signs and supports were also in good condition. Pictures acquired during the inspection are in Appendix A, Photos 5 and 6.

Photo 5. *Plug No. 6 – View of plug deformation from centerline of plug looking east, date: 4/12/05*

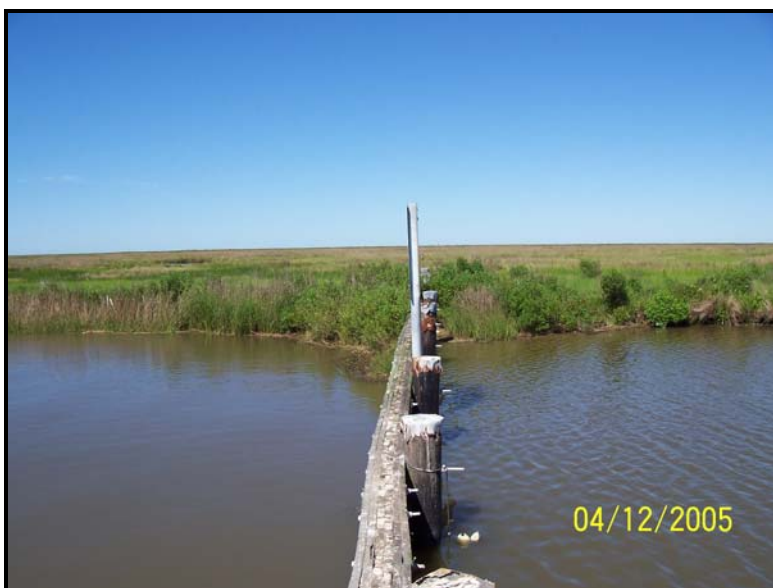
Photo 6. *Plug No. 6 – View of centerline of plug looking west, date: 4/12/05*

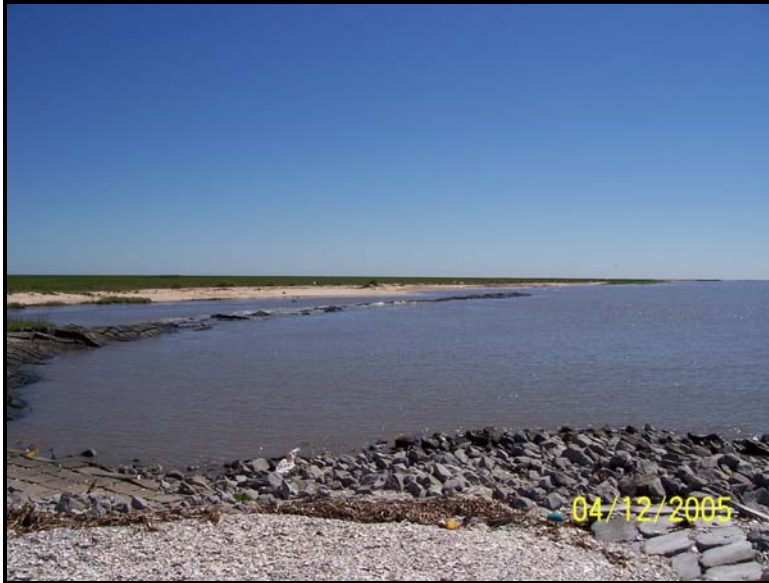
The Transco Canal bulkhead consists of steel sheetpile with timber whalers and rock armoring/plug (constructed by others). Articulated concrete mats were installed on the west and east sides of the bulkhead during Phase III of the project. The steel sheet pilings were rusty the entire length of the bulkhead, and some of the tie rods were corroded through and disconnected from the sheetpile wall. However, the bulkhead was well-aligned and not leaning. It was noted that there is a small breach around the bulkhead and on top of the rock where, during high tides, the water can flow into Transco Canal. Also it seems that, during high tides, the water will overflow the weir near the center and flow into the canal. The rock armoring/plug appeared to be in good condition. The articulated concrete mats on the east side were in poor condition with apparent overall and differential settlement of the mats along the length. We also observed erosion behind the mats due to over wash from the Gulf of Mexico and flow around the breach at the end of the structure which could eventually lead to a breach into the Transco Canal through the marsh. The articulated concrete mats on the west side appeared to be in good condition. Pictures acquired during the inspection are in Appendix A, Photos 7 – 15.

Photo 7. *Plug No. 4A – View of east petraflex mats looking east, date: 4/12/05. Mats will be capped with limestone rip rap under TE-22 O&M Project.*

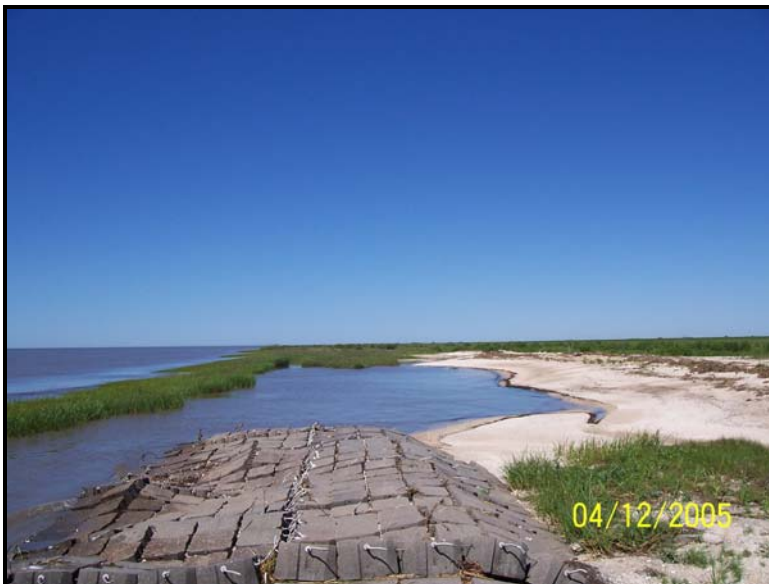
Photo 14. *Plug No. 4A – View of the end of the west petraflex mats looking west, date: 4/12/05. Shoreline adjacent to mats is beginning to erode behind mats.*

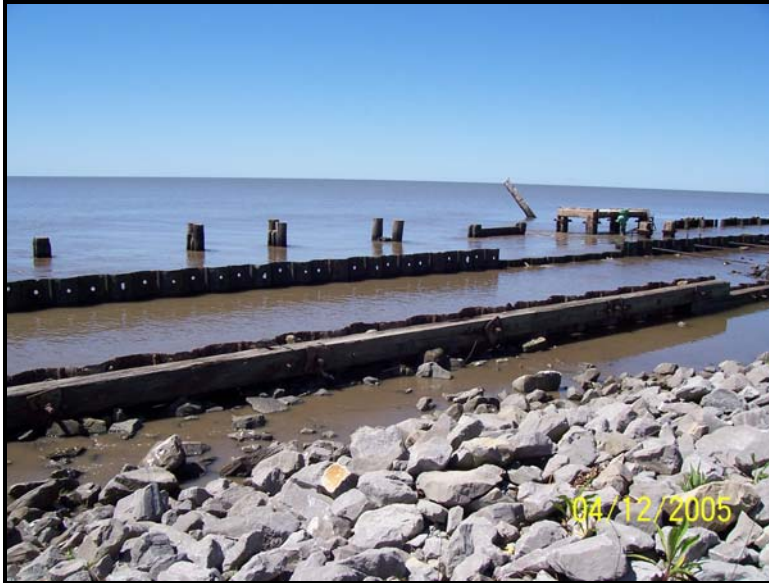
Photo 15. *Plug No. 4A – View of bulkhead looking south, date: 4/12/05. Small breach just behind bulkhead where water is exchanging with Transco Canal at high tidal events. Also lower middle section of bulkhead can be seen where bulkhead is being overtopped in high tidal events.*

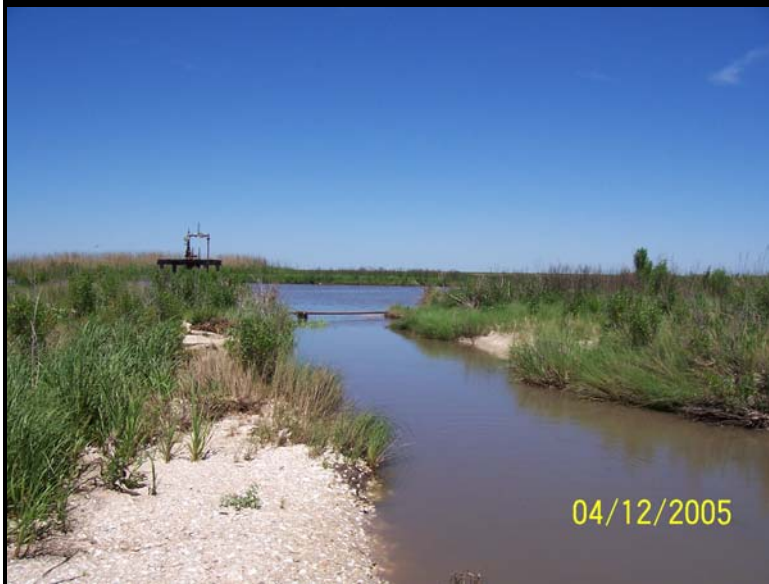
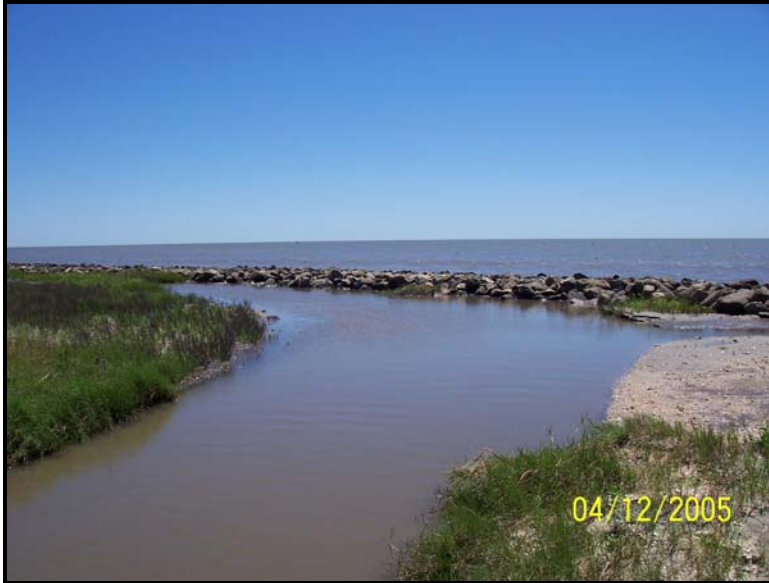
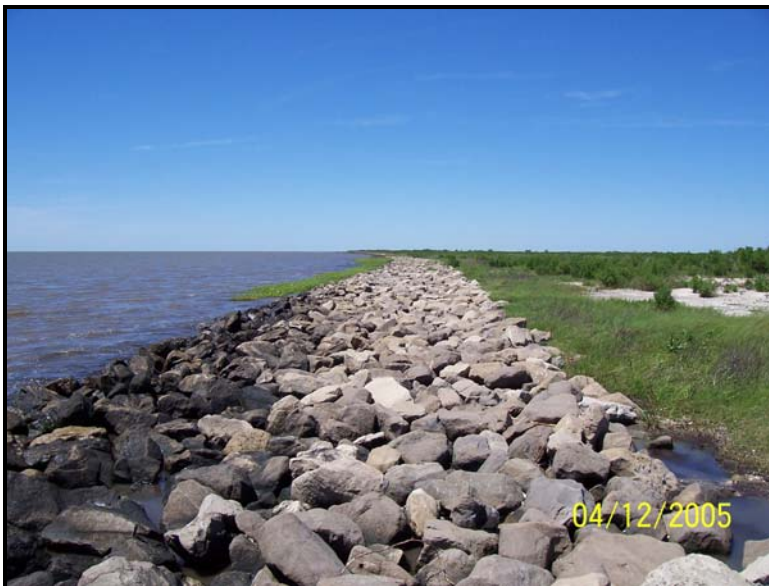
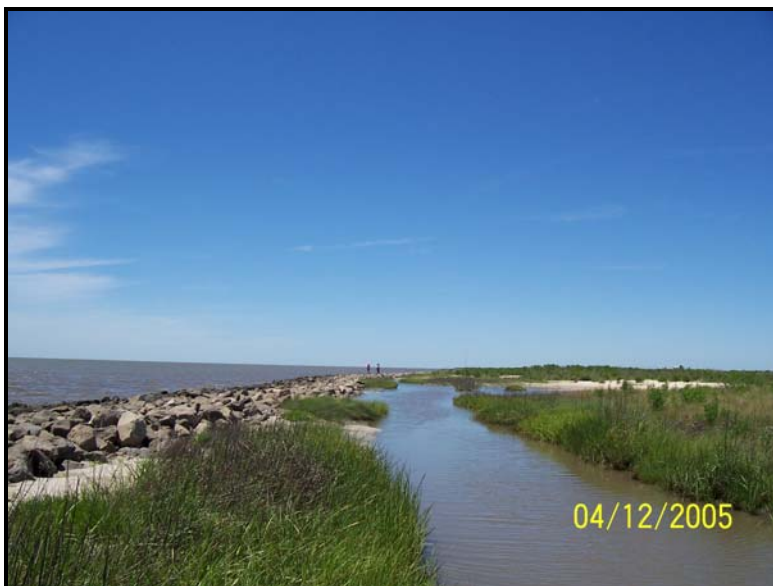
The rock dike along Area 4 of Phase III appeared to have some noticeable settlement of the structure. The average height of the dike is approximately 1 ft (0.3 m) above marsh level and it seems that during high tidal events and/or high wave action that the dike is being over washed. The breach around the east end of the dike does not seem to be any worse than last year. Pictures acquired during the inspection are in Appendix A, Photos 16 – 21.

In Phase III - Area 4 the rock dike appears to have settled and is being over washed during high tidal and wave action events. A survey of the rock dike should be conducted to verify the elevation of the dike and to determine if any action is necessary.

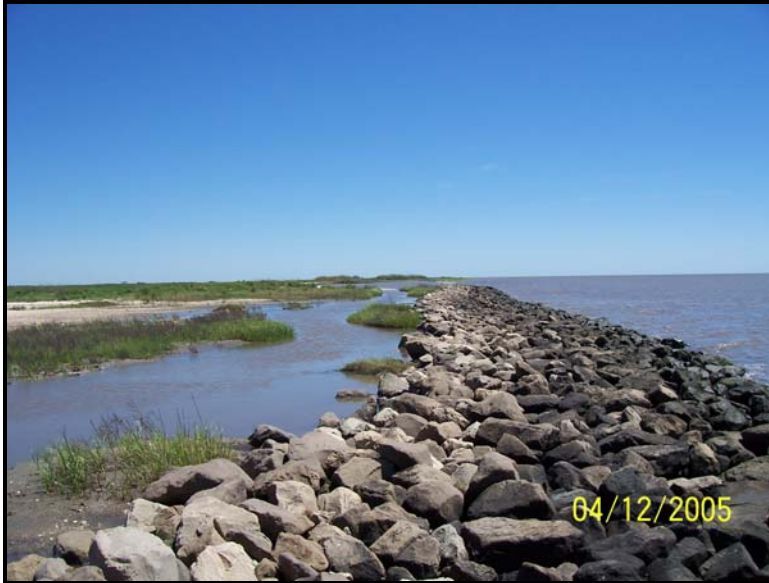
Photo 19. *Area 4 Rock Dike – View of rock dike from end of Mobil Canal looking southeast, date: 4/12/05. Rock dike elevation appears to be very low.*

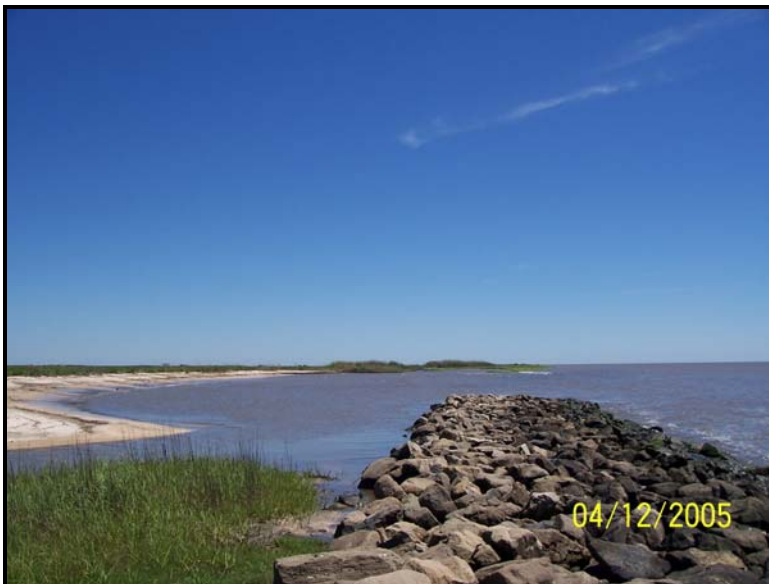
Photo 20. *Area 4 Rock Dike – View of east end of rock dike looking southeast, date: 4/12/05. Adjacent shoreline is eroded approximately 50 – 75 feet behind rock dike.*
