**2005 Operations, Maintenance,
and Monitoring Report**

**EAST TIMBALIER SEDIMENT
RESTORATION, PHASES 1 & 2**

State Project Number TE-25 & TE-30
Priority Project List 3

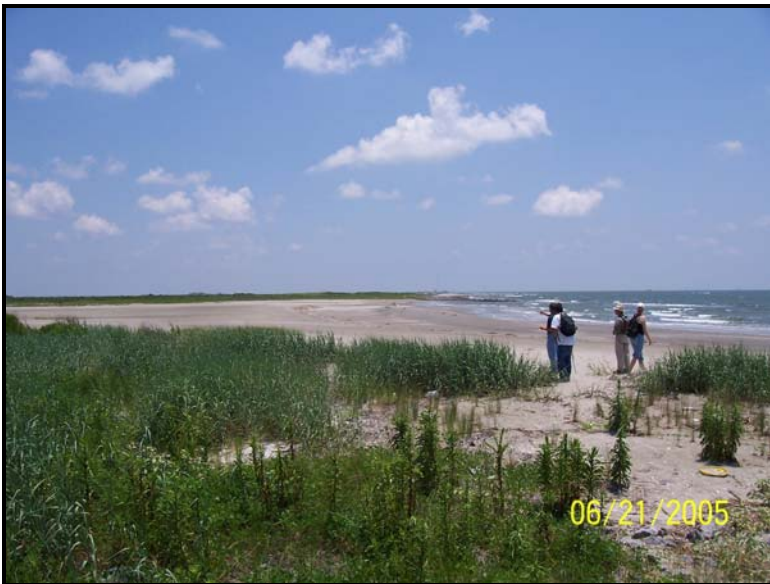
Photo 5. Sta. 28+50, View of marsh platform sand overwash looking east (100_0448.jpg). Note scoured dune area of lower elevation in background.

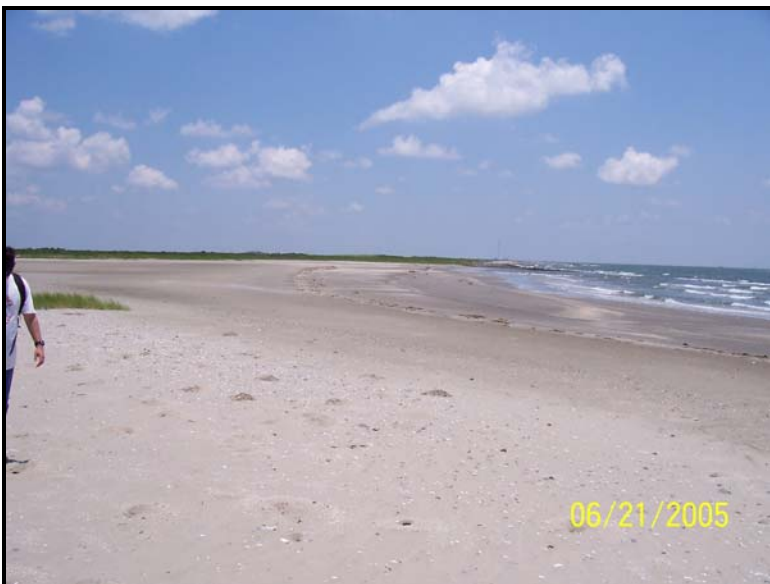
Photo 6. Sta. 29+00, View of marsh platform sand overwash looking east (100_0449.jpg).

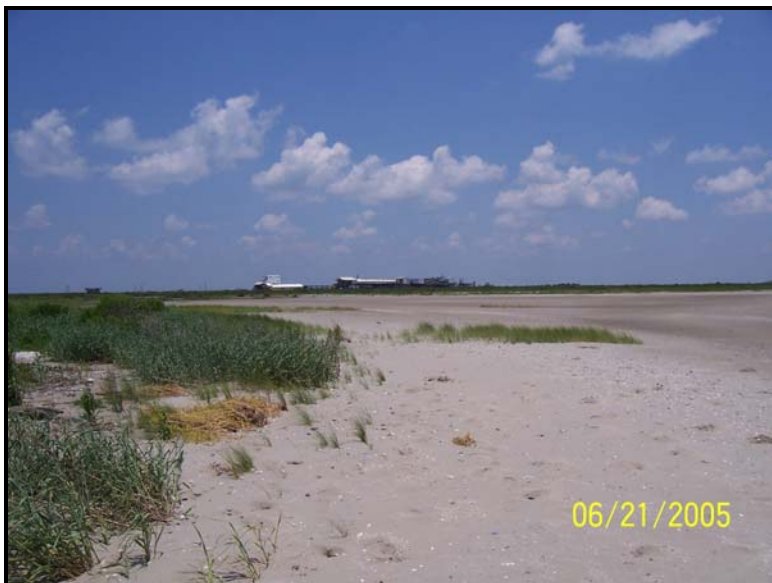
Photo 7. Sta. 29+00, View of marsh platform sand overwash looking northeast (100_0450.jpg).

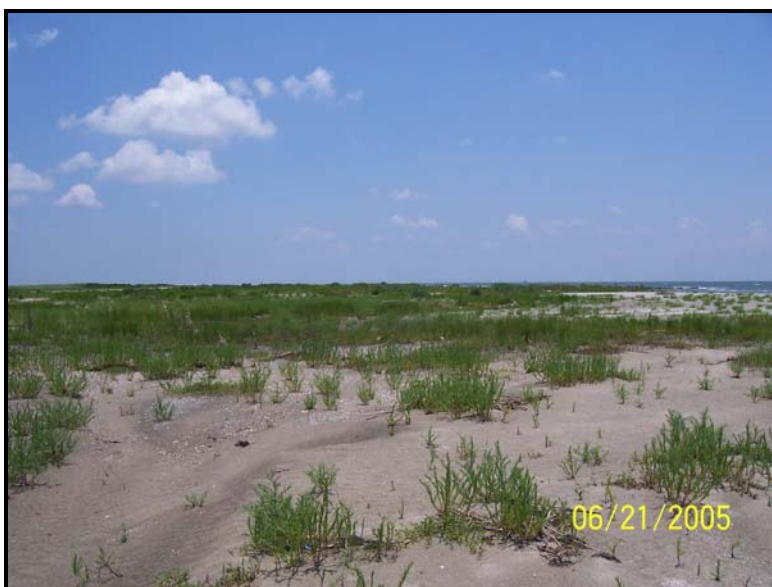
Photo 8. Sta. 41+00, View of marsh platform sand overwash looking east (100_0451.jpg).

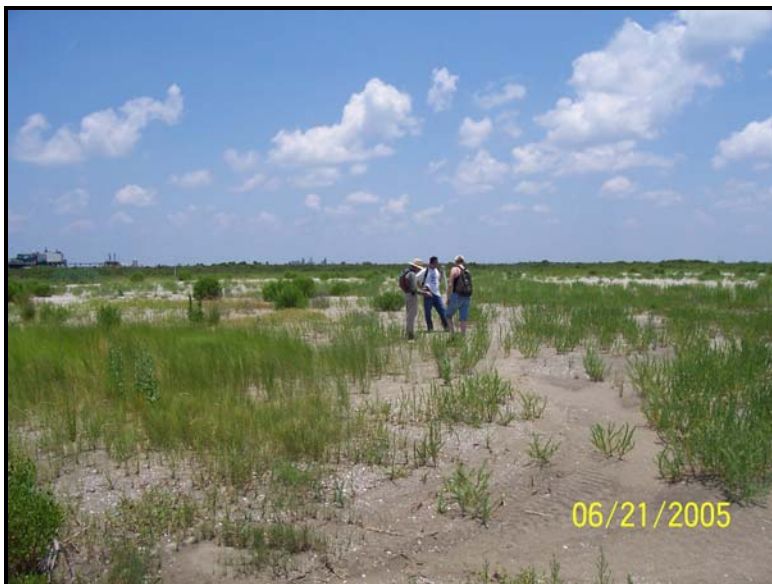
Photo 9. Sta. 41+00, View of marsh platform sand overwash looking northeast (100_0452.jpg).

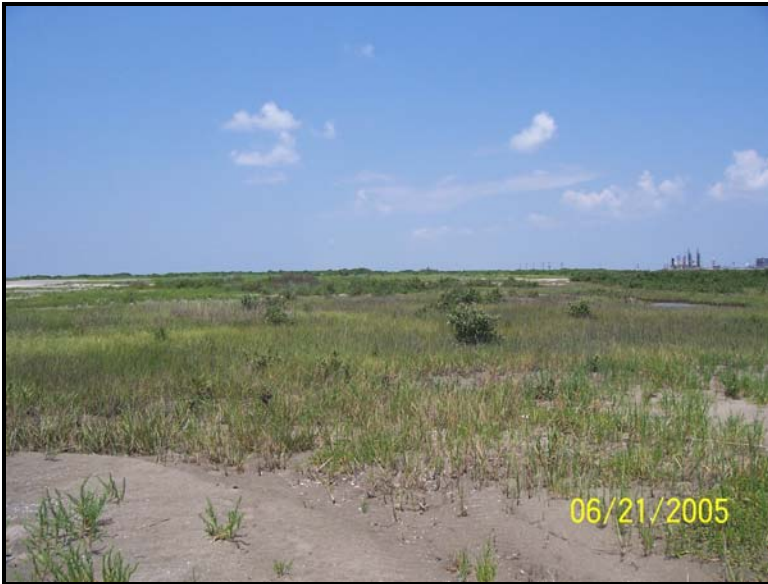
Photo 10. Sta. 41+00, View of marsh platform sand overwash looking west (100_0453.jpg).

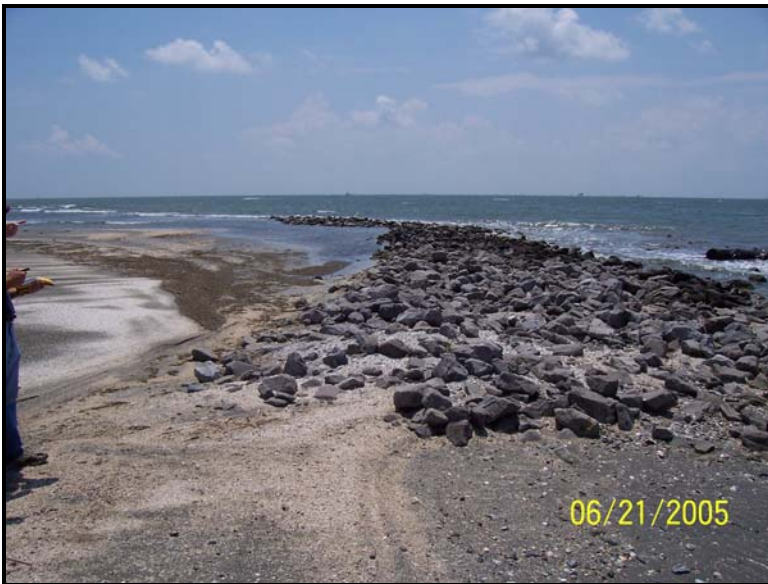
According to the as-built plans, the revetment consisted of Class 440 lb riprap constructed along the gulf-side face of the front containment dike. The rock revetment associated with the project could not be seen other than the tops of a few rocks when the gulf waves would break. Presently, only open water or sloping beach face exists behind the rock revetment. At the western portion of TE-25 it appears from aerial photographs that the revetment located along the western end and the southwest corner are no longer visible (Station -4+00 to 1+00). This also appears to be the case in the southeast corner of this area. The storms of late 2002 removed sediment in these areas (Station 6+00 to 9+00). The rocks were apparently scattered by the storms or leveled to an elevation below the tide. Also, the revetment along the shoreline that could be seen at the west end appears to be a much smaller class of rock. It is not clear if this revetment is from the project, rock placed by the oil company, or a combination of both (Appendix A, Photo 1). Generally, it appears that as the dune fill continues to erode or overwash onto the marsh platform and as the island experiences rollover, the rock revetment will remain isolated in front of the island as the island continues to retreat.

Photo 11. Sta. 44+00, View of rubble mound revetment tie-in at "old" rocks looking southeast (100_0443.jpg).

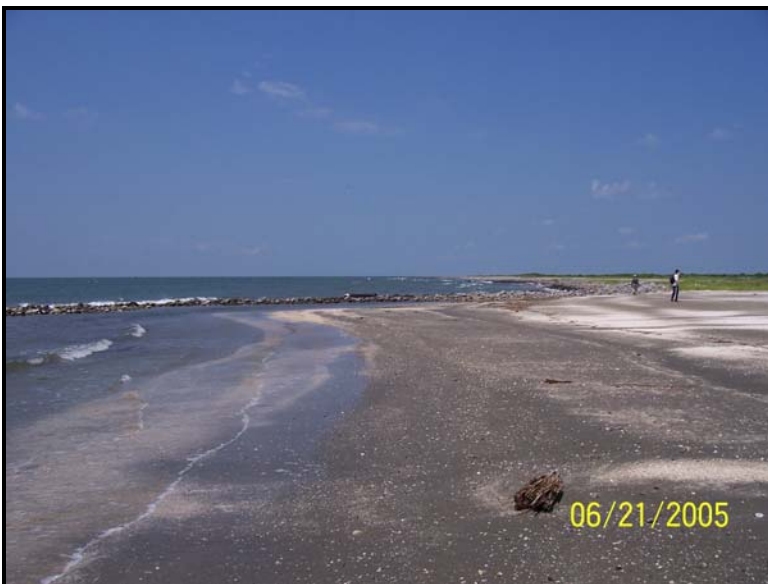
Photo 12. Sta. 44+50, View of rubble mound revetment tie-in at "old" rocks looking west (100_0441.jpg).

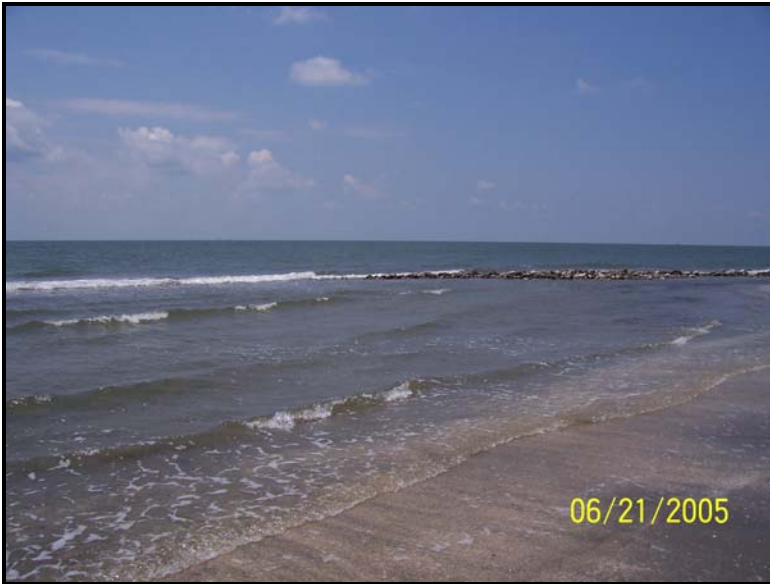
Photo 13. Sta. 44+50, View of rubble mound revetment tie-in at “old” rocks looking southwest (100_0442.jpg).

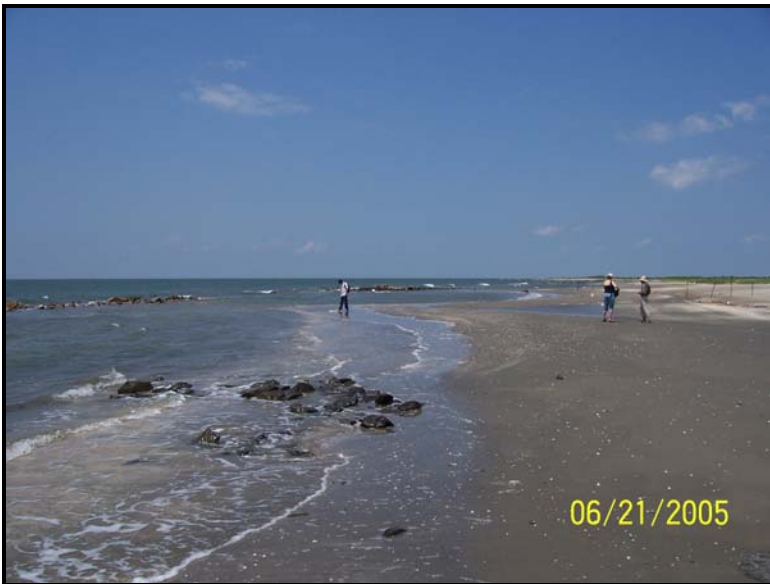
Photo 14. Sta. 50+50, View of rubble mound revetment looking west (100_0438.jpg).

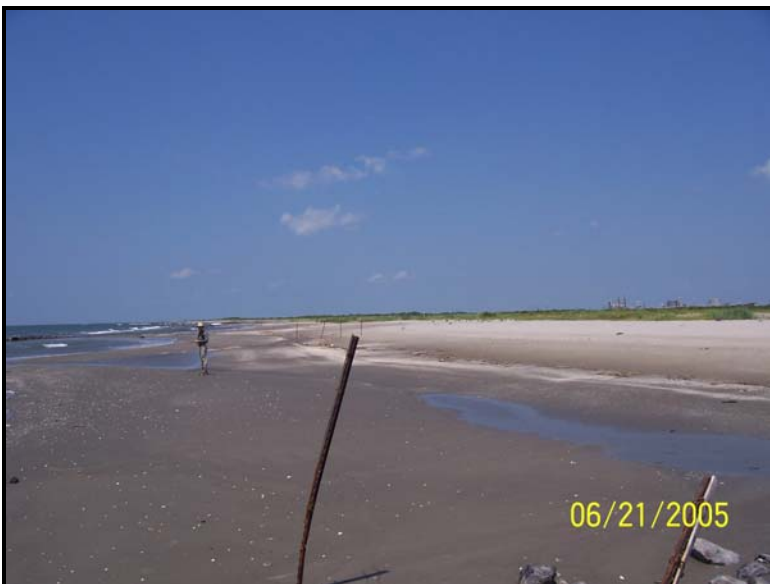
No sand fencing was found completely intact during the inspection. Some fence posts remained on the TE-25 project (Appendix A, Photos 15, 20-21). The late 2002 storms appeared to have removed the sand fencing from the project area.

Photo 15. Sta. 50+50, View of dune fill looking west (100_0440.jpg).

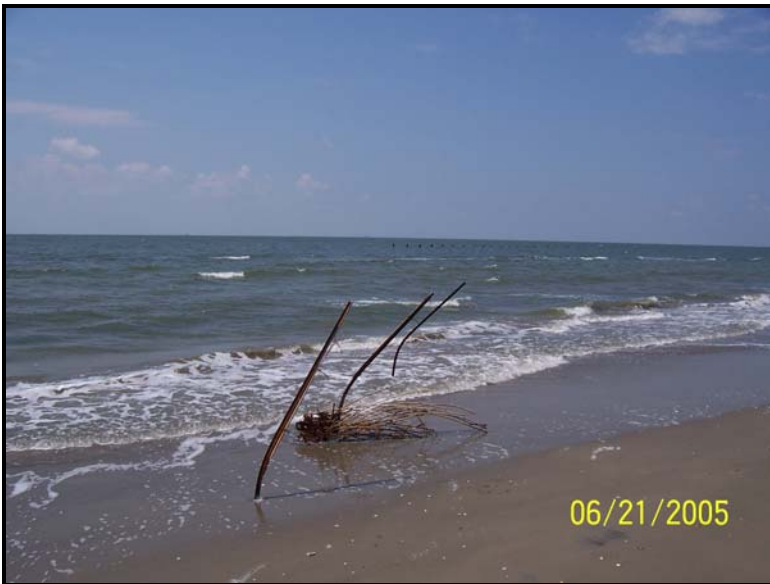
Photo 20. Sta. 64+50, View of sand fencing posts looking southwest (100_0437.jpg).

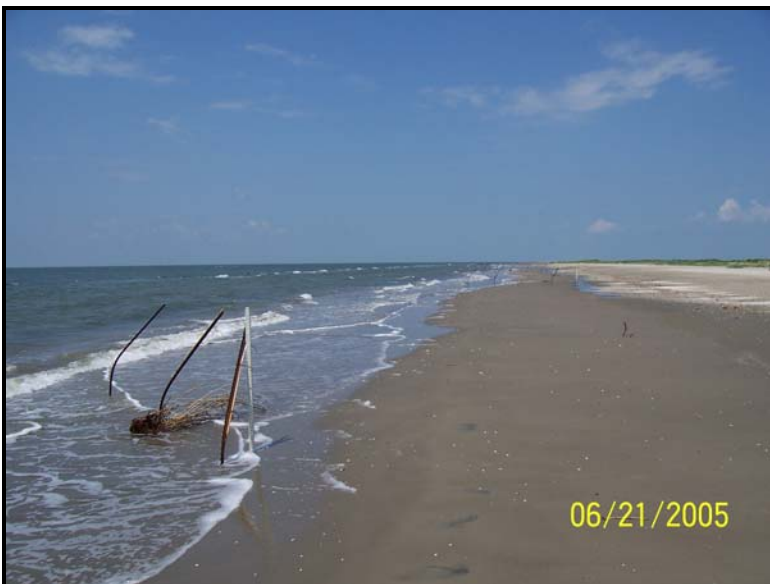
Photo 21. Sta. 64+50, View of sand fencing posts and dune fill looking west (100_0435.jpg).

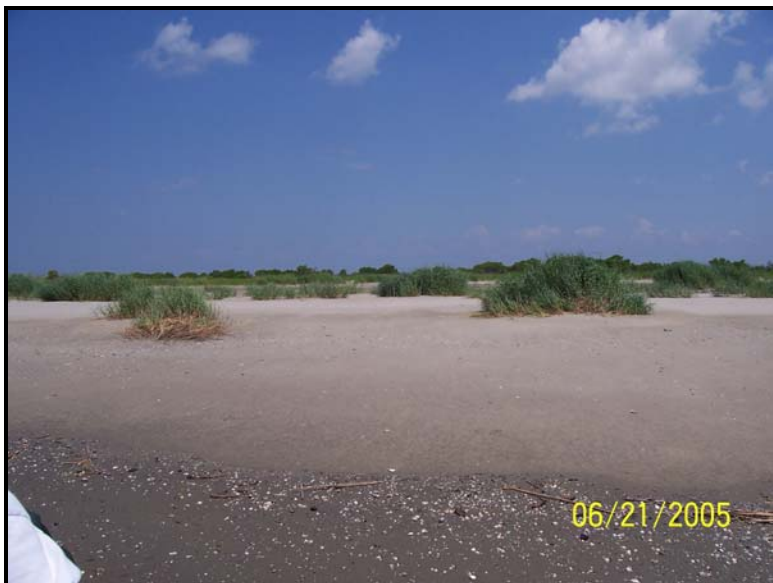
Photo 22. Sta. 64+50, View of marsh platform and sand overwash looking north (100_0436.jpg). Note dune formation on top of marsh platform as island overwashes.

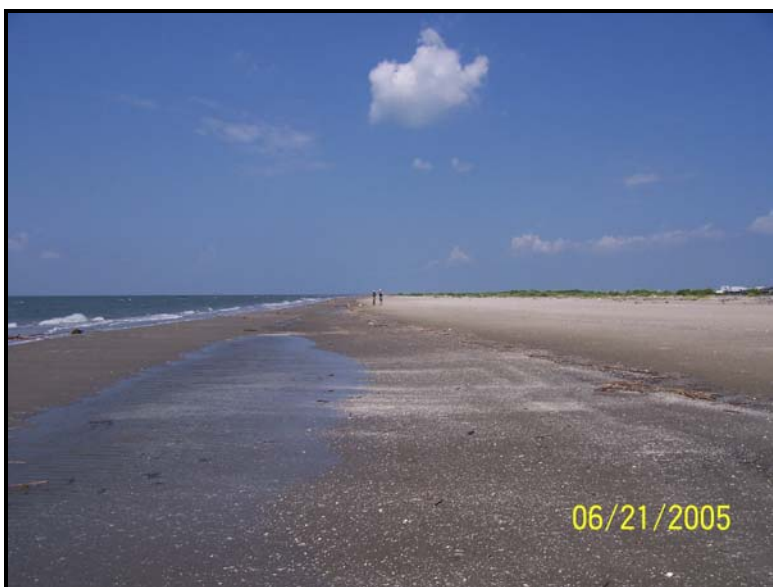
Photo 23. Sta. 78+50, View of remaining dune fill and marsh platform with sand overwash looking west (100_0434.jpg).

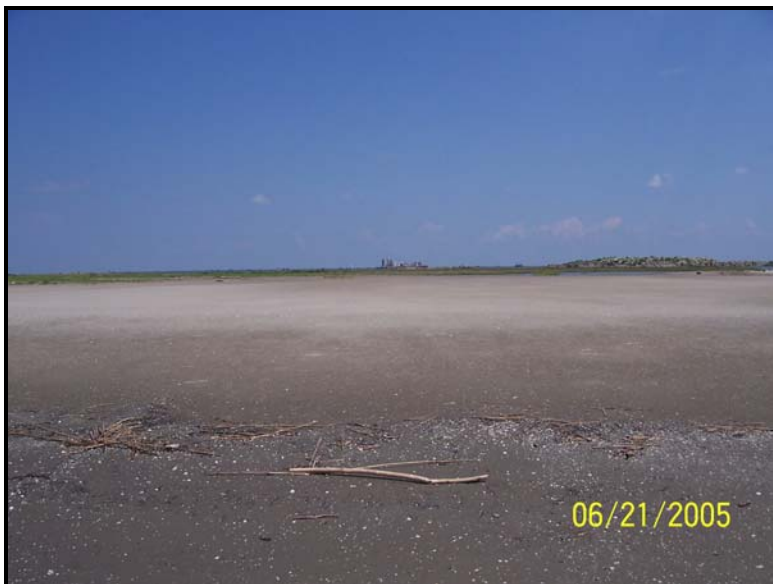
Photo 24. Sta. 78+50, View of marsh platform with sand overwash looking north (100_0433.jpg).

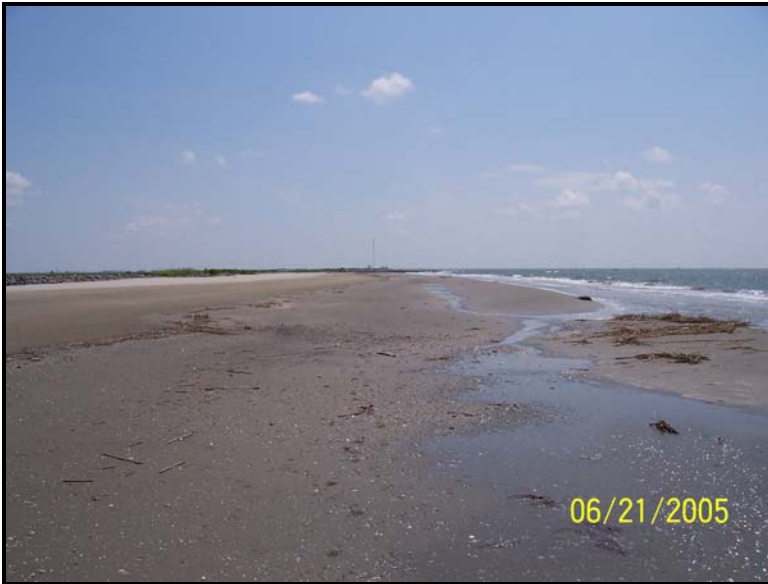
Photo 25. Sta. 78+50, View of remaining dune fill and marsh platform with sand overwash looking east (100_0432.jpg).

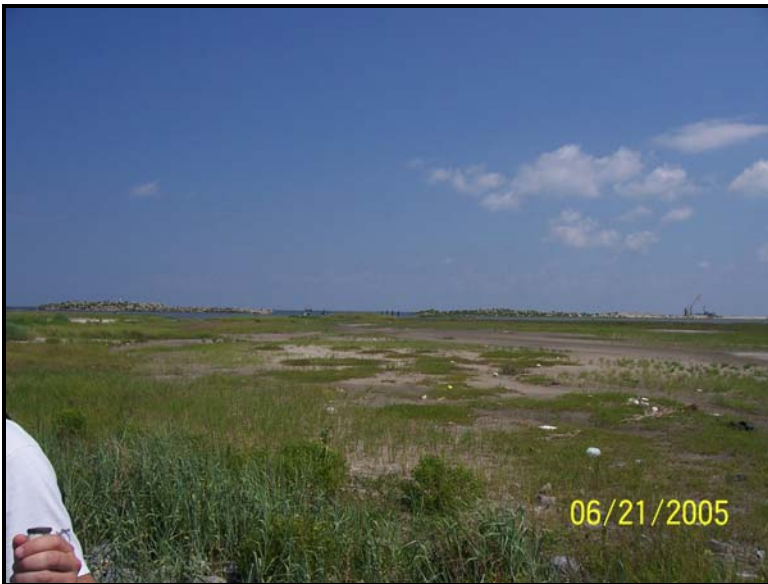
construction has had profound effects on the dynamics of the sediment movement. The rocks are believed to have been originally placed to protect island infrastructure. The rocks trapped dune sediment in some areas holding sediment and protecting the back barrier marsh from washover. However, gaps in the revetment have promoted scouring of dune sediment and washover into the marsh. In some areas of the island, much of the dune sediment appears to have been washed over onto the marsh platform. On the east end, sediment continues to move to the bayside of the island. In fact, dredging by the oil company along the back of the island has been ongoing in order to maintain an access channel for the oil and gas infrastructure. Much of this material is probably sediment from the project that has moved to the back of the island. The dredged material has been stacked on the bayside of the island alongside the access channel (Appendix A, Photos 29-30).

Photo 29. Sta. 89+00, View of remaining marsh platform of TE-30 project and maintenance dredging spoil material (background) looking north (100_0426.jpg).

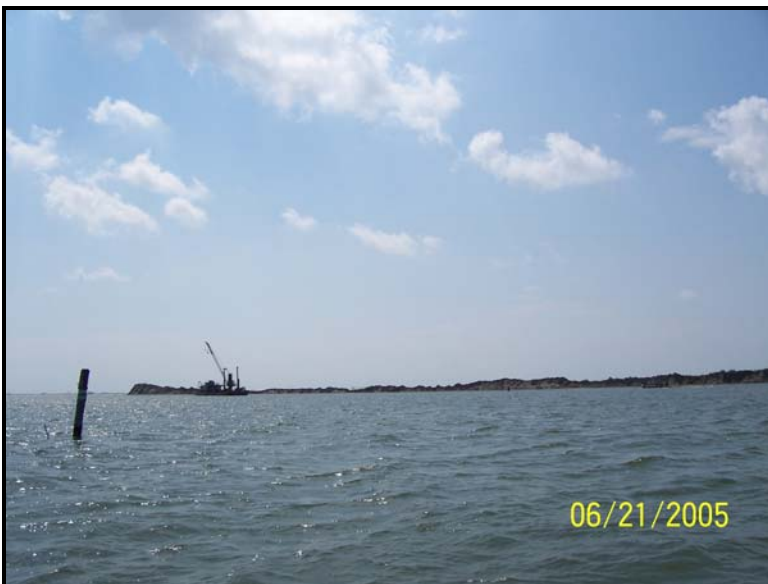
Photo 30. View of maintenance dredging spoil material from access canal north of TE-30 project looking south (100_0423.jpg).
