**State of Louisiana  
Department of Natural Resources  
Coastal Restoration Division and  
Coastal Engineering Division**

**2005 Operations, Maintenance,  
and Monitoring Report**

**Marsh Island Hydrologic  
Restoration**

State Project Number TV-14  
Priority Project List 6

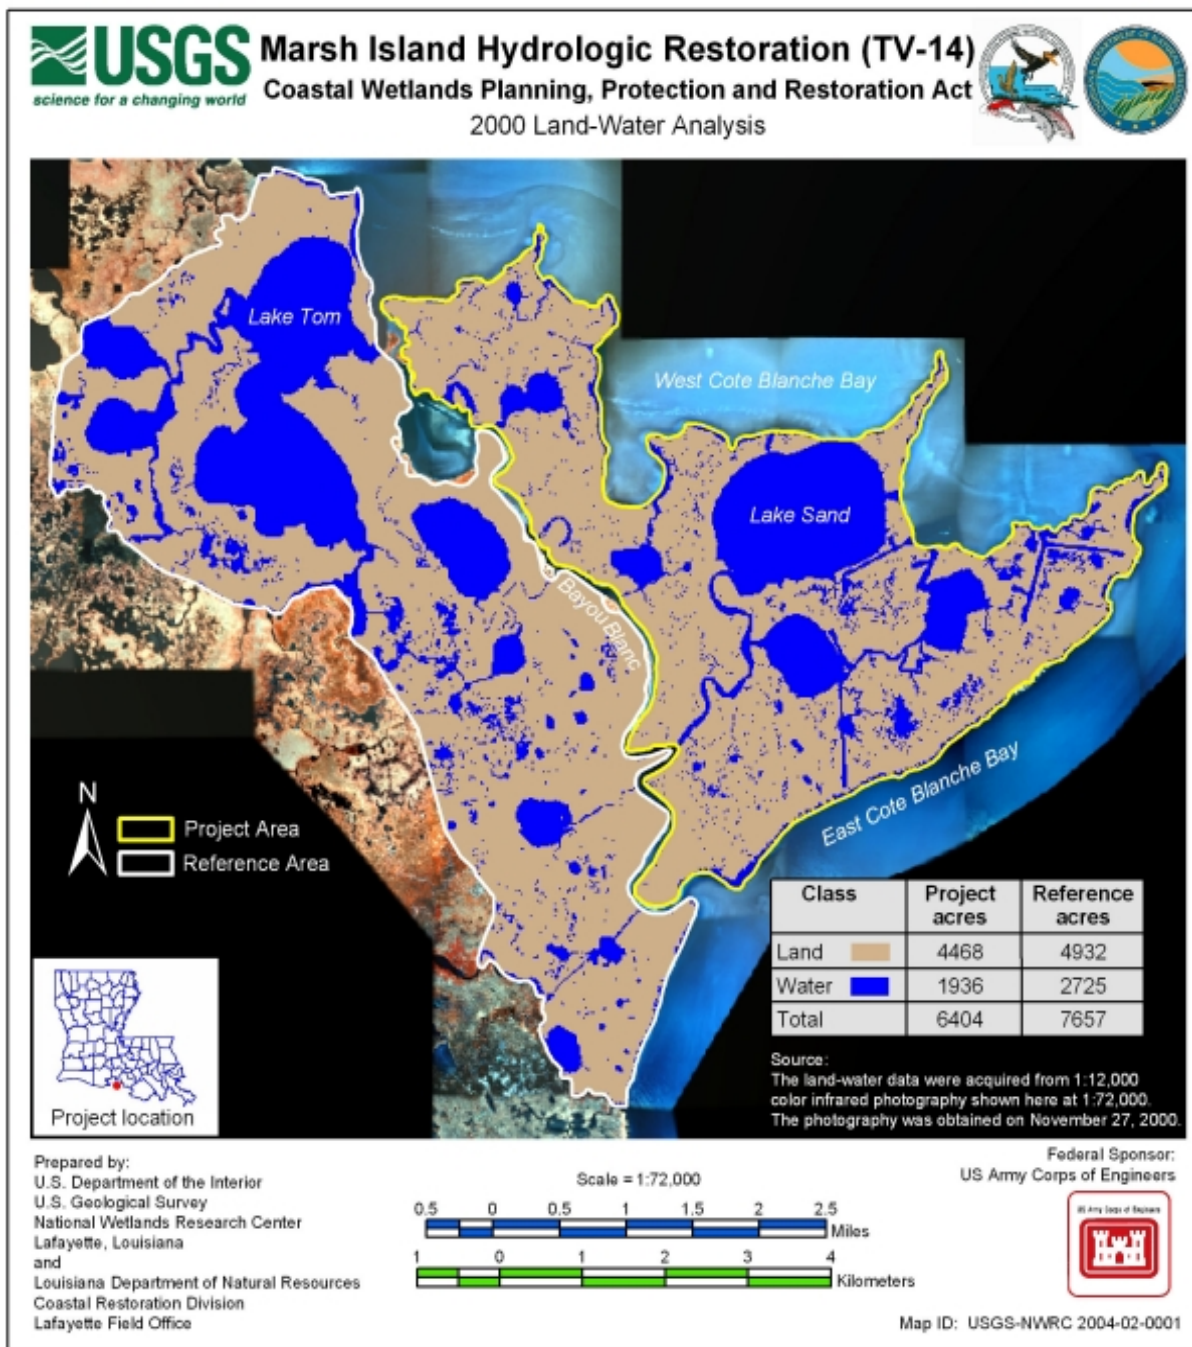
**Figure 7.** Results of the 2000 land:water GIS image classification for the TV-14 project and reference areas from aerial photography taken November 27, 2000.

Pre-construction classification (2000) indicated 69.8% land and 30.2% water within the project area and 64.4% land and 35.6% water within R1 (figure 7). The next scheduled aerial photography was collected in November 2004 and the classified imagery obtained will be included in the next report.

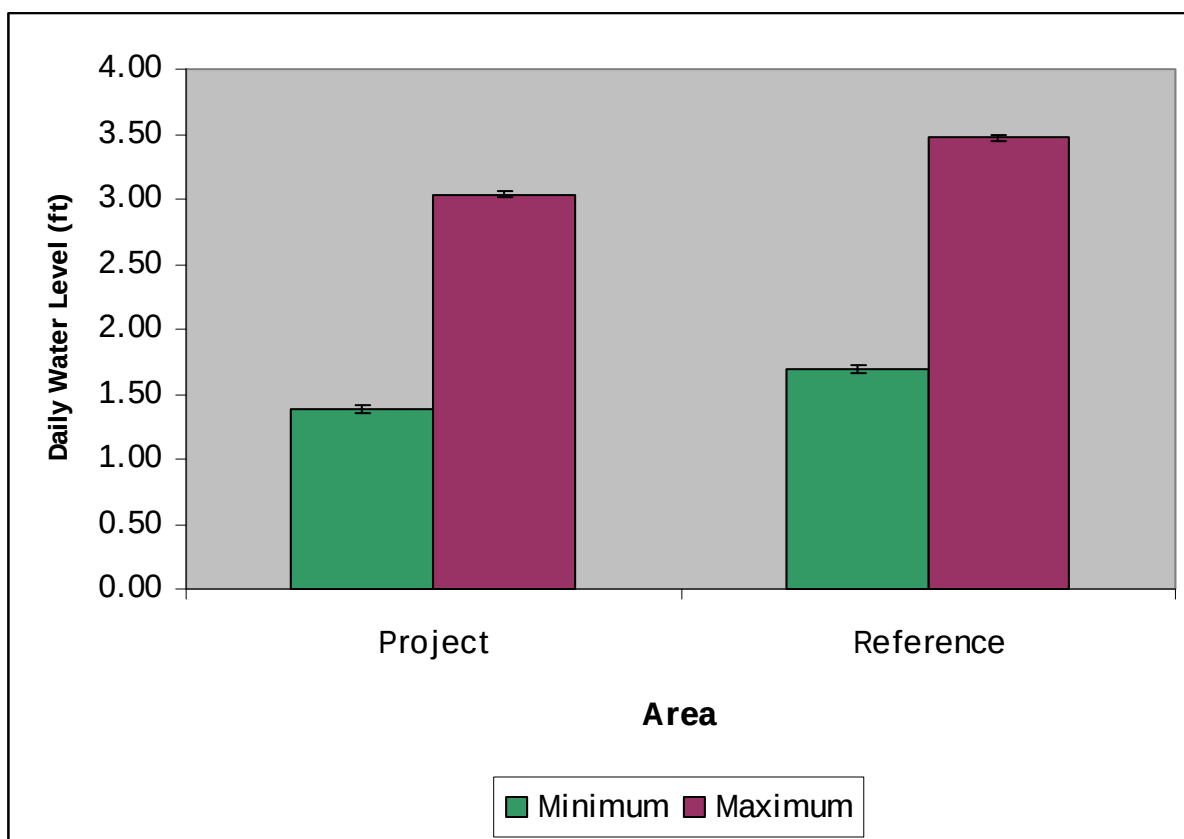
**Figure 13.** Relative minimum and maximum water levels for project (TV-14) vs. reference areas, in feet.

Hourly salinity and relative water level data for the two project and two reference stations for 2004 are presented in figures 9–12. Minimum, maximum, and mean water levels within the project area were all significantly lower ( $P < 0.0001$ ) than in R1 during the year (figure 13). Daily water level variability was significantly lower (0.13 ft [0.04 m]) within the project area than in R1 during 2003 (figure 14). As this decrease in water level variability was relatively small, the biological significance of this change could not be determined without more detailed vegetation sampling and analysis.

The project thus far seems to be effective in reducing water level variability within the project area. Future analysis will provide information relative to the project's impacts on the sustainability of the vegetated wetlands on Marsh Island and the biological significance of this reduction in water level variability.
