Coastal Protection and Restoration Authority of Louisiana

2007/2008 Annual Inspection Report

HUMBLE CANAL HYDROLOGIC RESTORATION PROJECT (ME-11)

May 1, 2008
Cameron Parish

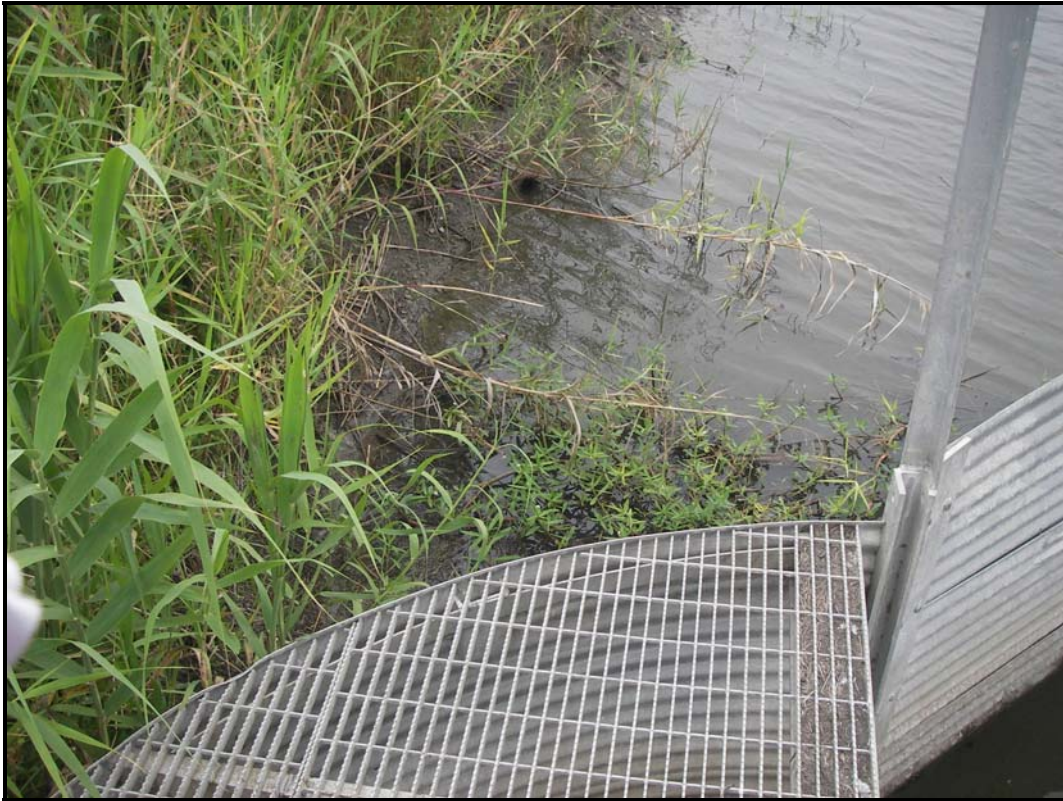
Overall, the structure is in good post construction condition. The inspection noted the erosion of the structure embankment behind each wing wall and over the structure identified in the previous O& M Inspections. Miscellaneous structure maintenance such as replacement of bolts and flap gate locking arms will be required. The camp building debris adjacent to the structure has burned since the last inspection and has caused damage to the hyacinth guard as noted above. (Photos: Appendix B, Photos 3, 4, & 5)

Photo 3, Inlet side of structure showing erosion behind wingwalls.

Item	Condition	Physical Damage	Corrosion	Photo #	Observations and Remarks
Steel Bulkhead / Caps	good				
Steel Grating	good			4	
Stop Logs	good				Stoplogs on this structure are made of aluminum and should last practically forever.
Hardware	fair			5	Some of the hardware needs to be replaced or repaired.
Timber Piles	good				
Timber Wales	good				
Galv. Pile Caps	good				
Cables/ lifting device	good				
Signage /Supports	N/A				
Rip Rap (fill) (foreshore dike)	good				
Eathern Embankment	good			3	Erosion has occurred behind each wingwall and over the structure.
Inlet Channel/Plug	good

- Repair and/or replace miscellaneous hardware.
- Add crushed stone on top of structure.
- Repair hyacinth guard.
- Replace warning signs on marine barrier.

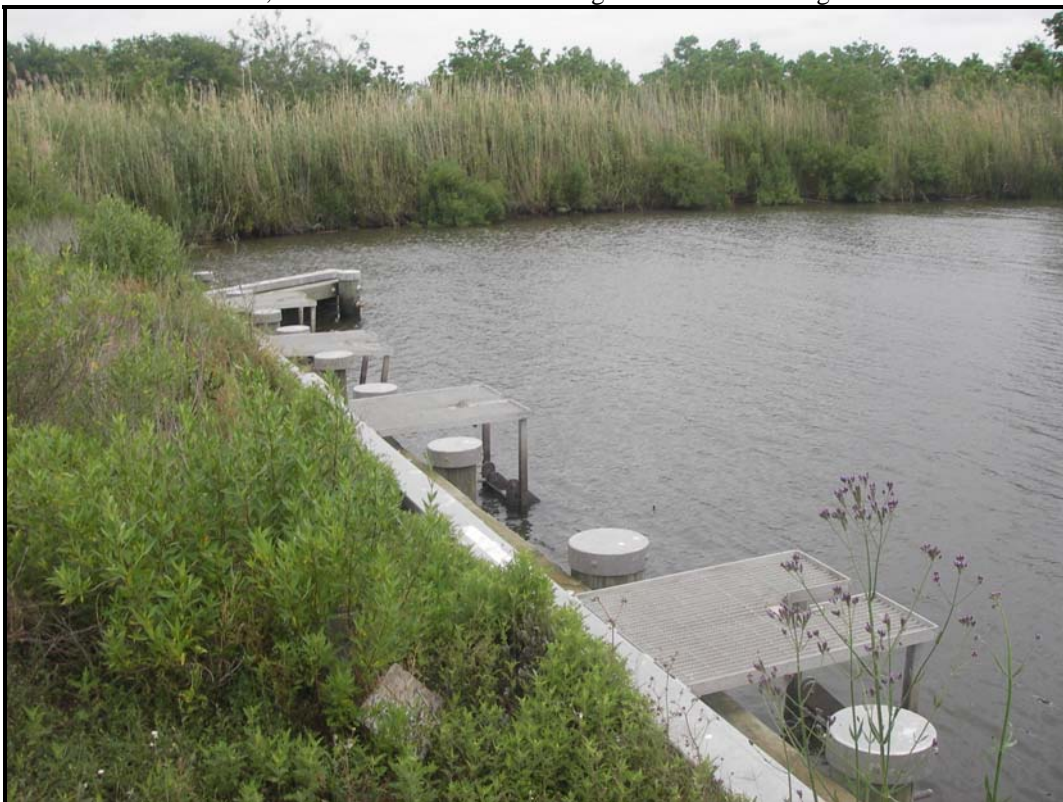
Photo 4, Outlet side of structure.

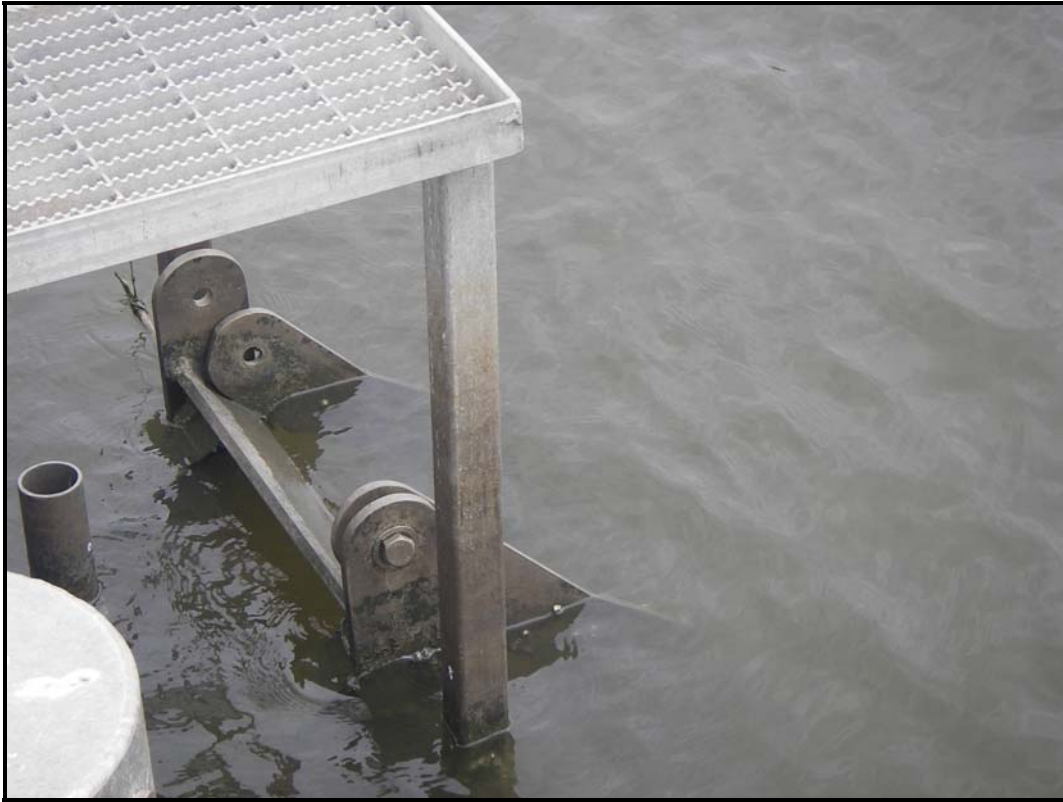
Photo 5, View showing missing hardware.
