## **Coastal Protection and Restoration Authority of Louisiana**

## **2008/2009 Annual Inspection Report**

## **MARSH ISLAND HYDROLOGIC RESTORATION PROJECT (TV-14)**

May 5, 2009  
Iberia Parish

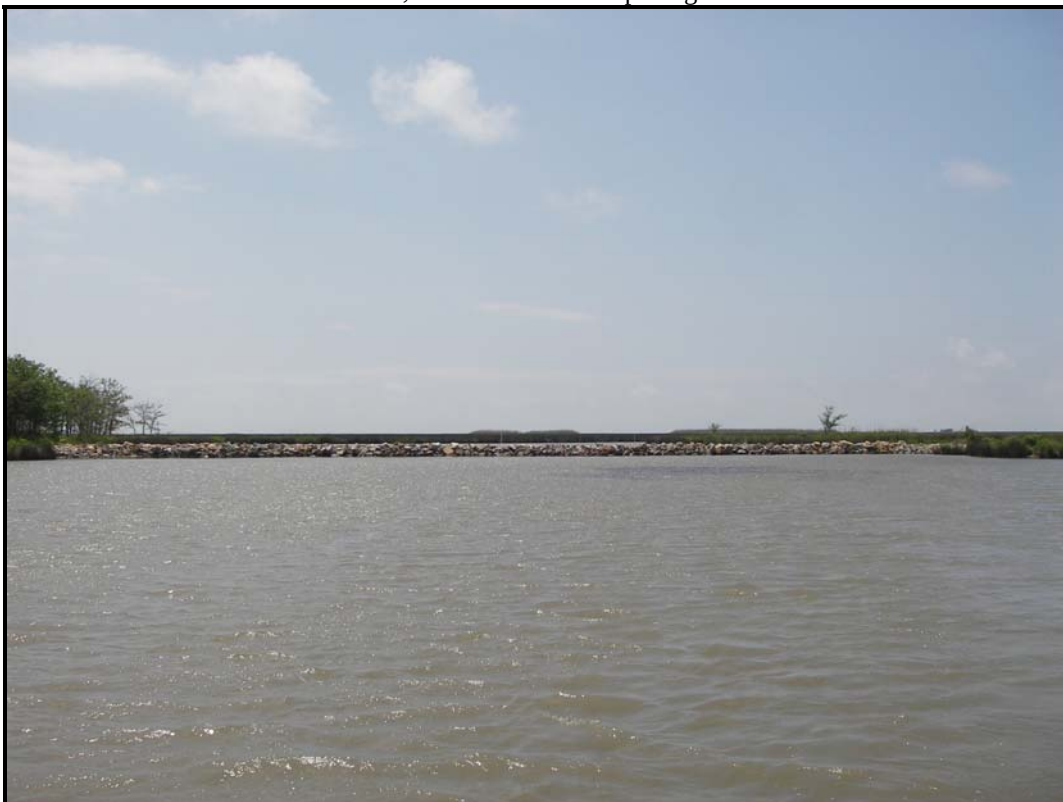
The erosion problems and Hurricane Rita damages have been repaired through the recent maintenance project that was completed in February 2009. The dike was capped and bank paving installed on both ends of the closure. This site is in good condition since this work was performed. (Photos: Appendix B, Photos 1-3).

**Photo No.2**, Closure No. 1 looking south

| Item | Condition | Physical Damage | Corrosion | Photo # | Observations and Remarks |
|---|---|---|---|---|---|
| Rip Rap (fill) | Good | | | 1,2,3 | Closure is repaired |

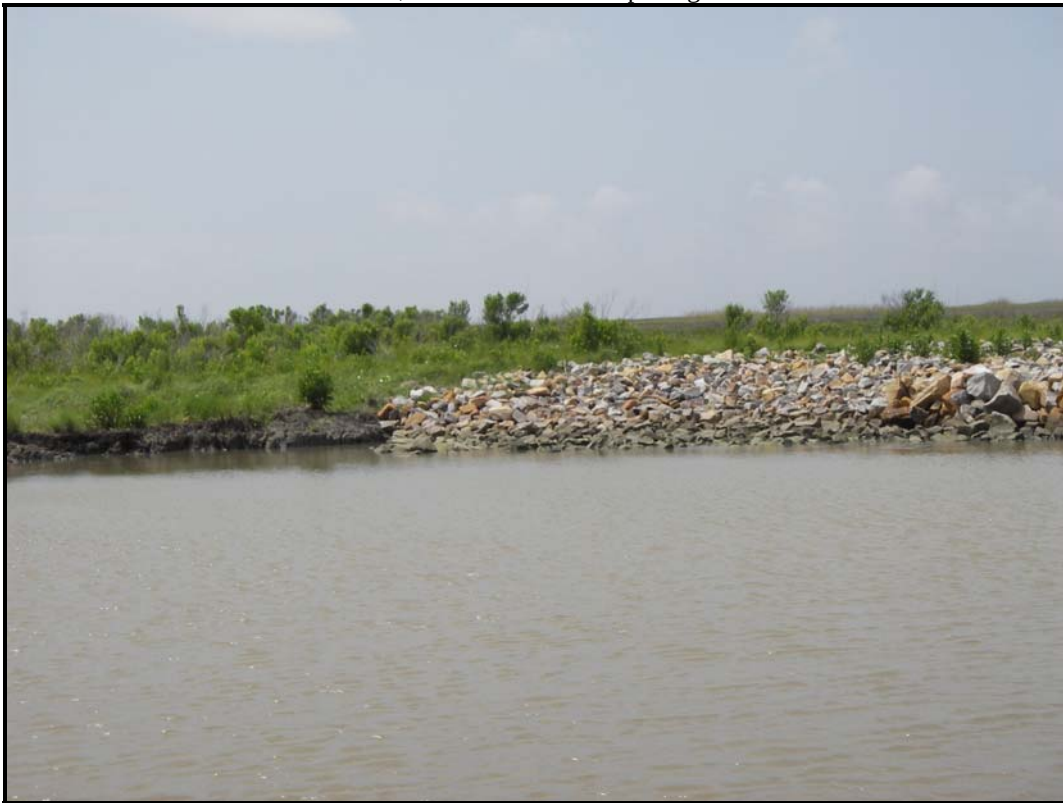
The dike was capped and bank paving installed as noted above and is in good condition since the work was performed. (Photos: Appendix B, Photos 4-6).

**Photo No. 4,** Closure No. 2 bank paving east side

| Item | Condition | Physical Damage | Corrosion | Photo # | Observations and Remarks |
|---|---|---|---|---|---|
| Rip Rap (fill) | Good | | | 4,5,6 | Closure is repaired. |

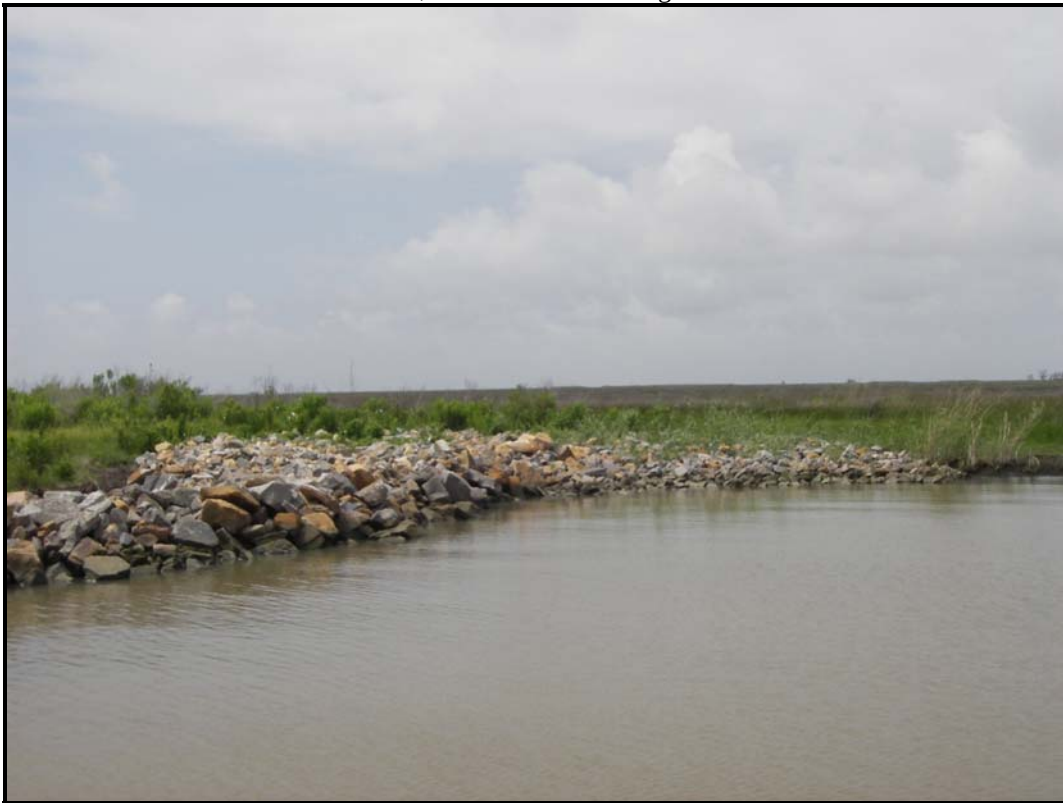
**Photo No. 6,** Closure No. 2 bank paving west side

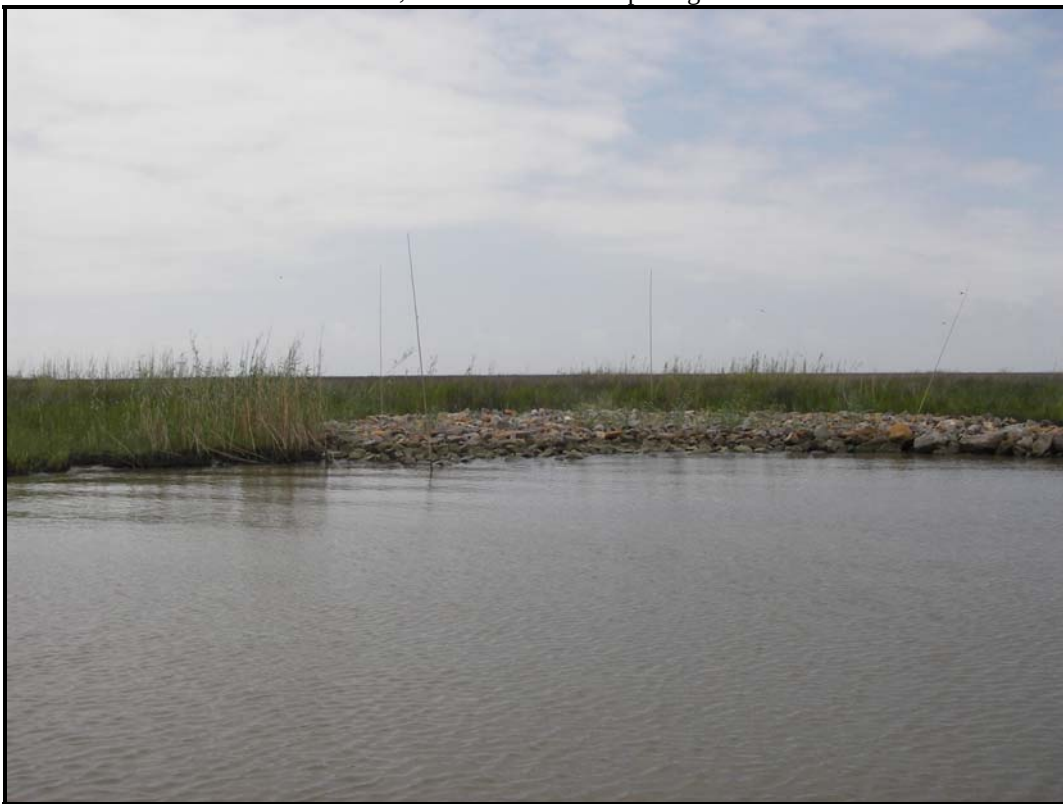
The Lake Sand Dike closure as originally constructed and recently repaired for Hurricane Rita damages, appears in good condition. The dike was capped in those areas where it was below elevation +3.0 as well as extended on the eastern end with bank paving. (Photos: Appendix B, Photos 8-9).

**Photo No. 8,** Closure No. 4 bank paving east side

| Item | Condition | Physical Damage | Corrosion | Photo # | Observations and Remarks |
|---|---|---|---|---|---|
| Rip Rap (fill) | Good | | | 8,9 | Lake Sand closure is repaired. |

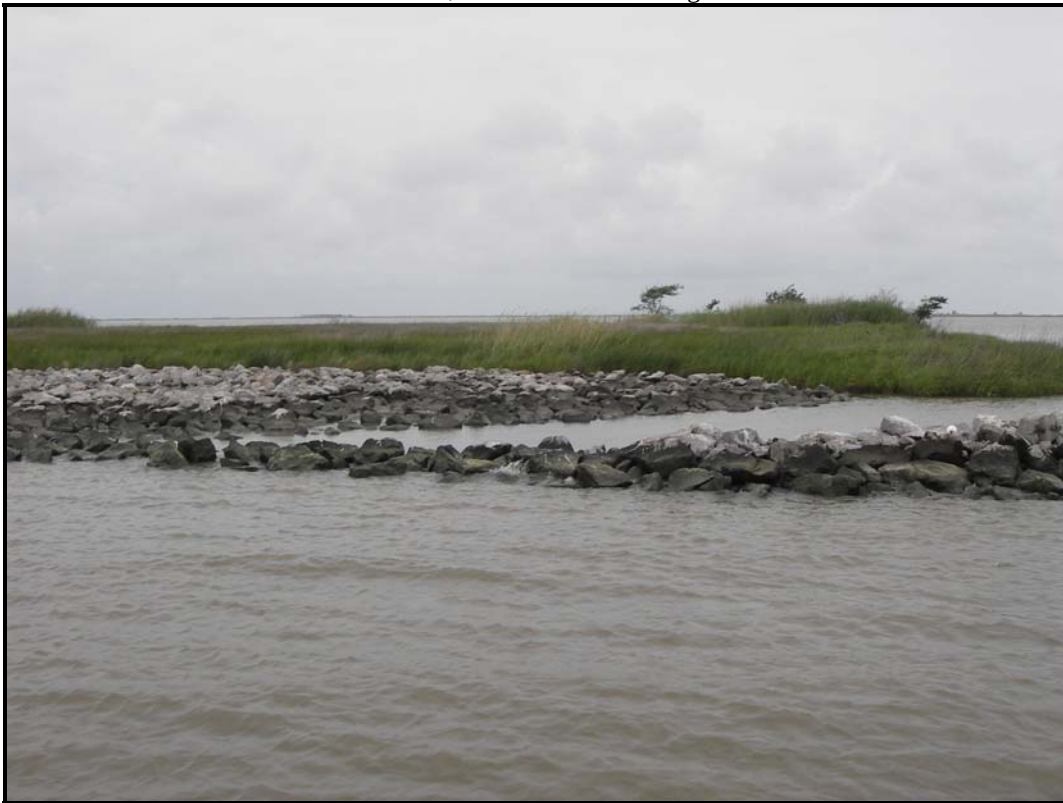
The steel sheet pile, rock riprap wingwalls, and stone bank/marsh paving placed as part of the Hurricane LILI repair project is in good condition and were apparently very effective in preventing additional damage by the erosive action of Hurricane RITA. The staff gage was re-set as part of the recent maintenance event. The overbank marsh areas paved to make same “hard” and paid for with O & M funding needs to be continually evaluated for its effectiveness. (Photos: Appendix B, Photos 10-12).

**Photo No. 10,** Closure No. 5 bank paving south side

| Item | Condition | Physical Damage | Corrosion | Photo # | Observations and Remarks |
|---|---|---|---|---|---|
| Rip Rap (fill) | Good | | | 10,11,12 | Staff gage reset. |

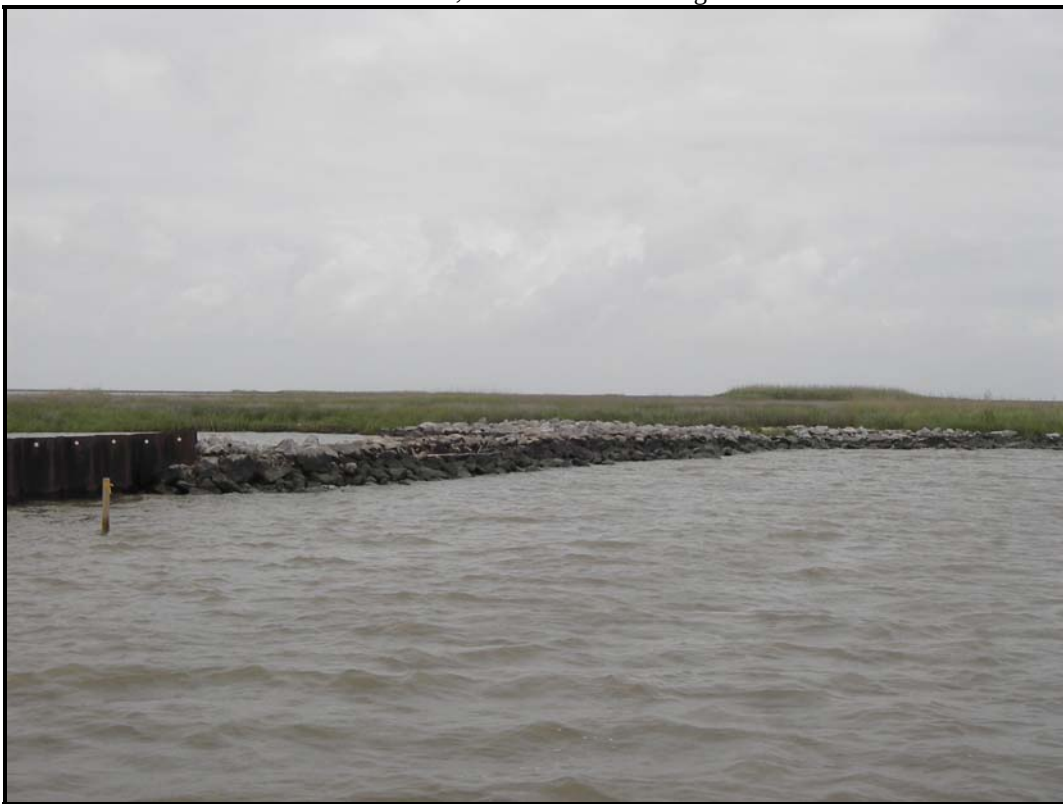
**Photo No. 12,** Closure No. 5 bank paving north side

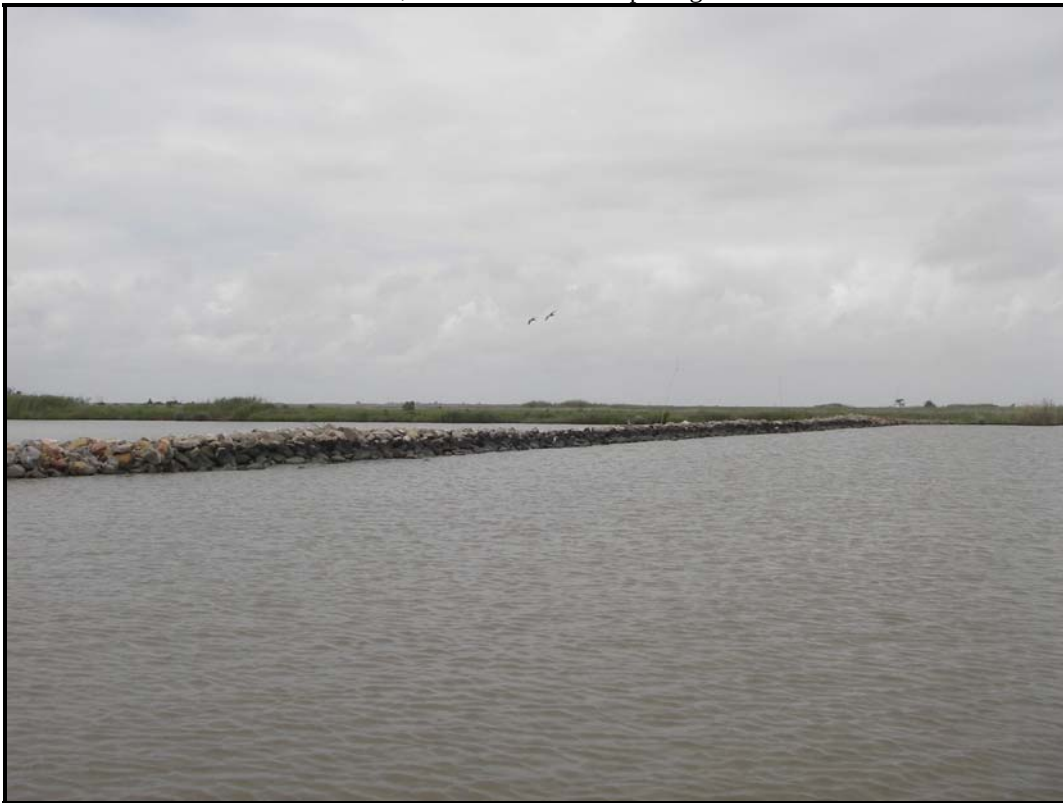
The breach on the southern end of the dike that had occurred prior to Hurricane Rita and subsequently worsened as a result of the tidal surge has been repaired as part of the recent maintenance event. The dike was extended on the northern end and bank paving was installed on both ends of the closure. This site is in good condition since the repairs have been made. (Photos: Appendix B, Photos 13-15).

**Photo No. 14,** Closure No. 6 looking west

| Item | Condition | Physical Damage | Corrosion | Photo # | Observations and Remarks |
|---|---|---|---|---|---|
| Rip Rap (fill) | Good | | | 13,14,15 | Breach has been repaired. |

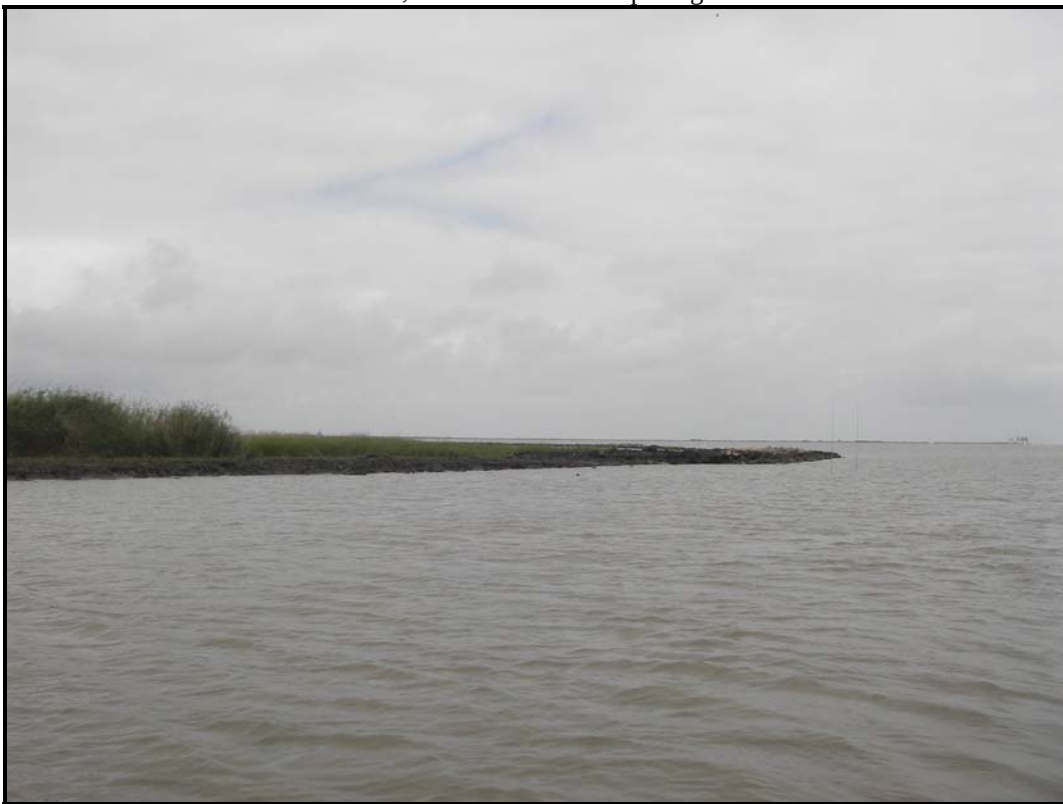
This closure site is in good condition and spoil material from the dredging of the north-south canal in 2008 was placed along the eastern end of the rock dike in an effort to stabilize this section of shore. In addition dredge spoil material was pumped behind the rock dike as part of this same access dredging and a small area of marsh creation was formed which is now starting to vegetate. (Photos: Appendix B, Photos 16-17).

**Photo No. 16,** Structure No. 7 spoil material connecting to rock dike

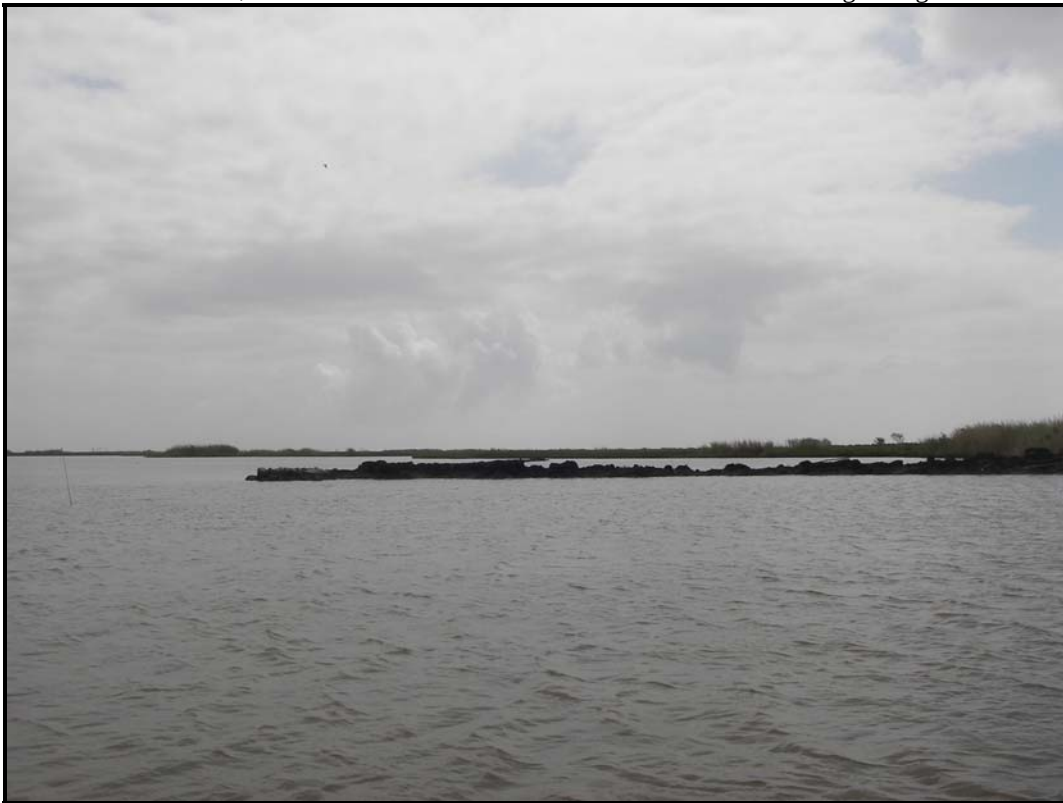
This closure site is in good condition since the existing breach on the south side of the closure was repaired as noted in the 2008 maintenance event noted above in Section IV. Spoil material was placed to close off the breach and also placed on top of the existing rock dike. Spoil material was also placed from the north end of the rock dike towards the bay to make a connection to the existing mitigation rock dike along the bayshore. (Photos: Appendix B, Photos 18-20).

**Photo No. 18,** Closure No. 8 spoil material connecting to rock dike at bay shore

| Item | Condition | Physical Damage | Corrosion | Photo # | Observations and Remarks |
|---|---|---|---|---|---|
| Rip Rap (fill) | Good | | | 18,19,20 | Breach has been repaired. |

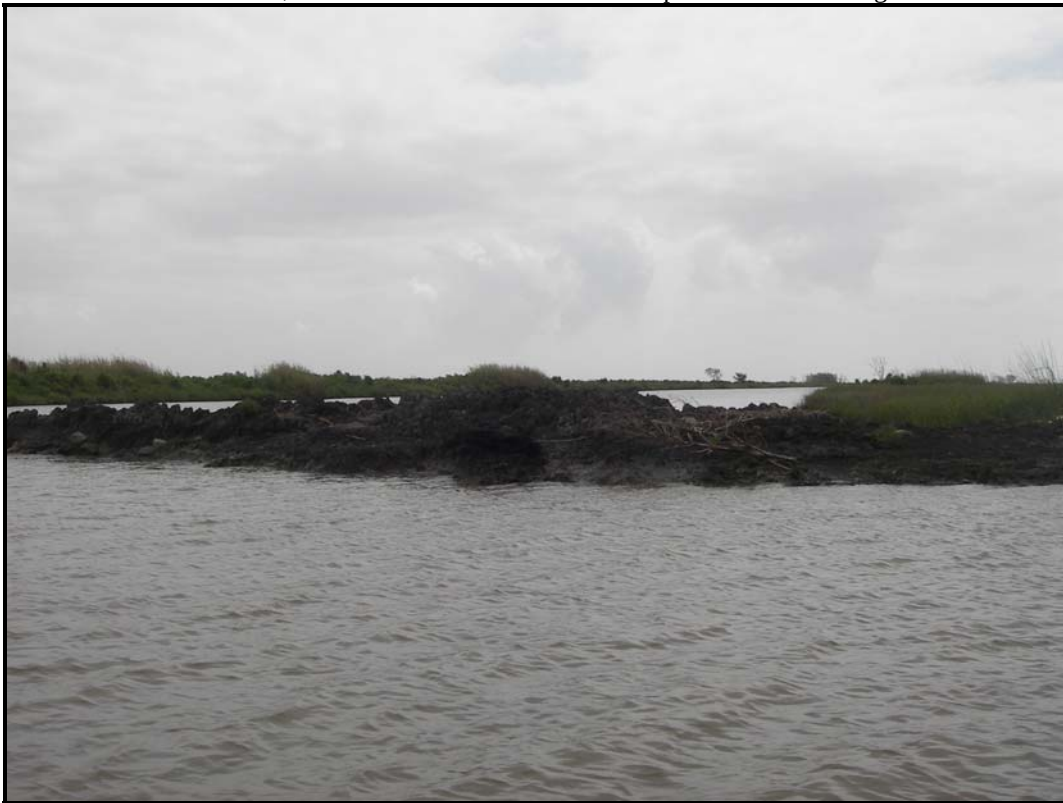
**Photo No. 20,** Closure No. 8 breach repair with spoil material
