**Coastal Protection and Restoration
Authority of Louisiana**

**2008/2009 Annual Inspection
Report**

**LITTLE VERMILION BAY
SEDIMENT TRAPPING
PROJECT
(TV-12)**

October 9, 2008
Vermilion Parish

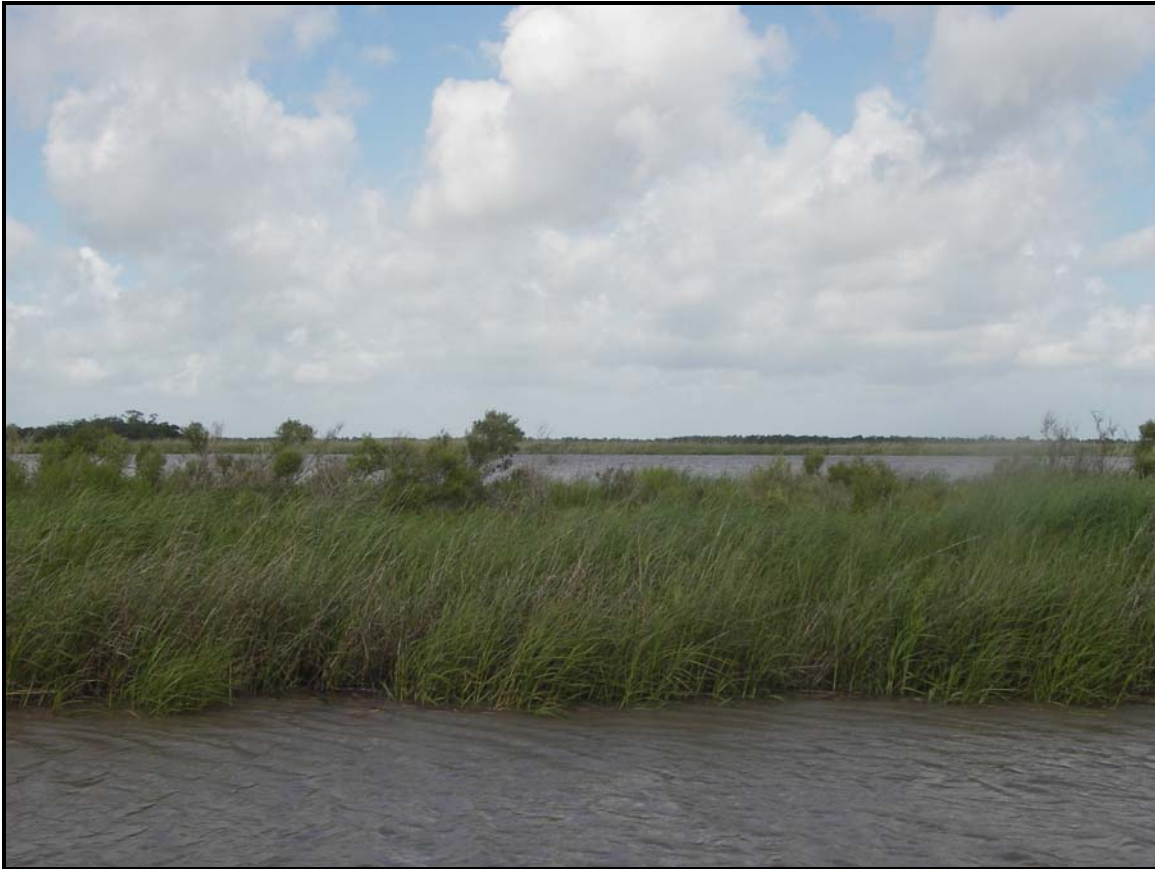
Photo No. 1, typical terrace

The project survived the storm intact. Erosion near the bays intersection with Freshwater Bayou continues to worsen however this is not a result of the storm. Terraces nearest Freshwater Bayou are eroding also. Water elevation was not available at the time of this inspection. Staff gauges will need to be re-established in the area. Erosion continues on the southwestern most terraces but vegetation is still evident and the terrace is still functioning as protection to the terraces to the north. (Photos: Appendix B, Photo 1)

Item	Condition	Physical Damage	Corrosion	Photo #	Observations and Remarks
Steel Bulkhead / Caps	N/A				
Steel Grating	N/A				
Stop Logs	N/A				
Hardware	N/A				
Timber Piles	N/A				
Timber Wales	N/A				
Galv. Pile Caps	N/A				
Vegetation	Good				
Signage / Supports	N/A				
Rip Rap (fill)	N/A				
Earthen Embankment (terraces)	Excellent				1 Terraces are in good condition, although some erosion is occurring.

The Little Vermilion Bay Sediment Trapping Project is in excellent condition and functioning as intended. Accretion between the terraces is still evident and continues to accrete. Emergent vegetation should soon become established. Maintenance required in 2009/2010:

- Installation of a staff gauge
