**Coastal Protection and Restoration
Authority of Louisiana**

**2008/2009 Annual Inspection
Report**

**OAKS/AVERY CANALS
HYDROLOGIC RESTORATION
PROJECT
(TV-13a)**

State Project Number TV-13a
Priority Project List 6

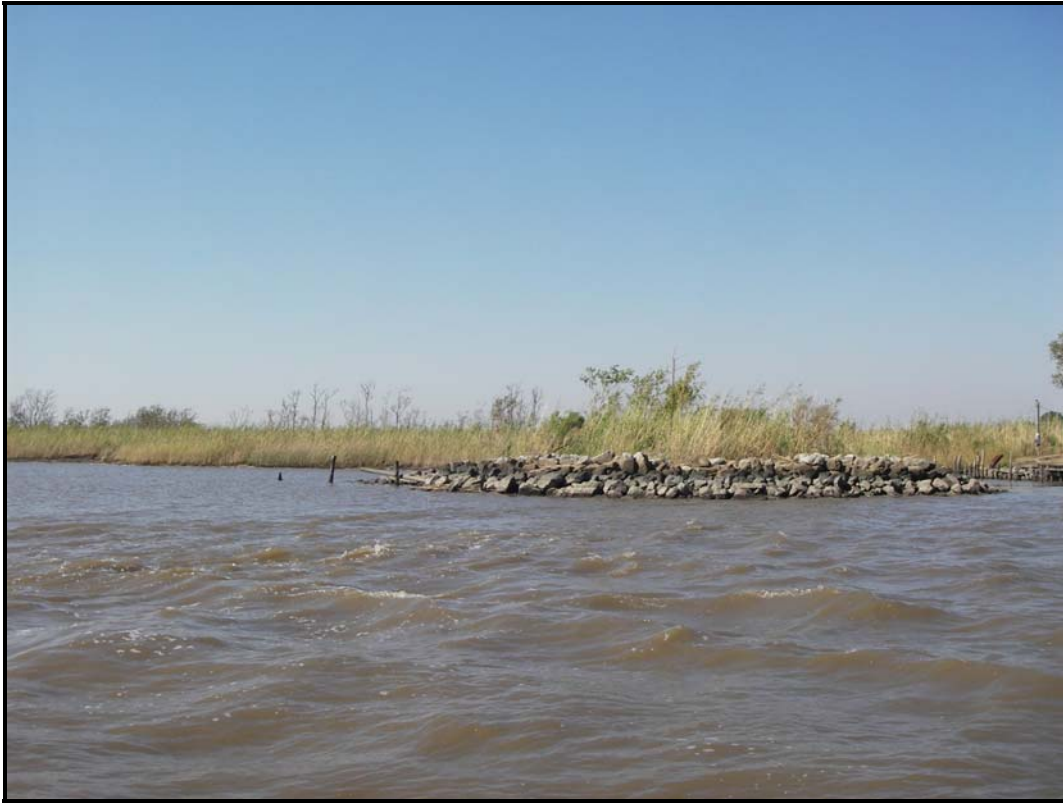
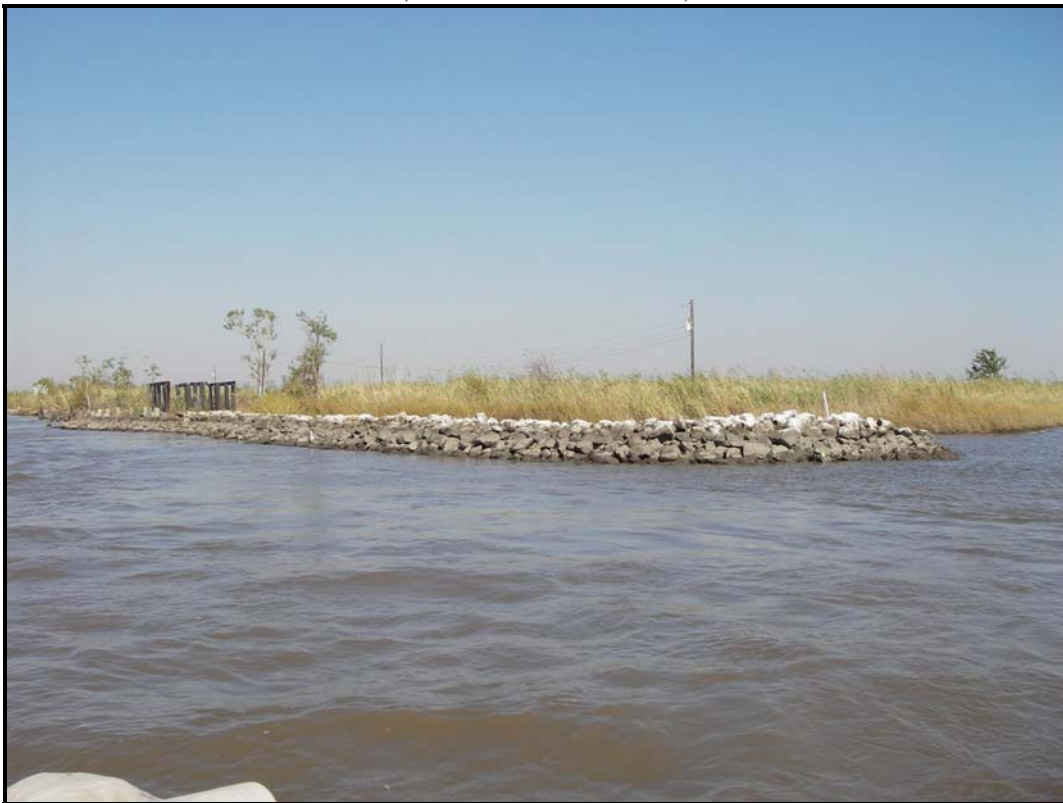
No worsening in this area was evident. The bank between the bay and Bayou Hebert is still only about 6 feet wide and has not gotten any worse. No immediate maintenance required at this time. (Appendix B; photos 1-2)

Photo No.1, Rock dike at Oaks Canal, west side

Photo No. 2, Rock dike at Oaks Canal, east side

Item	Condition	Physical Damage	Corrosion	Photo #	Observations and Remarks
Steel Bulkhead / Caps	N/A				
Steel Grating	N/A				
Stop Logs	N/A				
Hardware	N/A				
Timber Piles	N/A				
Timber Wales	N/A				
Galv. Pile Caps	N/A				
Vegetation	N/A				
Signage / Supports	N/A				
Rip Rap (fill)	Excellent			1,2	Rock in excellent condition
Eathern Embankment	N/A

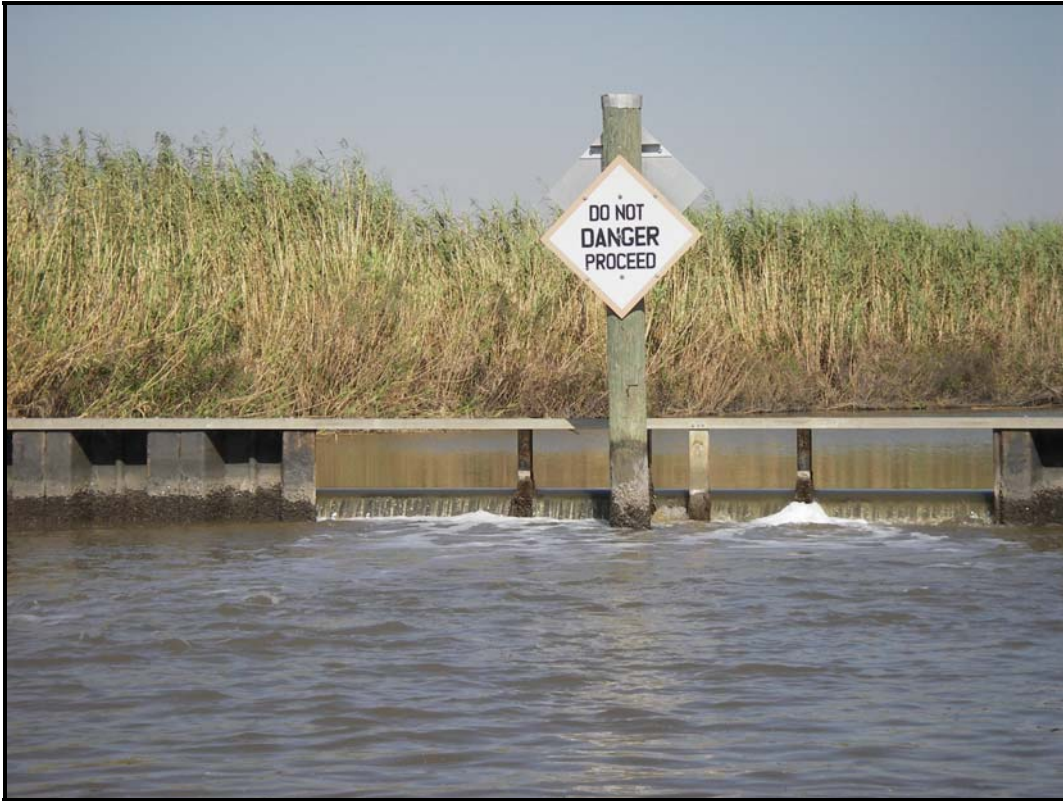
The structure is in excellent shape. Signage is stable. Wingwalls show no signs of any erosion. Three SS bolts are missing from pile cap and will eventually need to be replaced, probably by OCPR personnel. The levee from the structure to the GIWW is stable. No maintenance required at this time. The boat lifting device installed by the landowners on the western half of the structure has been removed and is on the ground adjacent to the structure. The landowner installed channel iron to accept stoplogs is still on the structure. This will be investigated further by OCPR. (Appendix B; photo 3)

Photo No. 3, Cow Path Structure

Item	Condition	Physical Damage	Corrosion	Photo #	Observations and Remarks
Steel Bulkhead / Caps	Excellent			3	
Steel Grating	N/A				
Stop Logs	N/A				
Hardware	Good			3	Three SS bolts missing from pile cap. Not critical. Landowner installed boat lifting device has been removed..
Timber Piles	N/A				
Timber Wales	N/A				
Galv. Pile Caps	Excellent				
Vegetation	N/A				
Signage /Supports	Excellent			3	
Rip Rap (fill)	N/A				
Eathern Embankment	Excellent

- Repair breach off of Oaks Canal.
- Repair vandalism to the rock plug.
- Repair low spots on the Oaks Canal where water is seeping through or over the existing levee.
- Add staff gage at Cow Path.

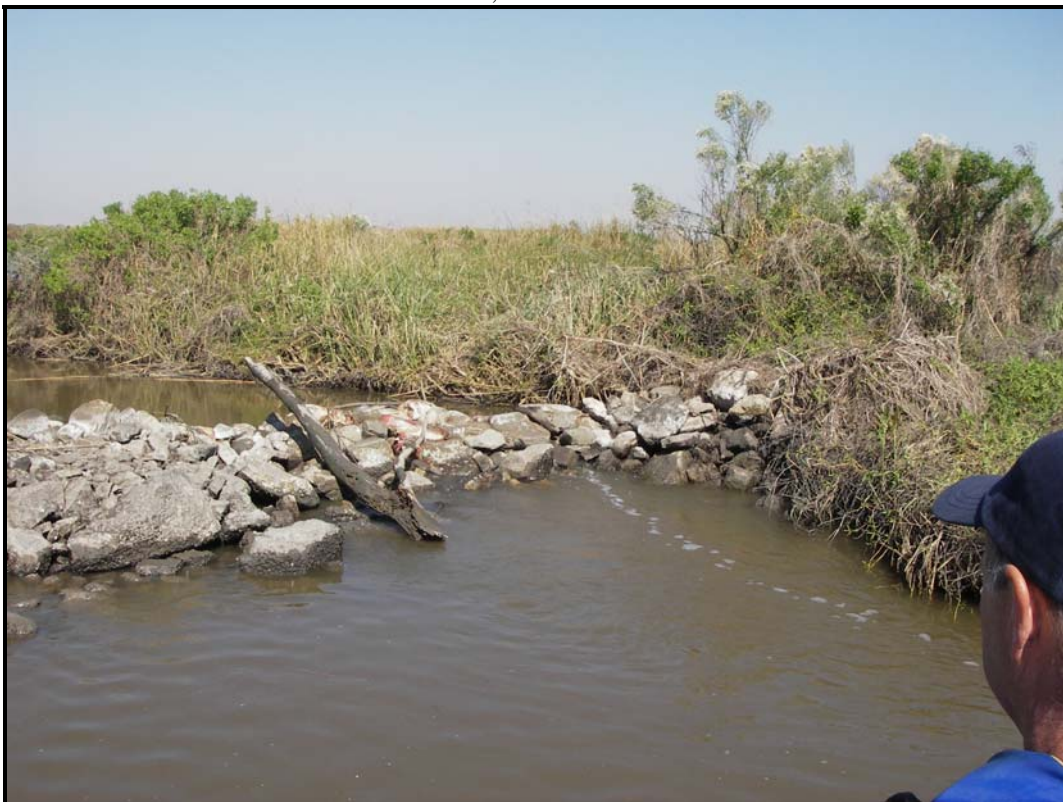
The plug is in good condition. There appears to be some rock moved from the east side of the closure allowing water to go over the rock at high tides and the landowners have placed sackcrete along this section as an interim solution. Tie-ins are stable. (Appendix B; photo 4)

Photo No. 4, Rock plug, view showing sackcrete on eastern end

Item	Condition	Physical Damage	Corrosion	Photo #	Observations and Remarks
Steel Bulkhead / Caps	N/A				
Steel Grating	N/A				
Stop Logs	N/A				
Hardware	N/A				
Timber Piles	N/A				
Timber Wales	N/A				
Galv. Pile Caps	N/A				
Vegetation	N/A				
Signage /Supports	N/A				
Rip Rap (fill)	Excellent			4	
Eathern Embankment	N/A

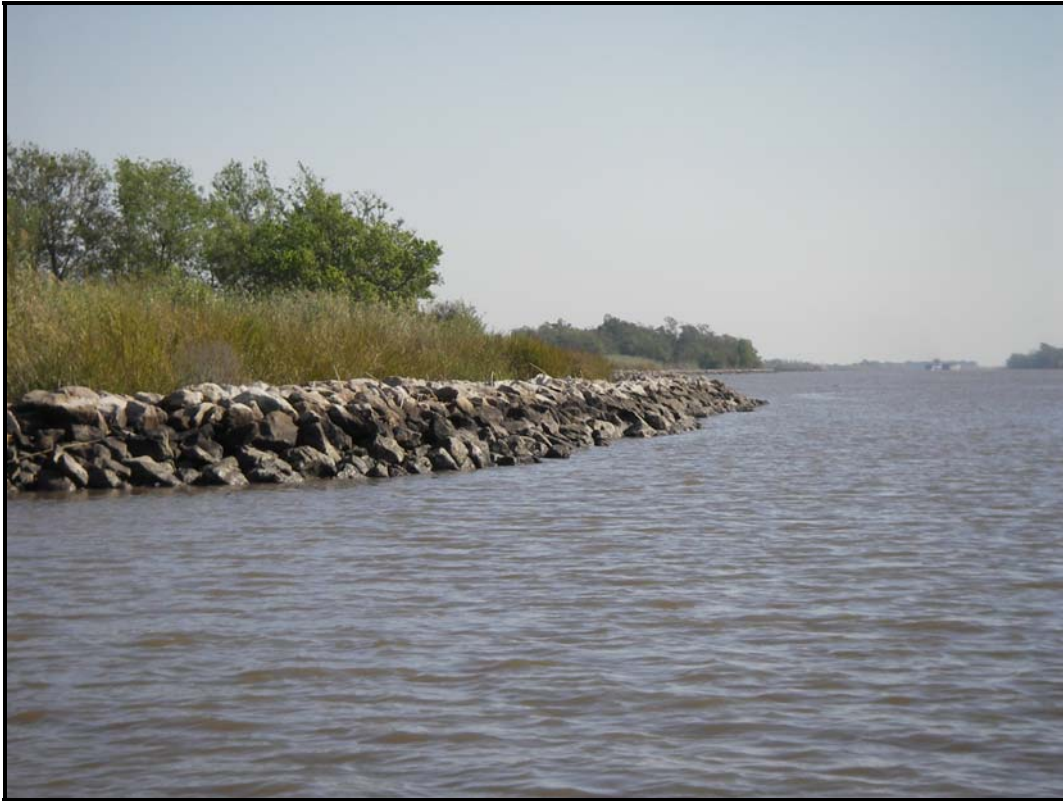
The dike is in excellent condition. Approximately 60 linear feet on the eastern end at a barge slip continues to settle but is in no need of immediate repairs. East and west tie-ins are stable, however there is some minor erosion occurring at the east tie-in which will be monitored on future inspections. The water level was low at the time of the inspection so the entire rock dike was visible. (Appendix B; photo 5)

Photo No. 5, Rock along north bank of GIWW

Item	Condition	Physical Damage	Corrosion	Photo #	Observations and Remarks
Steel Bulkhead / Caps	N/A				
Steel Grating	N/A				
Stop Logs	N/A				
Hardware	N/A				
Timber Piles	N/A				
Timber Wales	N/A				
Galv. Pile Caps	N/A				
Vegetation	N/A				
Signage /Supports	N/A				
Rip Rap/dike	Excellent			5	Dike is excellent post construction condition. Approx. 60 LF on eastern end has settled.
Eathern Embankment	N/A

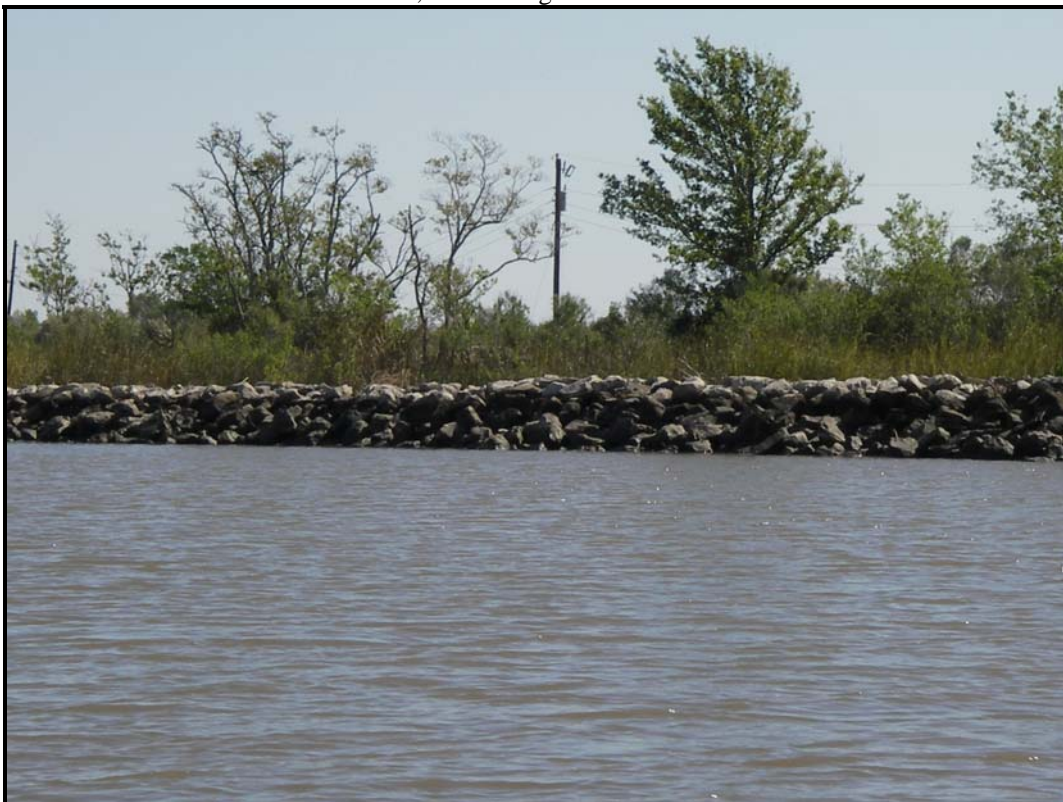
The dike is in immediate post construction condition and in no need of any repairs. (Appendix B; photo 6)

Photo No. 6, Rock along south bank of GIWW

Item	Condition	Physical Damage	Corrosion	Photo #	Observations and Remarks
Steel Bulkhead / Caps	N/A				
Steel Grating	N/A				
Stop Logs	N/A				
Hardware	N/A				
Timber Piles	N/A				
Timber Wales	N/A				
Galv. Pile Caps	N/A				
Vegetation	N/A				
Signage /Supports	N/A				
Rip Rap (fill)	Excellent			6	
Eathern Embankment	N/A

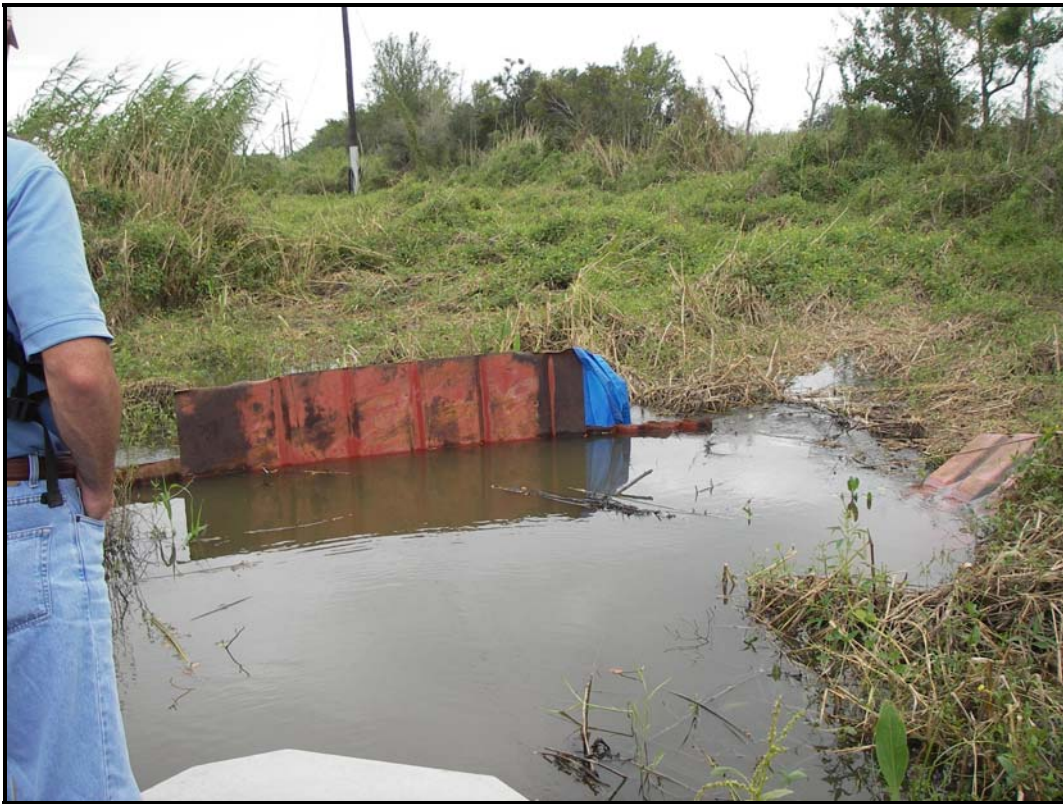
Overall, the Oaks/Avery Canals Hydrologic Restoration Project is in good condition and functioning as designed despite being submerged by the Hurricane Ike tidal surge. The landowners have pointed out a breach that has occurred off of the east bank of Oaks Canal which is circumventing the hydrologic boundary of the project, as well as some low spots along the canal (refer to Photo No. 7 in Appendix B). Plans and specifications are being prepared for a maintenance event for the following:

Photo No. 7, Breach area off of Oaks Canal, view showing landowner interim blockage of opening.
