2008/2009 Annual Inspection Report

SEDIMENT TRAPPING AT THE JAWS PROJECT (TV-15)

State Project Number TV-15 Priority Project List 9

September 30, 2008 St. Mary Parish

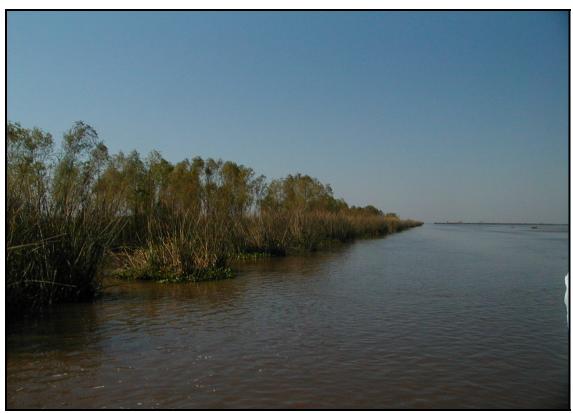
Photo No. 1, typical terrace

The terraces appear to be in good condition and do not appear to have suffered any damages from Hurricane Ike. Settlement on the ends of the terraces, furthest from the main channel of the Jaws, is significant but still functional. Warning signs were all in place and stable. Since water levels were slightly elevated, submerged and emergent

aquatic vegetation between the terraces wasn't as visible as during last year's inspection but still exists. Channels remain fairly clear. No need for any maintenance at this time. (Photos: Appendix B, Photos 1–2)
