**2008/2009 Annual Inspection  
Report**

**LAKE PORTAGE LAND  
BRIDGE PROJECT  
(TV-17)**

State Project Number TV-17  
Priority Project List 8

June 17, 2009  
Vermilion Parish

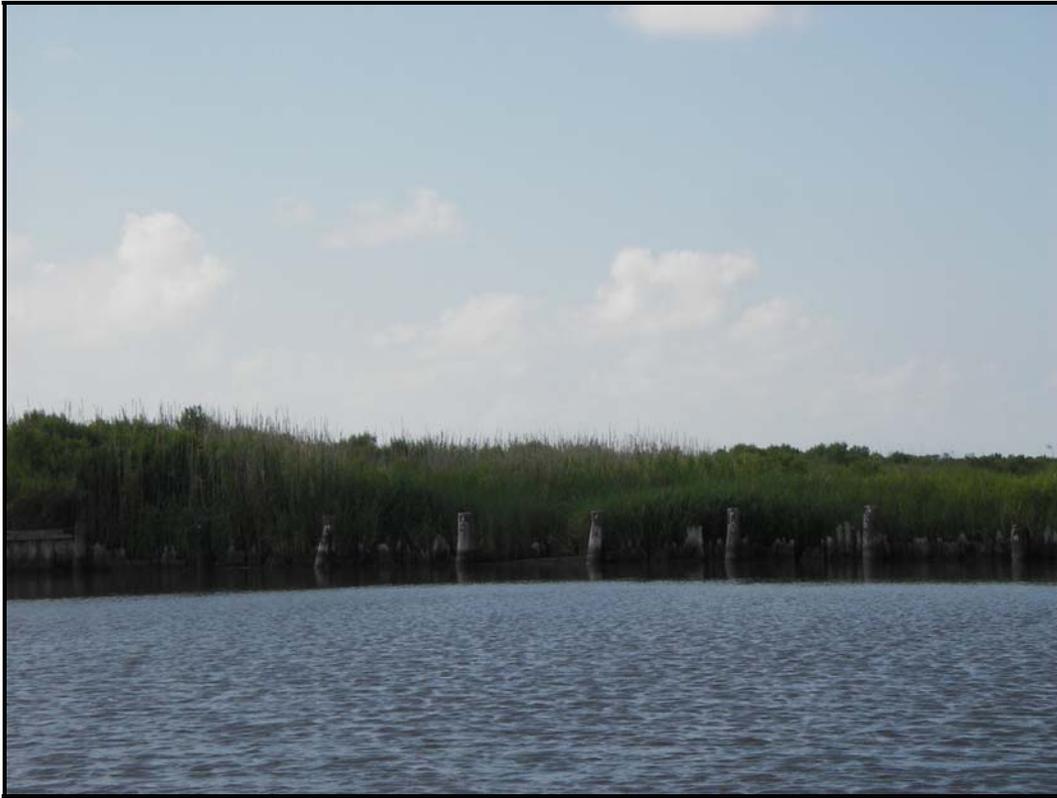
Area 1 is in good condition and vegetation has continued to expand from the containment banks moving towards the center of the channel and is 100 per cent vegetated. As a result of the inspection of Area 1, OCPR and NRCS agree that no corrective actions will be required this year. (Photos: Appendix B, Photo 1).

Photo 1, Area 1, View looking south at timber bulkhead.

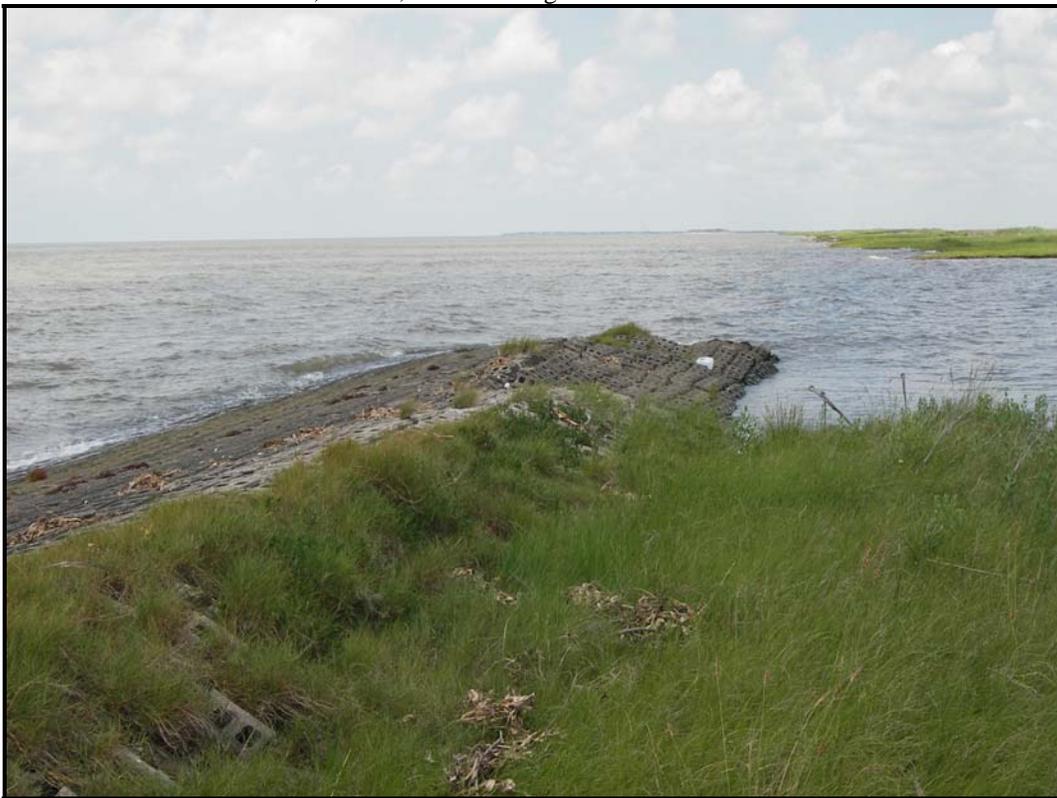
Area 2 is also in good condition and is fully vegetated, such that this reach was preexisting with additional dredge material added through this project to fill in any trenasses. Some erosion at the ends of the concrete mats along the Gulf shoreline has occurred over time and part of the mat system is showing signs of failure. Although the concrete mat system is not a feature to be maintained as part of this project, this area is experiencing erosion that may threaten the integrity of the overall project. Therefore, OCPD and NRCS agree that maintenance will be required at this time. (Photos: Appendix B, Photos 2, 3, 4 & 5).

Photo 2, Area 2, West side of concrete mats.

Overall, the Lake Portage Land Bridge Project is in good condition and functioning as designed. However, the erosion problem occurring at the Gulf shoreline will need to be addressed. Preliminary survey work has been completed to develop an accurate estimate of costs and subsequent CWPPRA funding request will be initiated in FY 2010.

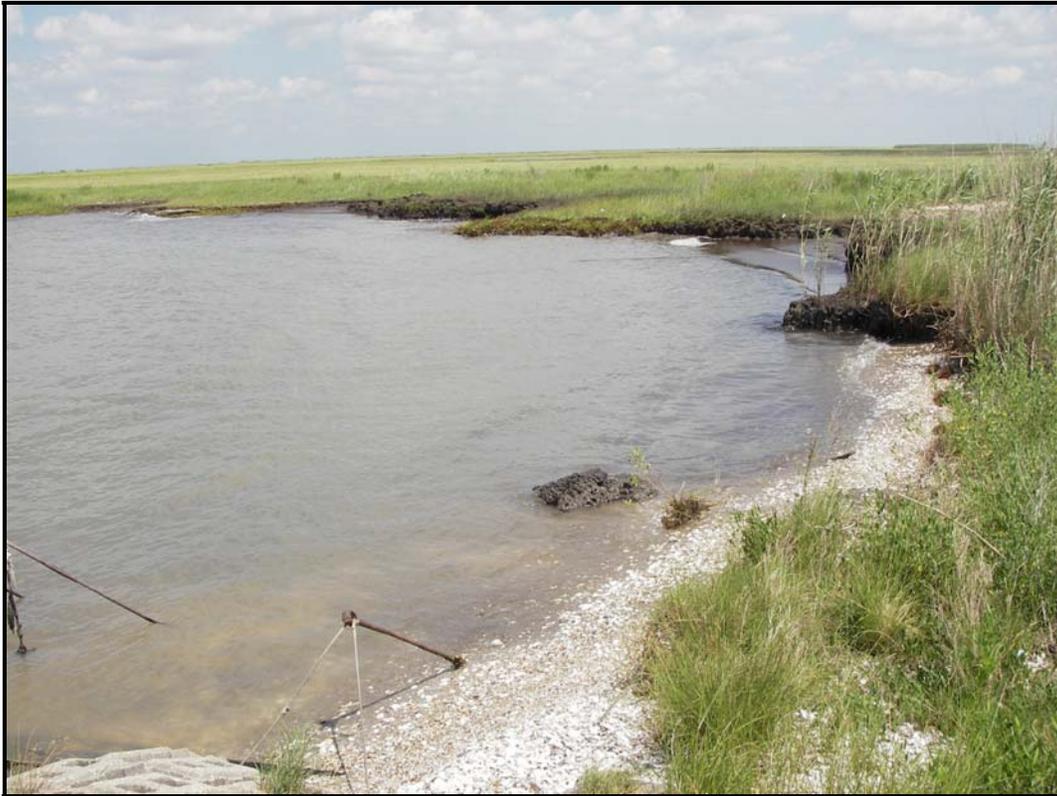
Photo 3, Area 2, Close up view of erosion on west side of concrete mats.

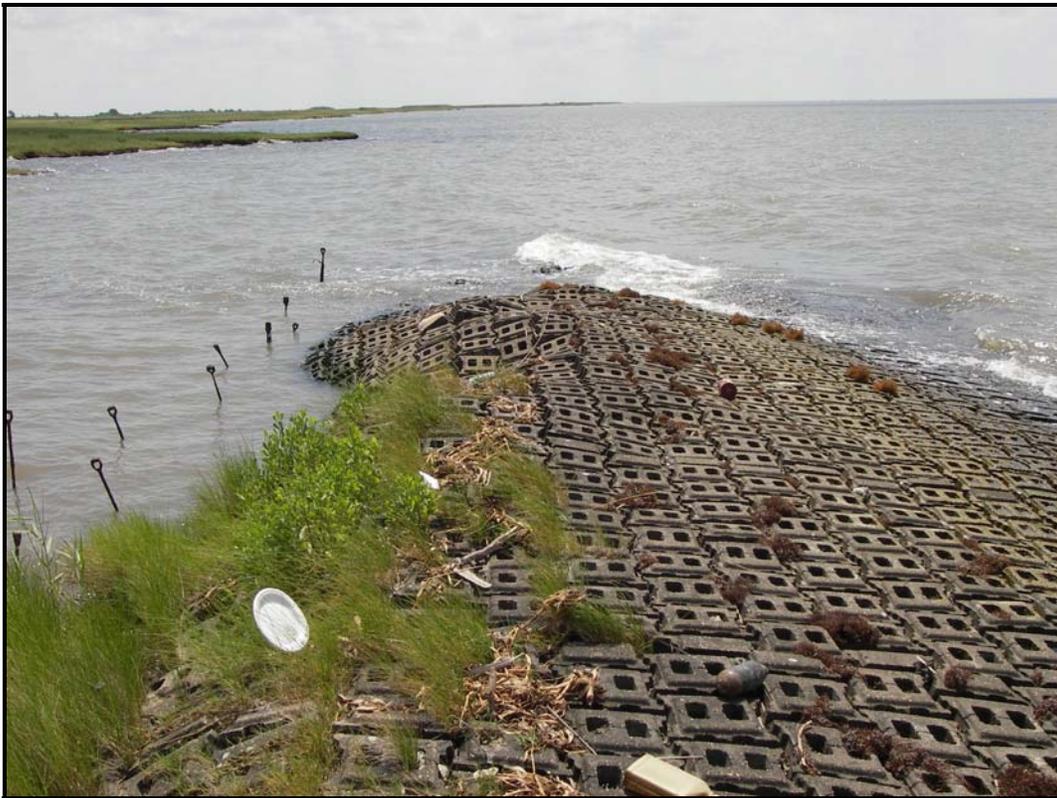
Photo 4, Area 2, East side of concrete mats.

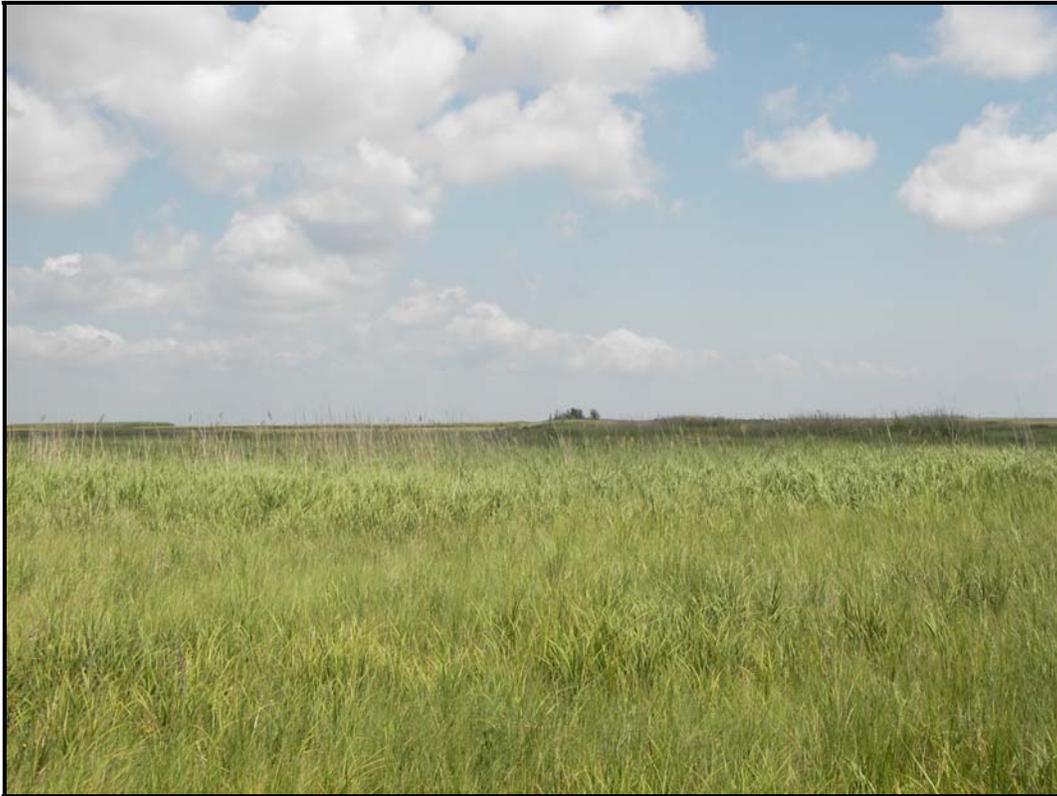
Photo 5, Area 2, View looking north.

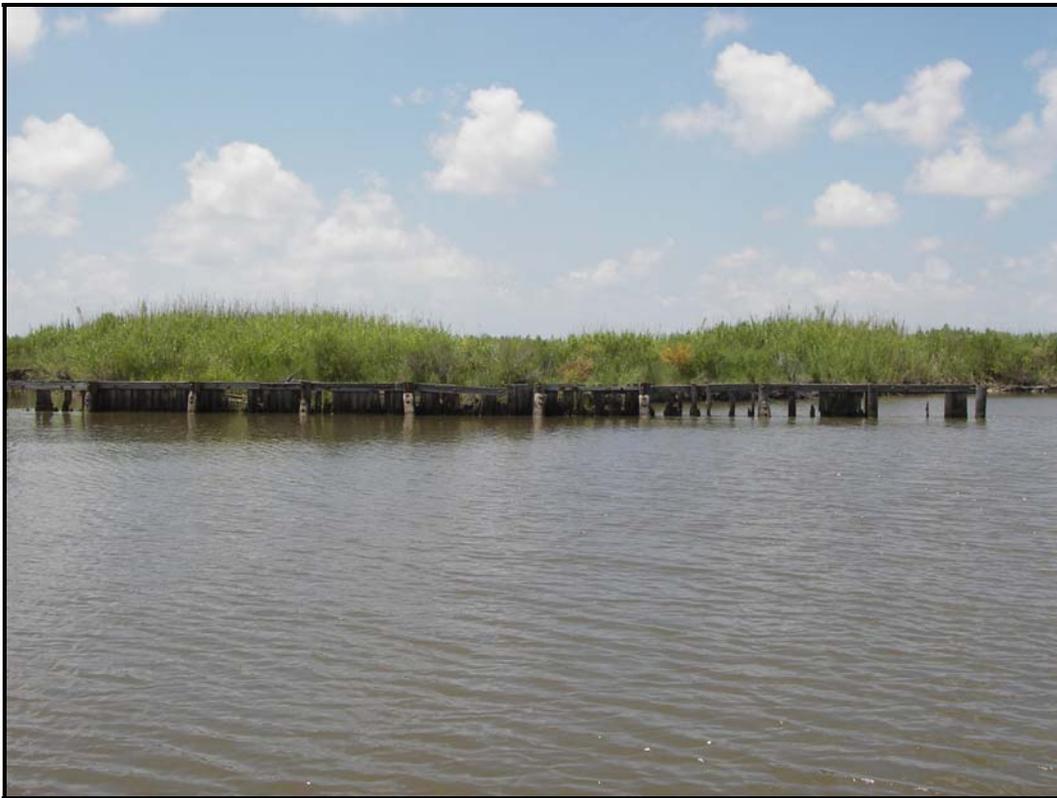
Area 3 also is in good condition. The northern part of this reach is fully vegetated, mainly due to the fact that this reach was constructed first, and has been in place since May, 2003. There is some minor erosion occurring on each side of the northern timber bulkhead which will need to be monitored on future annual inspections. OCPD and NRCS agree that this area is in good condition and no maintenance will be required at this time. (Photos: Appendix B, Photos 6).

Photo 6, Area 3, near bulkhead on north end.
