**Coastal Protection and Restoration
Authority of Louisiana**

2009 Annual Inspection Report

**Barataria Barrier Island Complex
Project: Pelican Island and Pass La
Mer to Chalant Pass Restoration**

State Project Number BA-38
Priority Project List 11

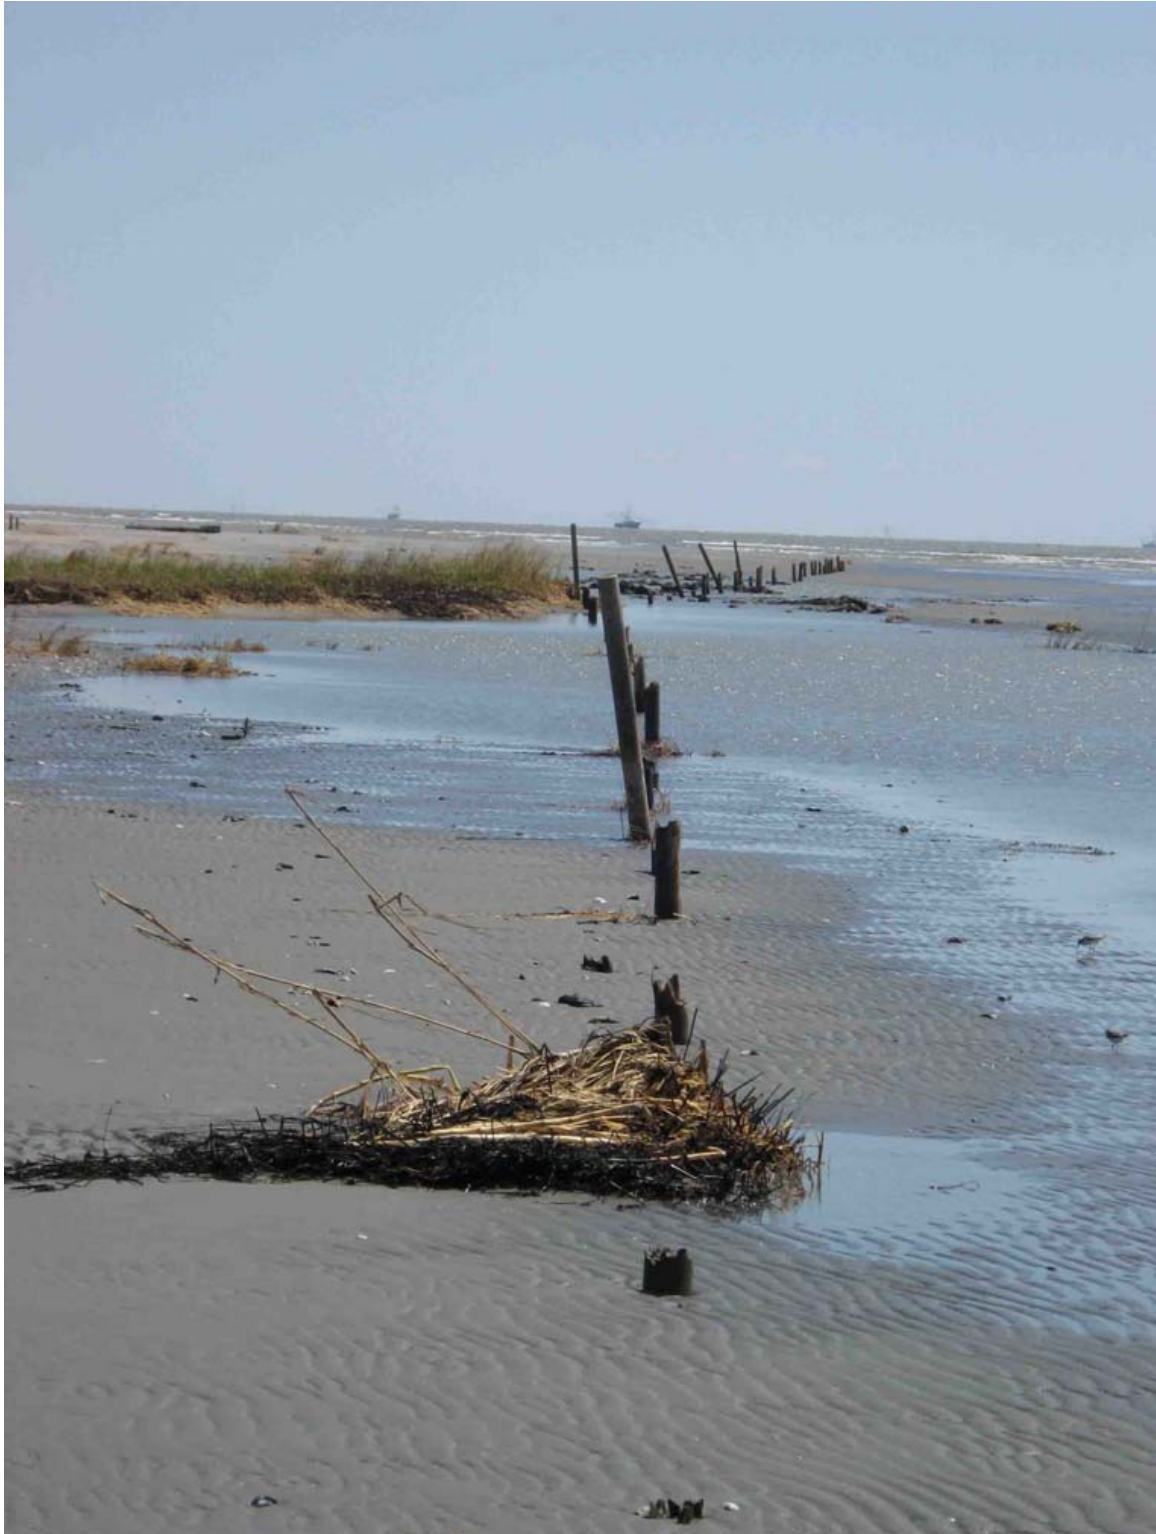
All of the sand fencing was relocated outside of the project area by the storms. (Photo #1)

Photo #1 –Damage to Sand Fence (now in surf line).

It is the recommendation of the OCPR/NOFO that the sand fencing and vegetative plantings be replaced as necessary.

- Sand Fencing and Vegetative Plantings.

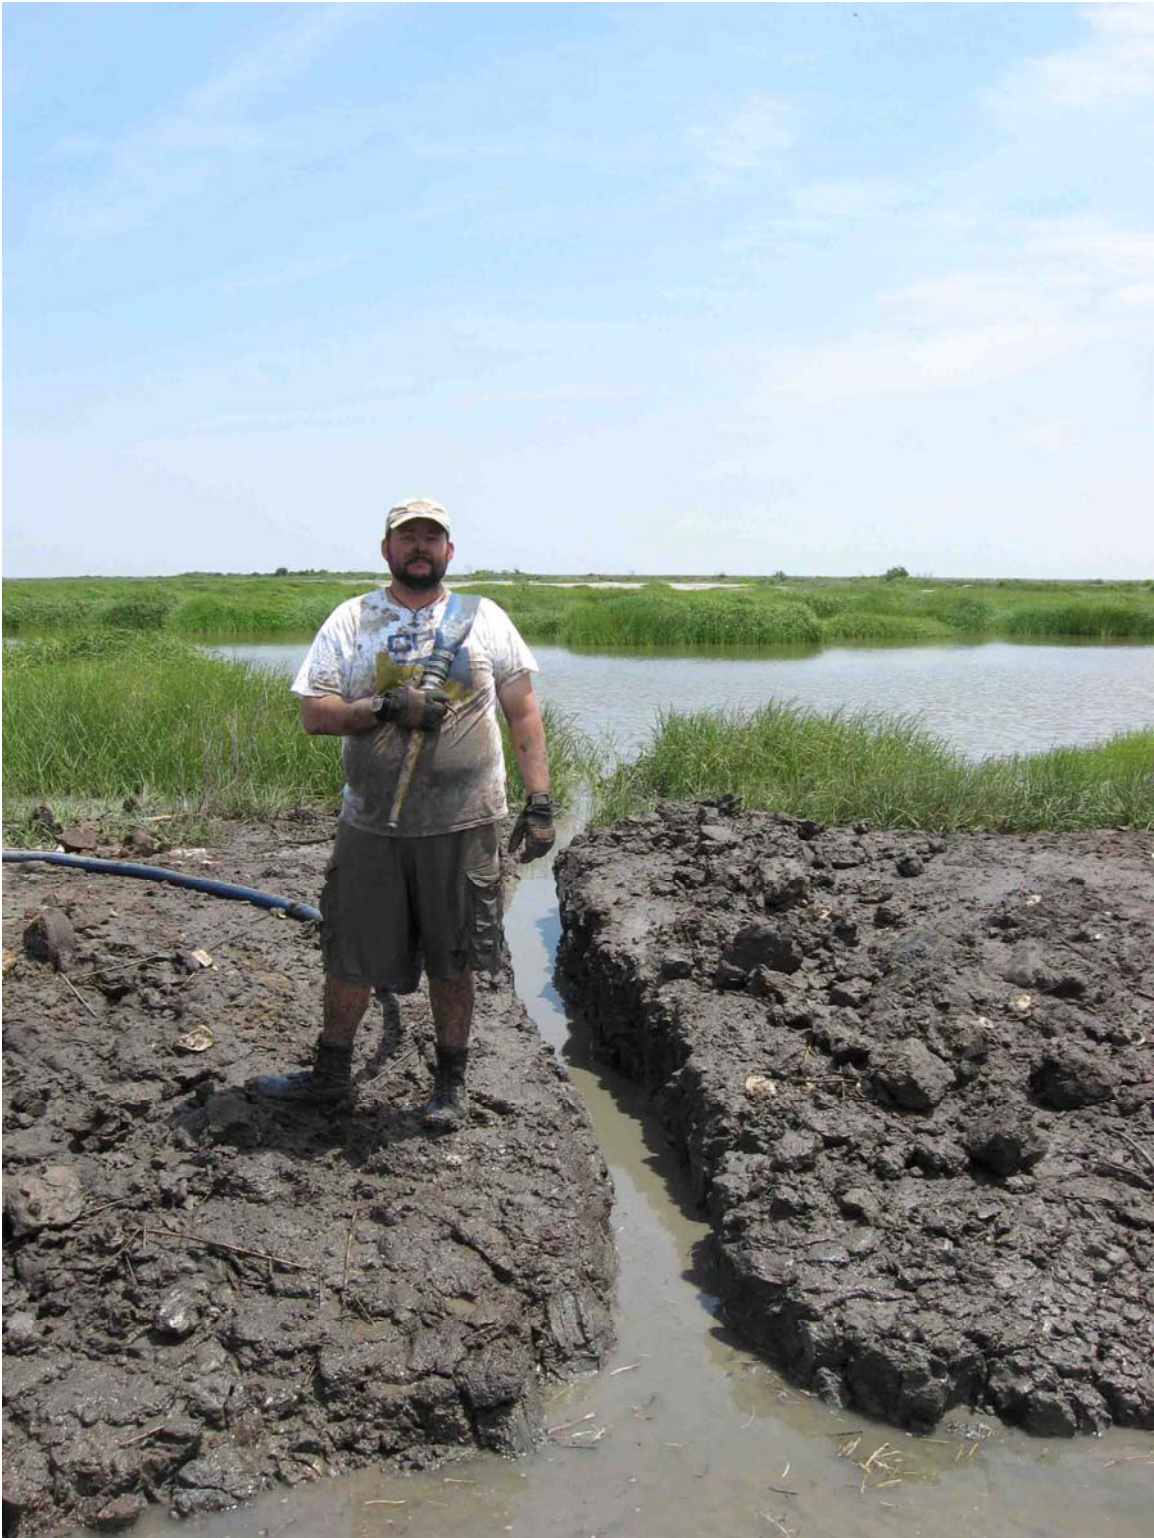
The containment dike was not degraded upon demobilization from the construction site. During the period between demobilization and this inspection the dike has been slowly degrading due to natural processes. In May, 2008, members of the OCPR and NMFS hydraulically cut 4 gaps into the containment dike using a high pressure pump. At the time of the inspection these gaps were larger and allowing water to exchange between the project area and outer marshes and canals. Photos #2 and 3)

Photo #2 – Hydraulic Dike Gapping.

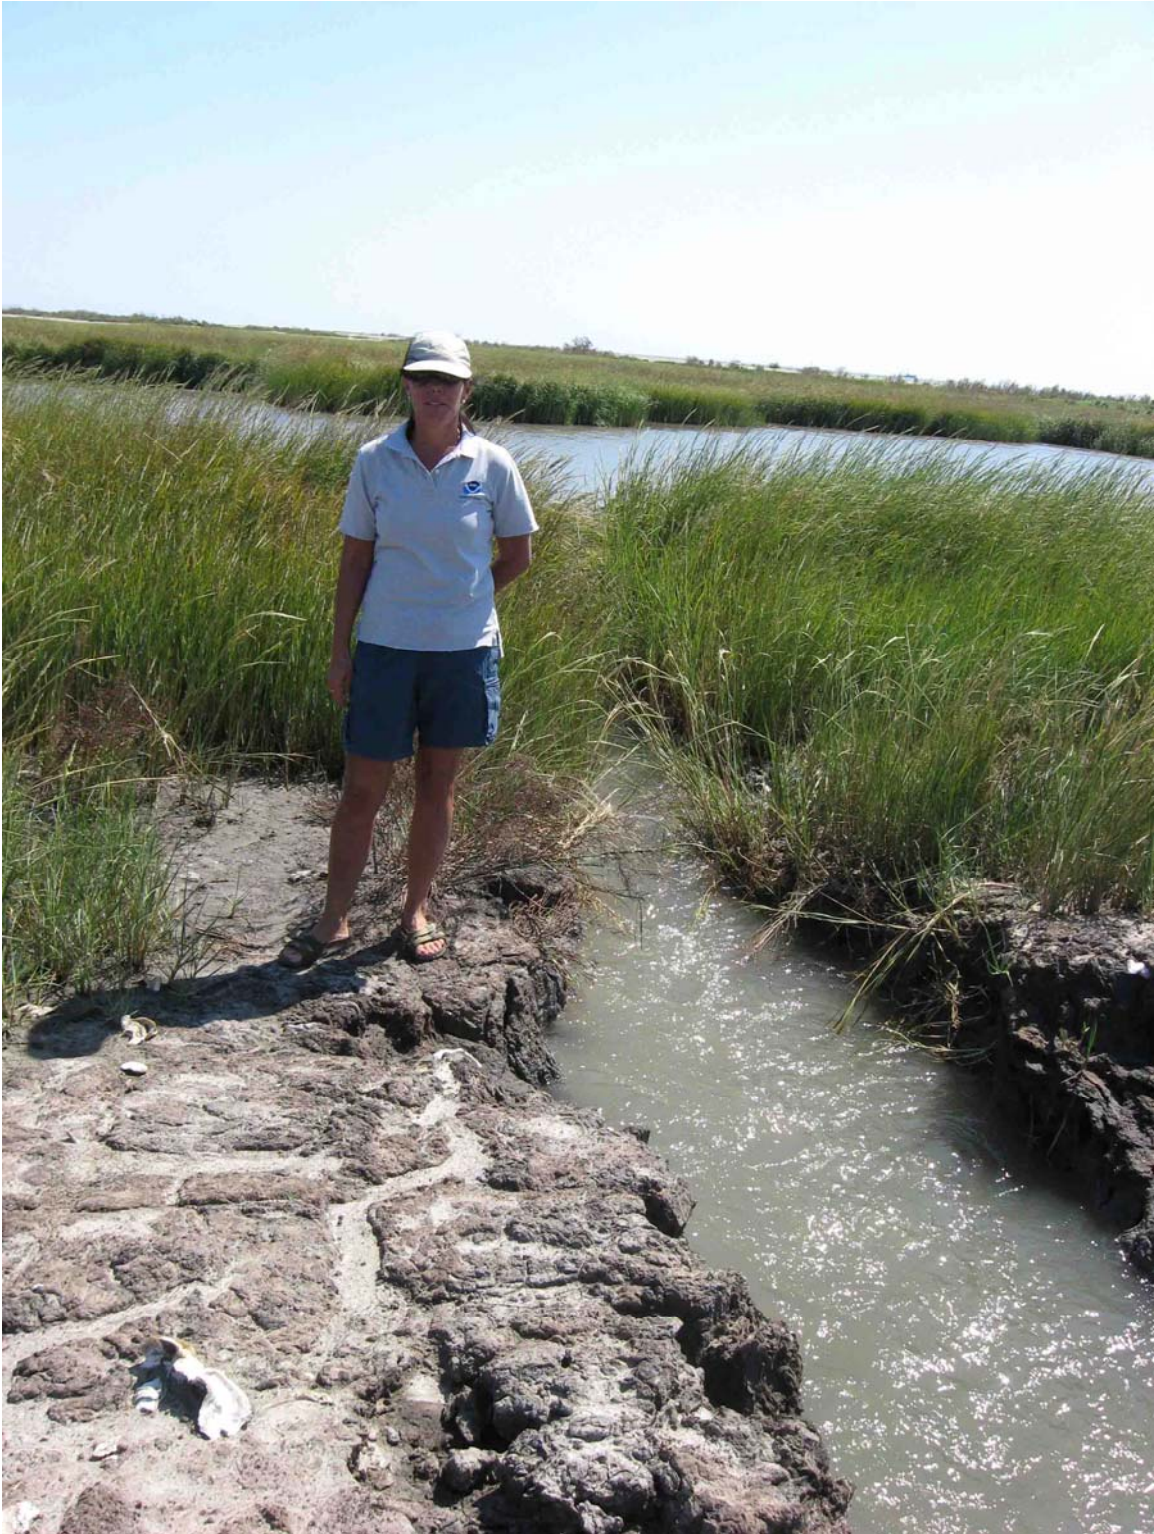
Photo #3 – Dike Gap (at 6 months).
