2009 Annual Inspection Report

Barataria Bay Waterway East Bank Protection

State Project Number BA-26
Priority Project List 6

July 1, 2009
Jefferson Parish

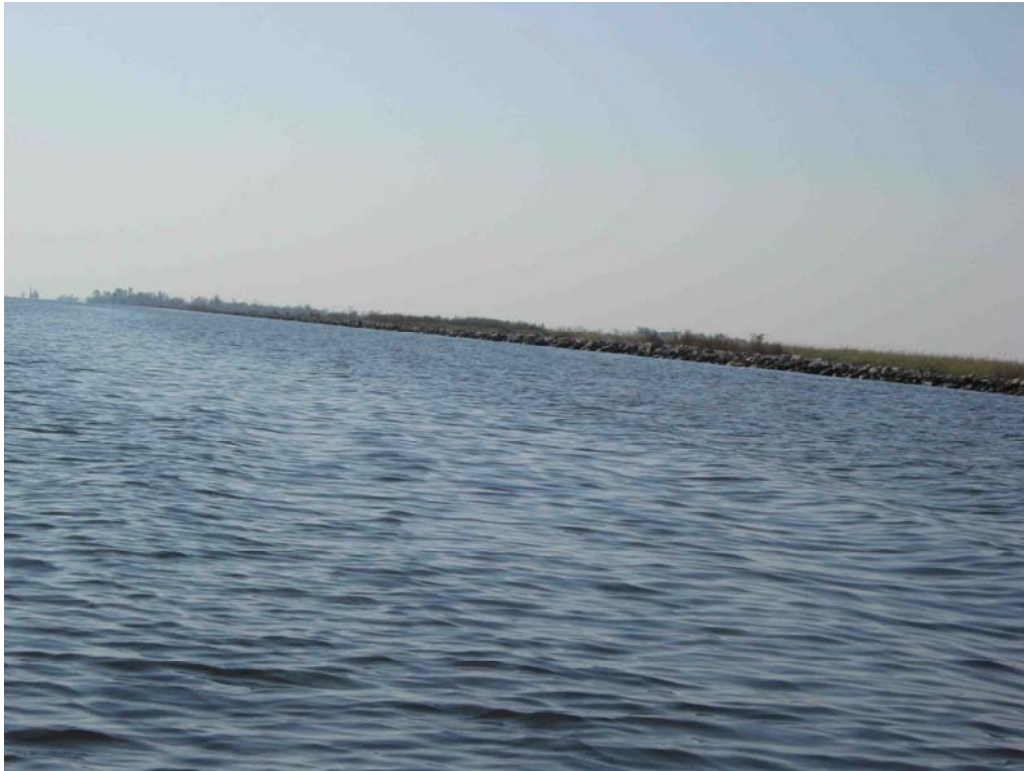
There are no noticeable damages to the rock structure since the previous inspection (Photo #1). Some settlement has been observed. A small gap in the rock structure was seen at approximate coordinates N29.61380°, W 090.07905°. This gap is probably the result of vandalism and should be monitored (Photo #2).

Photo #1 – Shoreline Protection Looking North

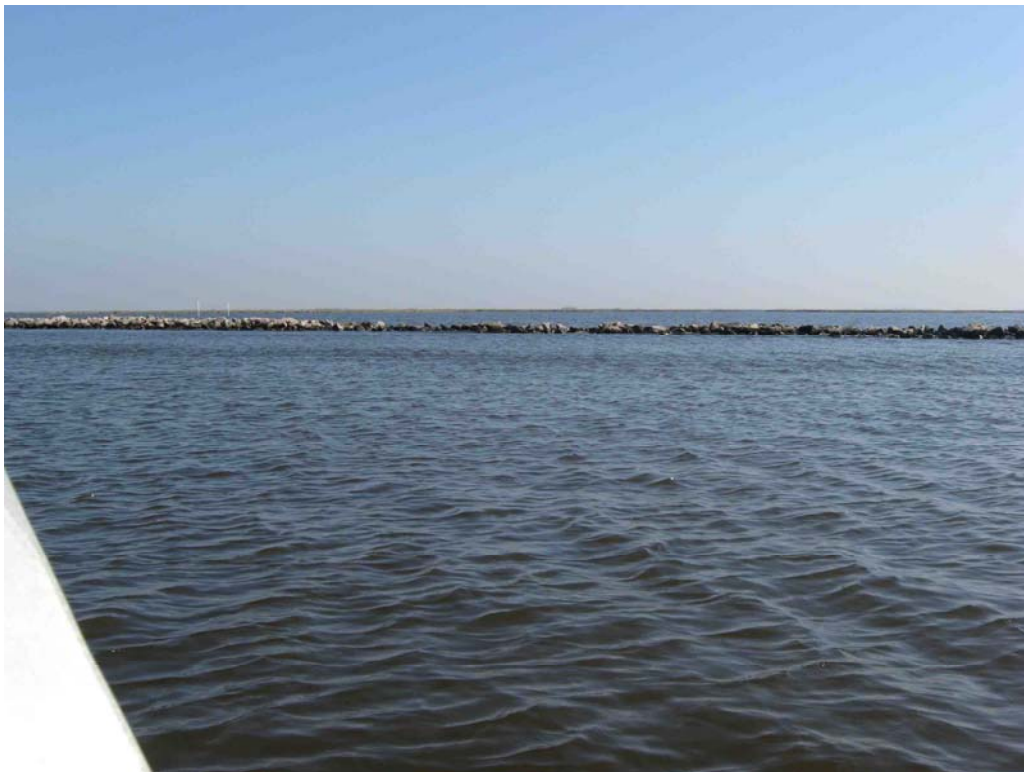
Photo # 2 – Small gap in Shoreline Protection.

Item	Condition	Physical Damage	Corrosion	Photo #	Observations and Remarks
Foreshore Rock Dike	Good	small gap	None	1, 2	small gap at approx. coordinates N29.61380, W090.07905
Settlement Plates	Good	None	None		
Signage /Supports	Good	None	None
