**State of Louisiana
Department of Natural Resources
Coastal Restoration Division and
Coastal Engineering Division**

**2004 Operations, Maintenance,
and Monitoring Report**

Cameron Creole Plugs Project

State Project Number CS-17
Priority Project List 1

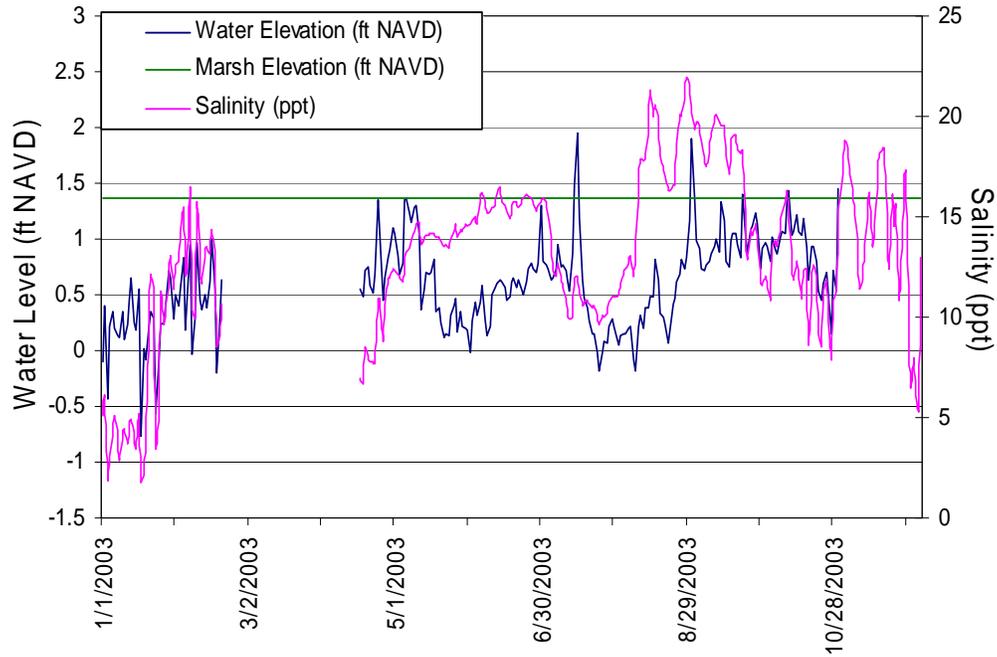
Station CS17-01R (1/1/03 -12/31/03)
Salinity and Water Level Data

Salinities were higher at CS17-01R than at the other stations for 2003 ($p < 0.0001$) (figure 10). This is most likely because the recorder is located in Calcasieu Lake and is impacted by saltwater entering the lake through the Calcasieu Ship Channel. Salinity has shown the same trend at the four recorders in the CS-17 project since 1997 (figure 11). Of the other 3 stations, CS17-11 in the northern project area, had the lowest salinity and CS17-01R in Calcasieu Lake had the highest salinity. There were no specific project goals for salinity.

Water levels were lower at station CS17-01R than the other 3 stations in 2003 (figure 12). Water levels were highest at CS17-12 ($p < 0.0001$). Stations CS17-02R and CS17-11 had approximately the same mean water level for the year. Water level and the percent of time the marsh was flooded at station CS17-12 in the southern project area has increased relative to the reference station CS17-02R since 1999 (figures 13 and 14). One goal of the CS-17 project was to decrease the duration of flooding in the southern project area. These data show that water levels have increased in the southern project area.

Figure 6. Hourly salinity and water level data at station CS17-01R in Calcasieu Lake. Water level readings above marsh elevation indicate that the marsh was flooded.

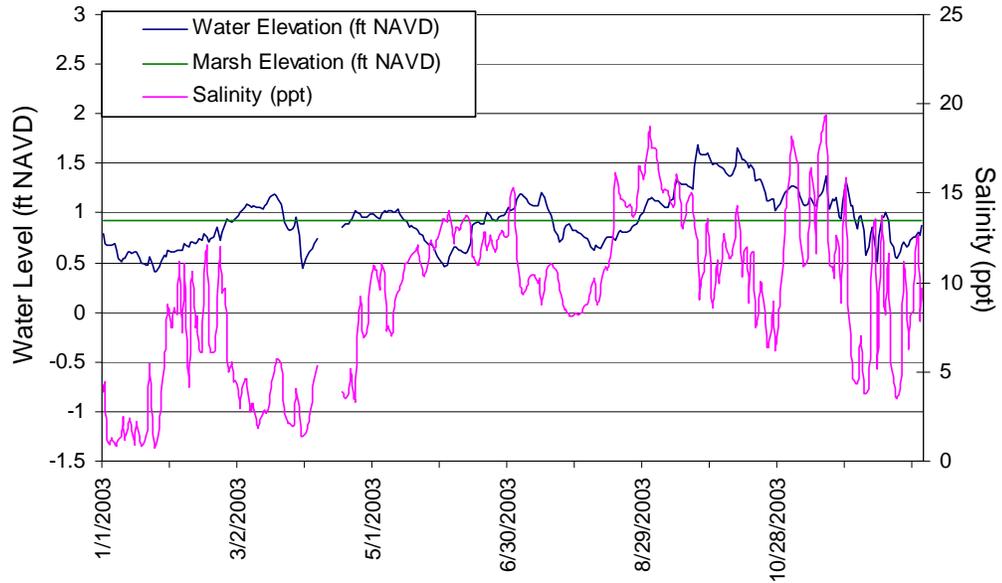
Station CS17-02R (1/1/03 -12/31/03)
Salinity and Water Level Data

Figures 7. Hourly salinity and water level data at station CS17-02R in the borrow canal. Water level readings above marsh elevation indicate that the marsh was flooded.

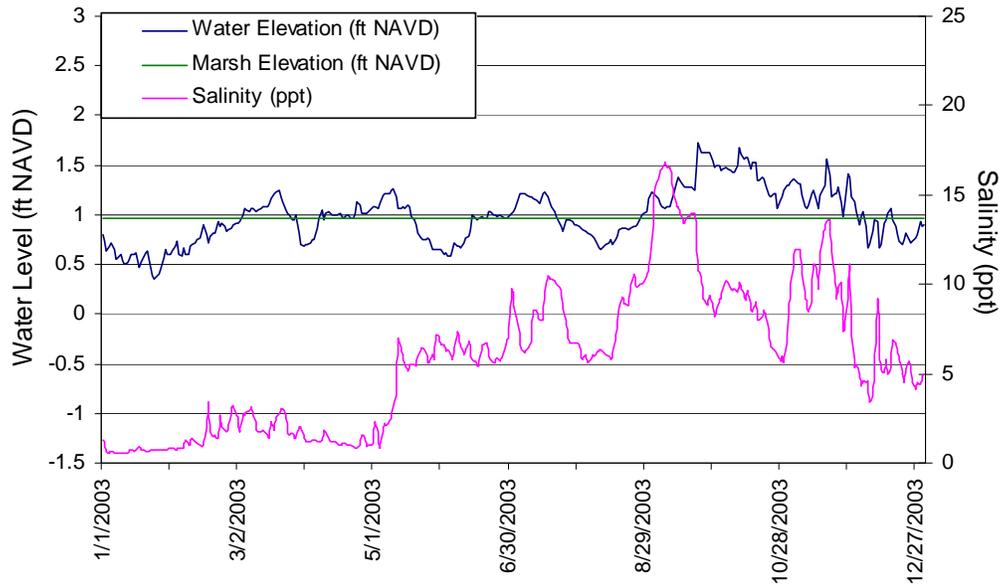
Station CS17-11 (1/1/03 -12/31/03)
Salinity and Water Level Data

Figure 8. Hourly salinity and water level data at station CS17-11 in the northern project area. Water level readings above marsh elevation indicate that the marsh was flooded.

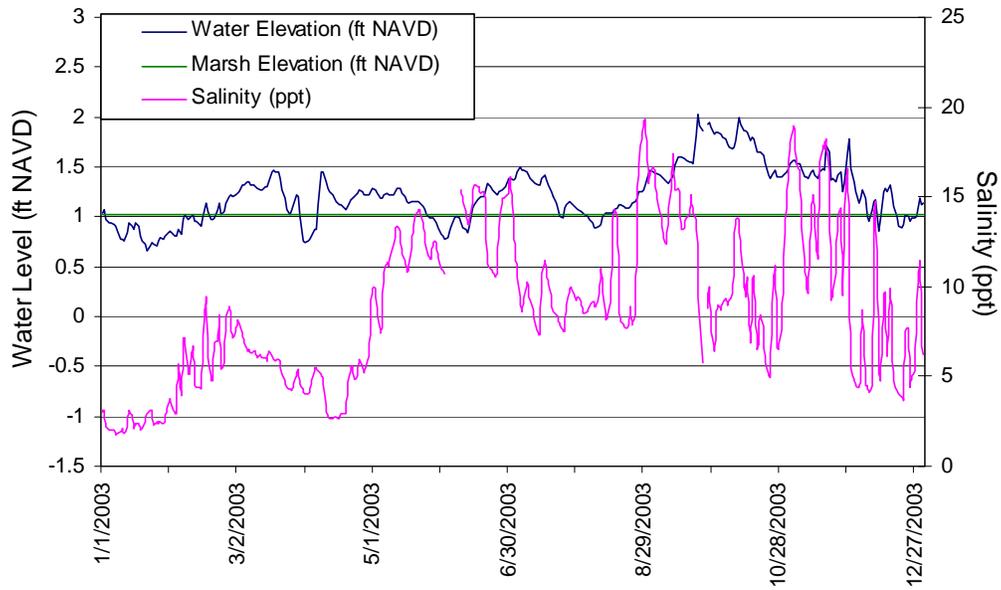
Figure 9. Hourly salinity and water level data at station CS17-12 in the southern project area. Water level readings above marsh elevation indicate that the marsh was flooded.

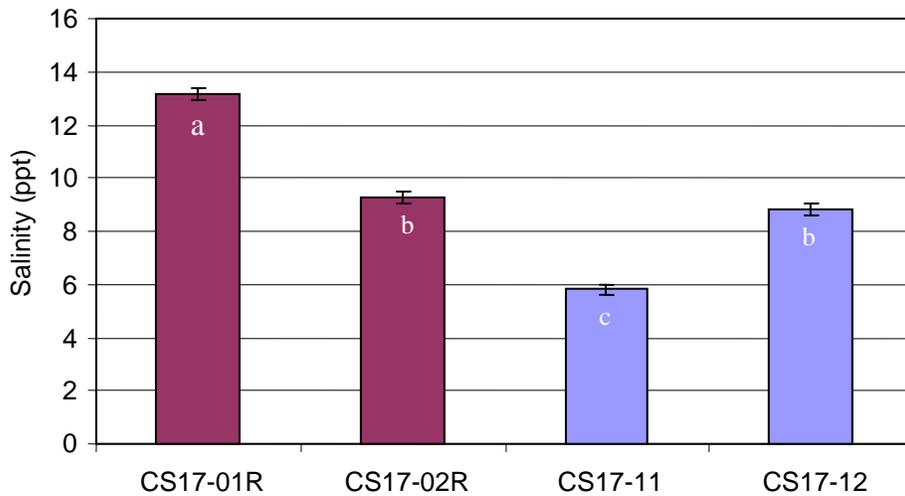
Figure 10. Yearly mean salinity of daily means for 2003 at each CS-17 recorder (Mean \pm SE). CS17-01R, the recorder in the lake, was found to be significantly higher than the other three recorders. CS17-02R, the recorder in the borrow canal, was found to be higher than CS17-11 (in the northern project area) but not CS17-12 (in the southern project area). Levels not connected by the same letter are significantly different.

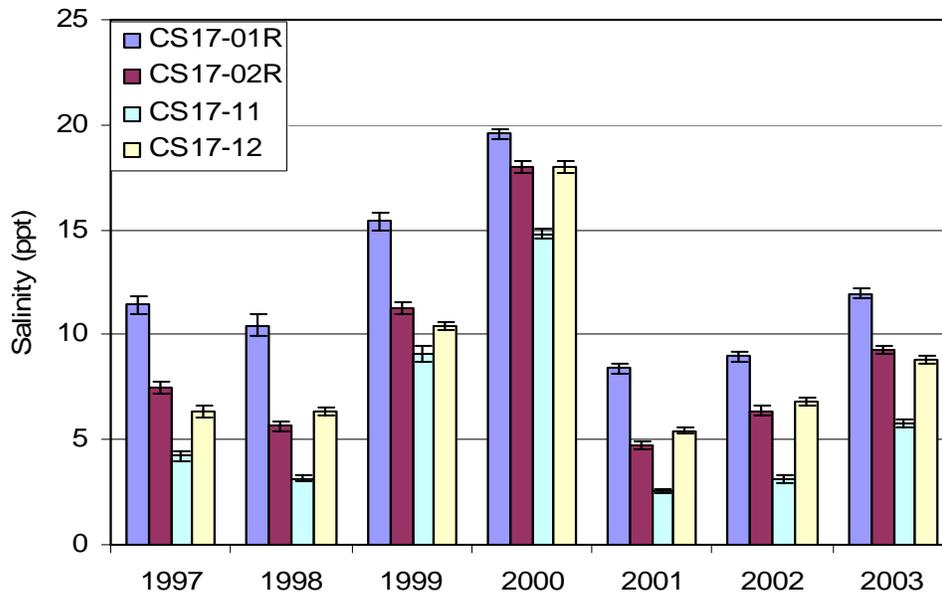
Figure 11. Yearly salinity over the course of the CS-17 project. Salinity has increased and decreased due to rainfall while salinity trends among the four recorders have remained the same since 1997.

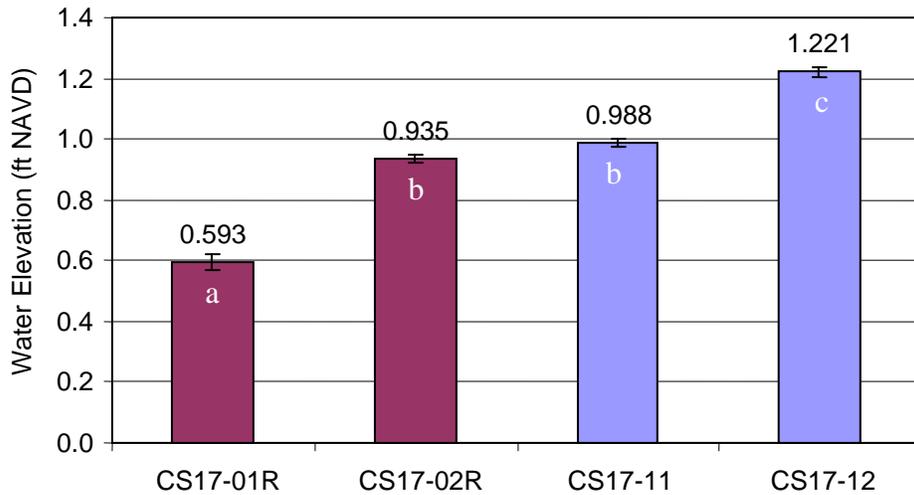
Figure 12. Yearly mean water level of daily means for 2003 at each CS-17 recorder (Mean \pm SE). Water elevation at CS17-01R, the recorder in the lake, was found to be significantly lower than at the other three recorders. CS17-12, the recorder in the southern project area, was found to be higher than the other recorders. Levels not connected by the same letter are significantly different.

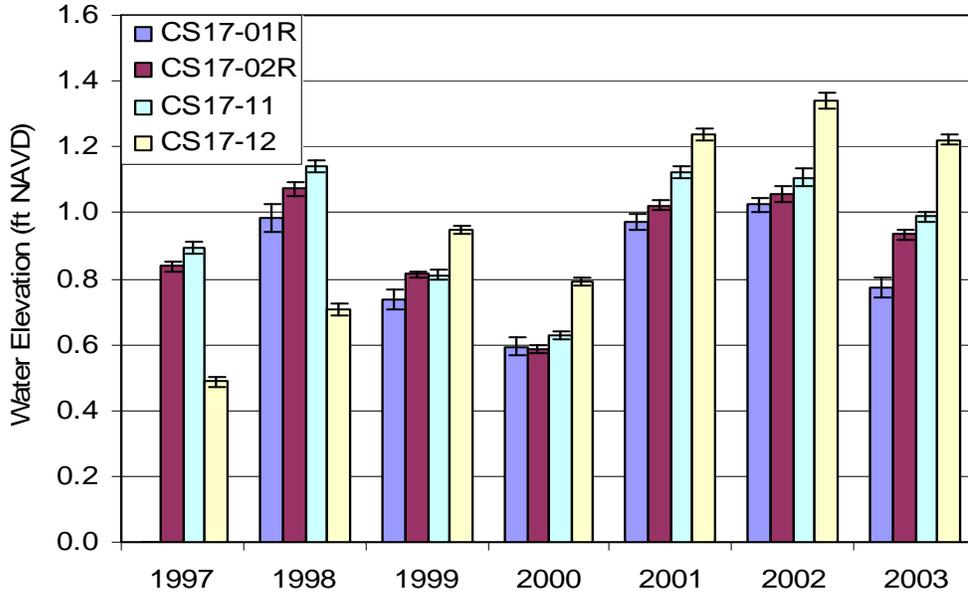
Figure 13. Yearly water levels at each of the stations since 1997. Station CS17-12 has increased relative to the reference stations since 1997.

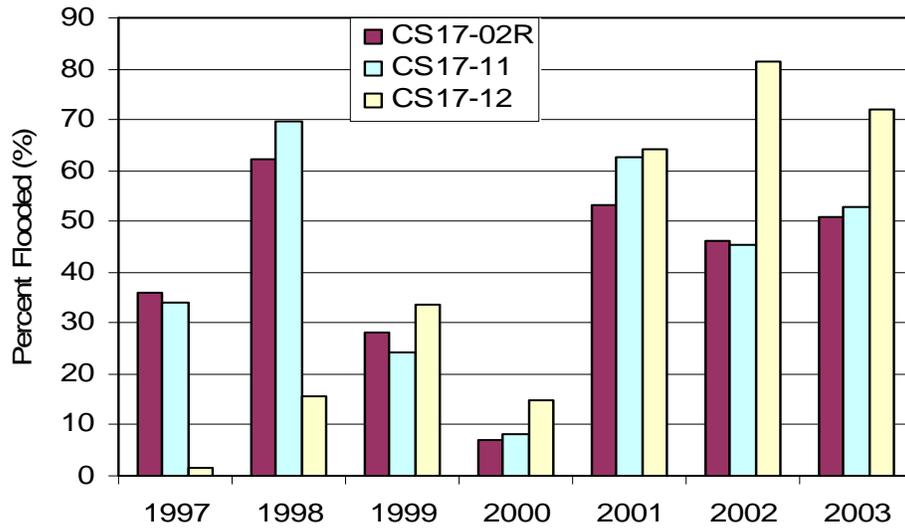
Figure 14. Percent of time the marsh was flooded at recorder stations in the CS-17 project area. Station CS17-12 has increased since 1999 relative to the reference recorder.

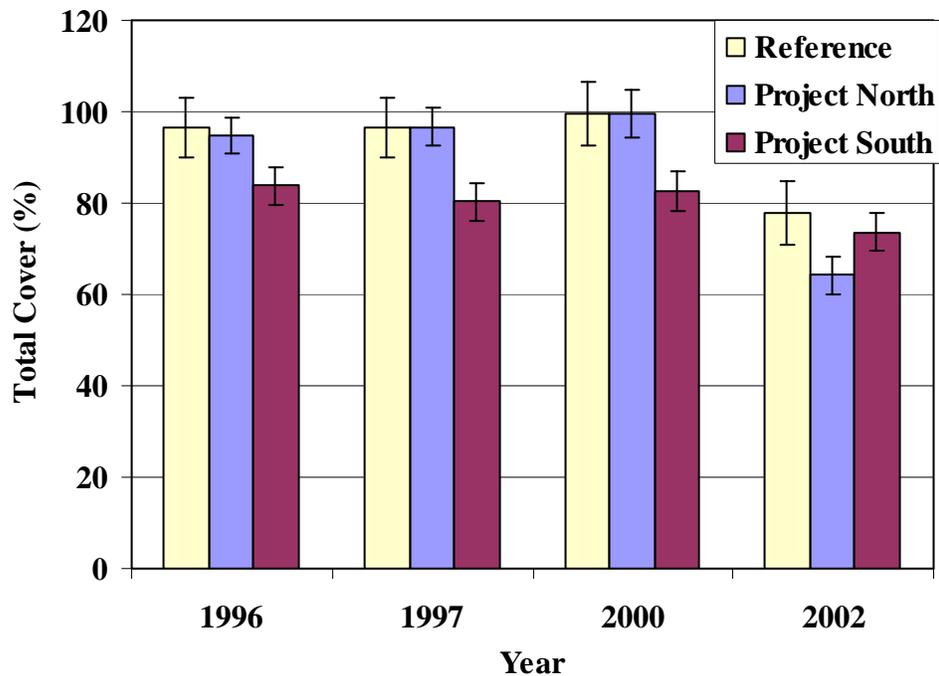
Figure 15. Total percent cover in the two project and reference areas for each sampling year for the CS-17 Cameron Creole Plugs project (LS Mean \pm SE). Cover in 2002 was significantly lower than the other sampling years ($p < 0.0001$). There was also a significant interaction between project/reference areas and years ($p = 0.0211$). Post-ANOVA contrasts showed that the Southern Project area was significantly lower than the Reference area in both 1997 and 2000. The low cover values in 2002 could be due to increased frequency of inundation in 2001 and 2002 (figure 14).

Percent cover of emergent vegetation was relatively similar in the northern project and reference area until 2002 (figure 15) when cover decreased in both the northern and southern project areas. Cover in the southern project area has been lower than in the reference area throughout the project. The decrease in cover could be due to increased frequency of inundation in 2001 and 2002 (figure 14) but that alone would not explain loss of cover in the northern project area because inundation there was approximately the same as the reference area which did not decrease as much as the northern project area did. SAV decreased in 2000 and returned in 2002 (table 3). Changes in SAV are most likely due to changes in salinity from year to year (figure 11).

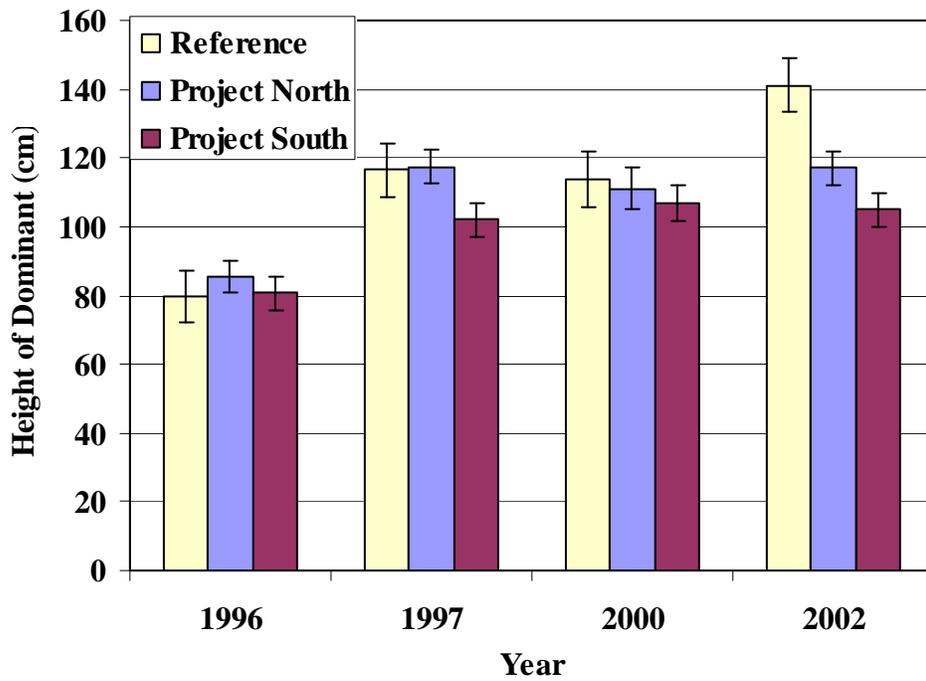
ANOVA of height of the dominant species revealed that height of the dominant species, *Spartina patens* was significantly higher in the reference area in 2002 than in the project areas in 2002 or any other year (figure 16). There was no difference in species richness in any years or areas. Richness was approximately 2 species per plot in all years and areas.

Figure 16. Height of the dominant species (*Spartina patens*) in the project and reference areas for each sampling year for the CS-17 Cameron Creole Plugs project (LS Mean \pm SE). The Southern project areas was significantly lower in height in 2002 ($p=0.0143$). This may be due to more flooding (figure 14).
