**State of Louisiana
Department of Natural Resources
Coastal Restoration Division and
Coastal Engineering Division**

**2004 Operations, Maintenance,
and Monitoring Report**

Sabine Refuge Protection

State Project Number CS-18
Priority Project List 2

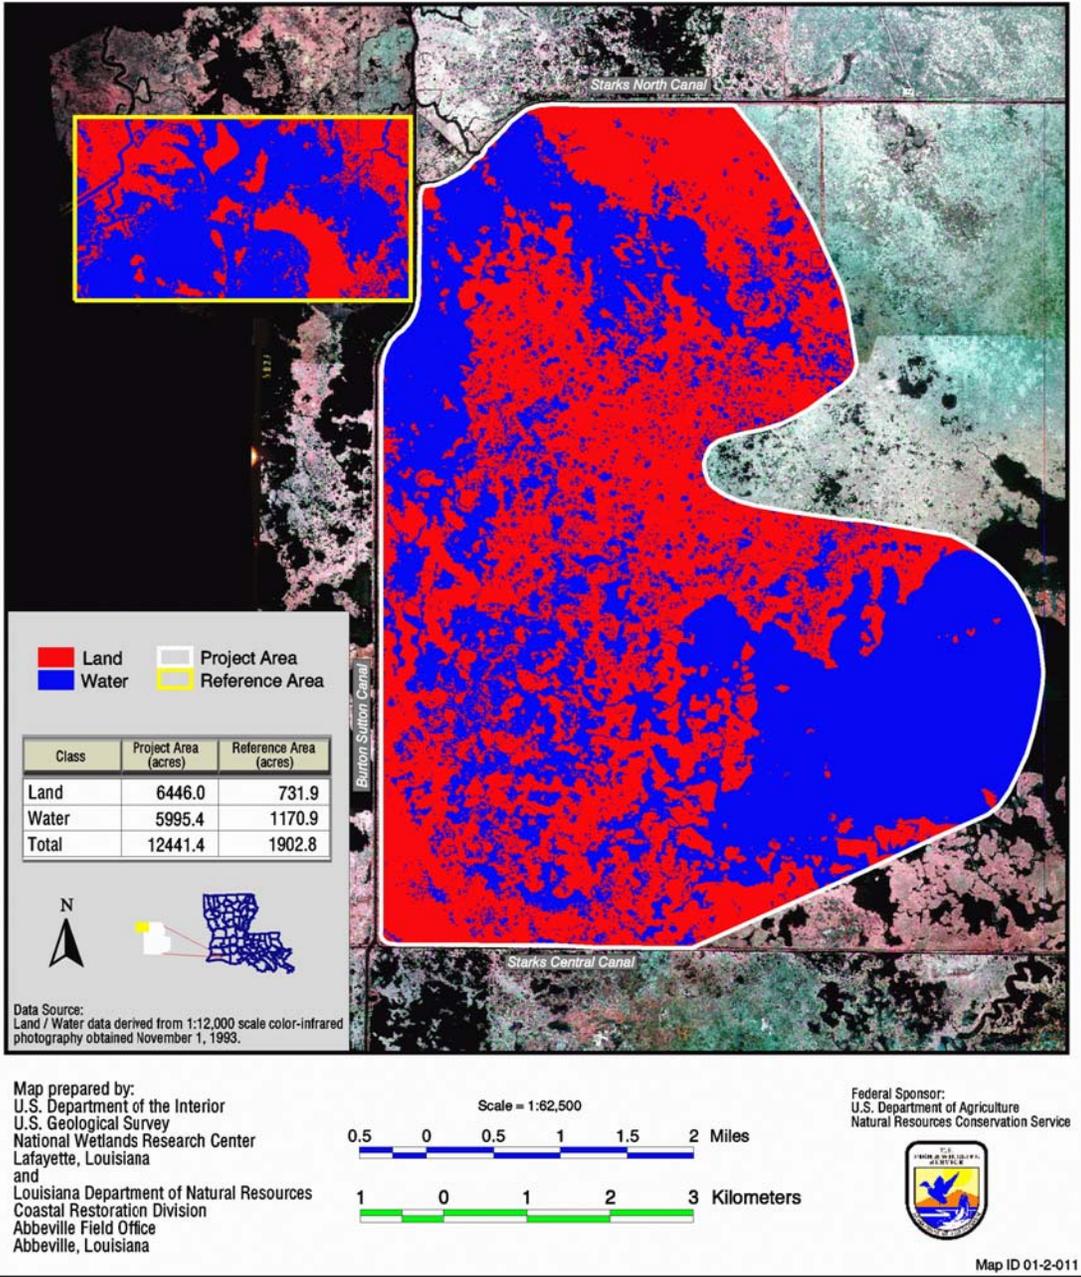
Land to water ratios in the project area were 51.8% land to 48.2% water pre-construction in 1993 and 45.9% land to 54.1% water in 1997 postconstruction. In the reference area in 1993, ratios were 38.5% land to 61.5% water and in 1997, ratios were 37.9% land to 62.1% water. It was determined that the 1997 post construction aerial photography was flown when water levels in Impoundment 3 were much higher than during pre-construction photography (1993). Because the reference area is not impounded, water levels were lower than in the impoundment, and land to water ratios did not reflect those in the project area. The land loss in Impoundment 3 (figures 2 and 3) is not as high as it appears. Field observations suggest that little or no land loss has occurred.

Figure 2. Sabine Refuge Protection (CS-18) GIS analysis of project and reference area pre-construction aerial photography (1993).

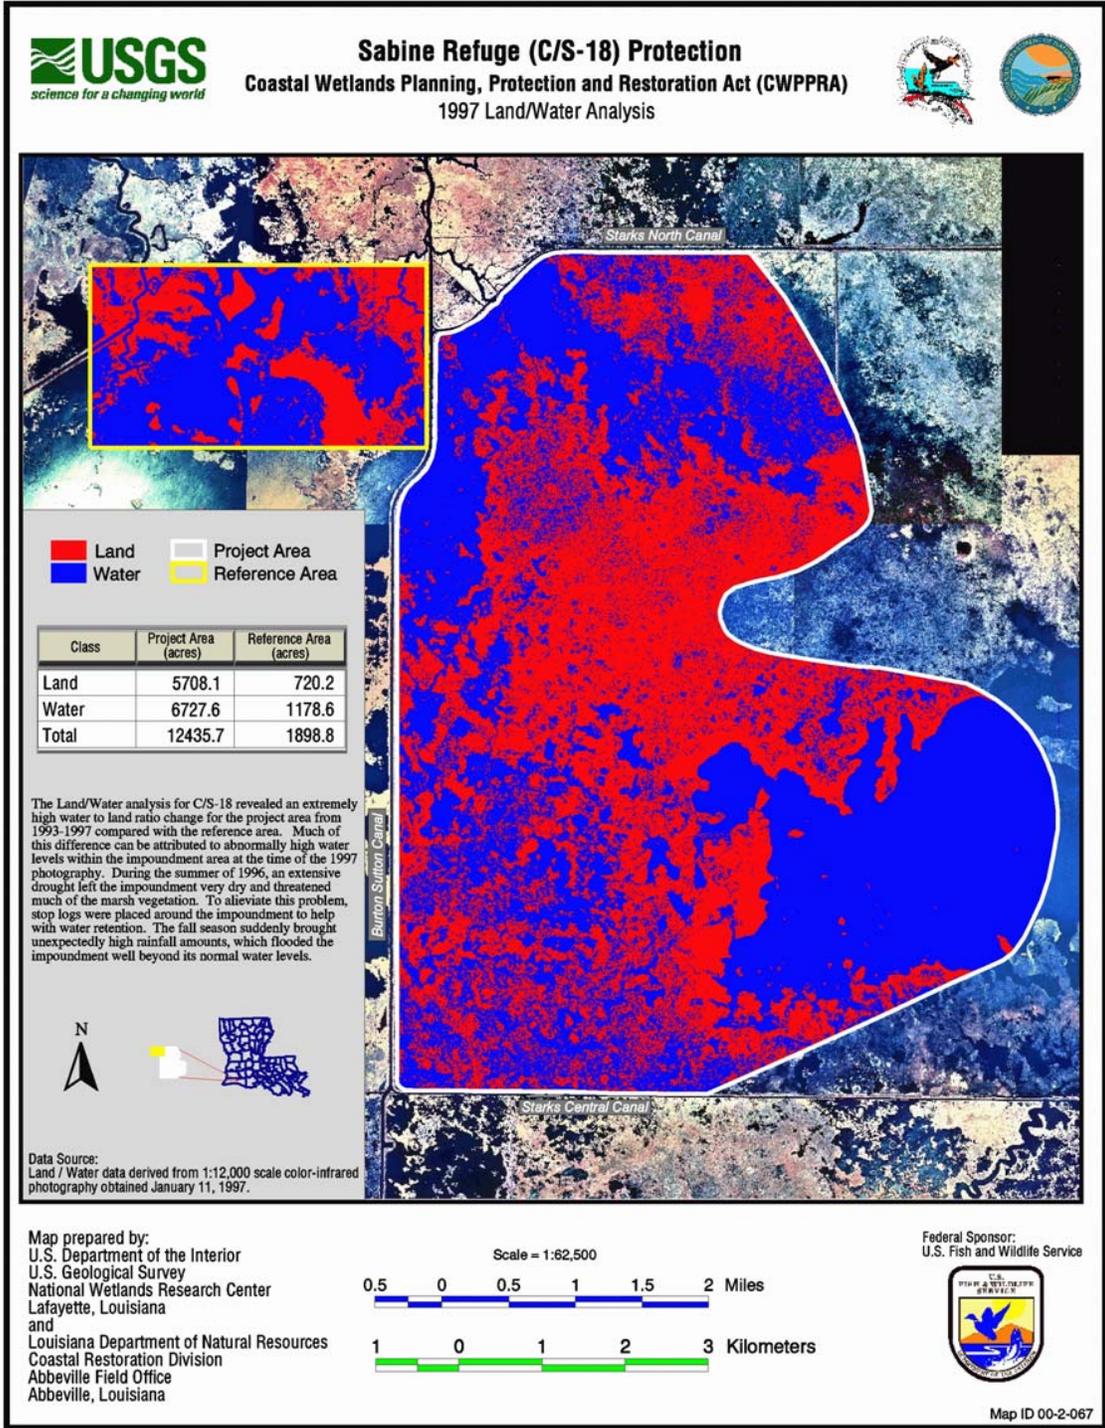
Figure 3. Sabine Refuge Protection (CS-18) GIS analysis of project and reference area post-construction aerial photography (1997).

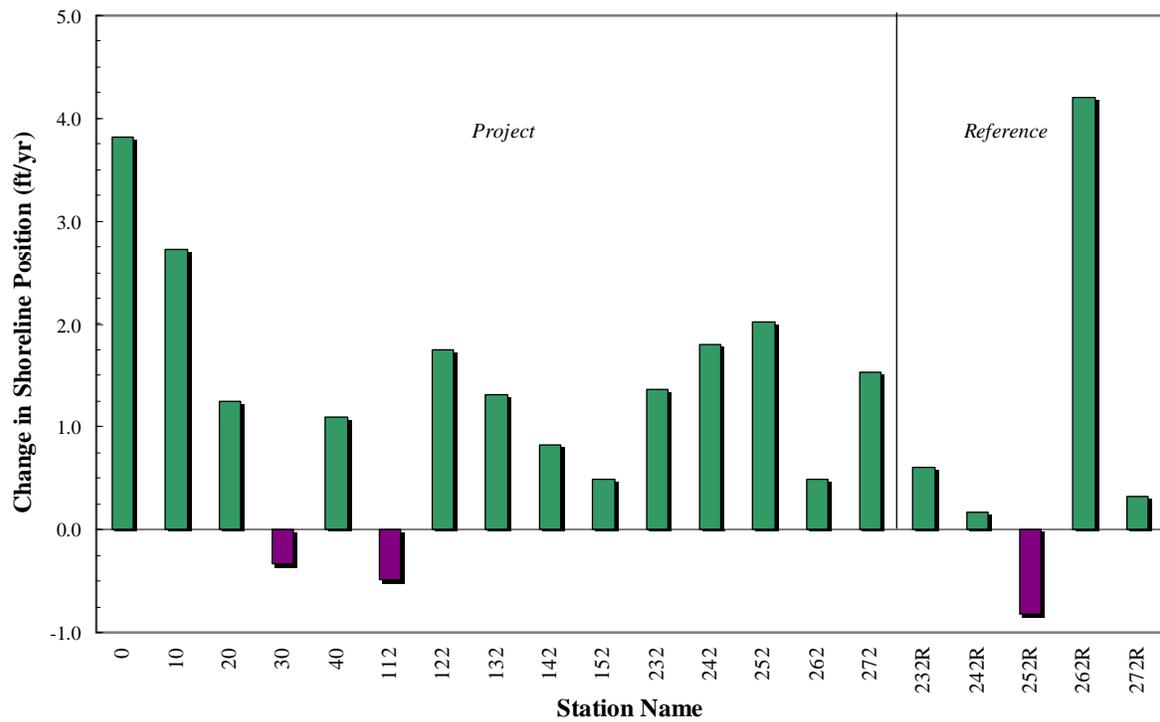
Shoreline survey results, presented in figures 4a and 4b, show shoreline position change during the study period differing by less than 8.5 ft (2.6 m) at any one station for both the project and reference areas. Shoreline advance was detected at all project stations except stations 30 and 112 and for all reference stations except 252R during the period between 1995 and 2000 (figures 5a and 5b). Mean shoreline advance rates were calculated to be 1.3 + 1.1 ft/yr (0.4 + 0.3 m/yr) and 0.9 + 1.9 ft/yr (0.3 + 0.6 m/yr) for the project and reference areas, respectively. The results of the two-sample t-test indicated that there was no significant difference in shoreline change rate detected between the project and reference areas ($P = 0.90$).

Figure 4. Sabine Refuge Protection (CS-18) shoreline change for the project and reference area from 1995 to 2000. Rates are calculated in ft/yr.

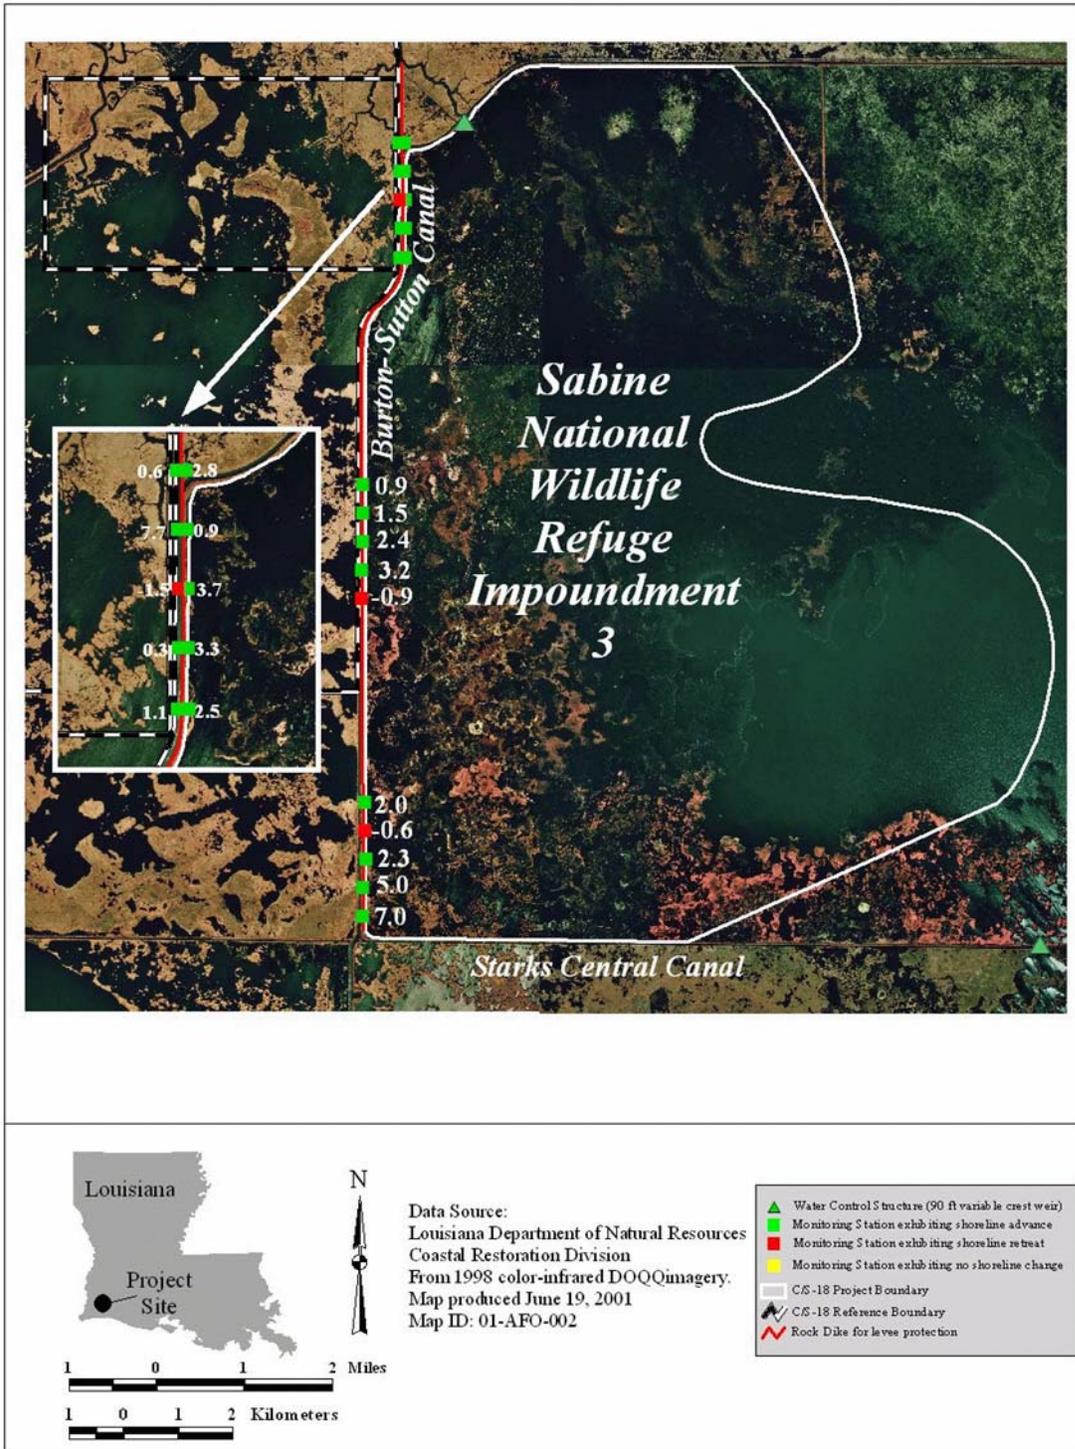
Figure 5. Sabine Refuge Protection (CS-18) shoreline change (ft) at project and reference area monitoring station locations between October 1995 and August 2000.
