**2004 Operations, Maintenance,  
and Monitoring Report**

**Black Bayou Hydrologic Restoration**

State Project Number CS-27  
Priority Project List 2

May 2004  
Calcasieu and Cameron Parishes

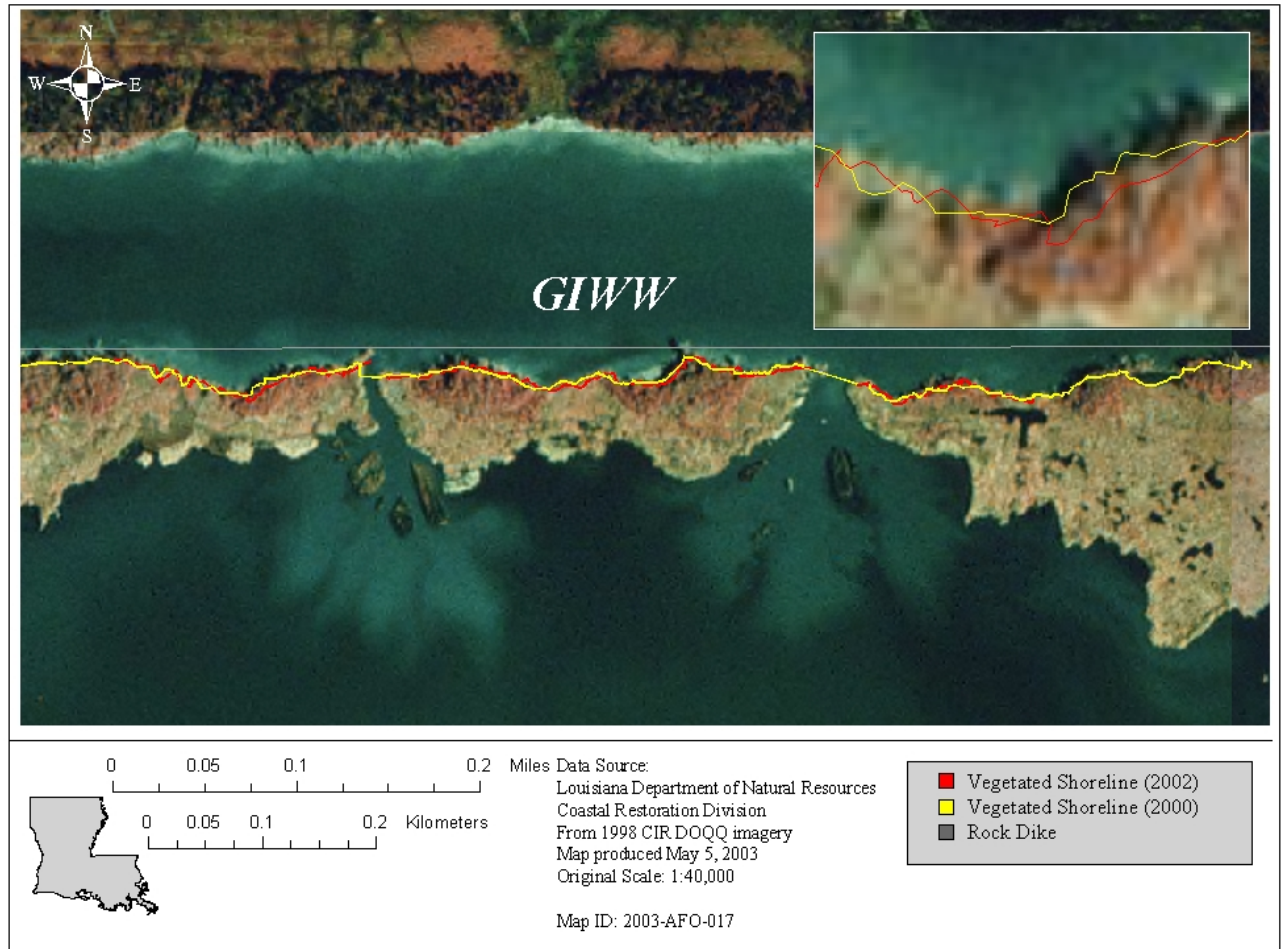
**Figure 4.** GPS surveys preconstruction (2000) and immediately postconstruction 2002 at the project section of GIWW bank. Picture inset shows a magnified view of the survey tracks.

A DGPS survey of a portion of the GIWW shoreline within the project boundary was conducted preconstruction (2000) and in spring 2002 after the rock dike feature was constructed. The reference area for this monitoring element was compromised because of another rock dike construction and therefore no meaningful comparisons can be made between project and reference. The GPS system we used is considered to have submeter accuracy. This means that each physical point should be within 3ft of the corresponding point on the map. An areal analysis of loss / gain was not conducted, but linear gains and losses as measured roughly in ArcMap were as much as 17ft and 27ft respectively (figure 4).

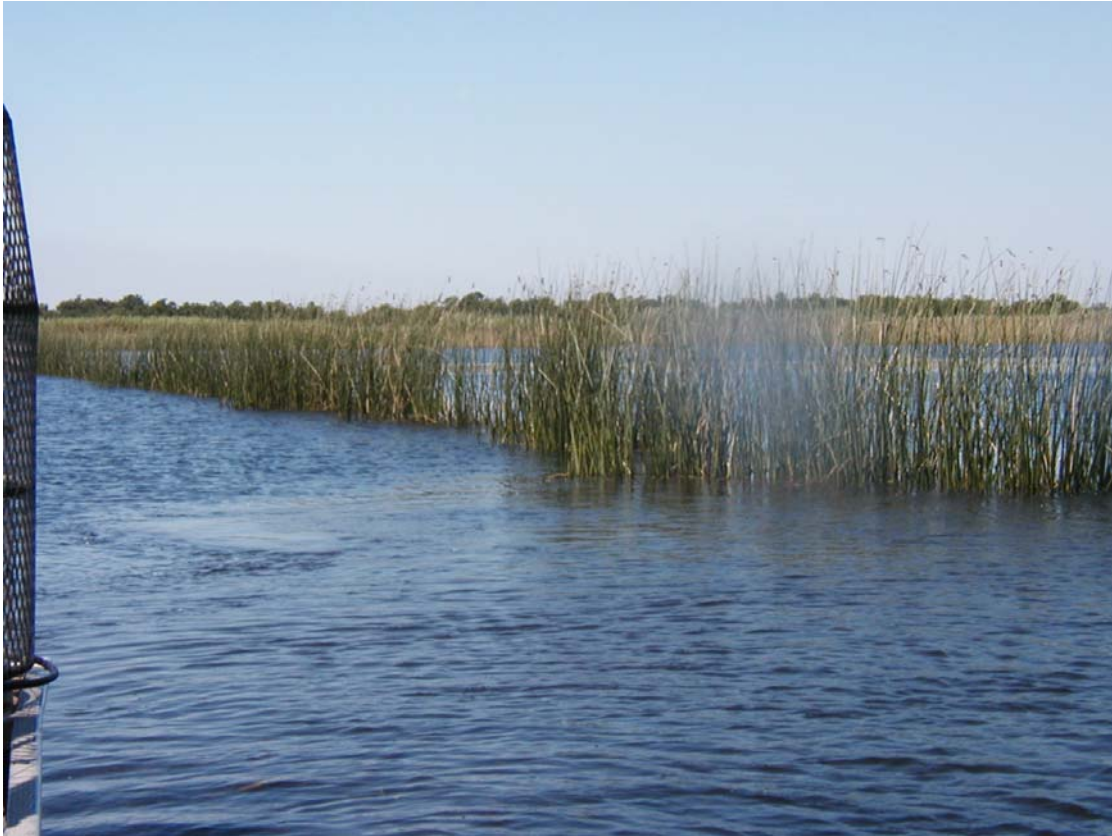
*Schoenoplectus californicus* (bullwhip) plantings were installed in 2002. Monitoring was conducted in September approximately 1 year after planting. Sample plots had varying survival success. Individuals were recorded as alive, absent, or dead. Except for a few, most plants counted as absent or dead were absent. A total of 53 plots containing 848 plants were sampled. The mean percentage found alive was 68%, the maximum was 100%, and the least amount found alive in a plot was 6%. Some plots had robust, healthy plants almost indistinguishable, whereas, other plots had plants with few stems in deteriorated condition (figures 9 and 10).

**Figure 9.** Healthy stand of planted *S. californicus*.

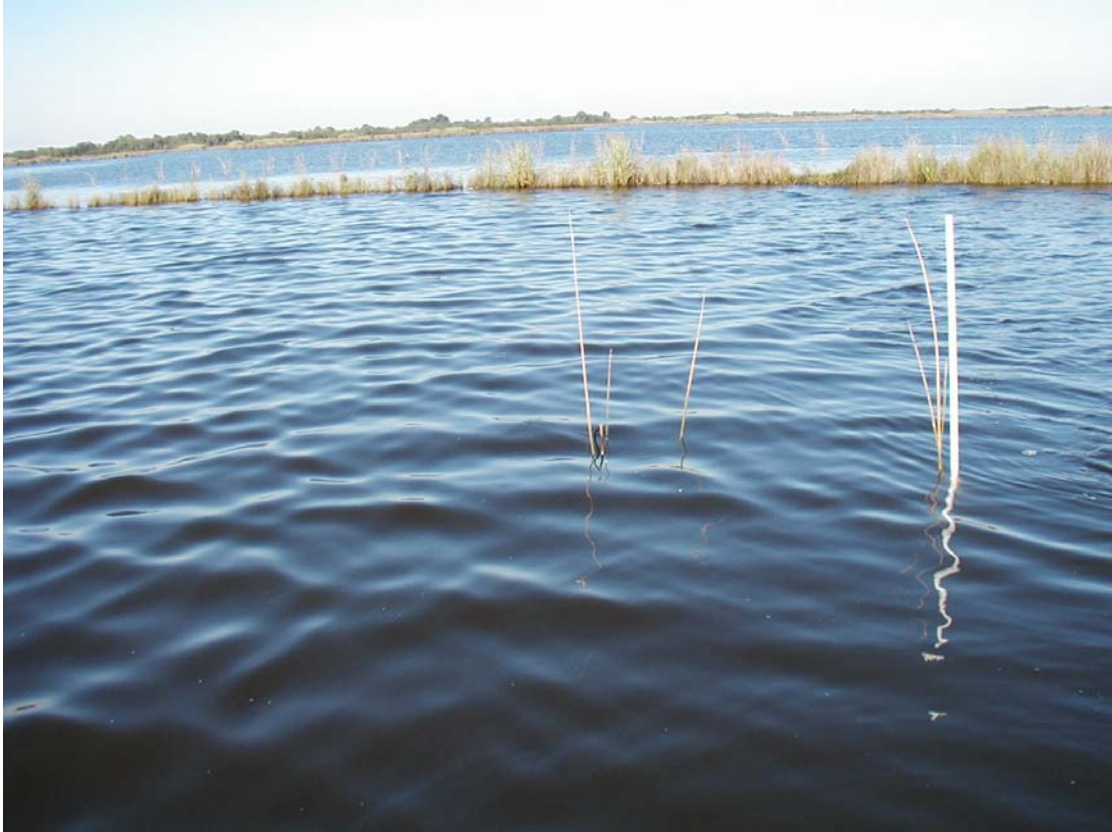
**Figure 10.** In the foreground, 2 surviving *S. californicus* planting stems.
