LAKE SALVADOR SHORELINE PROTECTION DEMONSTRATION PROJECT (BA-15)

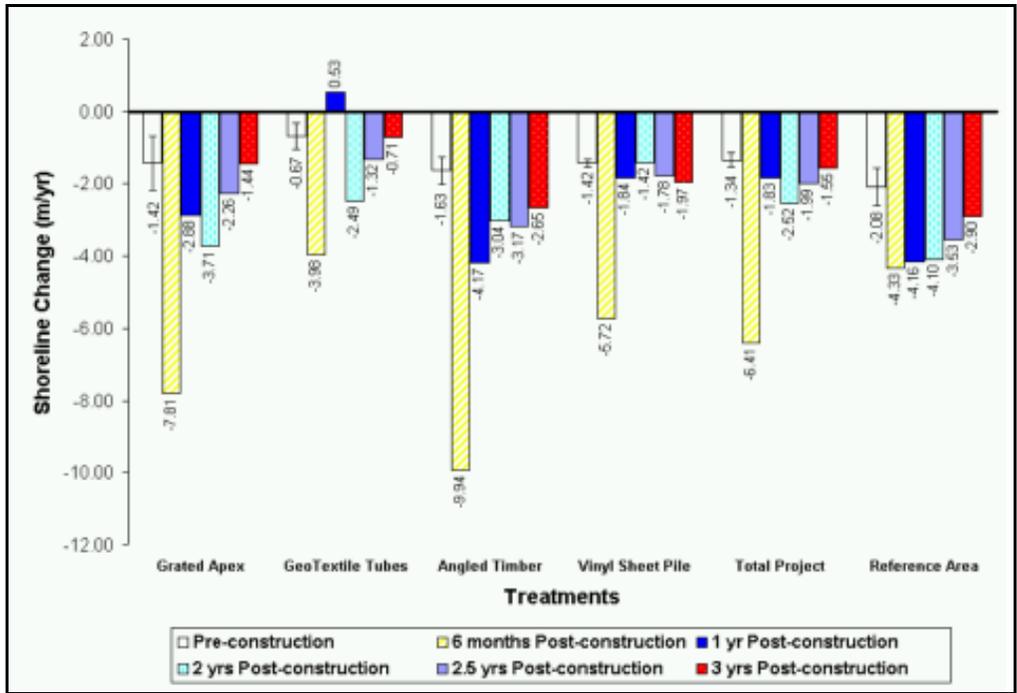
Figure 14. Shoreline change rates from DGPS data for all treatments at Phase 1 of the Lake Salvador Shoreline Protection (BA-15) Demonstration project from January 1996 to August 2000.

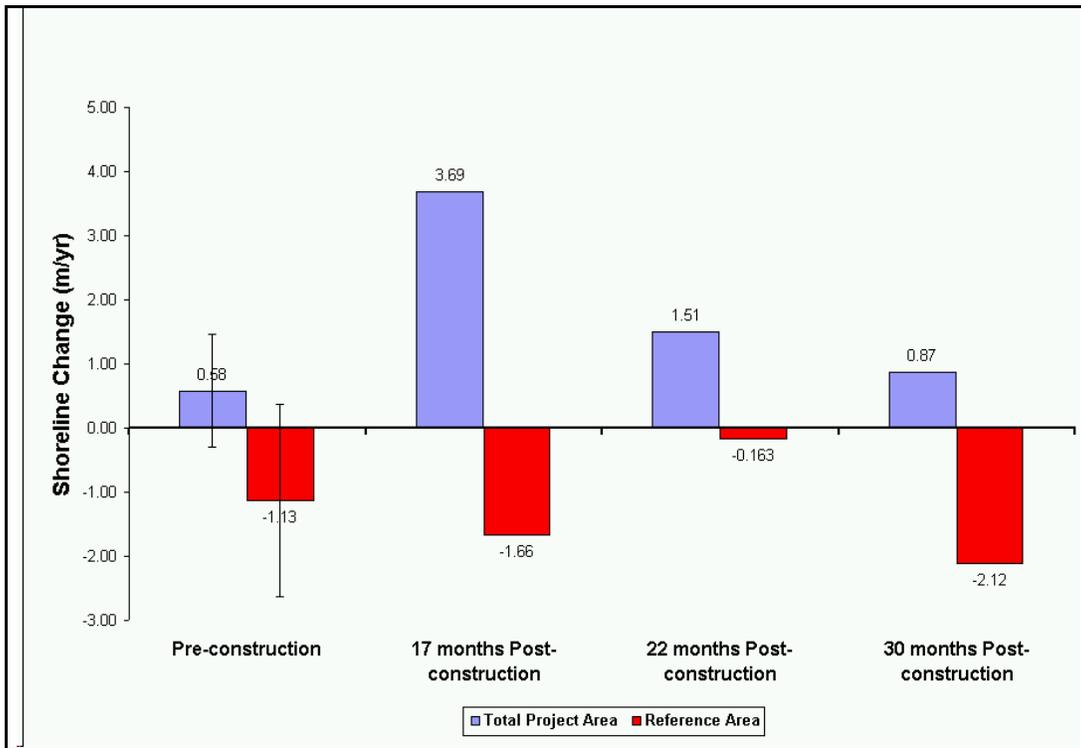
Figure 20. Shoreline change rates from DGPS data for Phase 2 of the Lake Salvador Shoreline Protection (BA-15) Demonstration project.

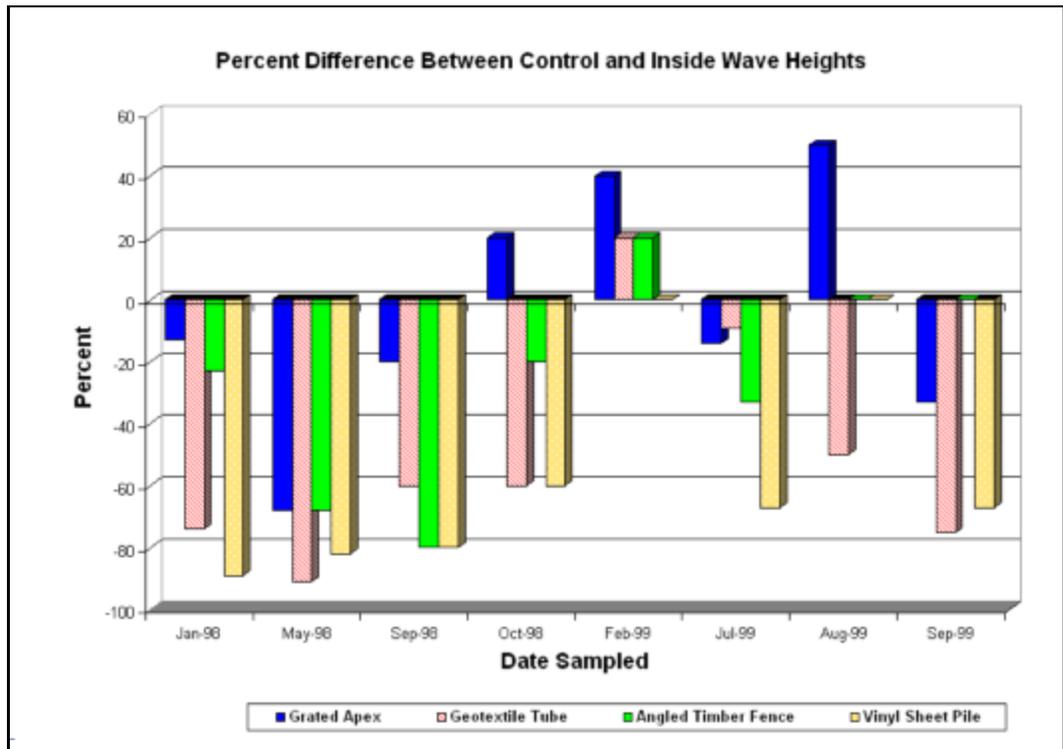
Figure 16. Average significant wave height reductions for all treatments during all sampling periods at Phase 1 of the Lake Salvador Shoreline Protection (BA-15) Demonstration project (from Stone et al. 1998a, 1998b, 1998c, 1998d, 1999a, 1999b, 1999c, 1999d, 1999e).

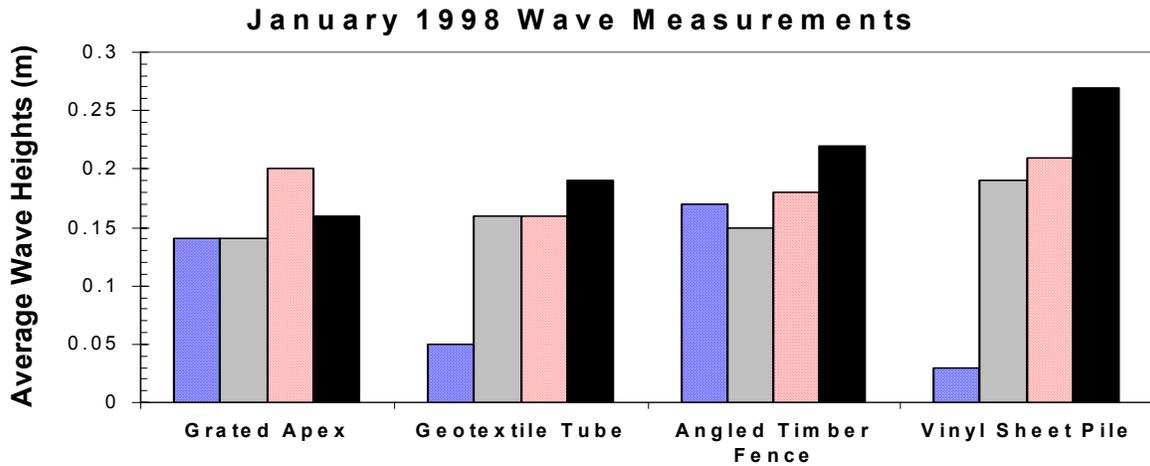
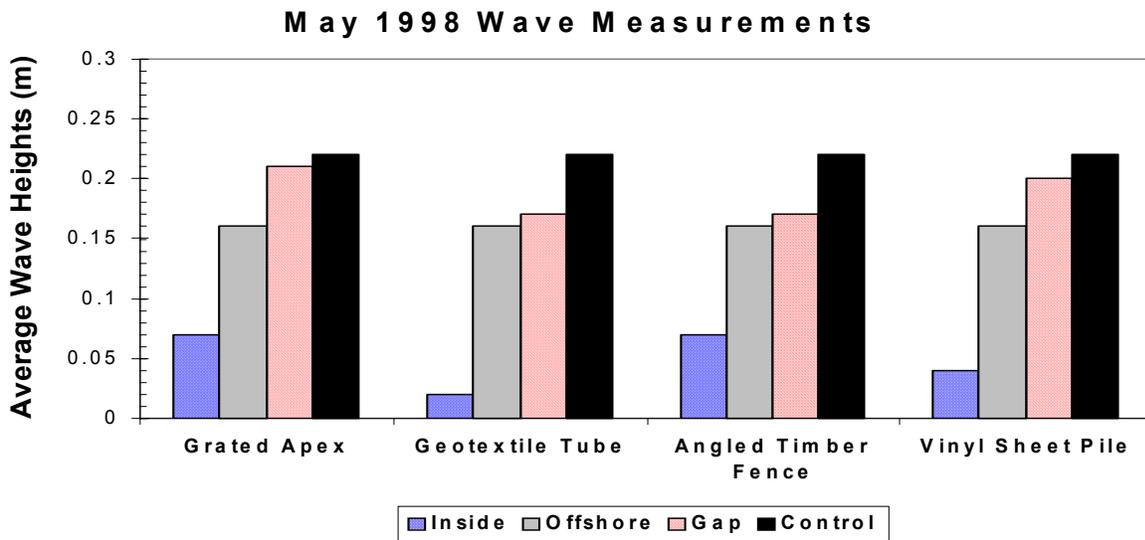
Figure 18. Average significant wave heights at each treatment on January 21, 1998 to May 6, 1998 at Phase 1 of the Lake Salvador Shoreline Protection (BA-15) Demonstration project (from Stone et al. 1998a, 1998b.)
