# LAKE SALVADOR SHORELINE PROTECTION DEMONSTRATION PROJECT (BA-15)

The Lake Salvador Shoreline Protection Demonstration Project (BA-15) was proposed on the Third Priority Project List (PPL-3). The project is located in two areas along the northern shore of Lake Salvador (figure 1) in St. Charles and Lafourche Parishes. Phase I of the project is along 5,900 ft (1,800 m) of shoreline along the Lake Salvador Wildlife Management Area (WMA) and is bounded on the west by Baie du Cabanage and on the east by Couba Island (figure 2). Phase II is located along 8,000 about (2,438 m) of shoreline on the southwestern shore of the lake (figure 3) and is bounded on the north by Baie du Chactus and to the south by Bayou Des Allemands (Curole et al. 2002, National Marine Fisheries Service (NMFS) 1997, NMFS 1996). The original project area encompasses 4070 acres of wetlands including 1122 acres of open water and 2948 acres of marsh. According to the Wetland Value Assessment (WVA), this project would protect 180 acres of freshwater marshes, benefit 130 acres of submerged aquatic vegetation and enhance 880 acres of coastal wetlands (NMFS 1996, NMFS 1997).

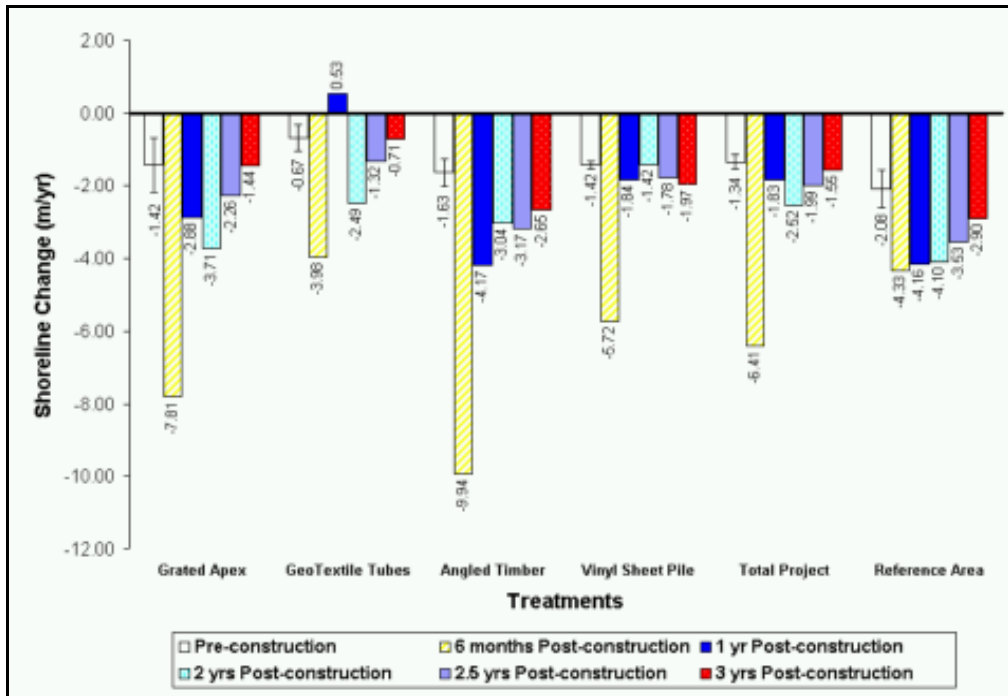
The Geotextile Tubes were the only structures that showed a shoreline progradation rate which was 1.74 ft/yr (0.53 m/yr). However, progradation occurred only in the first year and by the second year the Geotextile Tubes began to fail structurally and shoreline erosion was recorded. It should be noted that Geotextile Tubes have been successful at reducing shoreline erosion in other areas such as Chesapeake Bay where no movement or damage to the structures occurred (Gill et al. 1995 as cited in Curole et al. 2002). These structures may still have potential in Louisiana with changes in fill material, installation methods, placement in relation to the shoreline and placement in firmer sediment conditions (Curole et al. 2002).

Figure 14. Shoreline change rates from DGPS data for all treatments at Phase 1 of the Lake Salvador Shoreline Protection (BA-15) Demonstration project from January 1996 to August 2000.

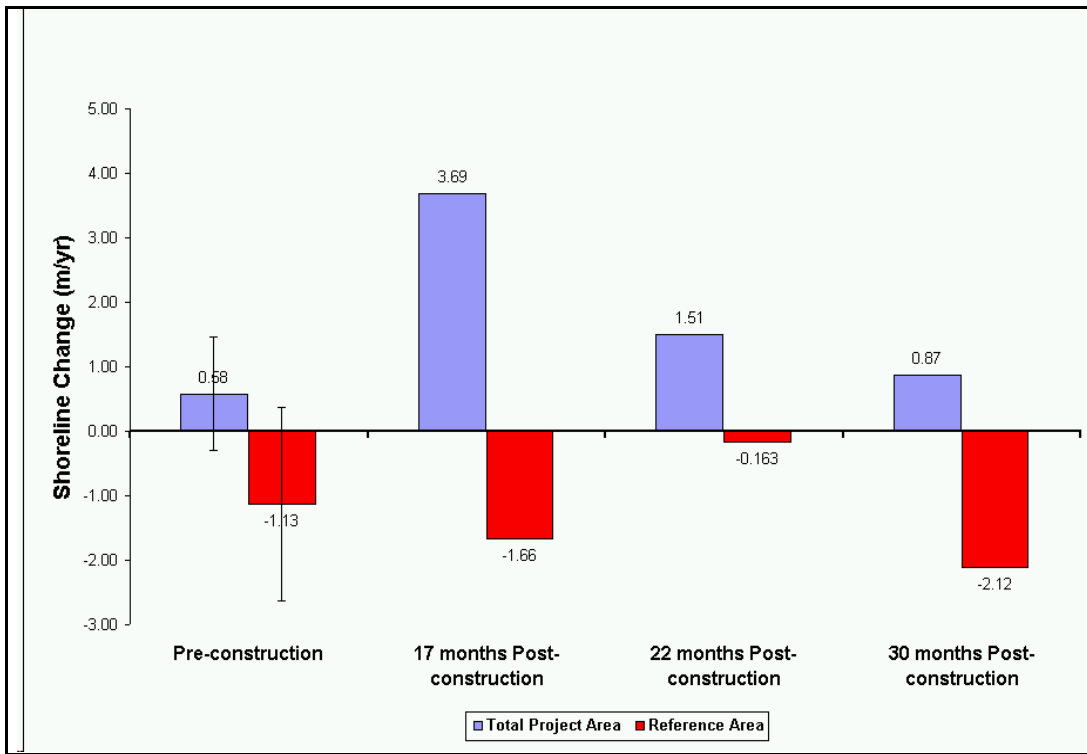
**Figure 20. Shoreline change rates from DGPS data for Phase 2 of the Lake Salvador Shoreline Protection (BA-15) Demonstration project.**

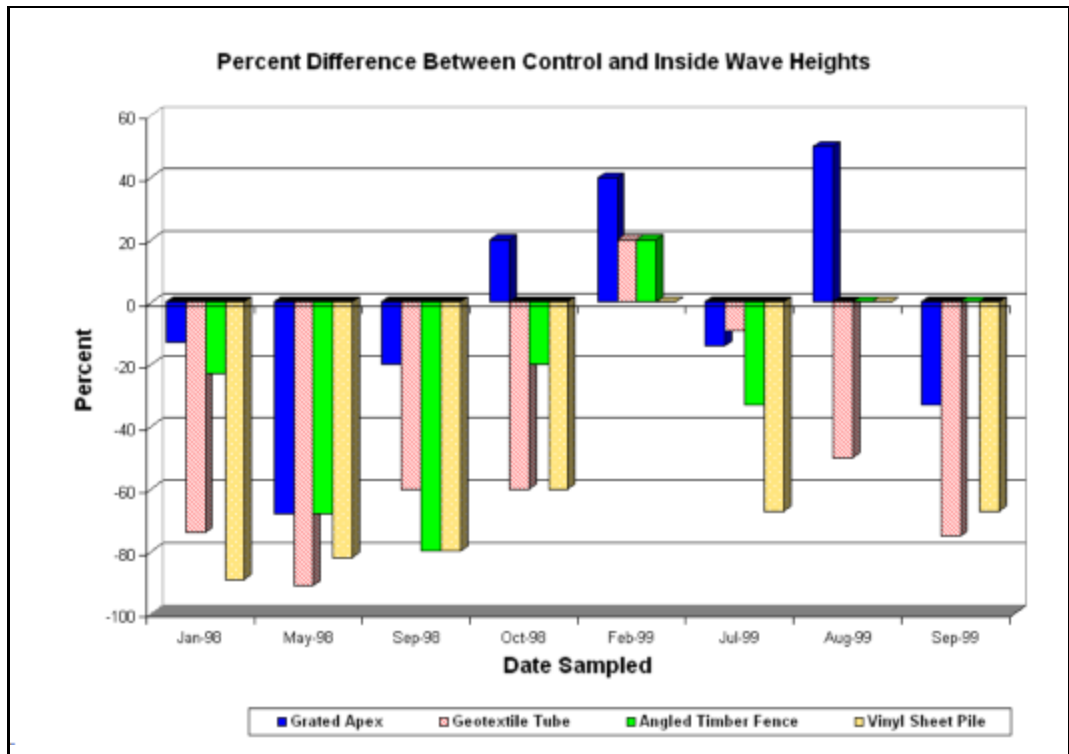
**Figure 16. Average significant wave height reductions for all treatments during all sampling periods at Phase 1 of the Lake Salvador Shoreline Protection (BA-15) Demonstration project (from Stone et al. 1998a, 1998b, 1998c, 1998d, 1999a, 1999b, 1999c, 1999d, 1999e).**

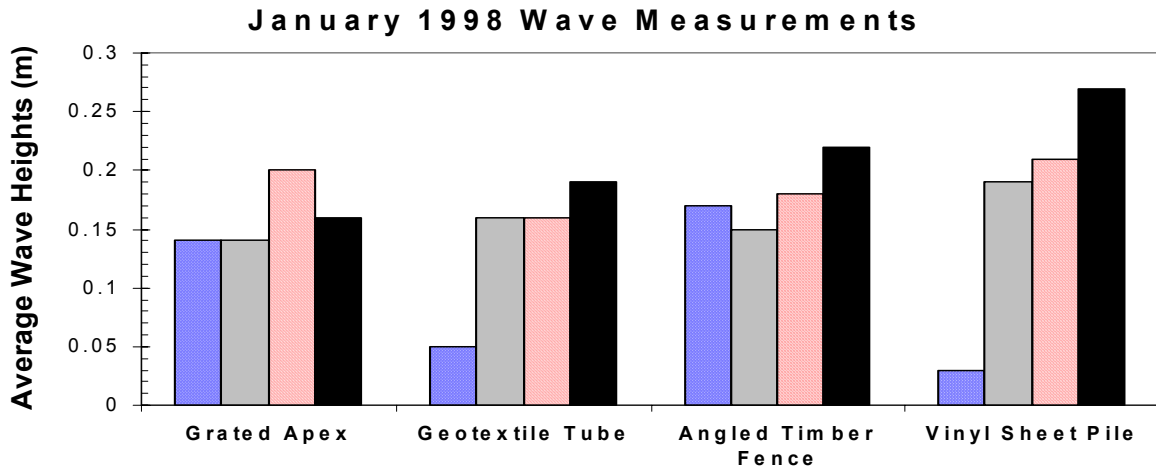
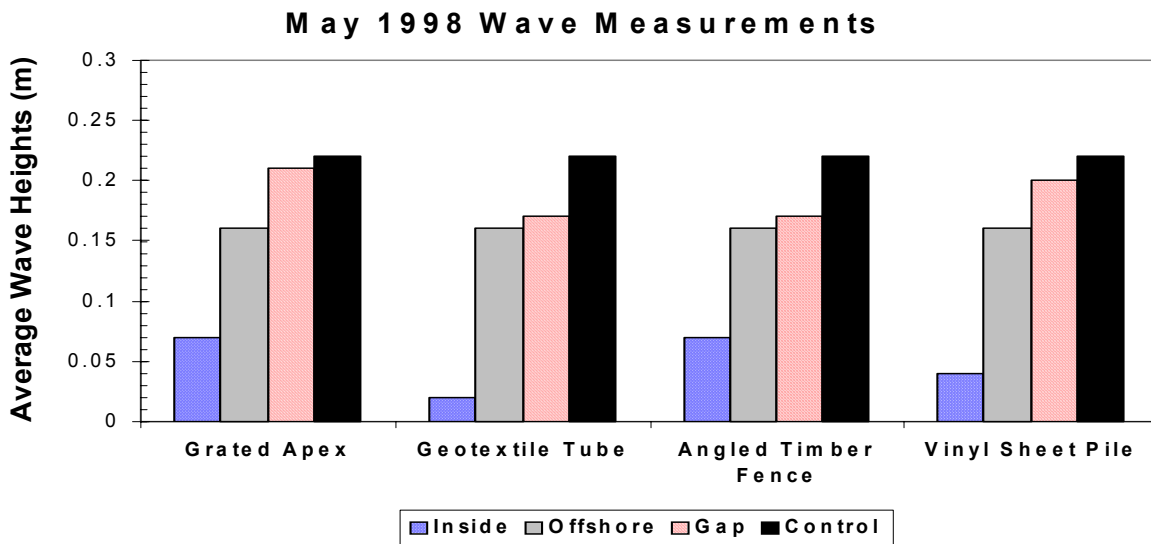
**Figure 18. Average significant wave heights at each treatment on January 21, 1998 to May 6, 1998 at Phase 1 of the Lake Salvador Shoreline Protection (BA-15) Demonstration project (from Stone et al. 1998a, 1998b.)**
