# **LAKE CHAPEAU SEDIMENT INPUT AND HYDROLOGIC RESTORATION (TE-26)**

## **I. INTRODUCTION**

### **I.1. Project Description**

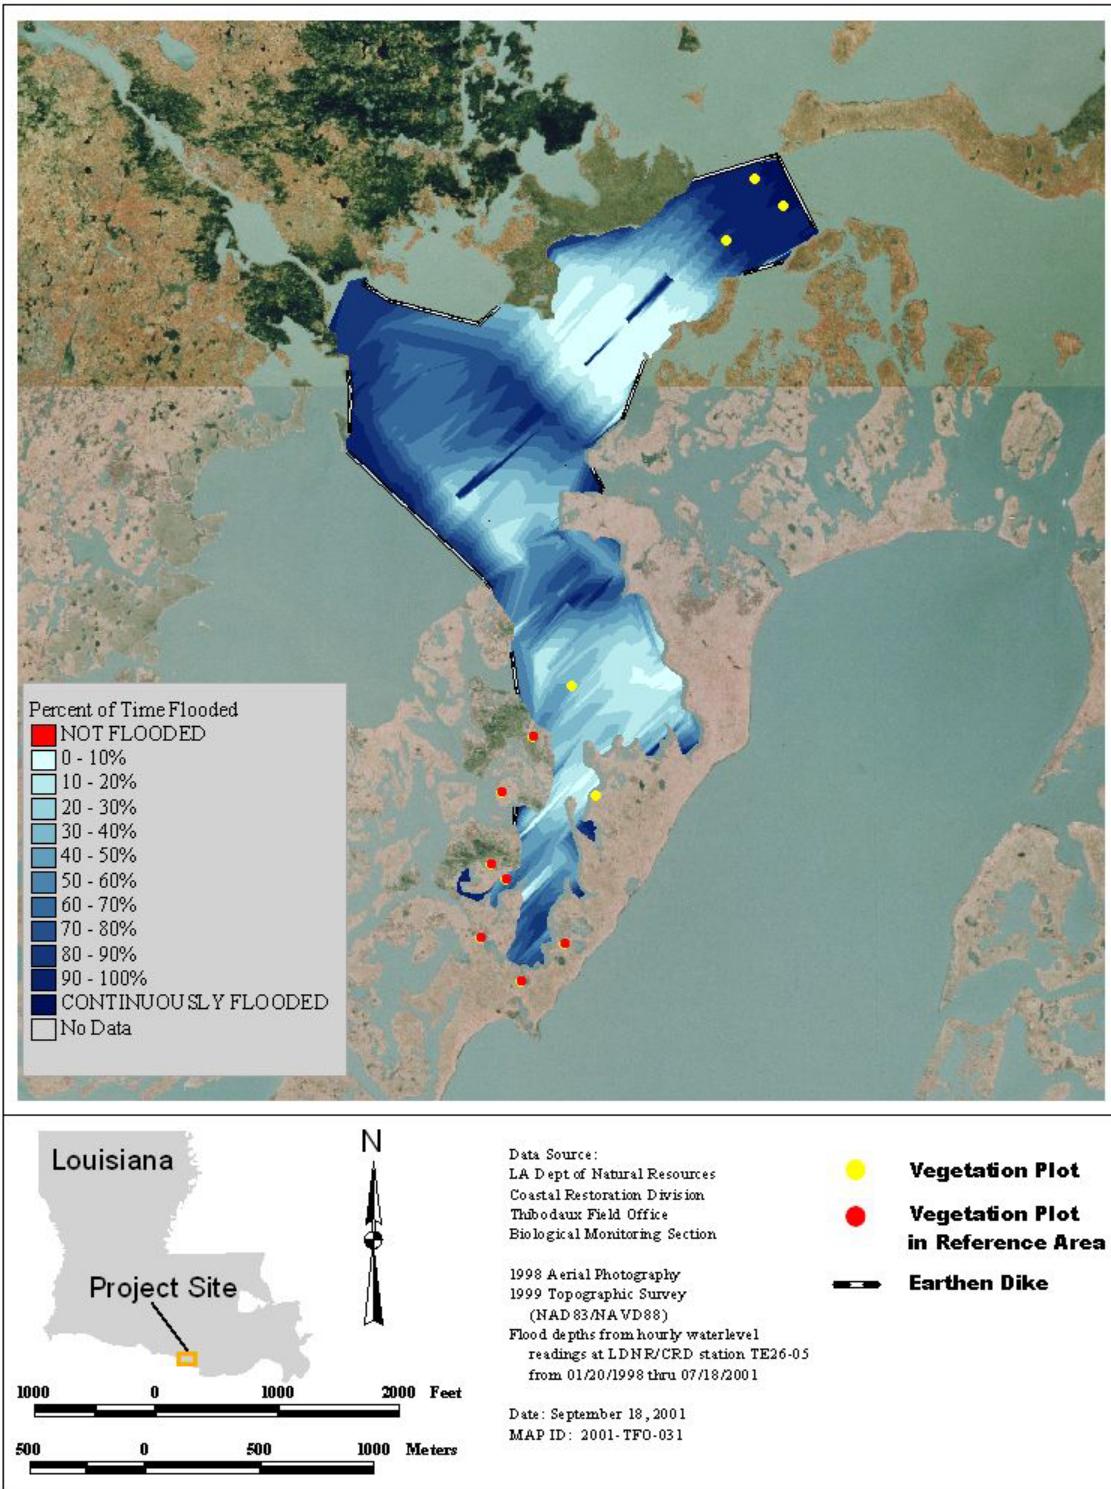
Figure 2. Percent of Time Flooded for Lake Chapeau Sediment Input and Hydrologic Restoration (TE-26).

No, the dredged spoil area is at a lower elevation and is flooded more often and deeper than surrounding marshes (Figure 2). Roughly 30% of the dredged fill area was flooded more than 60% of the time (Table 1).

Another dredge placement may be done to increase the elevation to that of the surrounding marsh elevation and establish the hydrologic separation. Then, seed the new fill areas, and back fill the pipeline canal.

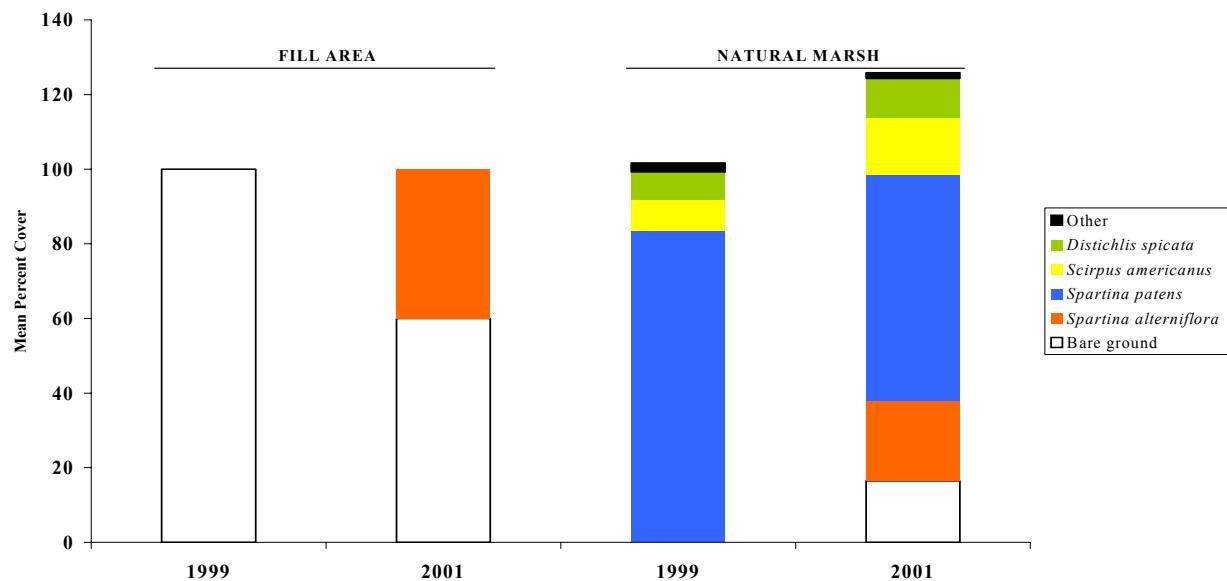
**Figure 3. Mean Percent Cover of Selected Species on the Dredge Material Fill Area at Lake Chapeau Hydrologic Restoration (TE-26) Project for 1999 and 2001 (LDNR)**

Percent cover of species combined is around 80% in the natural marsh. Percent cover in the reference plots of the fill area was around 40 % (Figure 3), which is half the coverage of the natural marsh. However, the reference plot locations were randomly selected prior to construction. Three of the five reference plots are in the north fill area that is flooded more than 80% of the time (Figure 2). Of the fill area above water, cover is similar to surrounding marshes at 80% cover (personal communication from Rick Hartman, NMFS and Darin Lee, LDNR).

No. *S. alterniflora* was planted in April 2000 and was the only species present in the fill area in 2001 vegetative plots (Figure 1). So the species composition is different from the natural marsh for the first year after planting (Figure 3).

The 168 acres of land created by fill does not yet represent the natural marsh. *S. alterniflora* plugs were added when the project failed to rapidly naturally vegetate.

Plantings were added to the project as previously mentioned, in order to vegetate the fill area.
