**2008 Operations,
Maintenance, and Monitoring
Report**

**FRESHWATER
INTRODUCTION SOUTH OF
HIGHWAY 82**

State Project Number ME-16
Priority Project List 4

April 2009
Calcasieu Parish

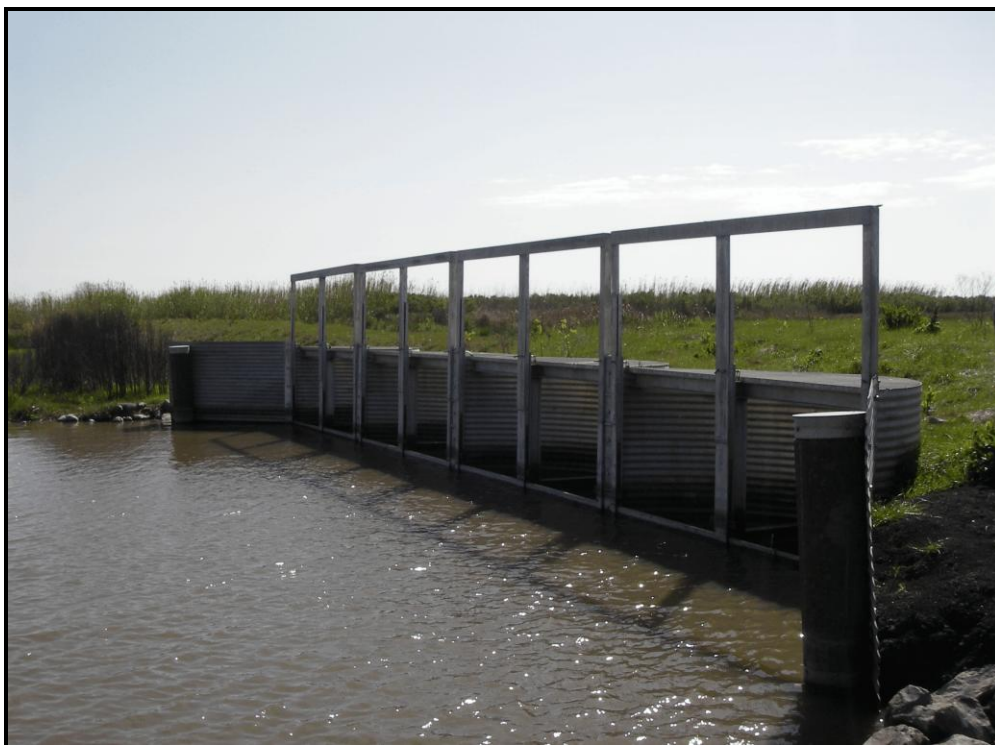
This structure is in good condition since completion of construction. Stop logs were set at approximately elevation +1.0 NAVD88. No water was flowing through the structure at the time of the inspection. The rock that was placed around the ends of the wingwalls has apparently been moved around by high water events and there is minor erosion occurring on the southwest quadrant of the outlet side of the structure. No maintenance is needed at this time however this area will be monitored for further erosion problems. (Photos: Appendix A, Photos 1, 2 & 3)

Photo No.1, View of inlet side of New Cop-Cop Structure.

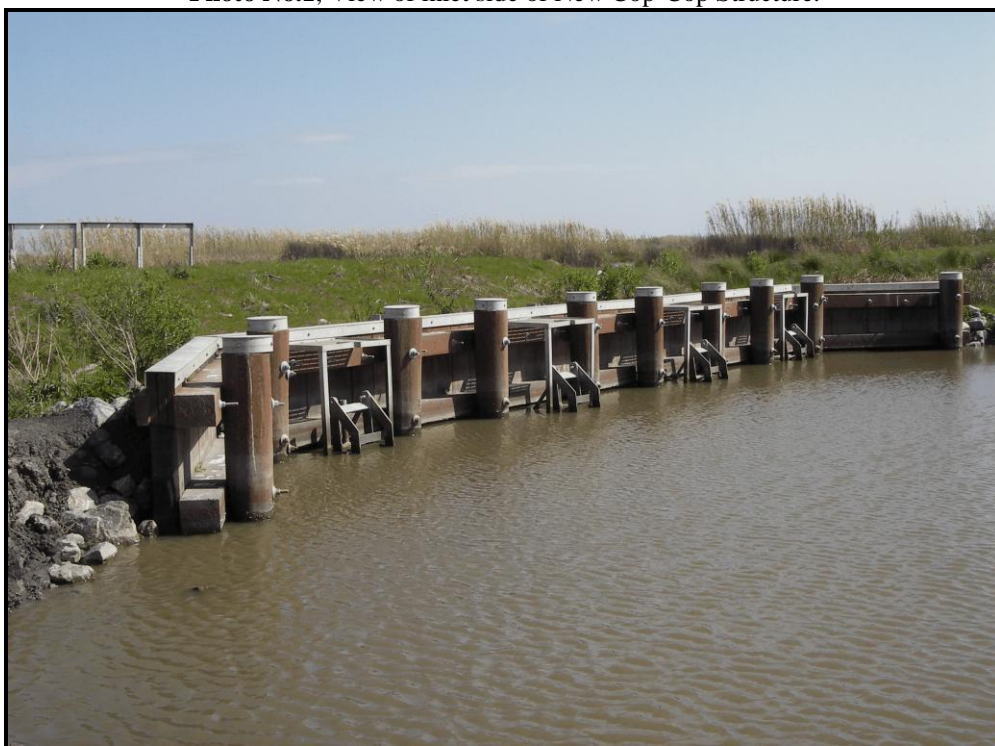
Photo No. 2, View of outlet side of New Cop-Cop Structure.

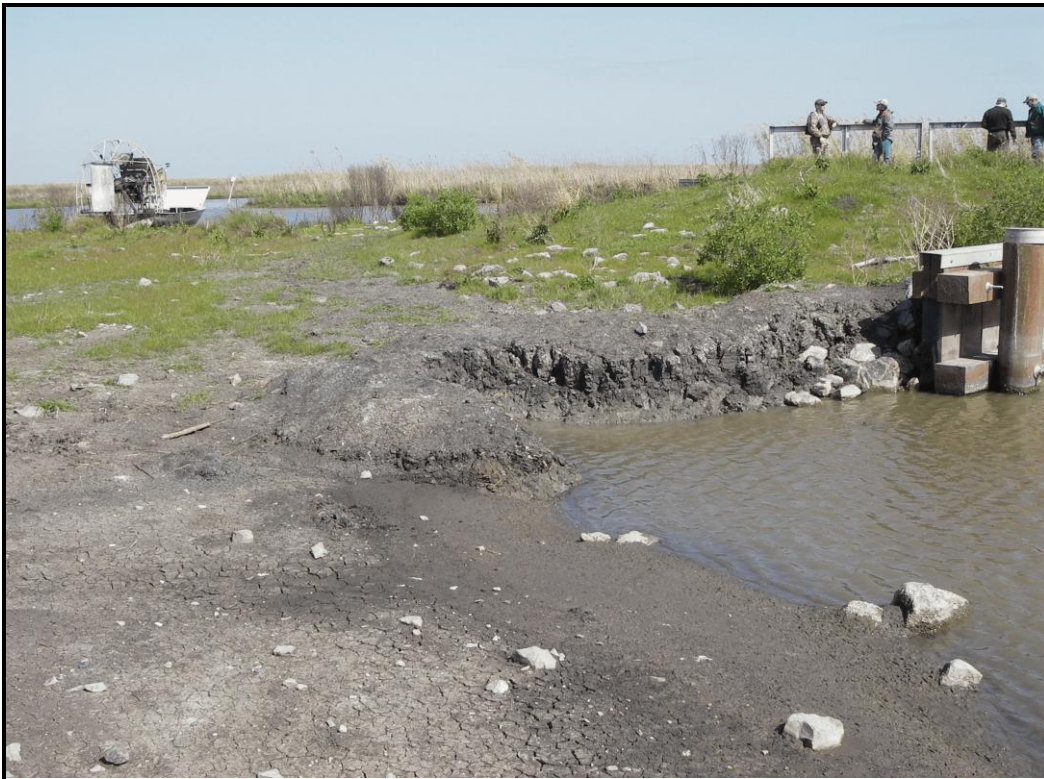
Photo No. 3, View showing minor erosion on SW quadrant of outlet side of New Cop-Cop Structure.

Item	Condition	Physical Damage	Corrosion	Photo #	Observations and Remarks
Steel Bulkhead / Caps	N/A				
Steel Grating	Good			1	
Stop Logs	Good			1	
Hardware	Good			1, 2	
Timber Piles Timber Walkway	Good			1, 2	
Timber Wales	Good			2	
Galv. Pile Caps	Good			2	
Cables	N/A				
Signage /Supports Staff Gages	N/A				
Rip Rap (fill)					
Earthen Embankment	Good			3	Some minor erosion on SW quadrant of outlet side of structure.

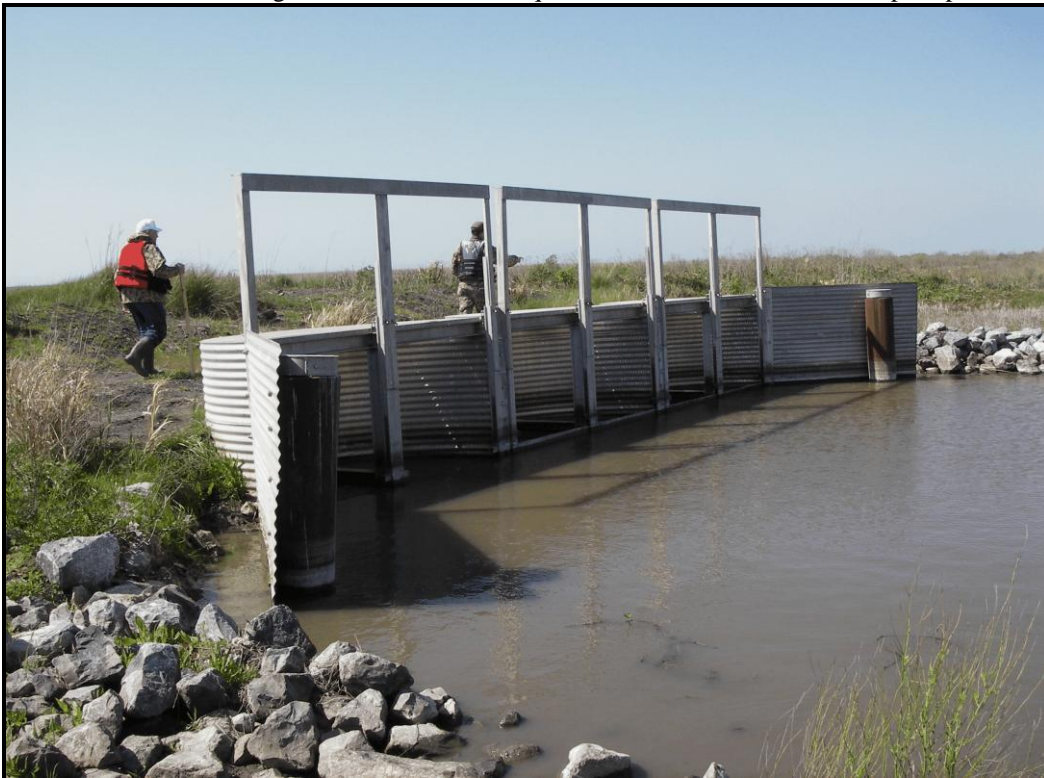
This structure is also in good condition and stop logs were set as noted above. The rock that was placed along each of the wingwalls is still in the same condition as post construction. Water was flowing through the most easterly culvert. No maintenance is required for this structure. (Photos: Appendix A, Photos 4 & 5)

Photo No. 4, View of inlet side of Structure No. 12.

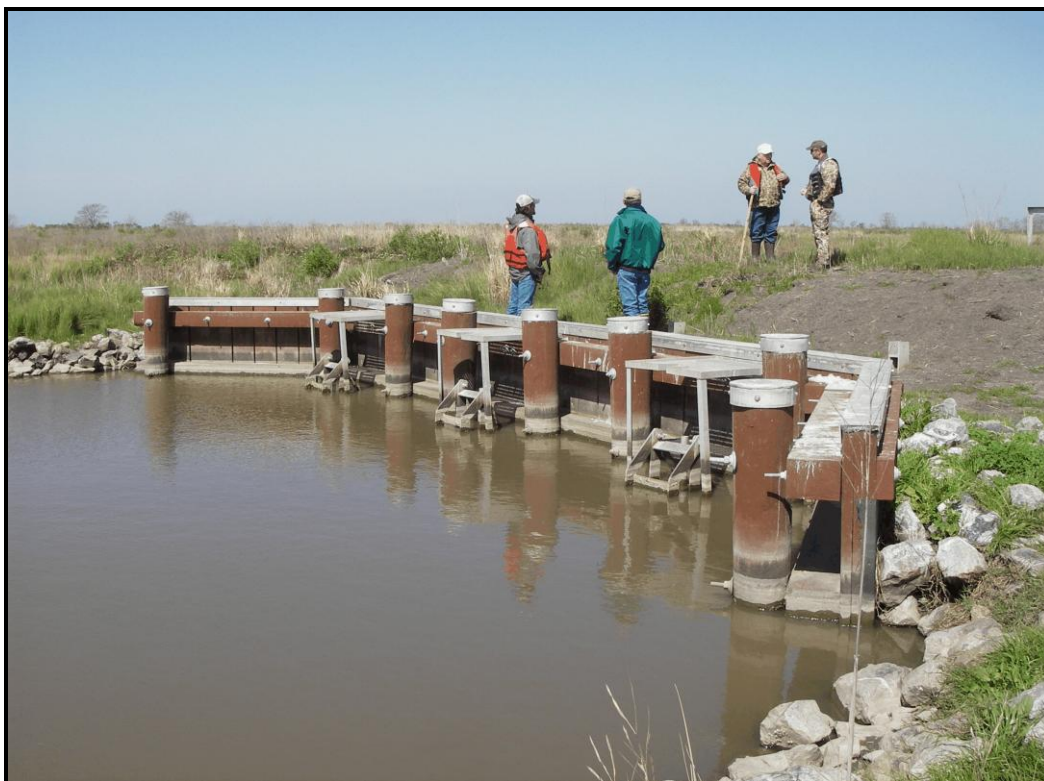
Photo No. 5, View of outlet side of Structure No. 12.

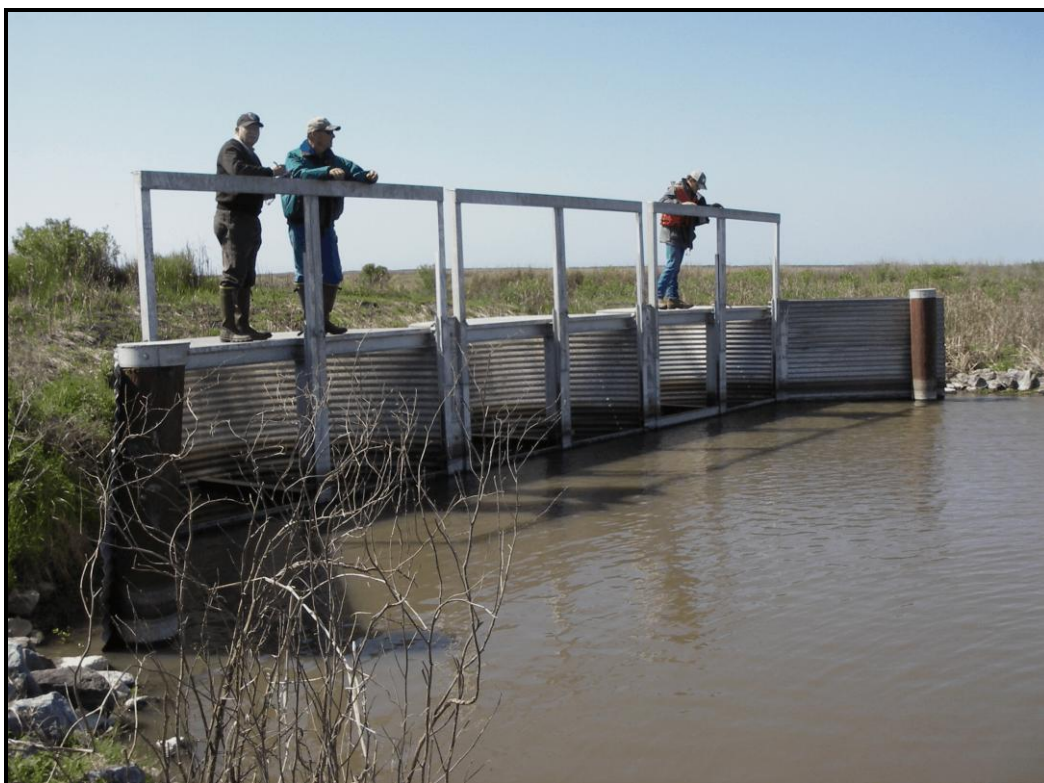
This structure is in good condition and stop logs are set as described above. No water was flowing through the structure at the time of the inspection. Rock along the wingwalls is in same condition as post construction. There appears to be more vegetation atop the backfilled portion of the structure at this location as compared to New Cop-Cop and Structure No. 12. No maintenance is required for this structure. (Photos: Appendix A, Photos 6 & 7)

Photo No. 6, View of inlet side of Structure No. 10.

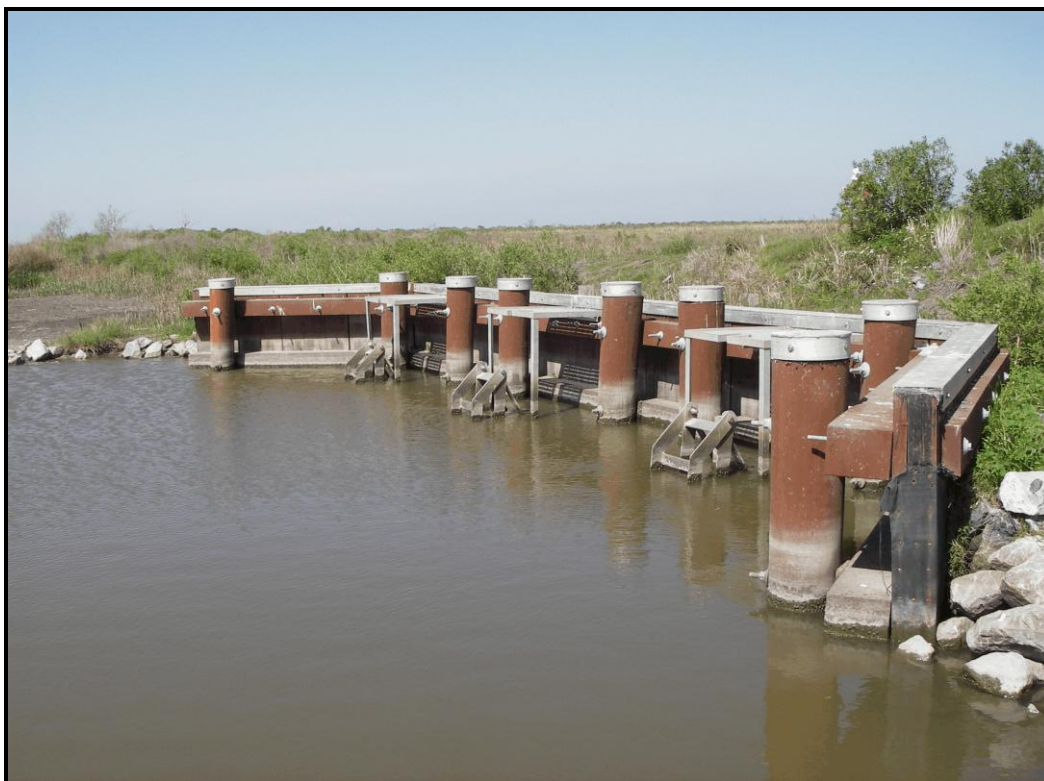
Photo No. 7, View of outlet side of Structure No. 10.

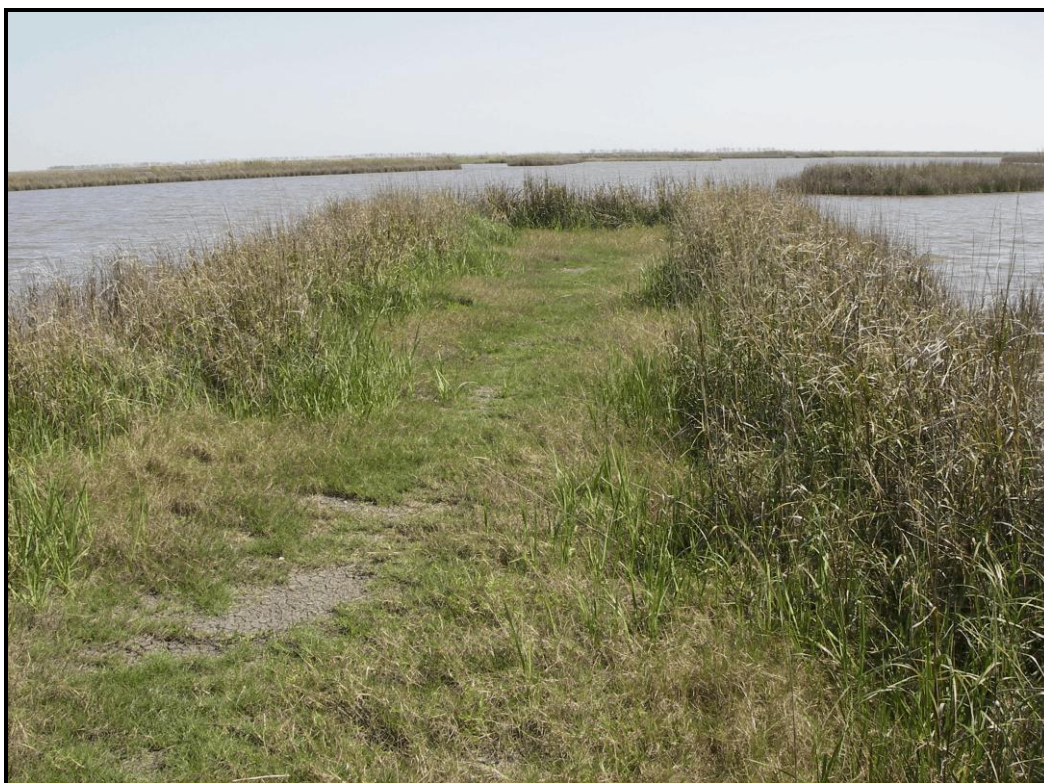
The earthen terraces are in excellent condition. Very little settlement of the earthen material has occurred since construction was completed. The vegetated plantings that were put along the edge of each terrace are fully matured and the crown of the terrace which was not planted has begun to vegetate to almost 100% cover. No maintenance is required for the terrace field. (Photos: Appendix A, Photo 7)

Photo No. 8, Typical view of earthen terrace covered with vegetation.

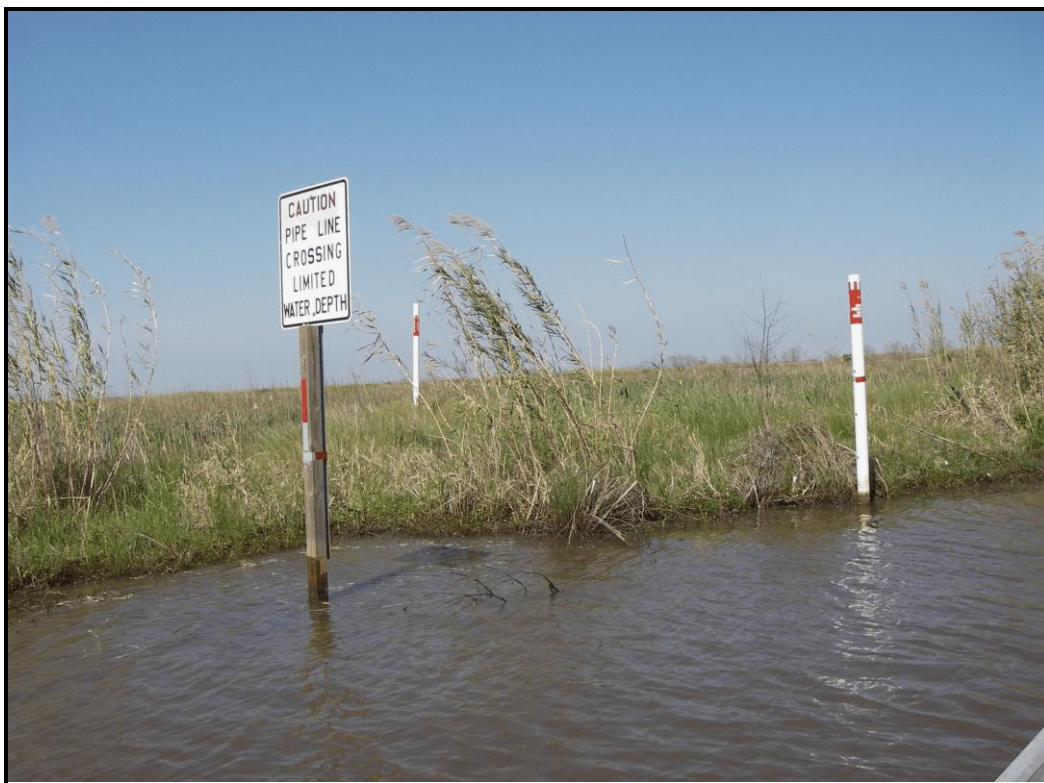
The adjacent marsh along this section of the Grand Volle South Channel which had spoil material placed on it by spray dredge equipment is in excellent condition. The channel appears to be flowing water as intended. The pipeline crossing signs are also in good condition and there was approximately 3 foot of water depth on top of the pipeline near the center of the channel. No maintenance is required at this time. (Photos: Appendix A, Photo 9)

Photo No. 9, View of Grand Volle South Channel Enlargement and Pipeline Crossing.

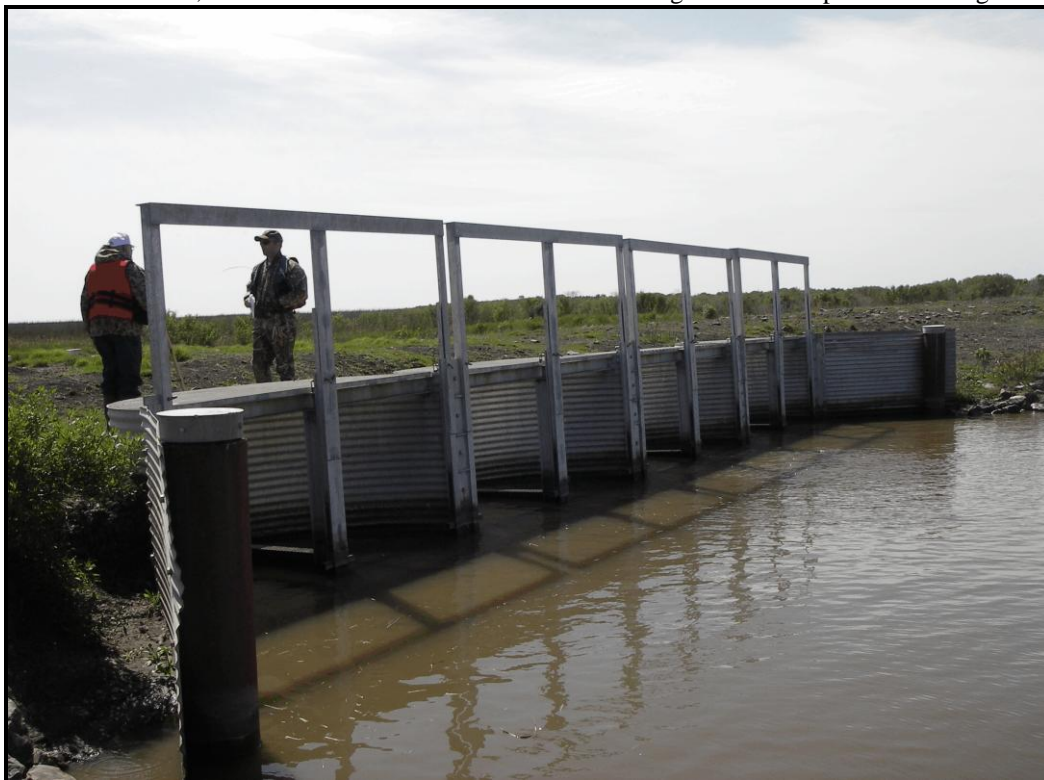
The New Dyson Structure is also in good condition since completion of construction. The rock along each of the wingwalls is stable. There are three minor areas of settlement atop the backfilled portion of the structure that has occurred. The stop logs were set at elevation +1.0 NAVD88 and no water was flowing through the structure. No maintenance is required at this time however the areas of settlement will be monitored for further problems. (Photos: Appendix A, Photos 10 & 11)

Photo No. 10, View of inlet side of New Dyson Structure.

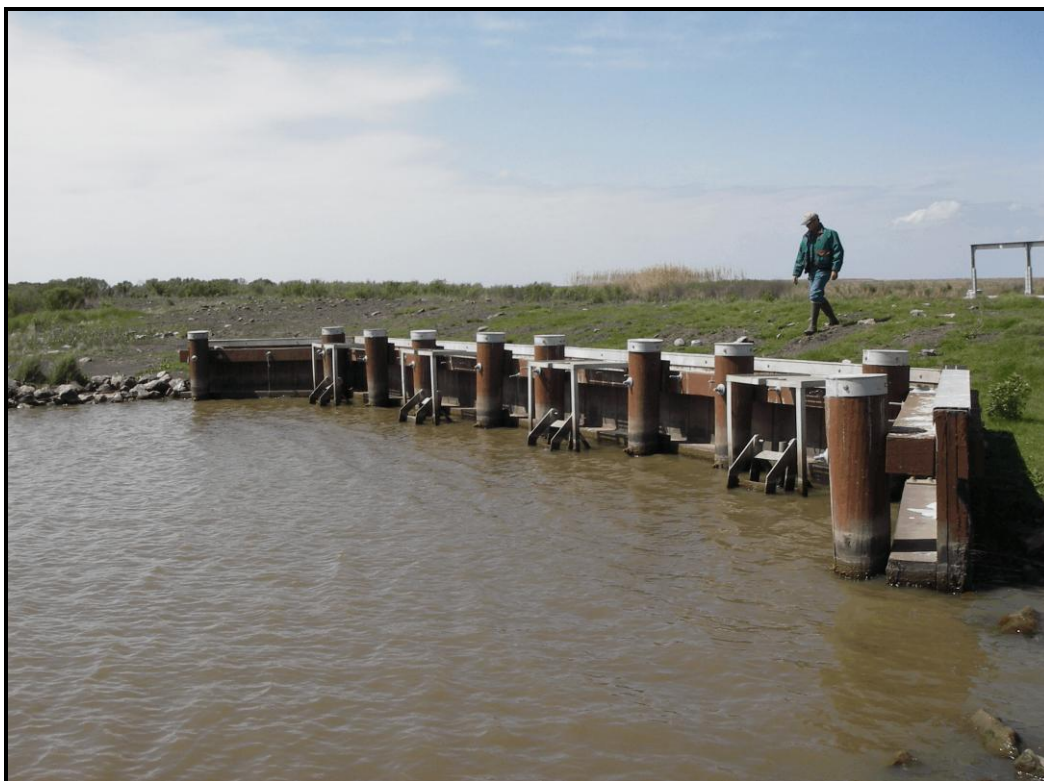
Photo No. 11, View of outlet side of New Dyson Structure.

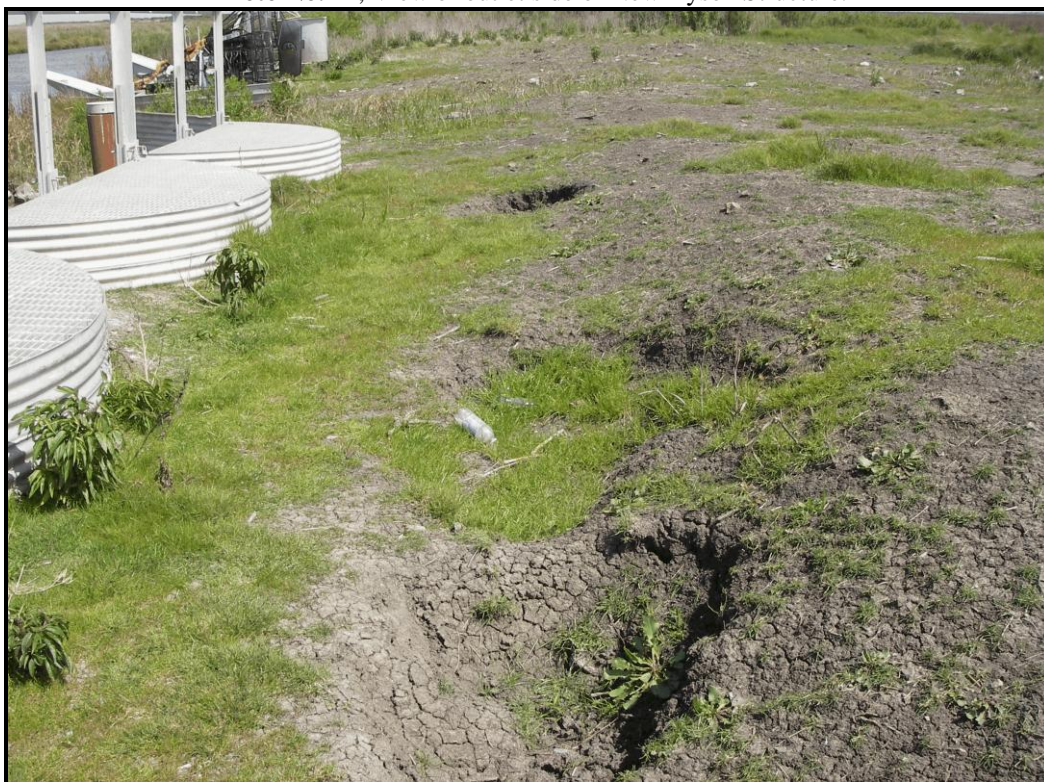
Photo No. 12, View showing three minor settlement areas atop the New Dyson Structure.

Item	Condition	Physical Damage	Corrosion	Photo #	Observations and Remarks
Steel Bulkhead / Caps	N/A				
Steel Grating	Good			10	
Stop Logs	Good			10	
Hardware	Good			10, 11	
Timber Piles	Good			11	
Timber Walkway					
Timber Wales	Good			11	
Galv. Pile Caps	Good			11	
Cables	N/A				
Signage / Supports	N/A				
Staff Gages					
Rip Rap (fill)	Good				
Earthen Embankment	Good			12	Some minor erosion atop the structure.

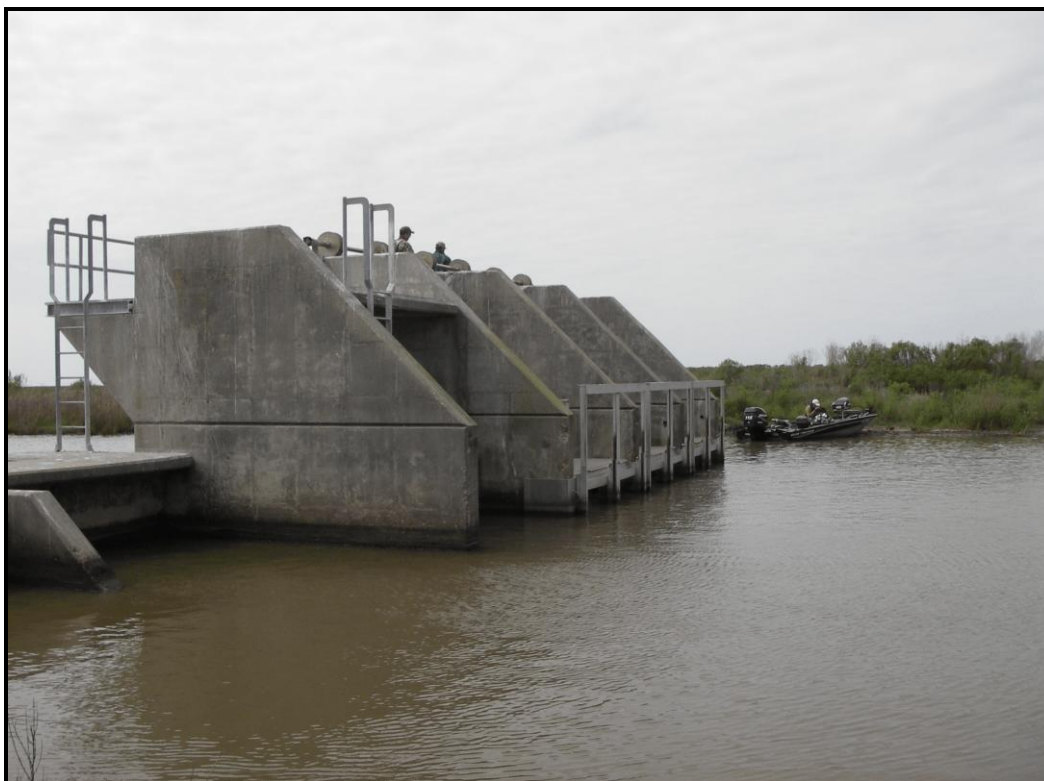
The refurbishment of the Little Constance Structure is in excellent condition. The stop logs were set at “just below marsh level” and no water was flowing through the structure at the time of the inspection. No maintenance is required at this time. (Photos: Appendix A, Photos 13 & 14)

Photo No. 13, View of the inlet side of the Little Constance Structure.

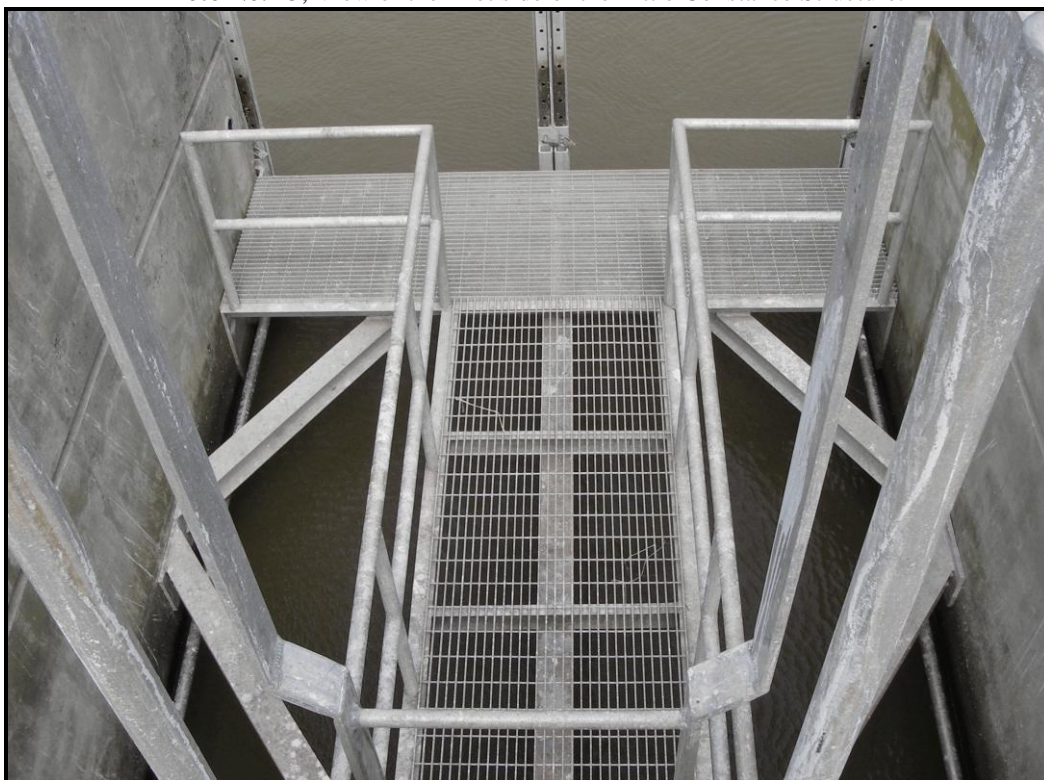
Photo No. 14, Typical view of a refurbished structure bay including inlet weir with flap gate on the Little Constance Structure.

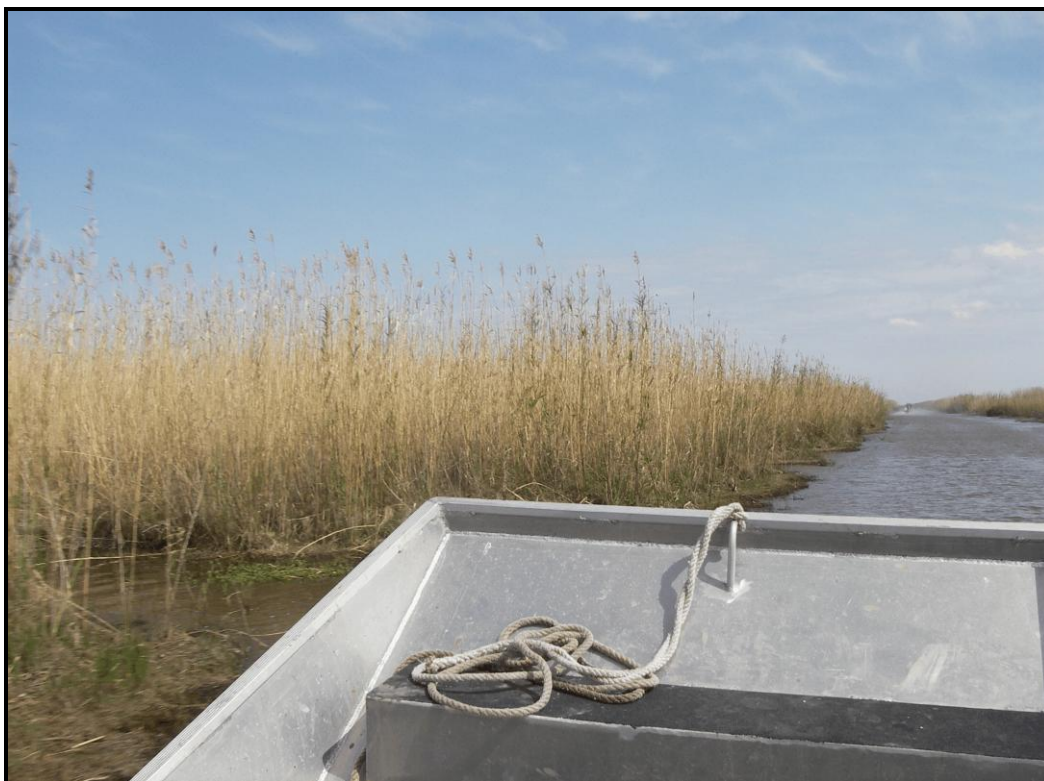
The adjacent marsh along this section of the Louisiana Highway 82 borrow canal which had spoil material placed on it by spray dredge equipment is in excellent condition. The borrow canal appears to be flowing water as intended. No maintenance is needed at this time. (Photos: Appendix A, Photo 15)

Photo No. 15, View of adjacent marsh along Louisiana Hwy 82 Borrow Canal.

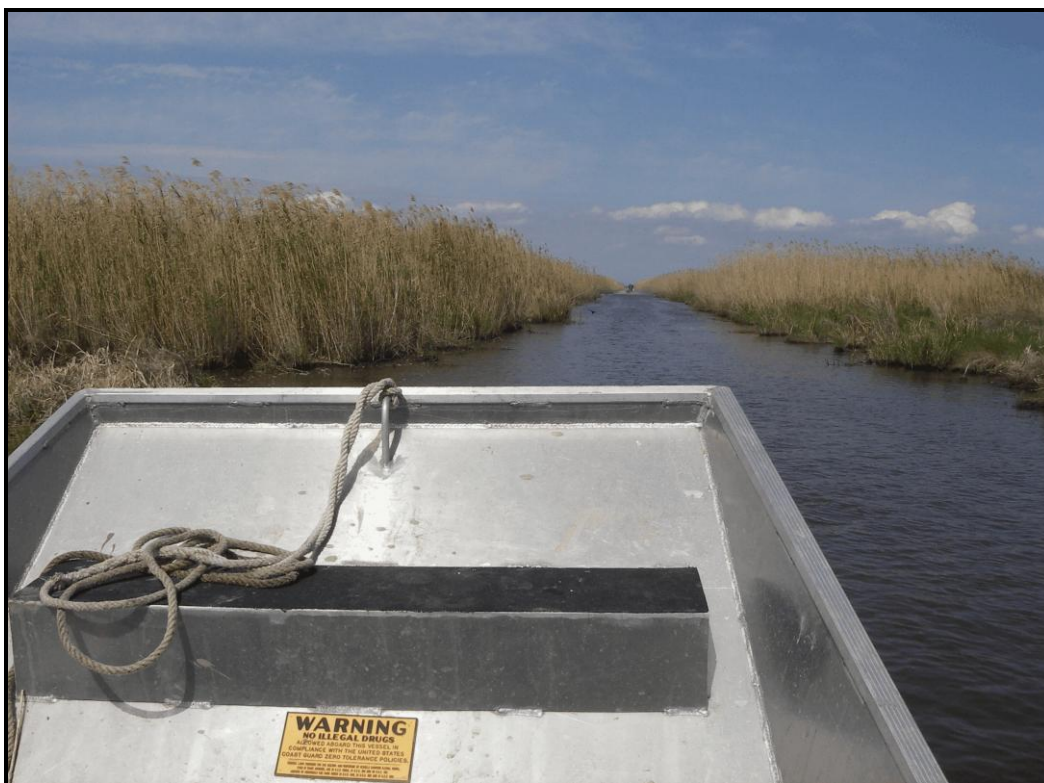
The adjacent marsh along this section of the Grand Volle North Channel which had spoil material placed on it by spray dredge equipment is in excellent condition. The channel appears to be flowing water as intended. The marine barrier at the entrance of Grand Volle Channel along the southern rim of White Lake is also in good condition. No maintenance is required at this time however there is some concern about possible erosion along the entrance into Grand Volle Channel just inside the marine barrier which will be monitored during future inspections. (Photos: Appendix A, Photos 16 & 17)

Photo No. 16, View of adjacent marsh along the Grand Volle North Channel Enlargement.

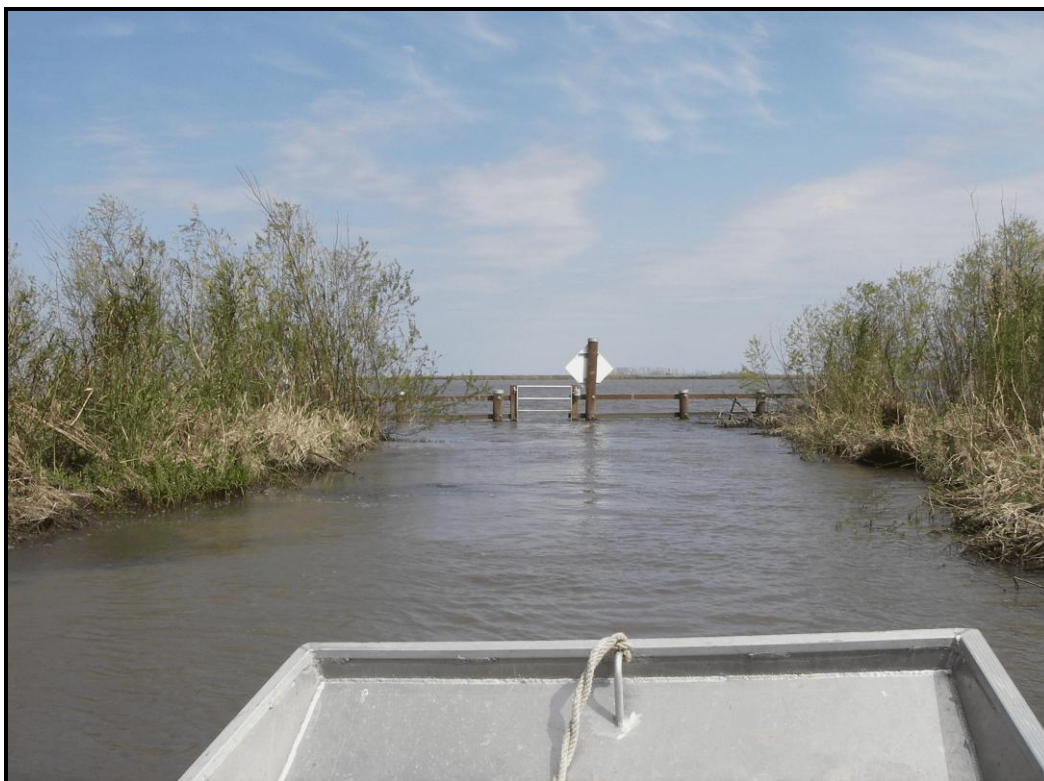
Photo No. 17, View of marine barrier at entrance of Grand Volle North Channel along the southern rim of White Lake.
