**2008 Operations, Maintenance,  
and Monitoring Report**

**Cote Blanche Hydrologic  
Restoration**

State Project Number TV-04  
Priority Project List 3

January 2008  
St. Mary Parish

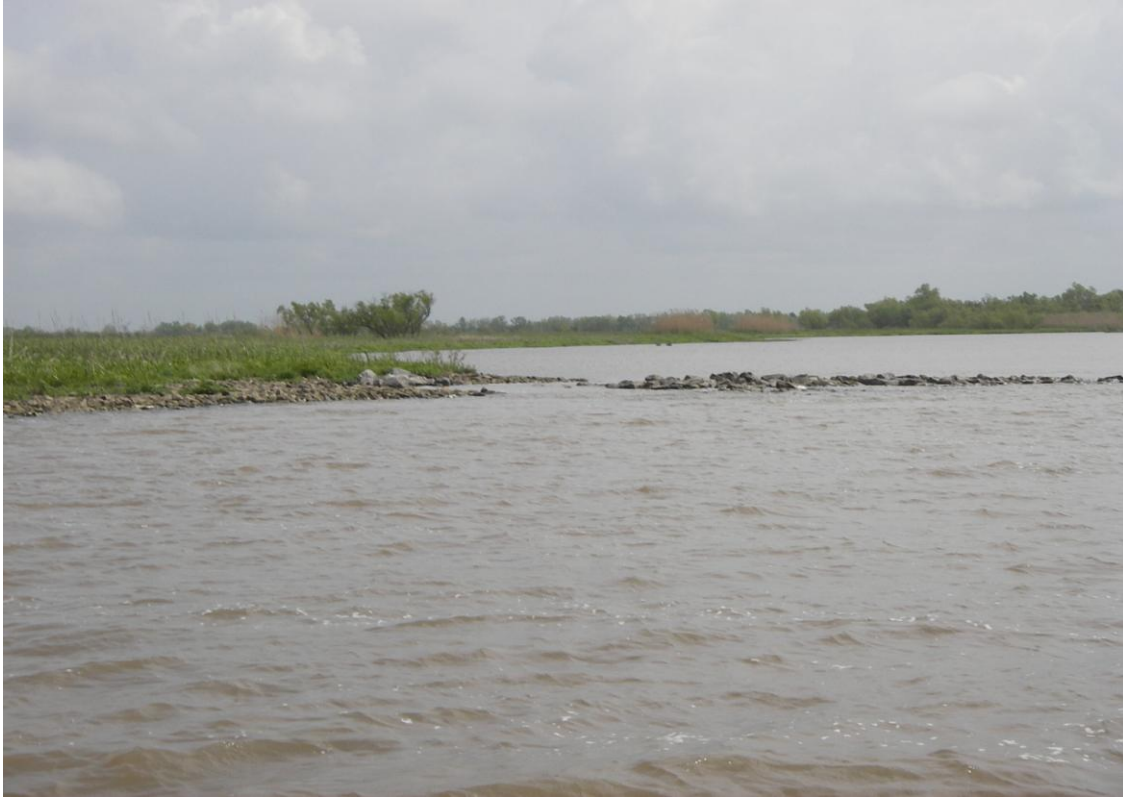
The Mud Bayou structure appears to be holding up fairly well. The coating on the sheet piles is peeling. The steel is beginning to show signs of rust and will need to be monitored. Signage is ok. (Photos: Appendix B, Photos 1-3).

**Photo 1**—North side of Mud Bayou Structure

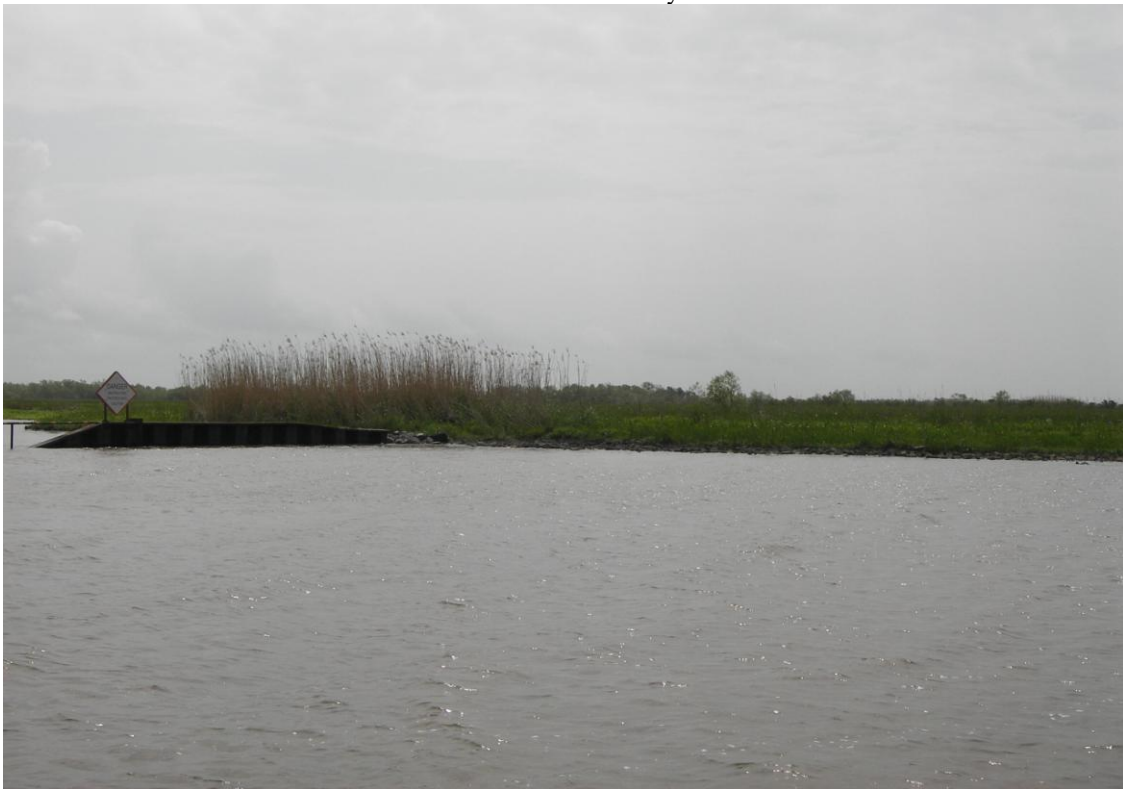
**Photo 2**—South side of Mud Bayou structure

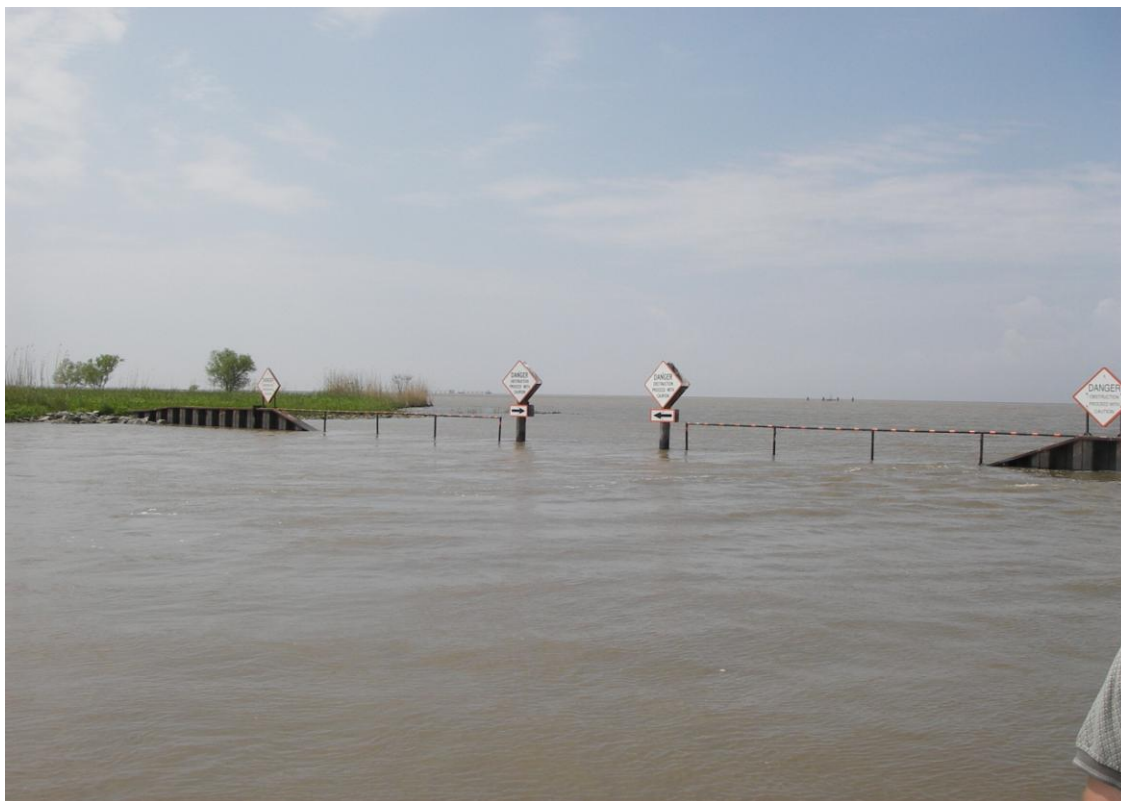
**Photo 3—Signage at Mud Bayou**

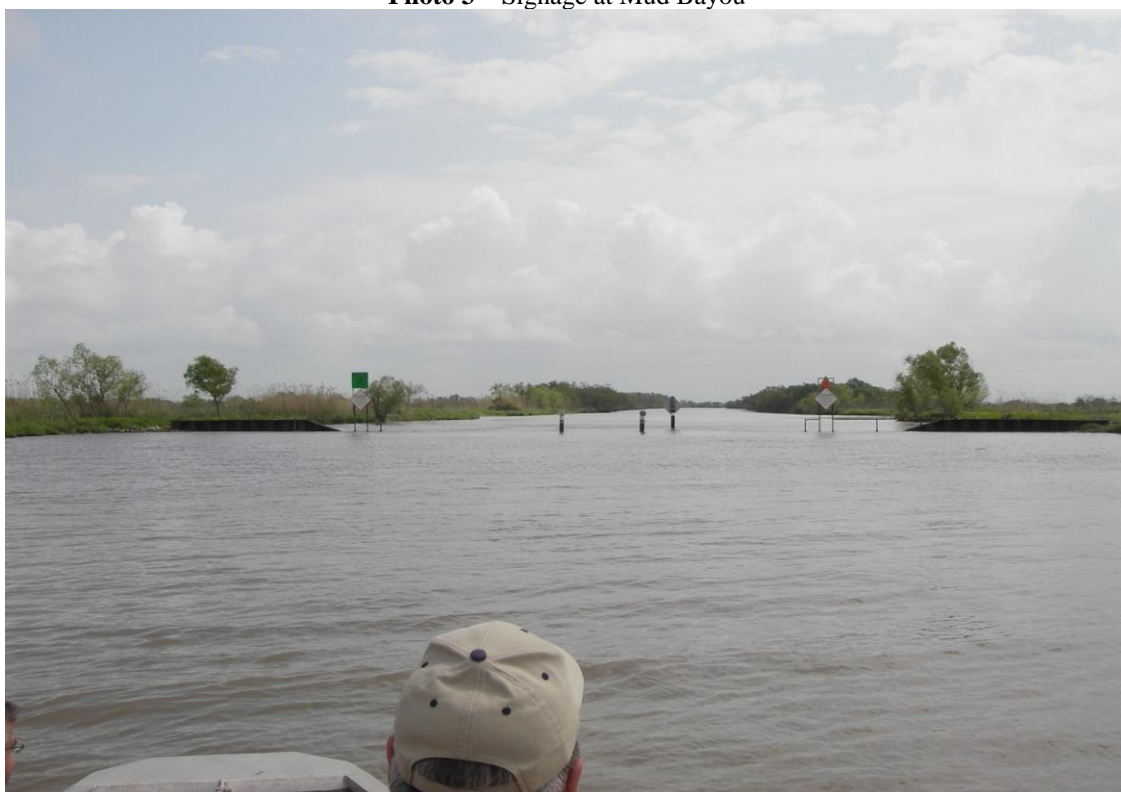
The Humble F Canal structure and signage are stable. The coating on the sheet piles is rusting on this structure and will be monitored as well. The south arrow sign is missing. (Photos: Appendix B, Photos 4-6).

**Photo 4—Signage at Humble F Canal**

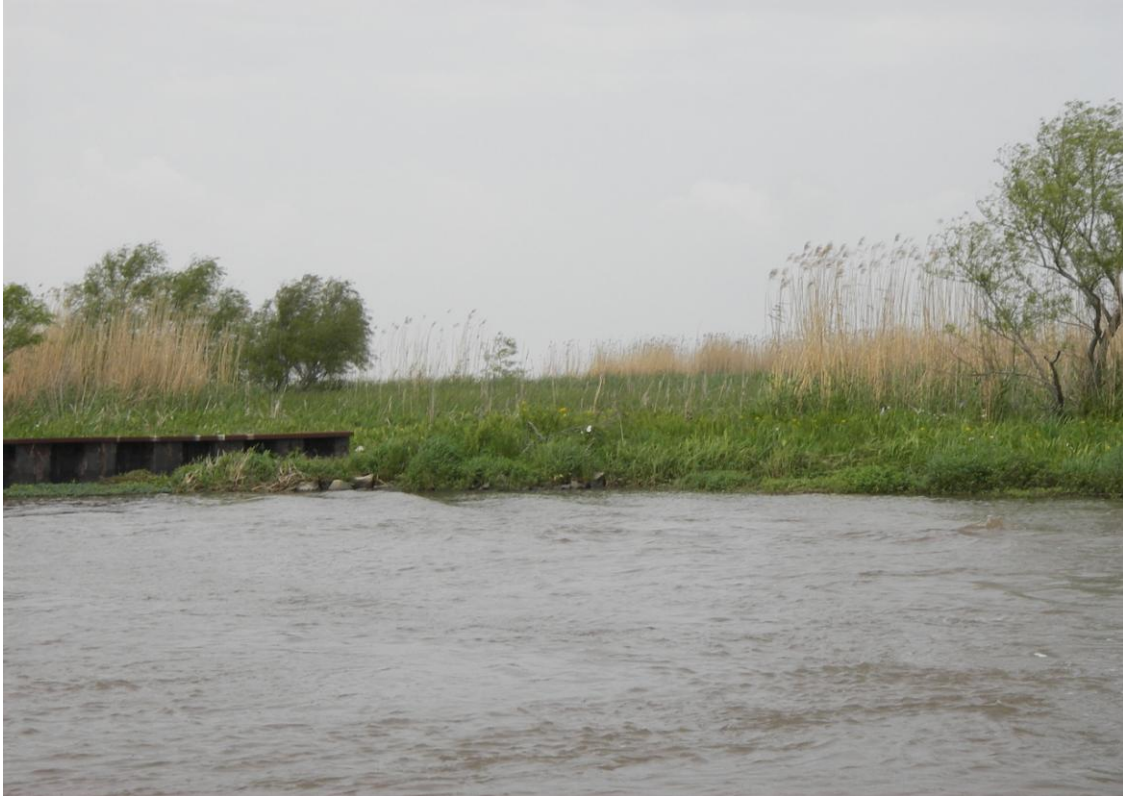
**Photo 5**—North side of Humble F Structure

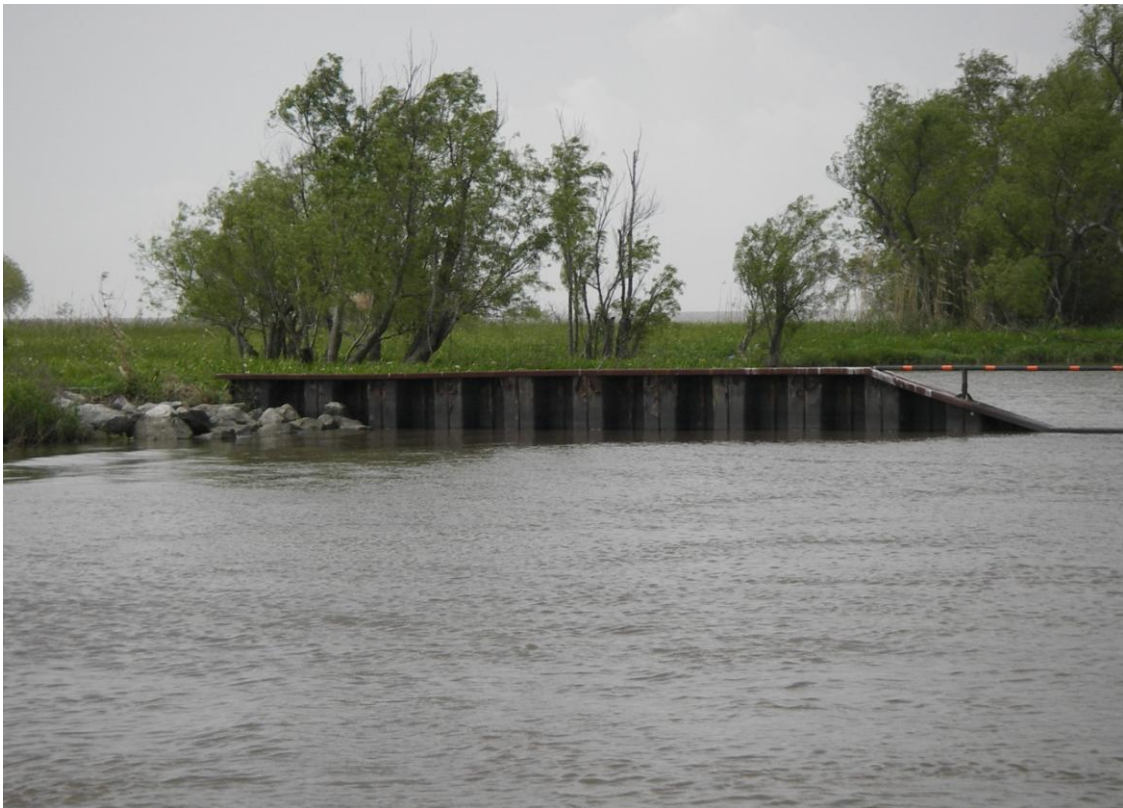
**Photo 6**—South side of Humble F Structure

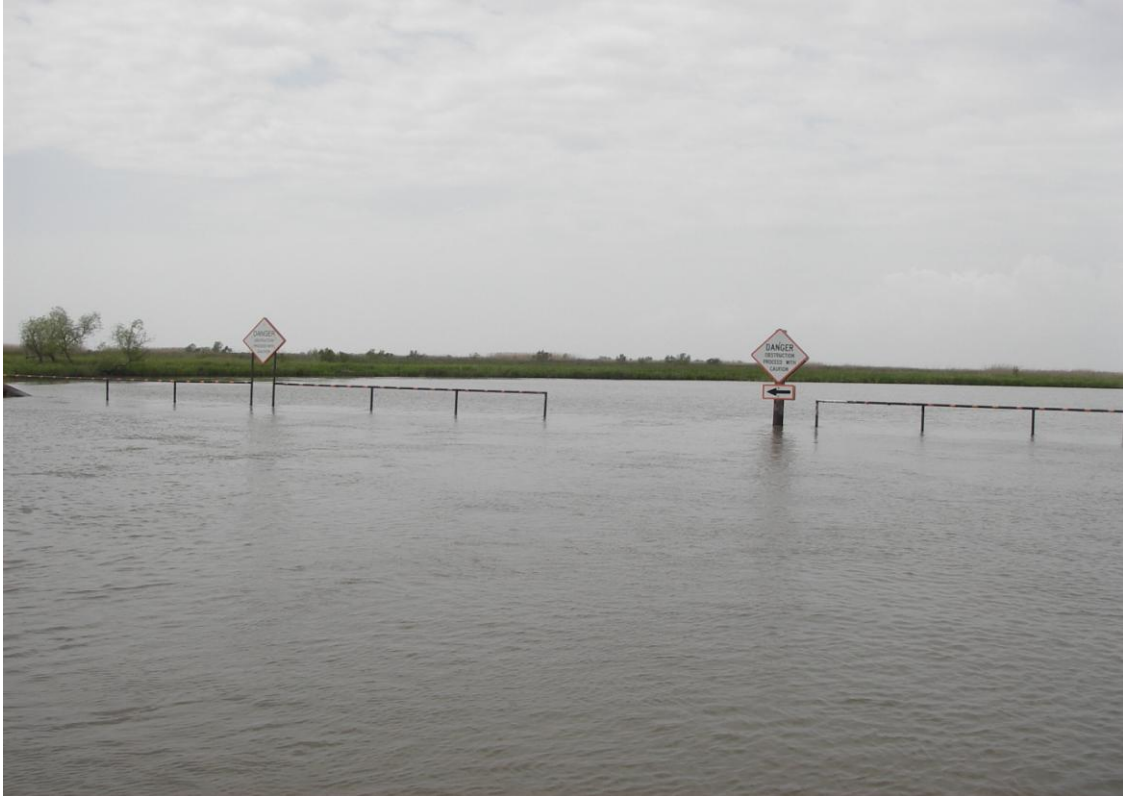
The Bayou Long structure and signage are stable. The coating on the sheet piles is rusting on this structure and will be monitored as well. Staff gauges are gone at this site. (Photos: Appendix B, Photo 7)

**Photo 7—Bayou Long Structure and signage**

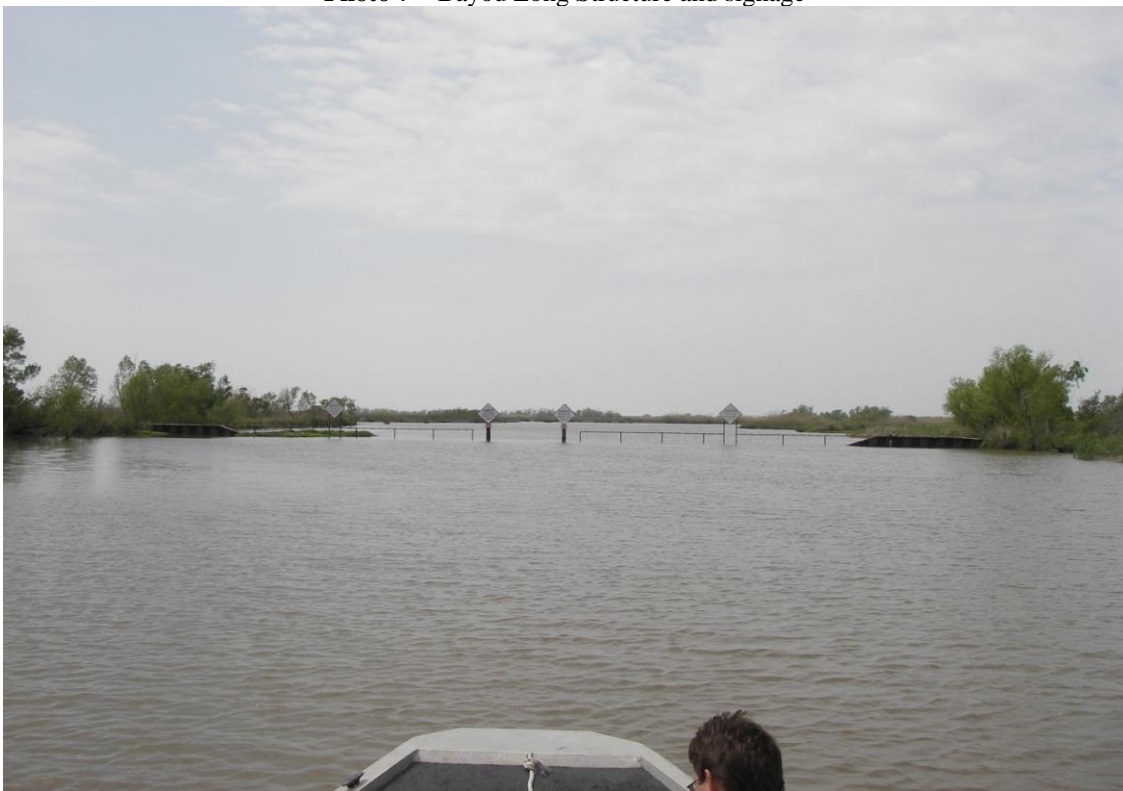
The Bayou Carlin structure and signage are stable. The coating on the sheet piles is rusting on this structure and will be monitored as well. (Photos: Appendix B, Photo 8)

**Photo 8—Bayou Carlin Structure and signage**

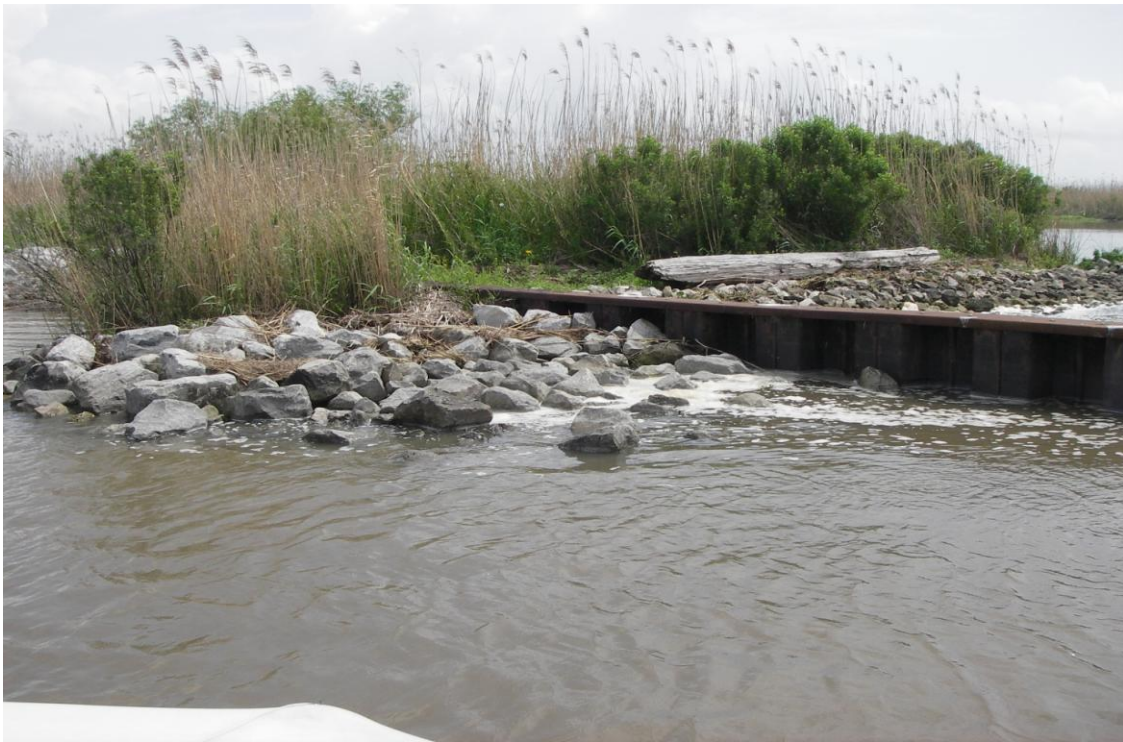
The Humble Canal structure has some minor damages that will be addressed as part of the School Bus Bayou repairs beginning in the summer of 2007. The shoreline at the south end of the rock riprap dike has experienced some erosion and the marsh area remaining is narrow and now subject to being breached allowing water to flow around the weir. Budget limitations will not allow this area to be addressed; however, Miami Corporation has proposed to address this area with mitigation dollars in the future. In the meantime, it will continue to be monitored. The “handrail” on the west side of the barge bay notch, actually a railing of 3 inch pipe that is approximately 2 feet above normal water levels that marks that reach of the sheet pile weir as being non-navigable to boaters, is broken and approximately 8-10 feet of same is missing. The balance of the north “handrail”, approximately 40 feet in length, is slightly bent towards the bay. The NW nav-aid sign is missing and will need to be replaced. One of the staff gauges needs to be replaced. (Photos: Appendix B, Photos 9-11, 14).

**Photo 9—East side of Humble Canal Structure**

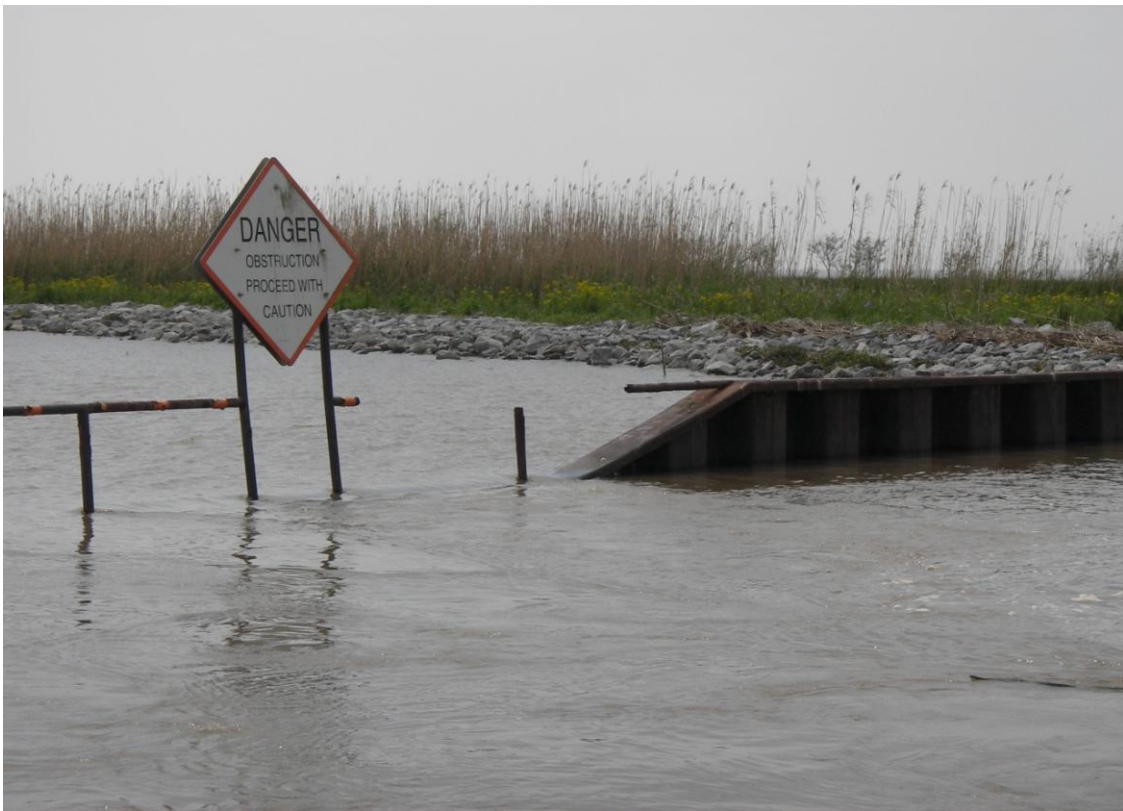
**Photo 10—West side of Humble Canal Structure**

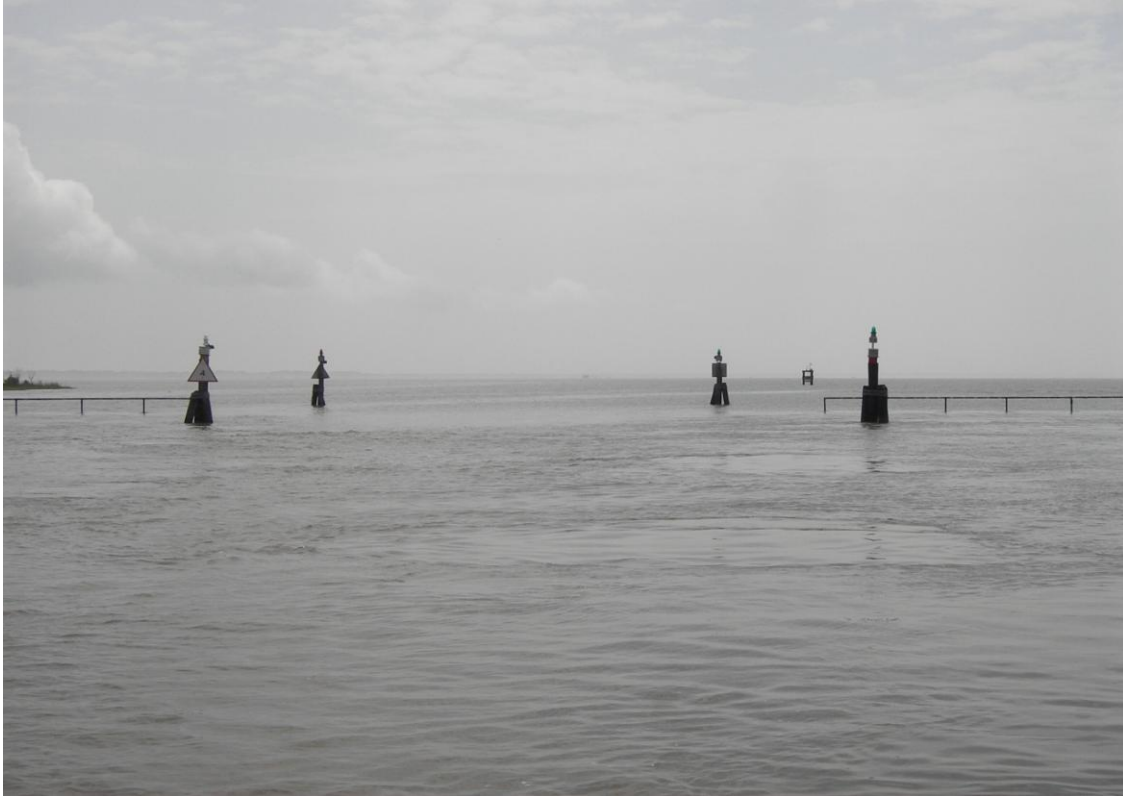
**Photo 11**—Missing sign and Nav-Aid lights at Humble Canal

- Replace Coast Guard sign at Humble Canal
- Verify staff gauges in the area
- Continue to monitor O&M dike elevation and functionality

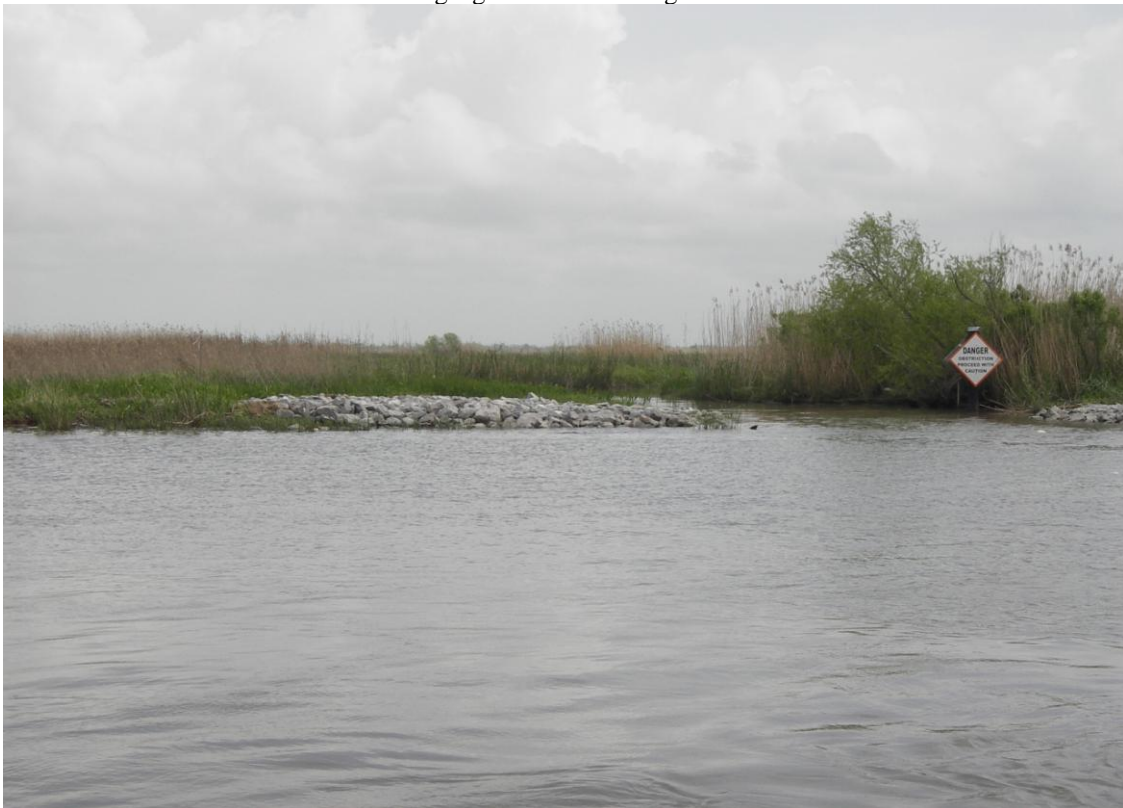
Construction of the foreshore rock dike and the low level weirs was completed in September, 2007. Though the dike has settled, it is still functioning as intended. Signage along the bay shore and at School Bus Bayou is stable. There was exposed geotextile fabric in the center of School Bus Bayou on both the east and west weirs. Apparently, rock at the bottom of the bayou has been completely displaced. This condition will be monitored. (Photos: Appendix B, Photos 12-13, 15-17).

**Photo 12**—Eastern weir at School Bus Bayou

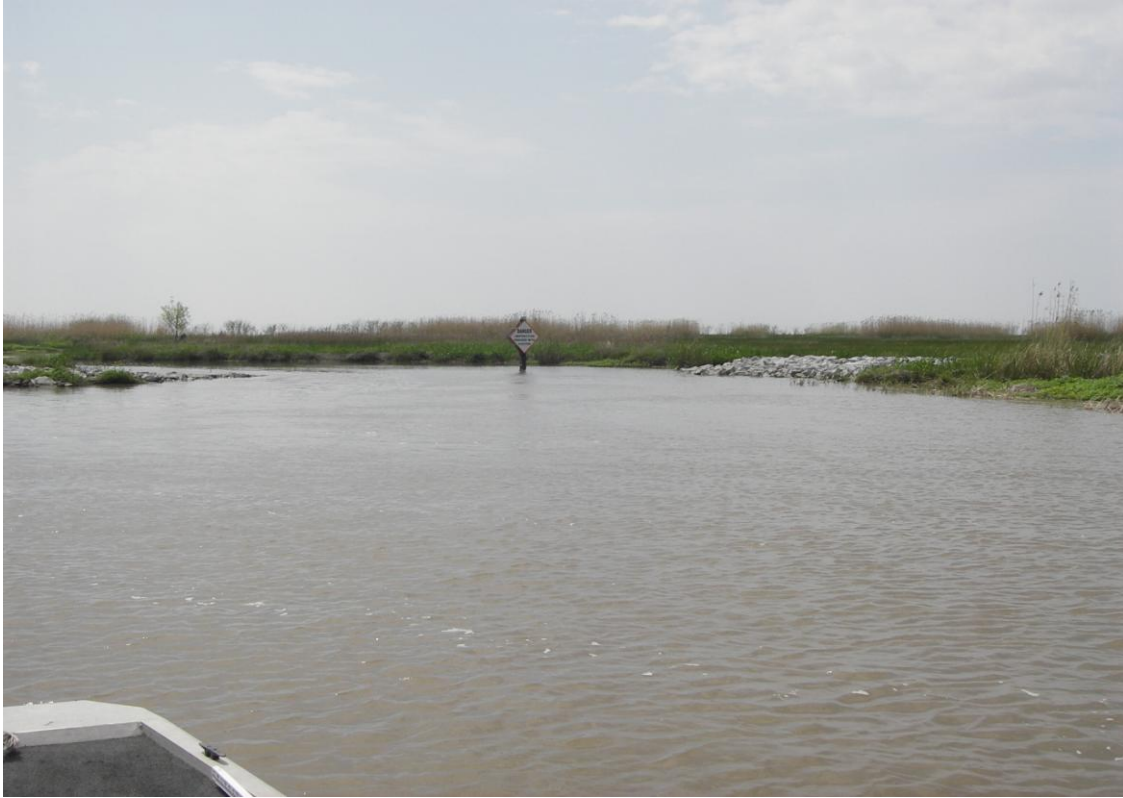
**Photo 13**—Western weir at School Bus Bayou

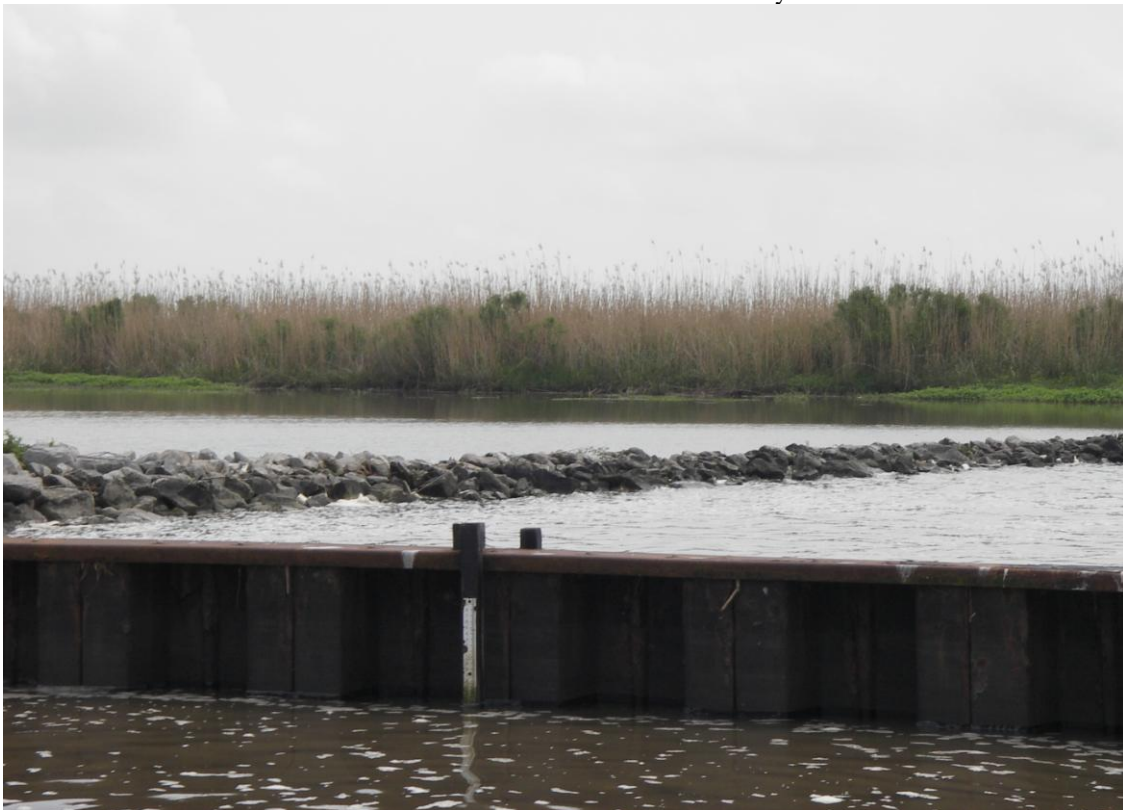
**Photo14**—Rock dike near Humble Canal

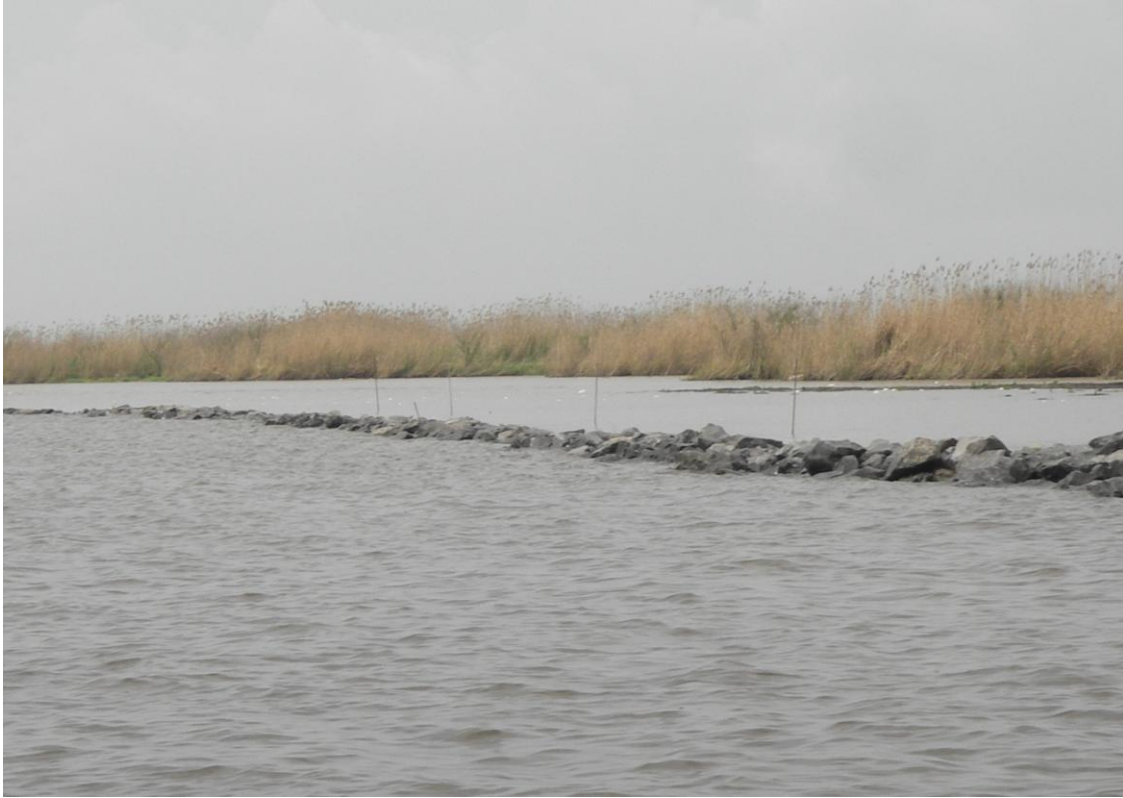
**Photo 15**—Typical good section of School Bus dike

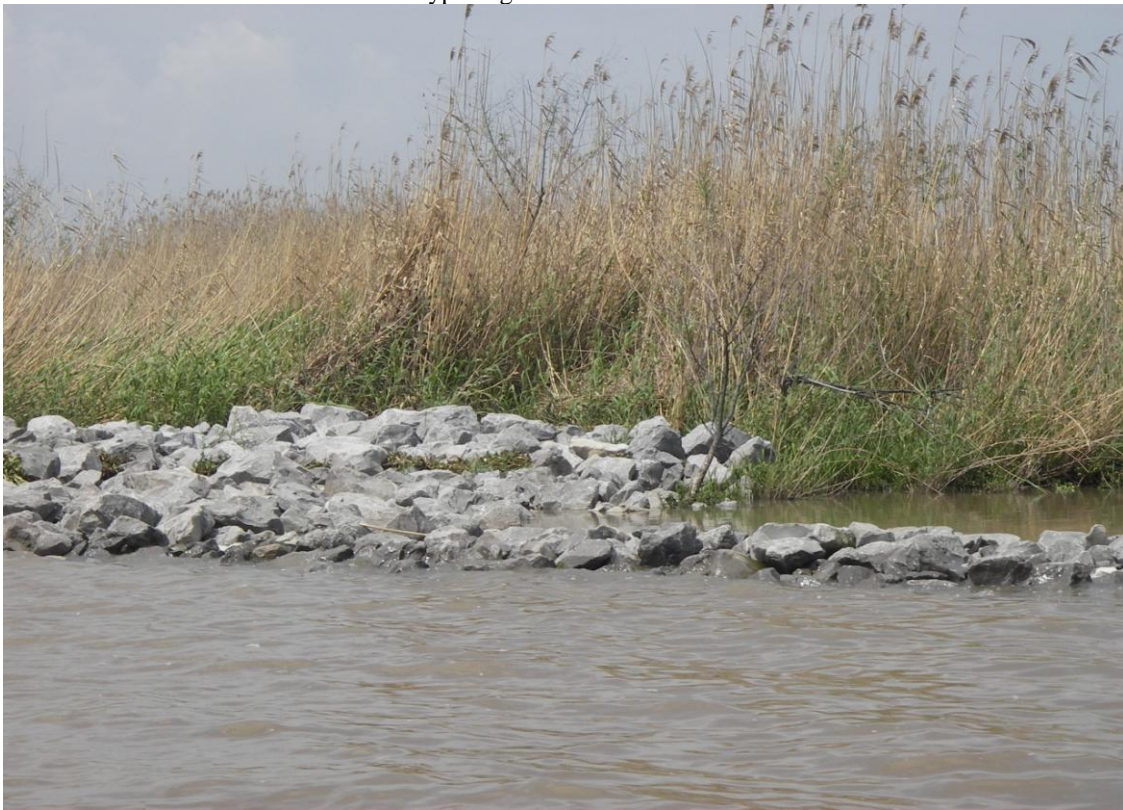
**Photo 16**—West tie-in of School Bus dike

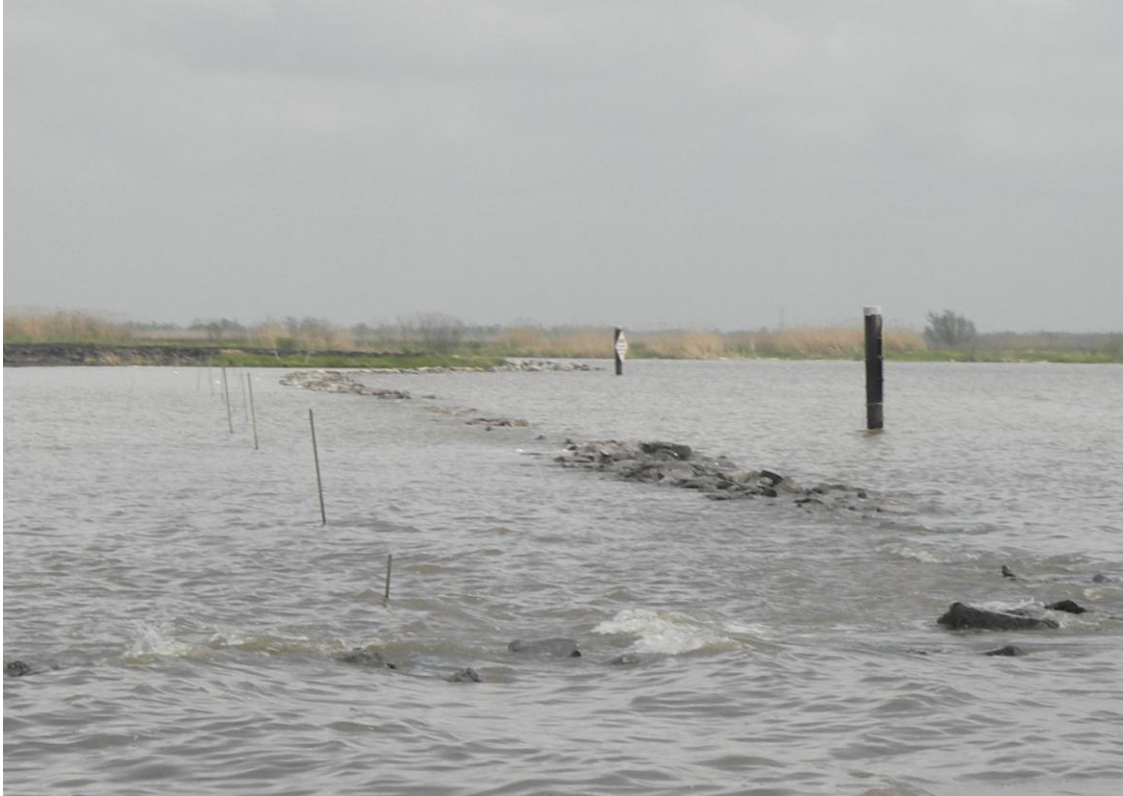
**Photo 17**—Typical settled section and signage of School Bus dike

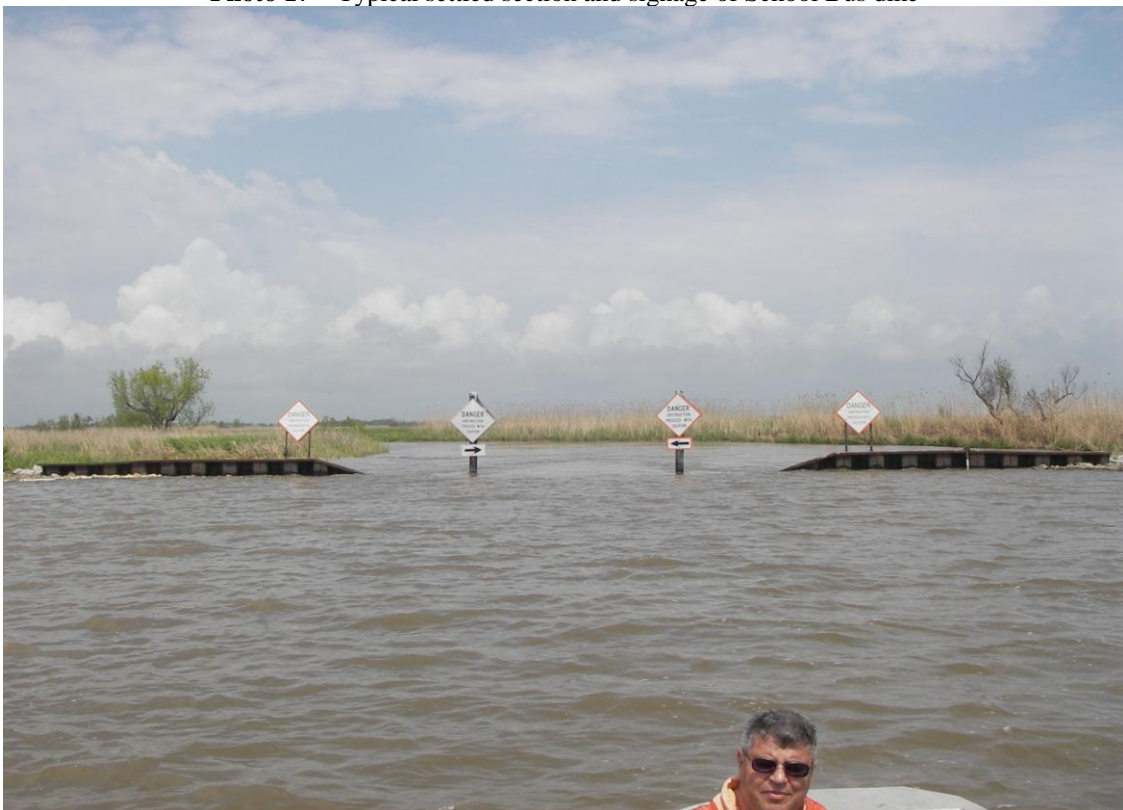
The Jackson Bayou structure and signage are stable. The coating on the sheet piles is rusting on this structure and will be monitored as well. (Photos: Appendix B, Photos 18-20).

**Photo 18**—Jackson Bayou structure and signage

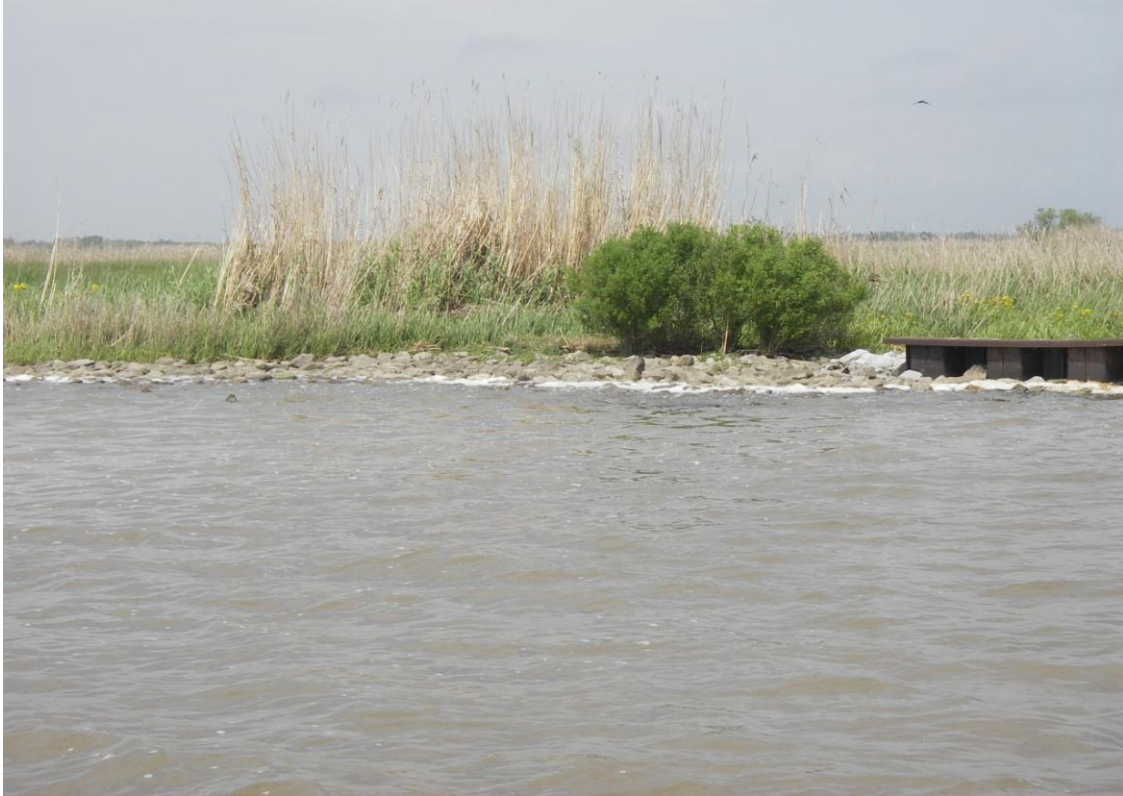
**Photo 19**—West side of Jackson Bayou structure

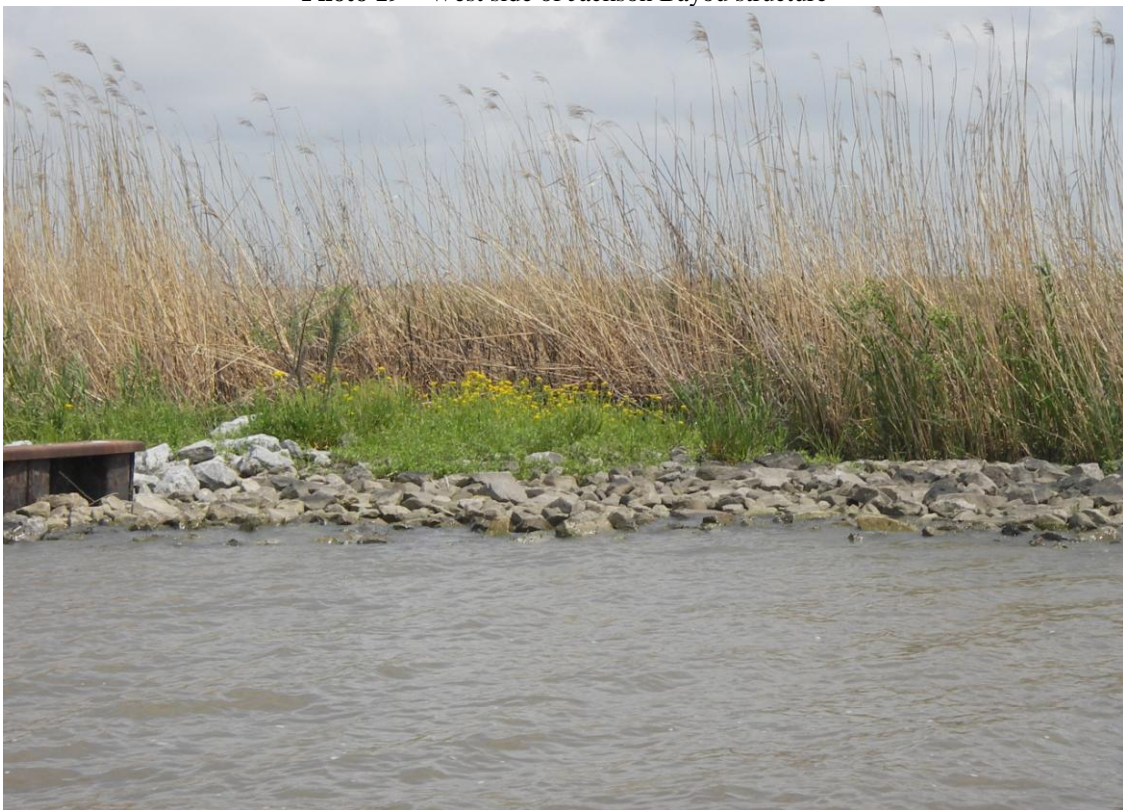
**Photo 20**—East side of Jackson Bayou structure

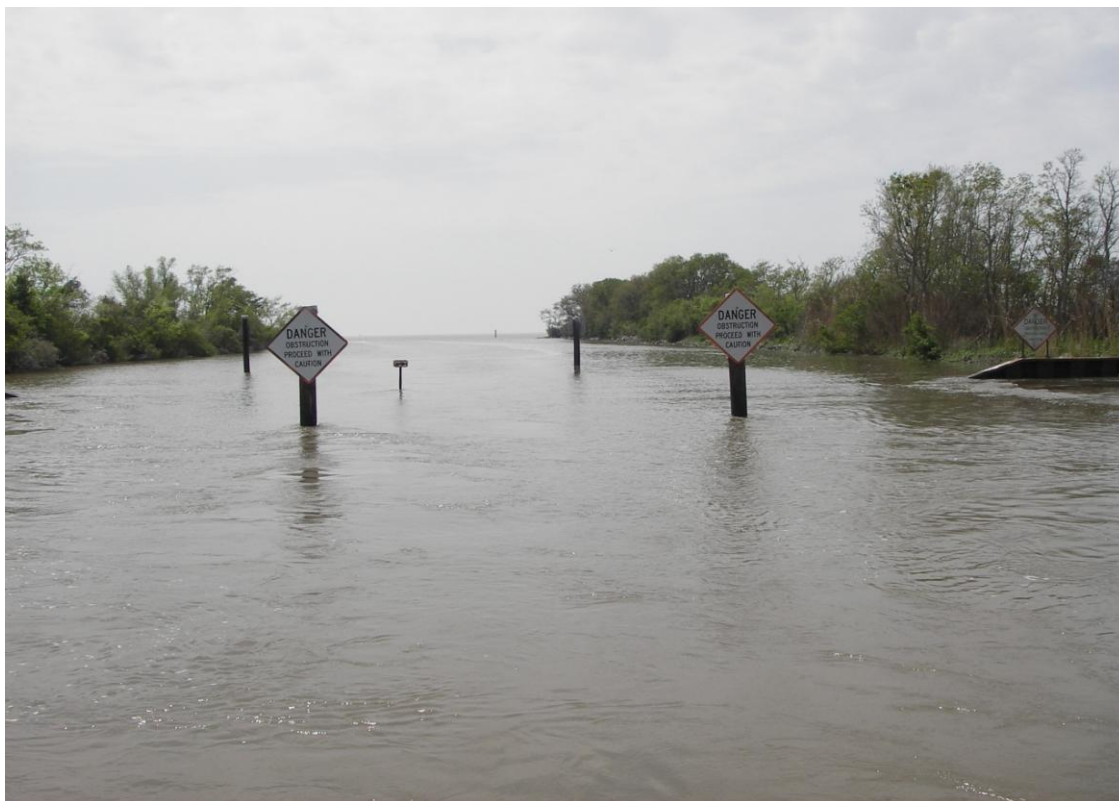
The British American Canal and signage are stable. The coating on the sheet piles is rusting on this structure and will be monitored as well. One of the directional arrows is missing, but may not need to be replaced at this time. (Photos: Appendix B, Photos 21-24).

**Photo 21**—British American Canal structure and signage

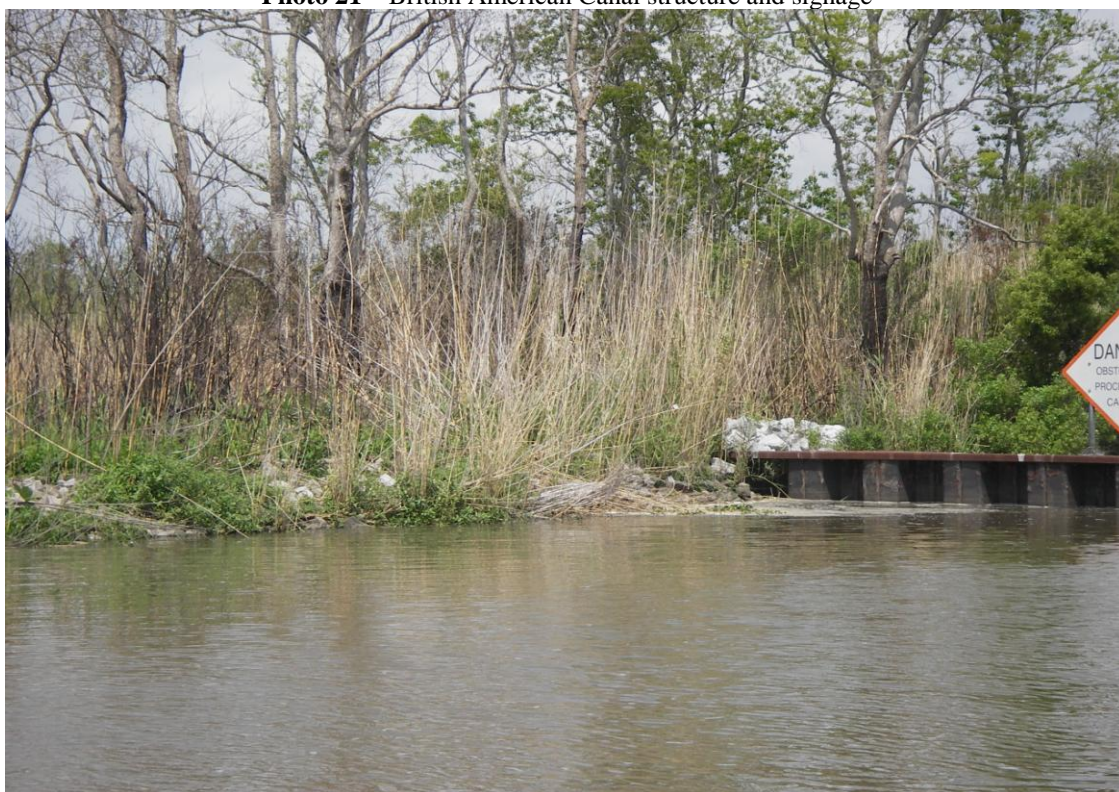
**Photo 22**—West side of British American structure

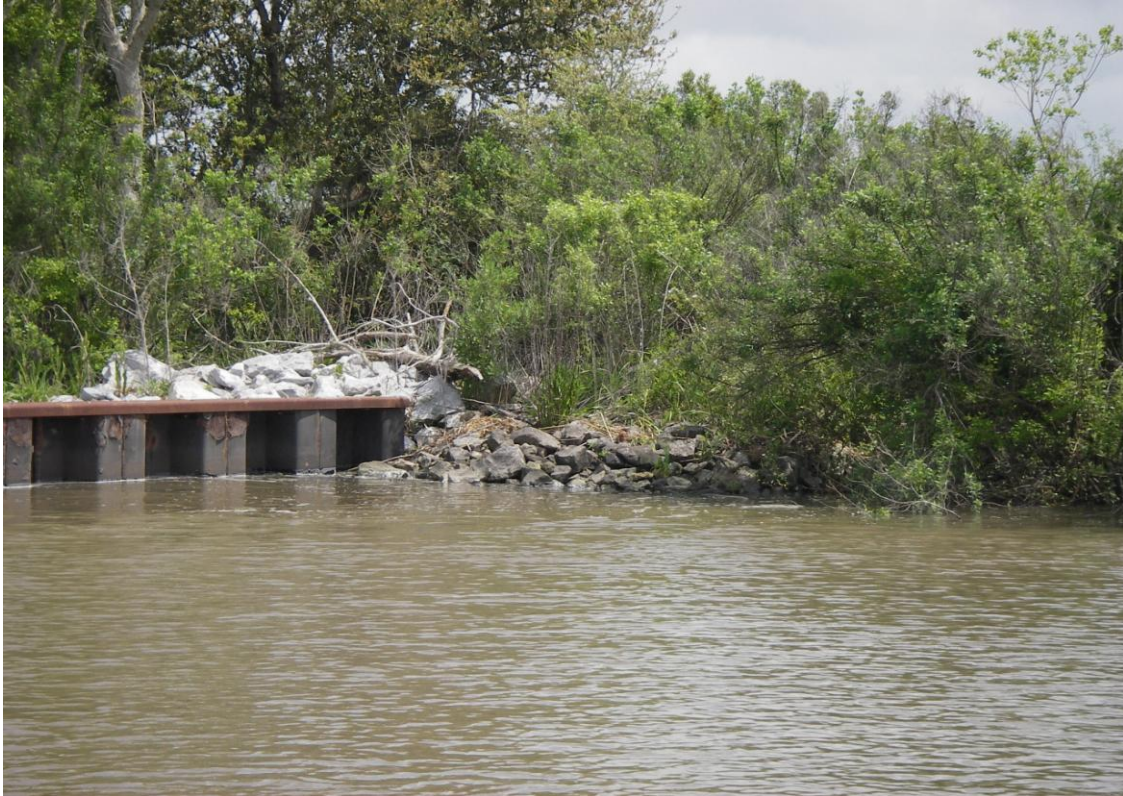
**Photo 23**—East side of British American structure

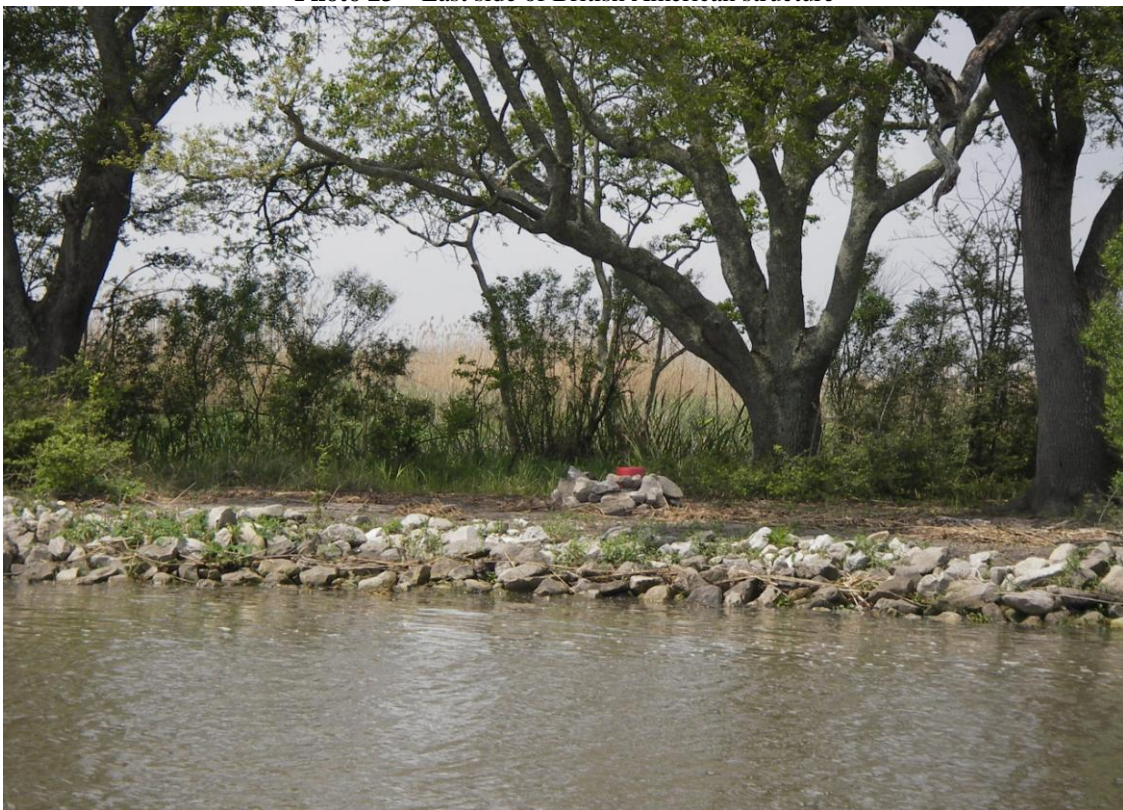
**Photo 24**—Rock along British American Canal
