**2008 Operations, Maintenance,  
and Monitoring Report**

**Cote Blanche Hydrologic  
Restoration**

State Project Number TV-04  
Priority Project List 3

January 2008  
St. Mary Parish

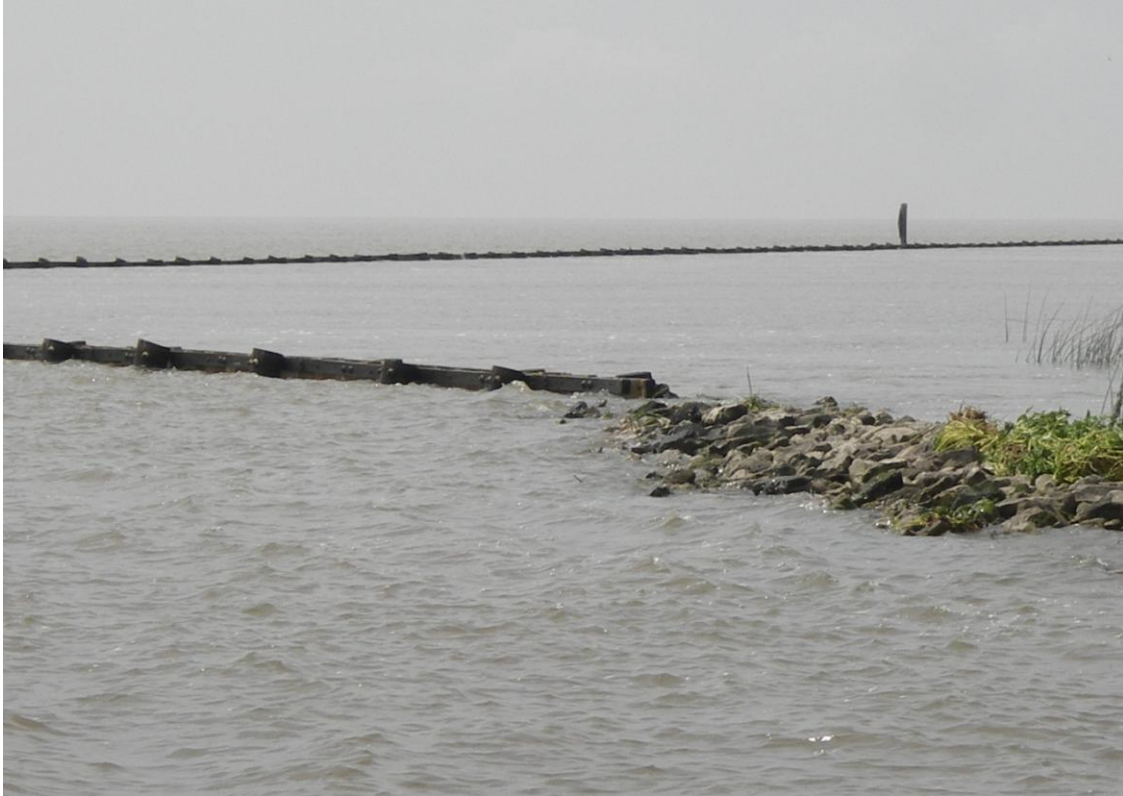
The PVC shoreline protection wall and signage are stable. Several pile caps are missing but no damage to the timber piles was noticed. Previous attempts to replace these pile caps have been unsuccessful. The piles will be monitored and should the need arise, will be painted or coated for protection. Sheet piles in several locations are missing. Replacement of these sheet piles may not be possible due to the rock at the base. There aren't enough missing to cause any problems as of yet. (Photos: Appendix B, Photos 25-26).

**Photo 25**—Rock and PVC wall near British American Canal

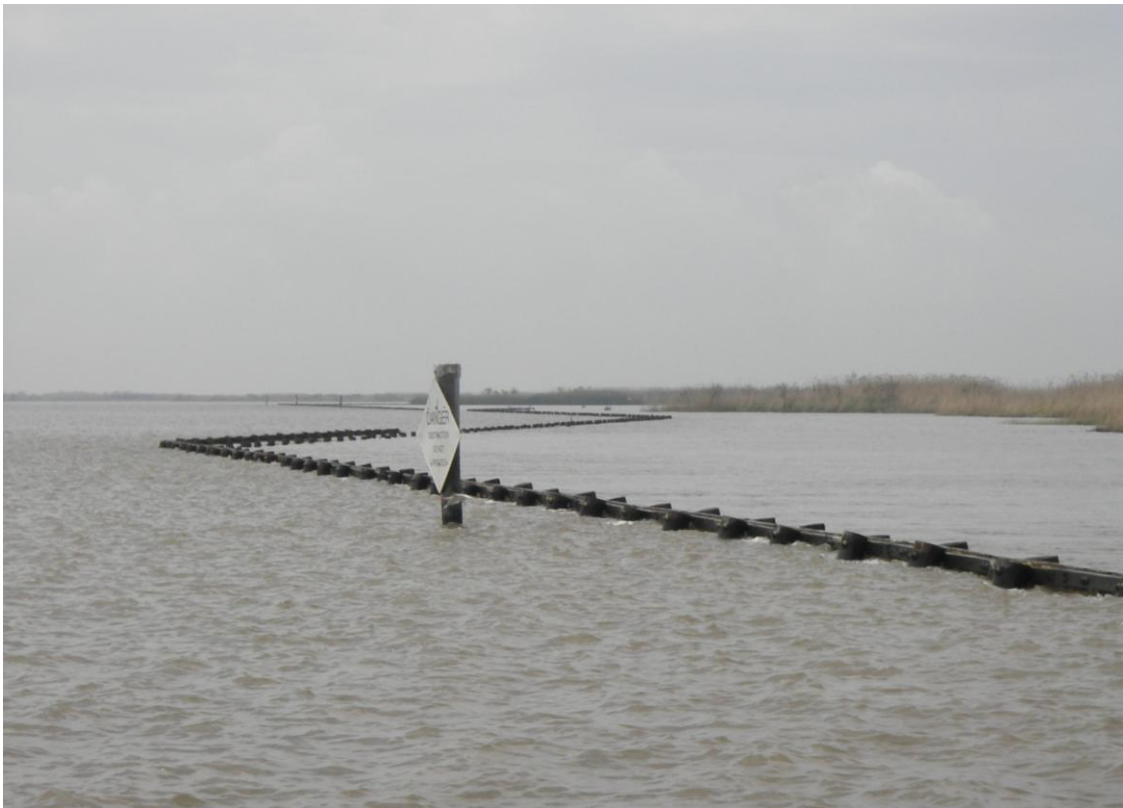
**Photo 26**—Typical section of PVC wall and signage
