## **2011 Operations, Maintenance, and Monitoring Closeout Report.**

### **SWEET LAKE/WILLOW LAKE HYDROLOGIC RESTORATION**

State Project Number CS-11B  
Priority Project List 5

June 2011  
Cameron Parish

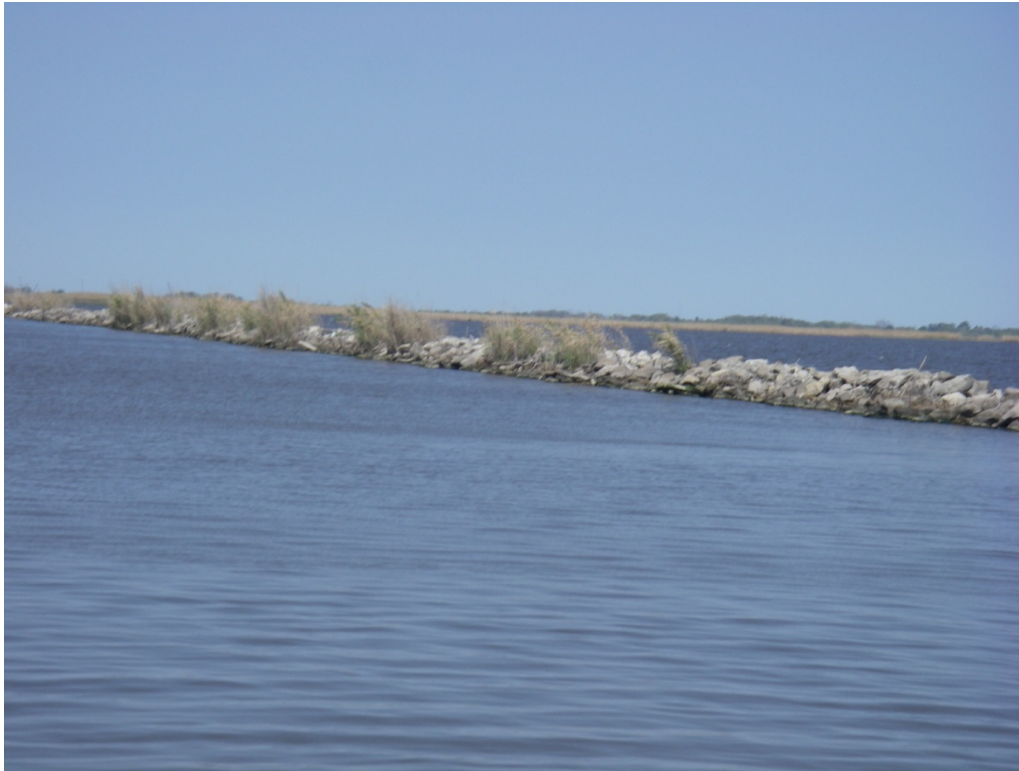
The dikes are in reasonably good condition. There are a few low places along the length of the rock dike with the most significant stretches along the open water areas adjacent to Sweet Lake along with an area approximately 50 feet wide along the very eastern end of the project area in which the dike appears to have been “pushed back” 10-12 feet apparently by a barge. There is another area approximately 4 feet wide in which the dike appears to have been removed by hunters or fishermen. It was discussed that maintenance repairs to these areas mentioned above may be incorporated into the CS-49 Freshwater Introduction Project such that the two projects are very near to each other and rock work along the GIWW is a feature of the CS-49 project. Several settlement plates are either broken or leaning and are of no use. No gauges were available in the vicinity to determine water levels. The condition of the shallow water terraces feature of the project was unable to be determined due to high water conditions in Sweet Lake and Willow Lake. (Photos: Appendix B, Photo 1, 2).

**Photo No. 1,** Typical rock dike

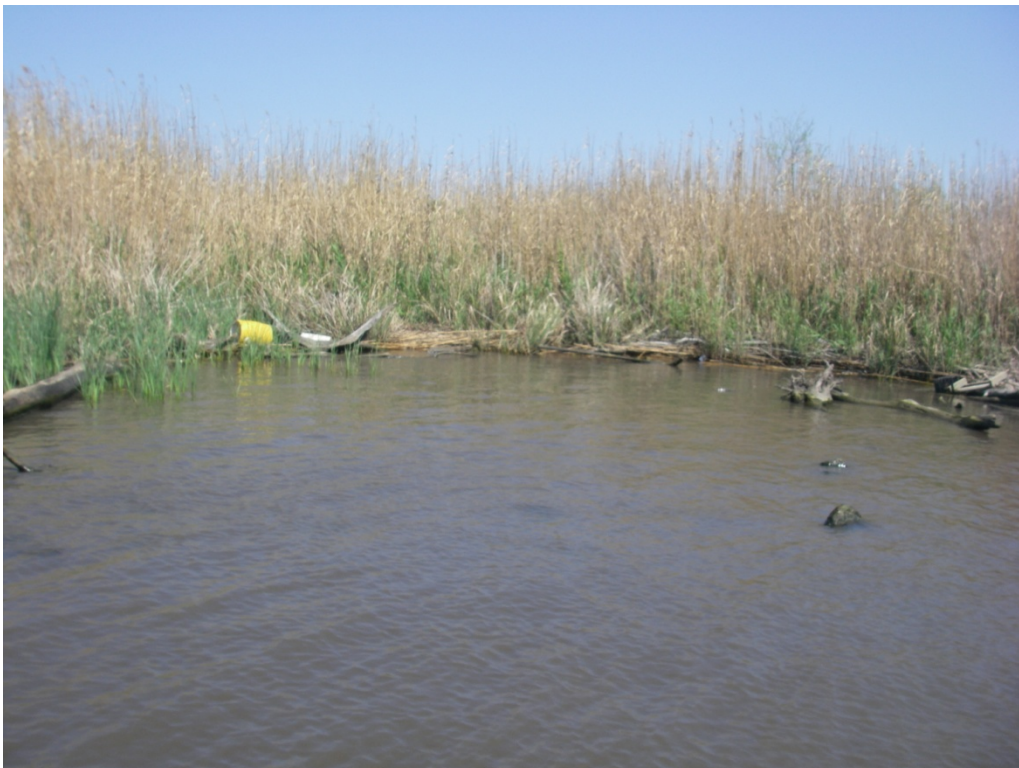
**Photo No. 2,** Area where rock dike has been “pushed back”

Item	Condition	Physical Damage	Corrosion	Photo #	Observations and Remarks
Steel Bulkhead / Caps	NA				
Steel Grating	N/A				
Stop Logs	N/A				
Hardware	N/A				
Timber Piles	N/A				
Timber Wales	N/A				
Galv. Pile Caps	N/A				
Cables	N/A				
Signage/Support	N/A				
Rip Rap(fill)	N/A				
Earthen Embankment	N/A				
Foreshore Dike	Good			1, 2	300 Linear feet of dike on eastern edge of Willow is low,. Also, there is a 50 foot section of rock dike that has apparently been pushed back. Another 4 foot section is missing in another area.
