**Coastal Protection and Restoration
Authority of Louisiana**

**2010/2011 Annual Inspection
Report**

**HWY. 384 HYDROLOGIC
RESTORATION PROJECT
(CS-21)**

February 9, 2011
Cameron Parish

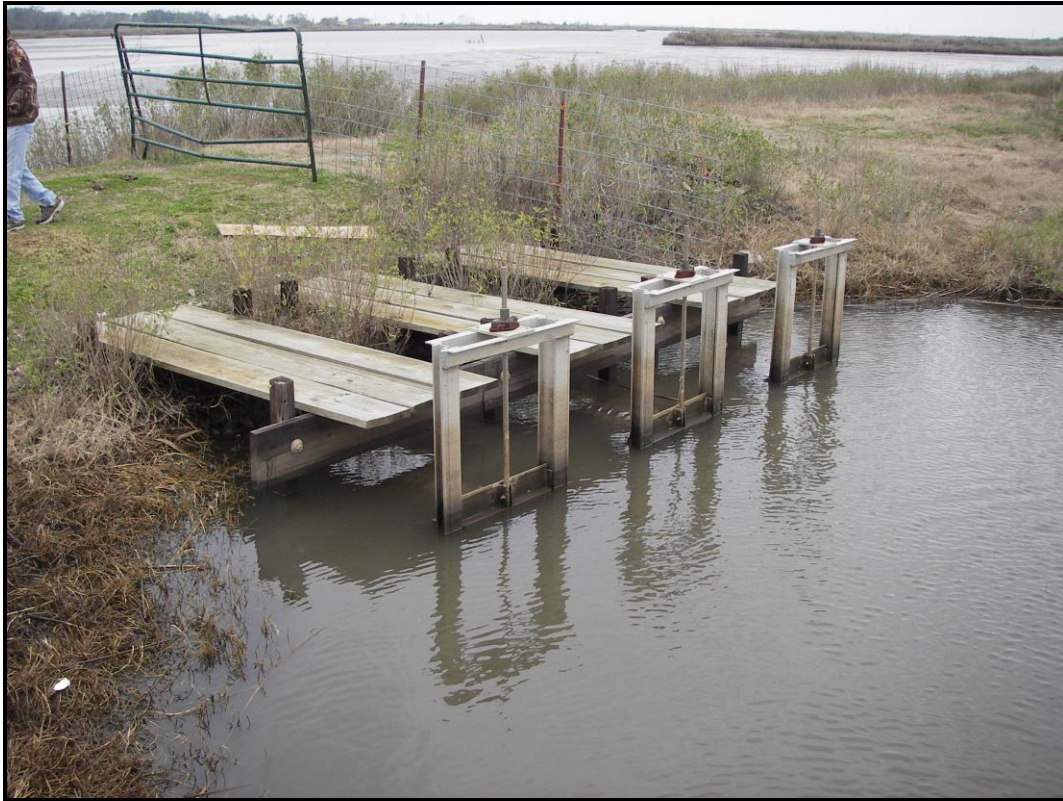
Photo No. 1, Structure No.1, inlet side.

The structure is in good condition.. The inside staff gage will need to be replaced. Rock placed on the bank during the maintenance event of June 2002 is stable and in no need of repair. The three outlet flap gates were lodged open apparently by rocks below the water surface. The operations contractor was contacted to provide a cost estimate to remove these obstructions. The hyacinth fence is in good condition. The road/levee leading up to the structure is in good condition since it was repaired in June 2006. The recently installed Portable Multi-Parameter Water Quality Troll 9500 – 29r operation sonde was operational. The solar panel should be cleaned and bird excluder devices installed. (Photos: Appendix B, Photos 1-3).

Item	Condition	Physical Damage	Corrosion	Photo #	Observations and Remarks
Steel Bulkhead / Caps	N/A				
Flapgates/Outlet Pipe	Good			3	3 flaps locked open due to obstruction.
Stop Logs	N/A				
Hardware/Sluiceways	Good			1	
Hyacinth Fence	Good			2	
Timber Piles	N/A				
Timber Wales	N/A				
Galv. Pile Caps	N/A				
Cables	N/A				
Signage /Supports	N/A				
Staff Gages	Poor				Staff gage outlet side of structure not readable.
Rip Rap (fill)	Good				
WQ Troll 9500 - 29r	Good				
Earthen Embankment					
Access Roadway	Good

- Structure No. 1 – install bird excluder device on solar panel, replace staff gage.
- Structure No. 12 – replace metal pile cap covers, install bird excluder device on solar panel.
- Structure No. 8 (Rock Plug) – install staff gauge (marsh side).

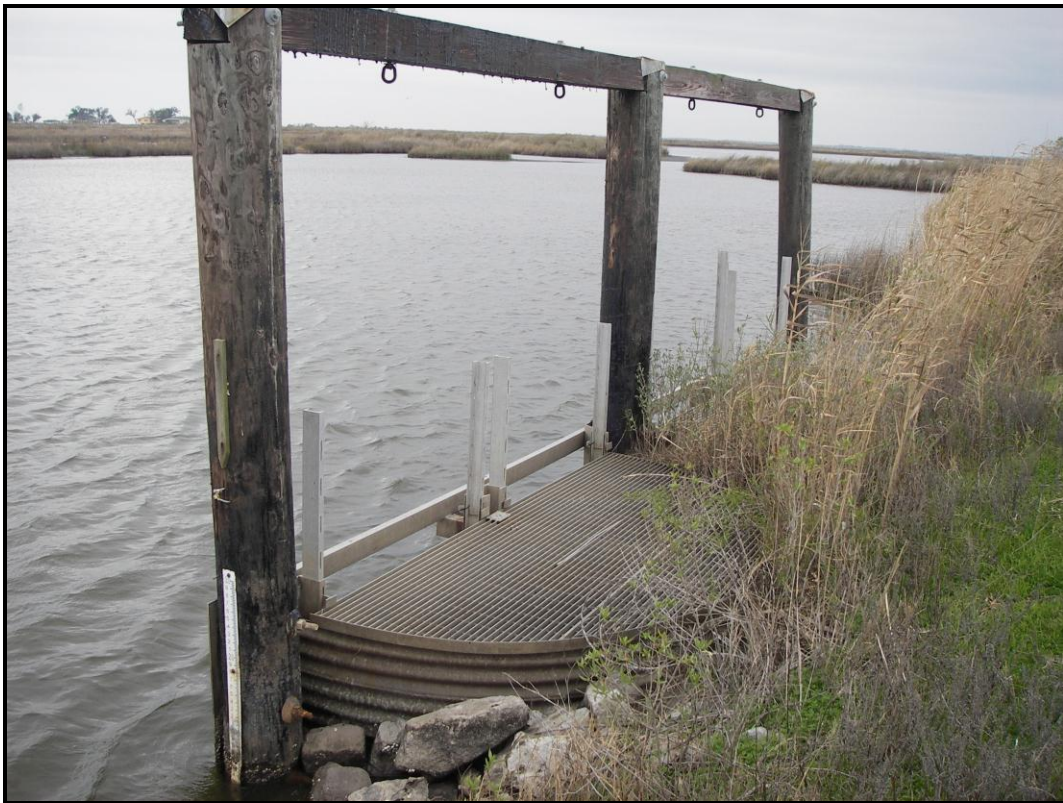
Photo No. 4, Structure No. 12, inlet side.

The structure is in good shape and the inlet and outlet sides appear undamaged. Water level on the outside was elevation +0.58 NAVD88 and the level inside was +0.4 NAVD88. Pile caps on the outlet side and the padlocks on the stop log locking devices have rusted and will eventually need to be replaced. Some of the lower anchor bolts on the structure show signs of corrosion and will be monitored. Rock that was placed during the maintenance of Nov. 2000 is stable. The road/levee leading up to the structure is in good condition since it was repaired in June 2006. (Photos: Appendix B, Photos 4-5).

Item	Condition	Physical Damage	Corrosion	Photo #	Observations and Remarks
Steel Bulkhead / Caps	N/A				
Steel Grating	Good			4	
Stop Logs	Good				
Hardware/Flapgates	Good				
Timber Piles	Good				
Timber Wales	N/A				
Galv. Pile Caps	Fair			5	Pile caps on outlet structure are corroded and will eventually need to be replaced.
Cables	N/A				
Signage /Supports	N/A				
Staff Gages	Fair				
Rip Rap (fill)	Good				
WQ Troll 9500 - 15r	Good				
Earthen Embankment					
Access Roadway	Good

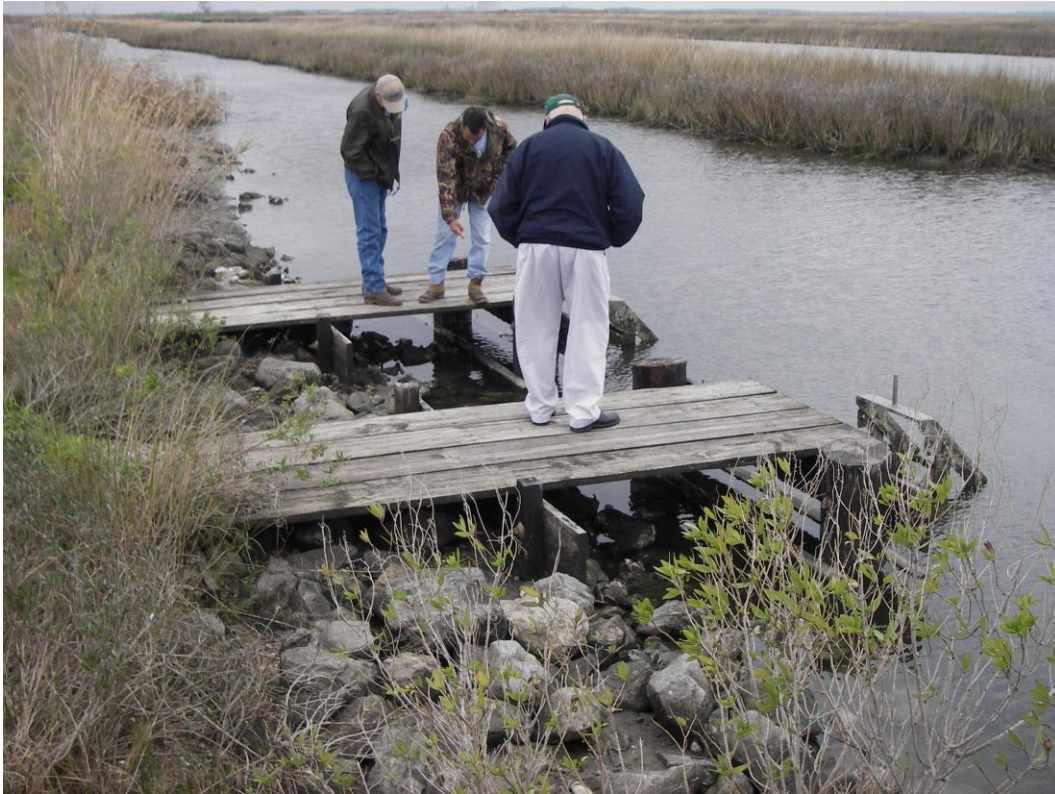
Photo No. 5, Structure No. 12, outlet side.

Photo No. 6, Structure No. 8, rock plug showing accretion occurring on lake side.

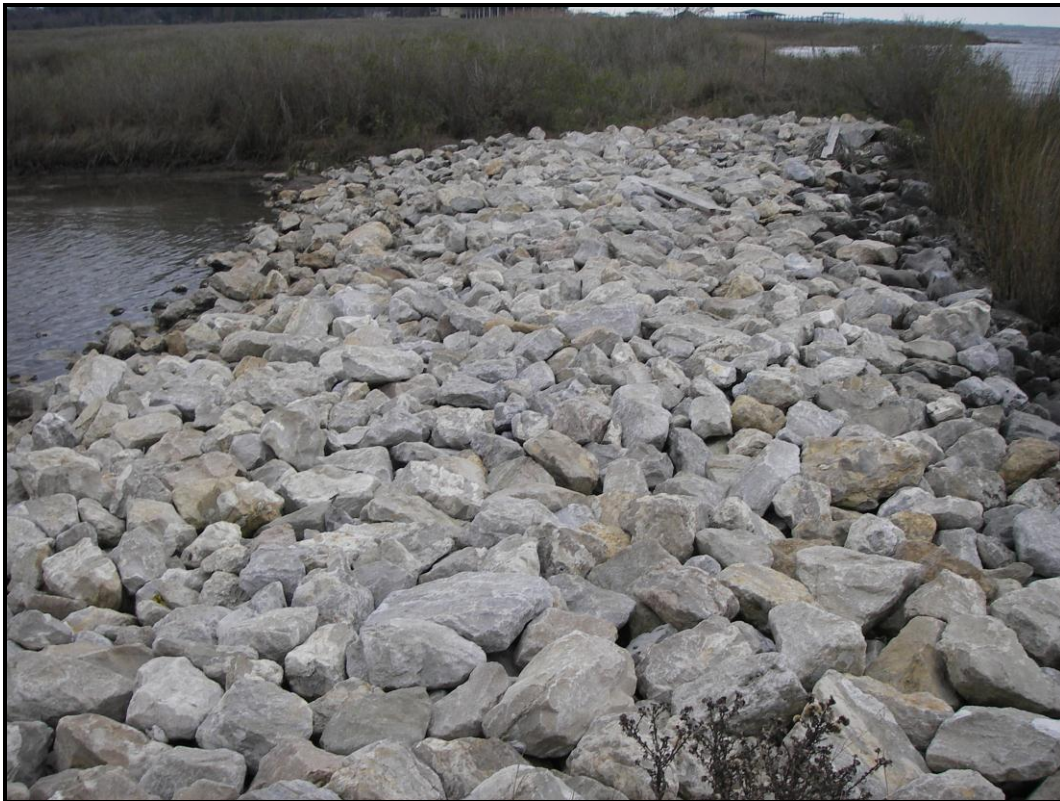
The rock plug is in good condition. Water levels could not be determined because the inside staff gage was missing. This staff gage will need to be replaced. The completed maintenance work in May 2005 to repair the plug from vandalism held up well under the high storm surge waters experienced during Hurricanes Rita and Ike. The interior area of the rock plug is showing signs of new vegetative growth in locations that were previously open water. The lakeside of the rock plug is also vegetating and is almost completely filled in. (Photos: Appendix B, Photo 6).

Item	Condition	Physical Damage	Corrosion	Photo #	Observations and Remarks
Steel Bulkhead / Caps	N/A				
Steel Grating	N/A				
Stop Logs	N/A				
Hardware	N/A				
Timber Piles	N/A				
Timber Wales	N/A				
Galv. Pile Caps	N/A				
Cables	N/A				
Signage / Supports	N/A				
Staff Gages	Poor				Inlet staff gage not readable.
Rip Rap (fill) (foreshore dike)	Good			6	
Earthen Embankment					The earthen levee that was rebuilt as part of the May '02 maintenance is in excellent condition beyond the limits of the channel.
