2010 Operations, Maintenance, and Monitoring Report

Humble Canal Hydrologic Restoration (ME-11)

State Project Number ME-11
Priority Project List 8

December, 2010
Lafayette Parish

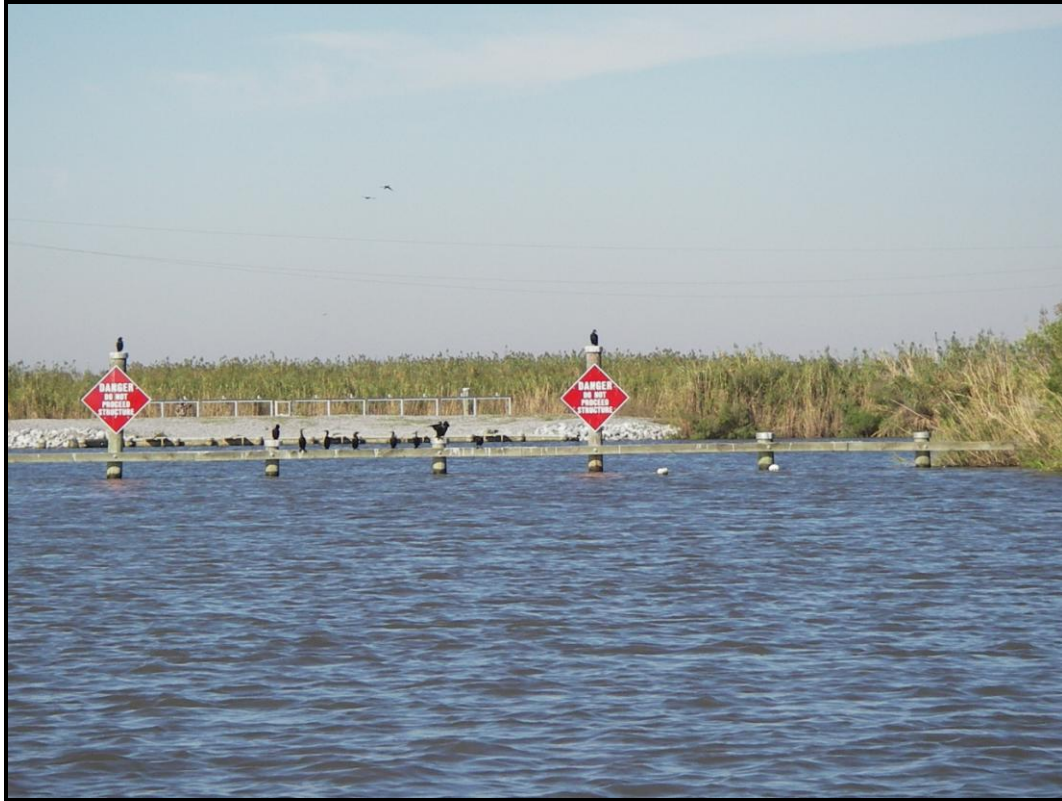
The structure is in excellent condition and the warning signs were recently replaced as part of a maintenance event. (Photos: Appendix A, Photo 1)

Photo 1, Marine barrier with signage.

Item	Condition	Physical Damage	Corrosion	Photo #	Observations and Remarks
Steel Bulkhead / Caps	good				
Steel Grating					
Stop Logs	N/A				
Hardware	good				
Timber Piles	good				
Timber Wales	good				
Galv. Pile Caps	good				
Cables	N/A				
Signage /Supports	good			1	
Rip Rap (fill)	N/A				
Eathern Embankment	N/A

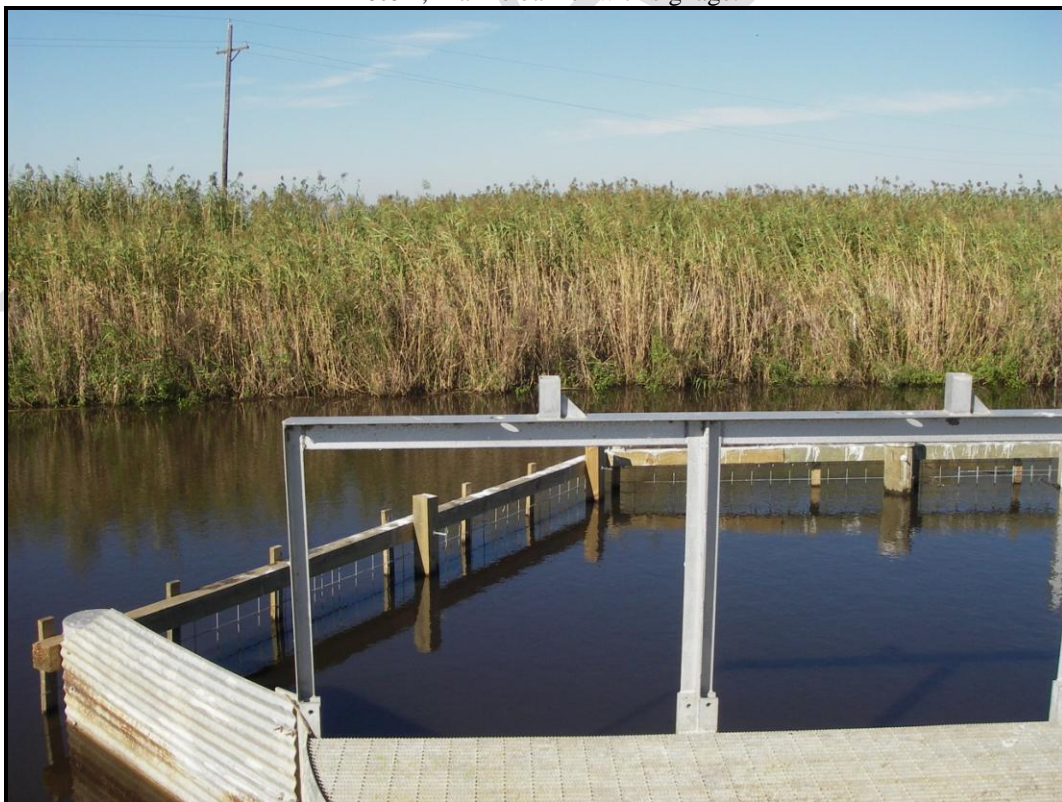
This feature is in good condition and also was part of the recent maintenance event to replace all of the wire fence material as well as repair of the hyacinth wooden pilings and bracing. (Photos: Appendix A, Photo 2)

Photo 2, Inlet side showing repairs to hyacinth fence.

Item	Condition	Physical Damage	Corrosion	Photo #	Observations and Remarks
Steel Bulkhead / Caps	good				
Steel Grating	N/A				
Stop Logs	N/A				
Hardware	good				
Timber Piles	good			2	
Timber Wales	fair			2	
Galv. Pile Caps	good				
Cables	N/A				
Signage /Supports	N/A				
Rip Rap (fill)	N/A				
Earthen Embankment	N/A

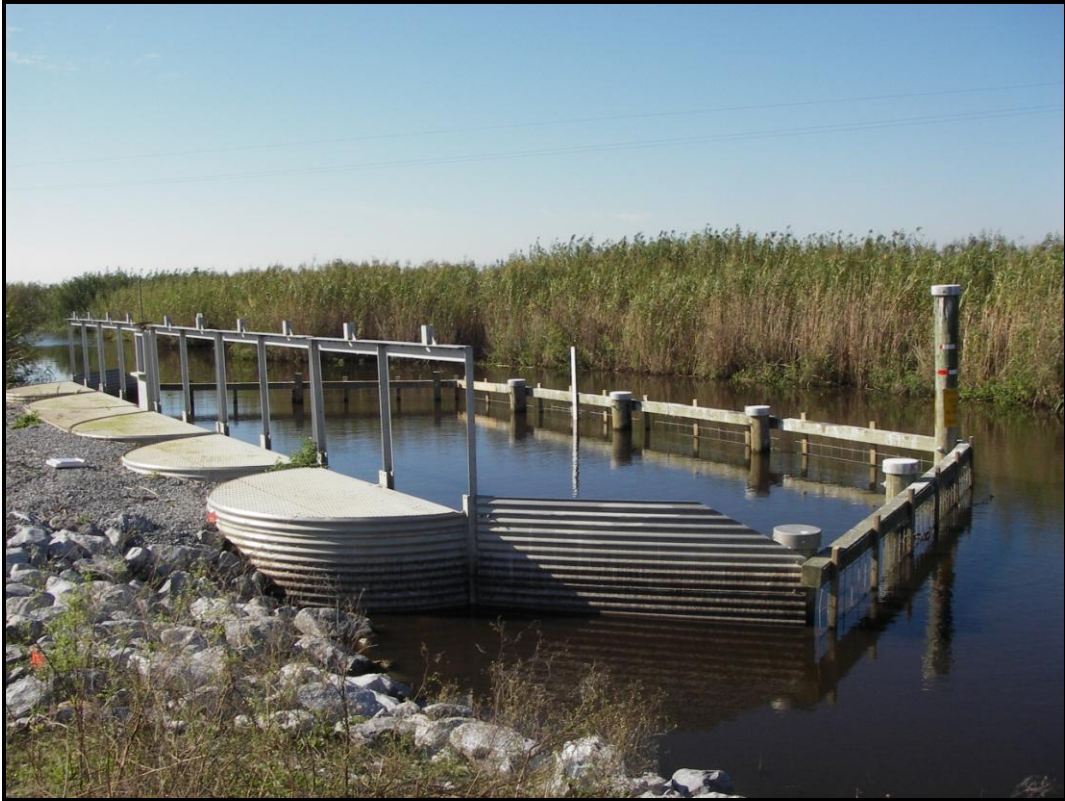
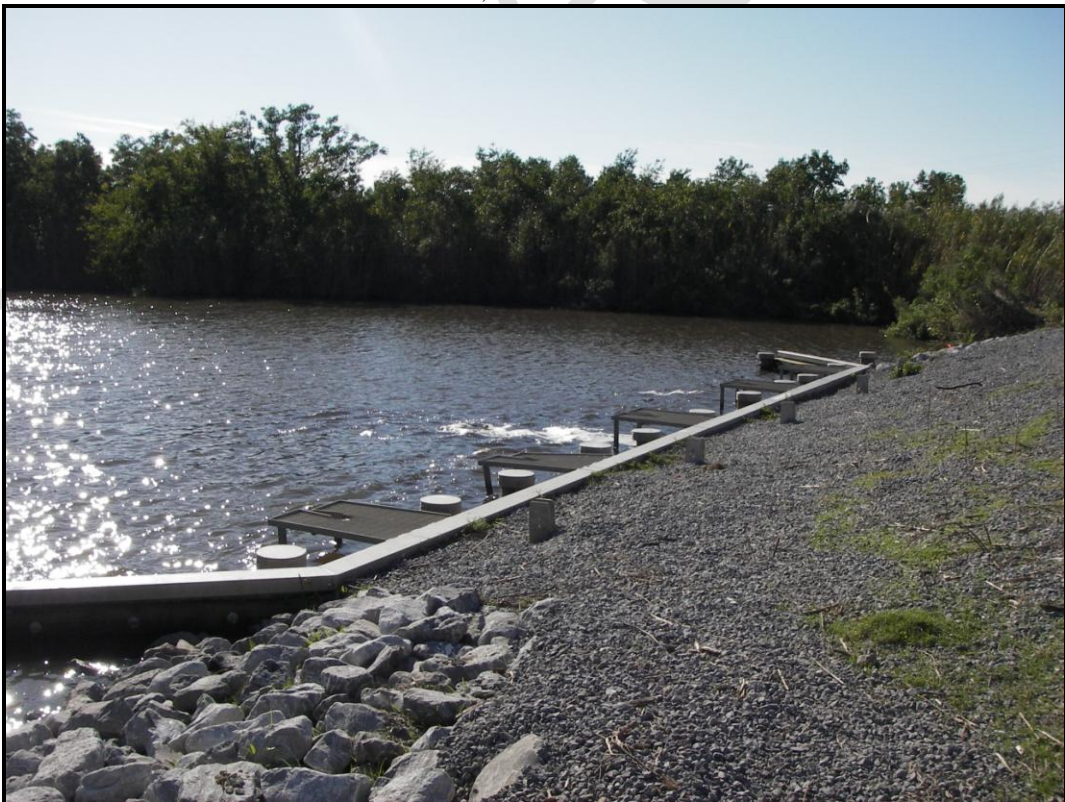
Overall, the structure is in good post construction condition. As part of the recent maintenance event rock armor was placed on the ends of the wingwalls on the inlet and outlet side of the structure. Crushed stone aggregate was also placed on the top portion of the structure. M & M Electric hired the services of a diver to check and clear out all flapgates. Several items were found wedged in the gates including a portion of an old lifting arm. Miscellaneous repairs were made to the flap gates, stoplogs and locking arms. Southside Machine fabricated an aluminum storage box for locking arms and stoplogs and was placed on Miami Corporation property off of Little Chenier Road. This storage box was added to the contract as a means to prevent vandalism. (Photos: Appendix A, Photos 3-5)

Photo No. 3, Inlet side of structure

Photo No. 4, Outlet side of structure

Item	Condition	Physical Damage	Corrosion	Photo #	Observations and Remarks
Steel Bulkhead / Caps	good				
Steel Grating	good				
Stop Logs	good			3 & 4	
Storage Box	good			5	
Hardware	good			3 & 4	
Timber Piles	good				
Timber Wales	good				
Galv. Pile Caps	good				
Cables/ lifting device	good				
Signage /Supports	N/A				
Rip Rap (fill) (foreshore dike)	good				
Eathern Embankment	good			3 & 4	
Inlet Channel/Plug	good

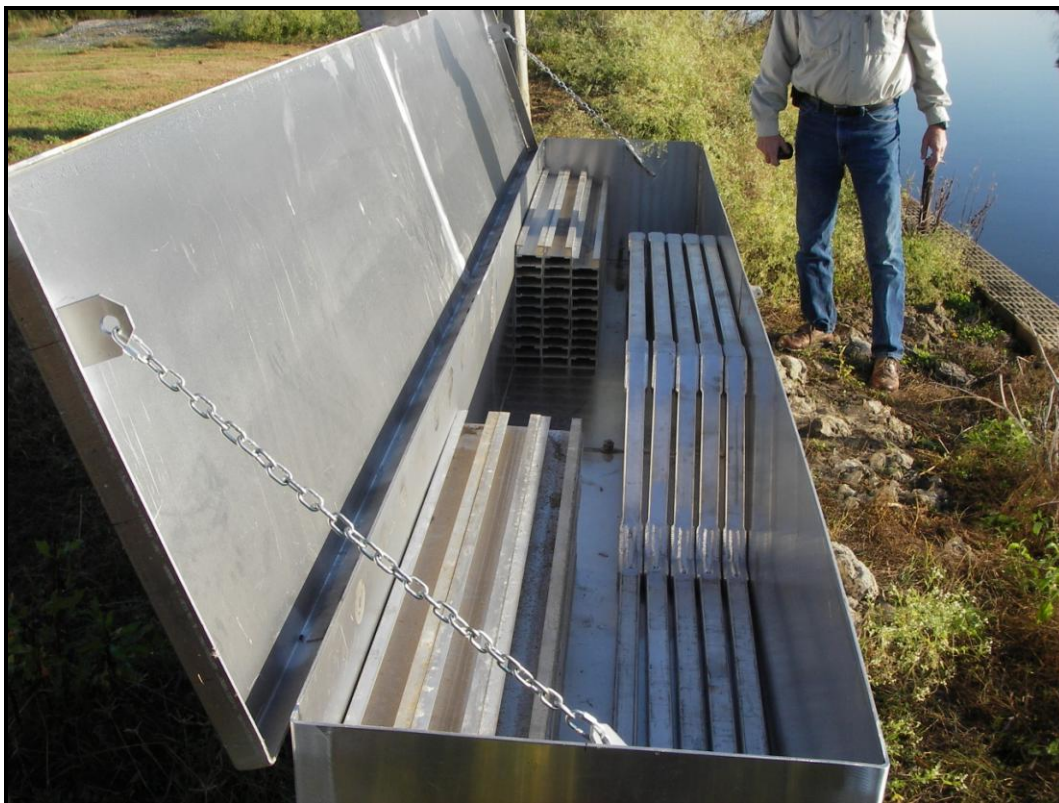
Photo No. 5, Storage box for locking arms and stop logs
