**2004 Operations, Maintenance,
and Monitoring Report**

Cameron Creole Plugs Project

State Project Number CS-17
Priority Project List 1

January 24, 2005
Cameron Parish

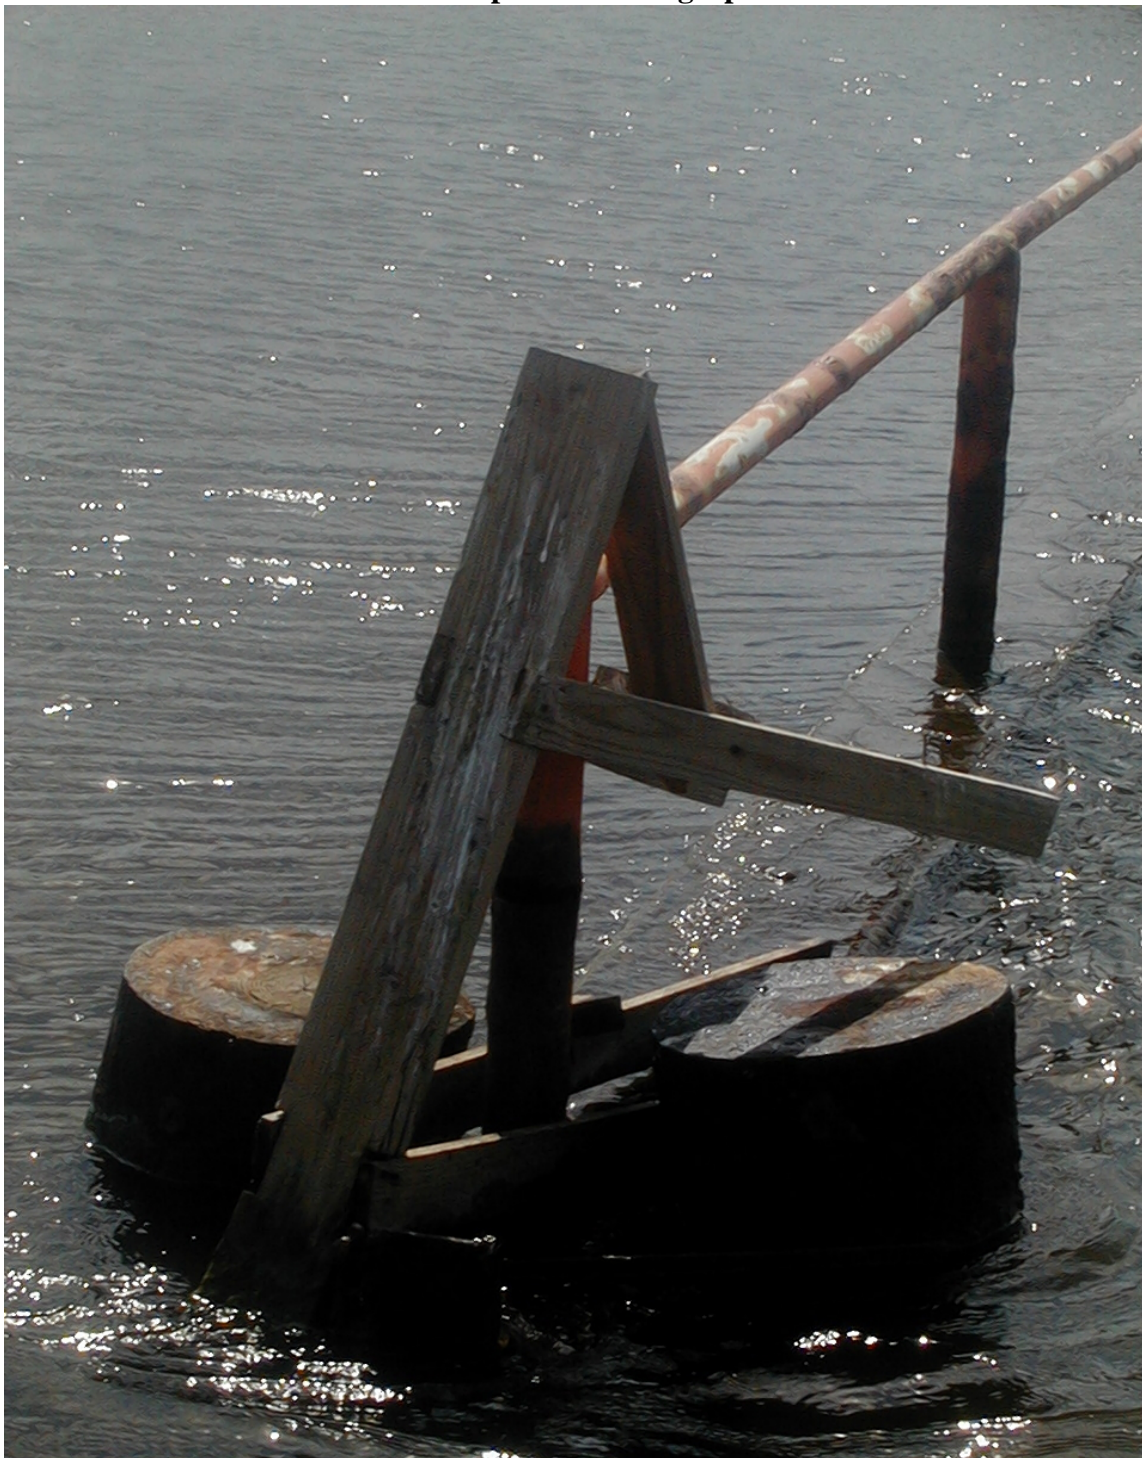
The structure is in relatively good condition. Signs are in immediate post construction condition. The sheet pile cap and the railing have rusted but only the railing will be replaced. USFWS personnel would like to incorporate soft bumpers into the boat bay. Lonnie Harper & Associates have begun preliminary engineering for this recommended maintenance. The structure, however, is functioning as designed

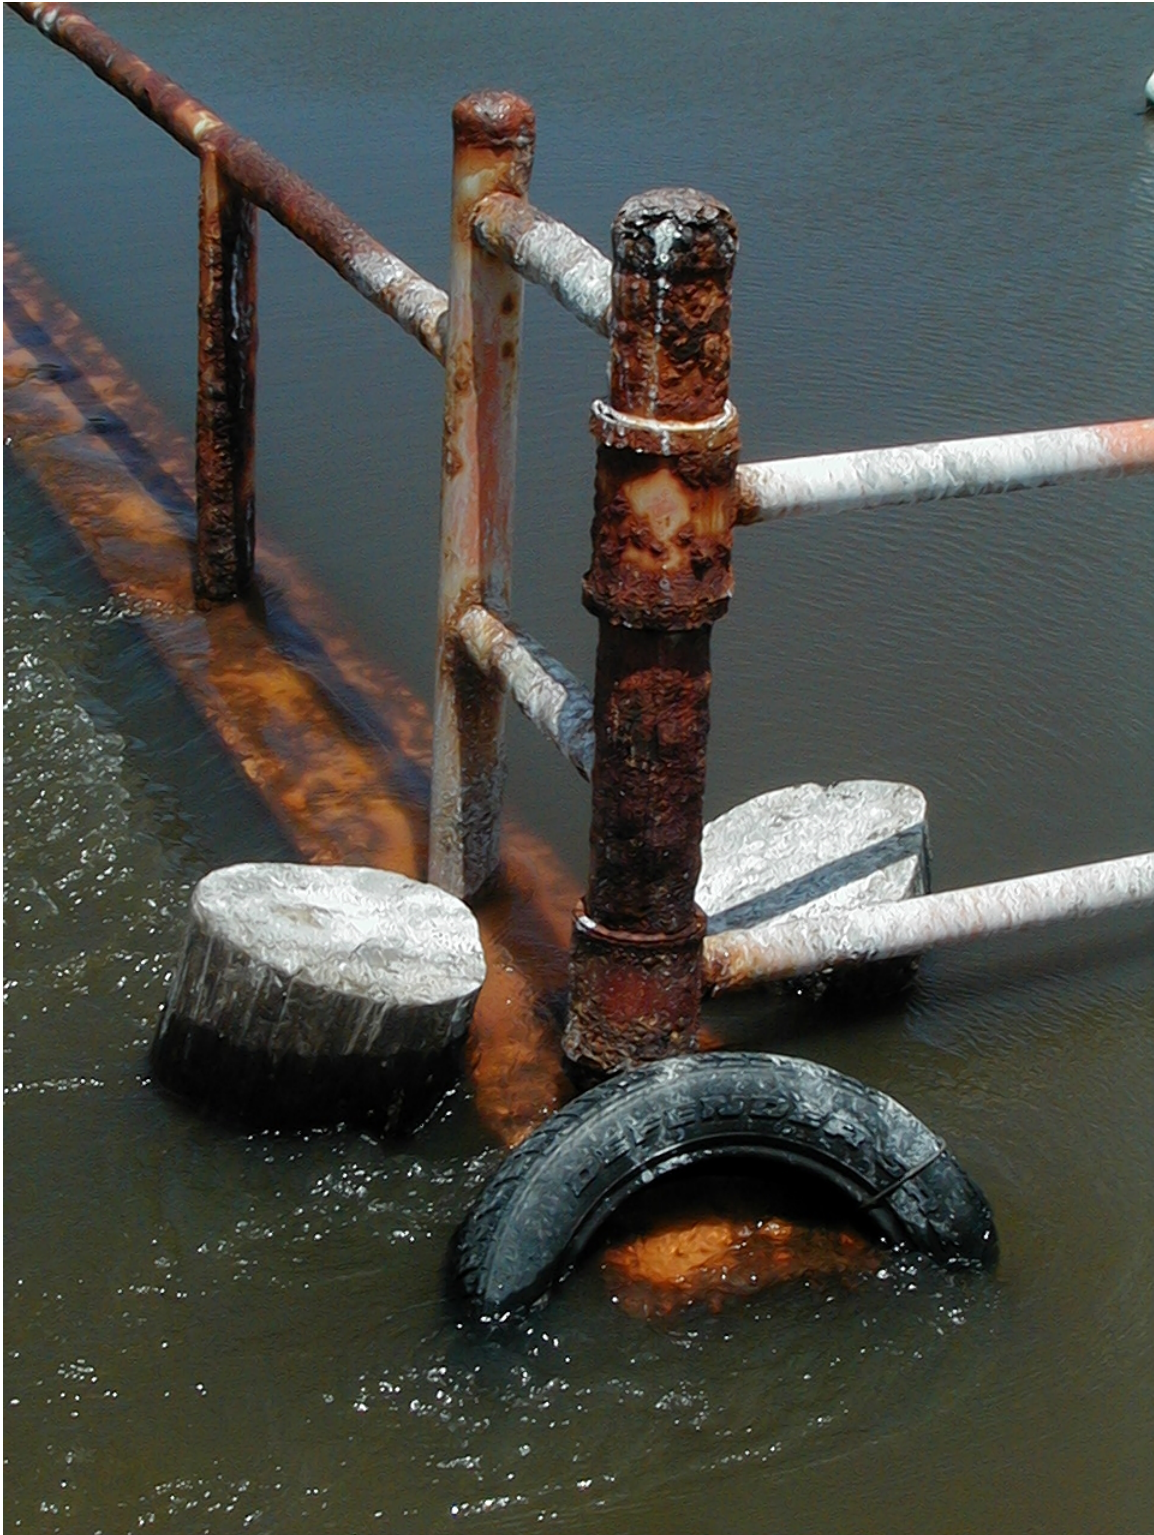
Structure is in similar condition as Structure #2. The railing will be replaced and the soft bumpers will be installed. The structure is functioning as designed.
