2010 Annual Inspection Report

DELTA WIDE CREVASSES (MR-09)

State Project Number MR-09
Priority Project List 6

October 7, 2010
Plaquemines Parish

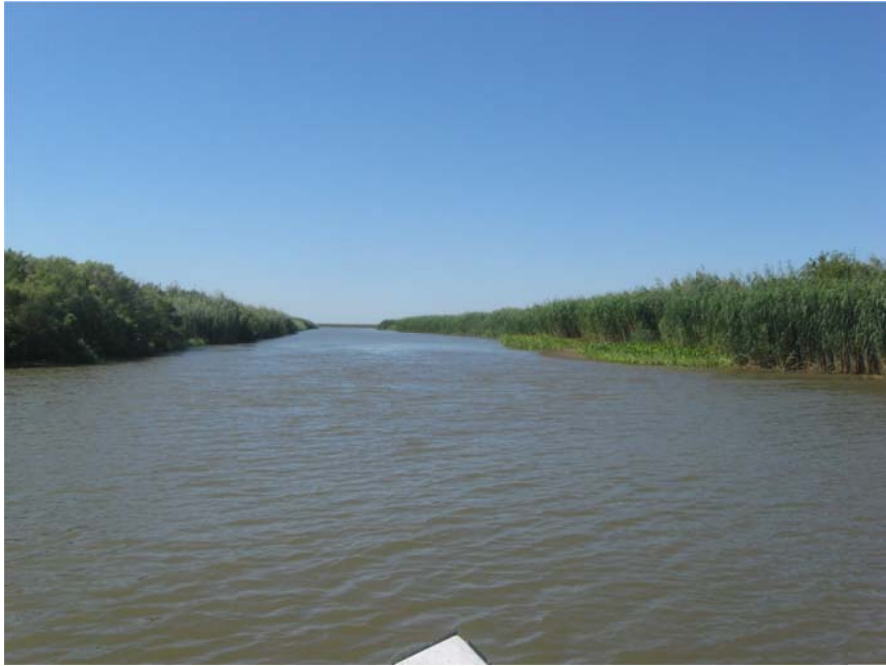
- E. Crevasse No. 12: (2,000 ft. X 75 ft. X -8.0 ft. NAVD 88) Despite being located off of the main channel, this crevasse appears to be functioning very well. There is sufficient current to carry sediments to the inner section of the bays and lagoons despite maintaining only slightly more than half its original depth. This crevasse had been originally dredged in (1999).

Crevasse No. 12 (view 1) Looking into crevasse from South East Pass.

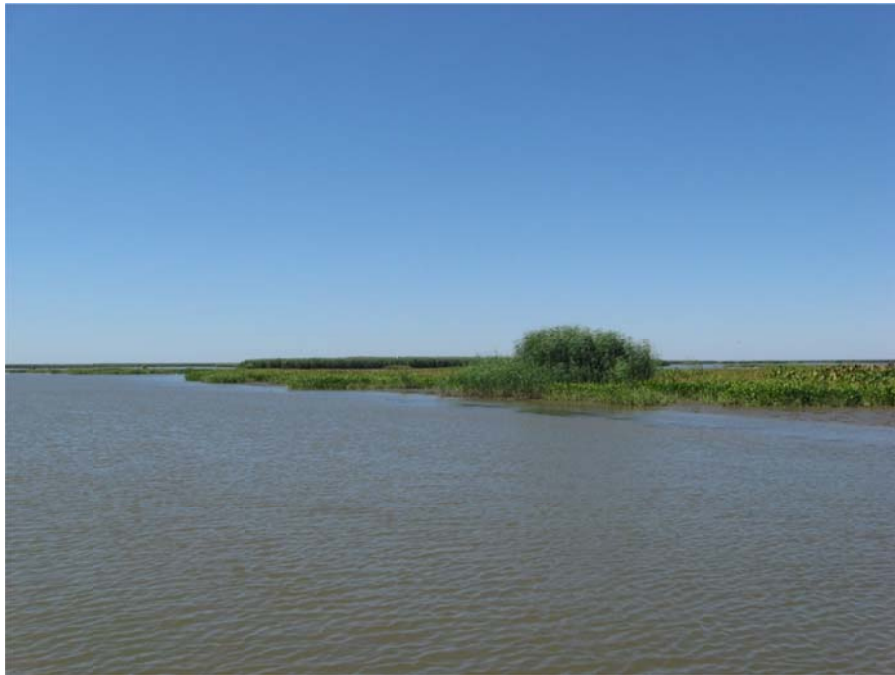
Crevasse No. 12, (view 2) Looking west. Vegetated Spoil area in center of view.

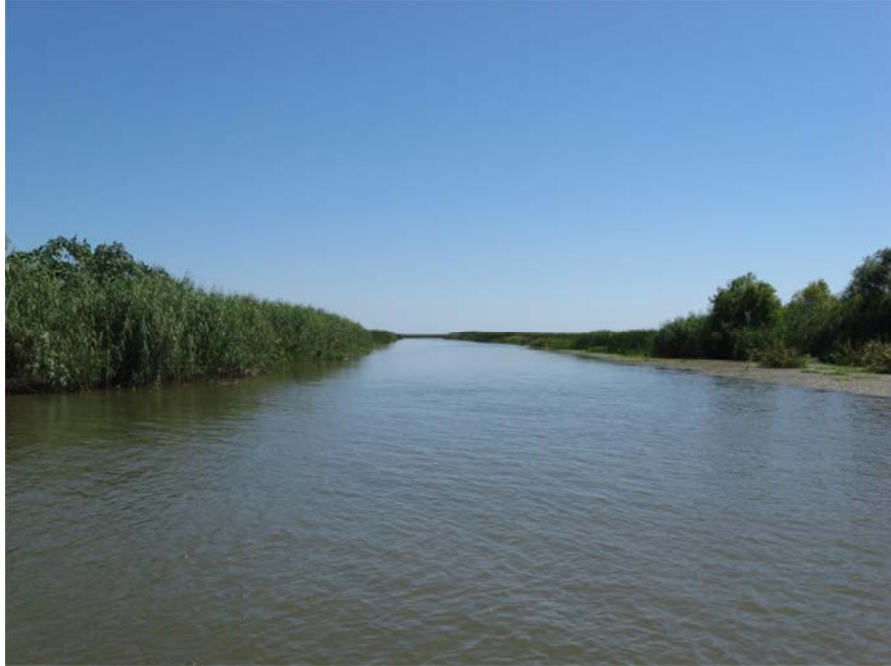
- D. Crevasse No. 11: (2,600 ft. X 100 ft. X -8.0 ft. NAVD 88) This re-dredged crevasse (1999) has maintained a good flow throughout its length. Soundings indicate that it has maintained over 80% of its original depth throughout, which is partly due to the current in this cut being more than adequate. All of the spoil deposited in the inner lagoon areas has vegetated very heavily and appears to be in excellent condition. The last three years of high water allowed much sediment to enter the interior marshes.

Crevasse No. 11, (view 1) Looking in from Pass-a-Loutre.
Crevasse has maintained its constructed width throughout.

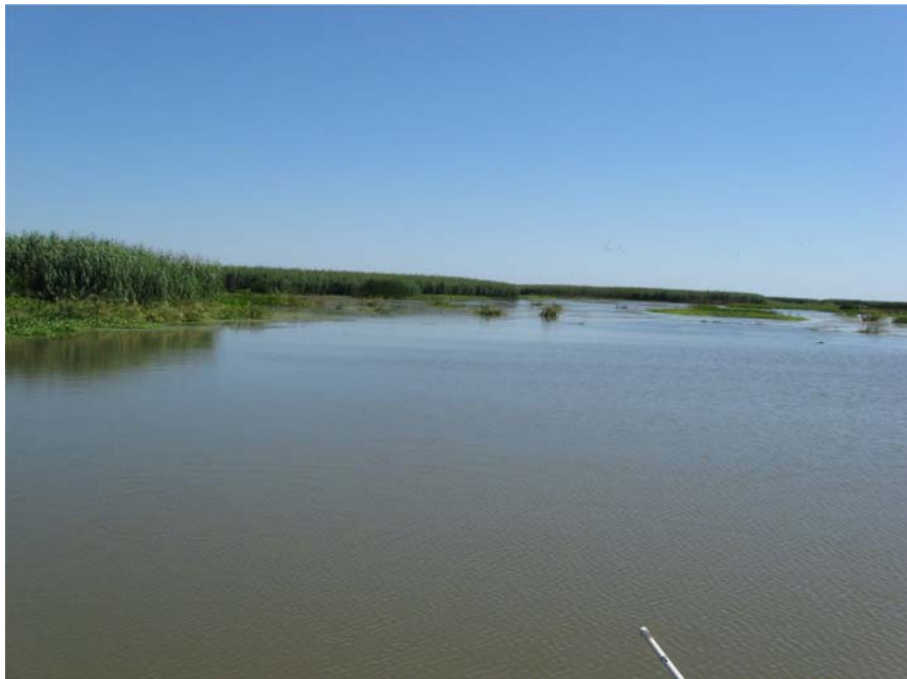
Crevasse No. 11, (view 2), Heavily vegetated crevasse
dredging spoil in bay area, foreground.

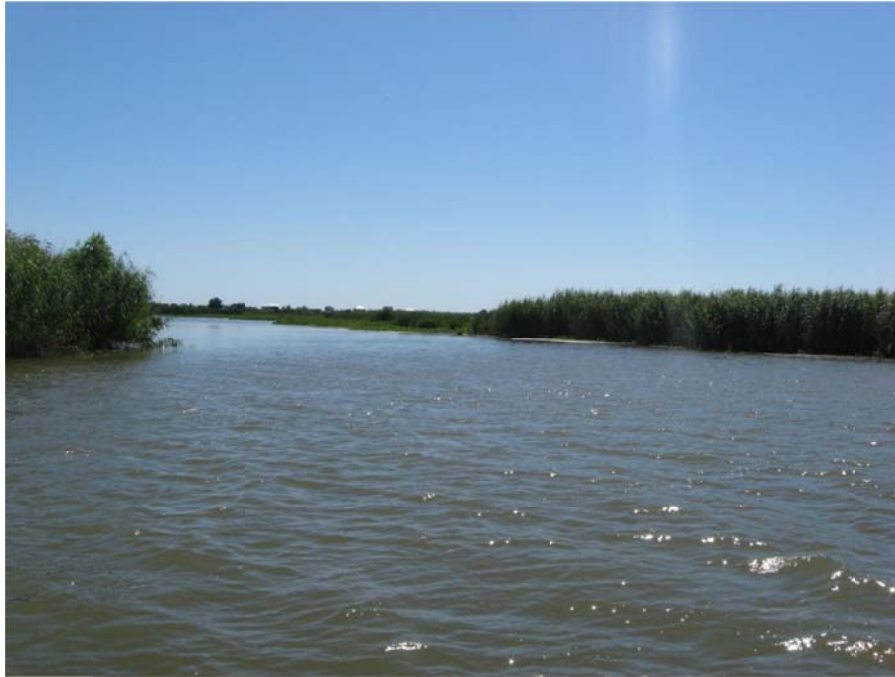
- A. Crevasse No. NC-1: (1,000 ft. X 100 ft. X -8.0 ft. NAVD 88) This 2005 new-crevasse appears to be in good condition. Soundings indicate that it has retained slightly more than half of its originally constructed depth. The interior indicates that river water is flowing very well through the channel carrying large amounts of sediment, and the spoil from the dredging of the crevasse is heavily vegetated throughout the deposited bay area.

Crevasse No. NC-1, (view 1) Looking south. Notice heavily vegetated construction easement from crevasse dredging.

Item	Condition	Physical Damage	Dimensions	Photo	Observations and Remarks
Crevasse # NC-1	Good	None	1,000 ft X 100 ft by -8.0' NAVD 88	Appendix B	This 2005 new-crevasse appears to be in good condition. soundings indicate that it has retained more than half of its original constructed depth. The interior indicates that river water is flowing very well through the channel carrying large amounts of sediment, and the spoil from the dredging of the crevasse is heavily vegetated throughout the deposited bay area.
Crevasse # NC-3	Excellent	None	1,400 ft X 100 ft by -8.0' NAVD 88	Appendix B	This 2005 new crevasse off of Main Pass is functioning very well, seems to be flowing very swiftly carrying much sediments to the interior bays. The interior is full of heavy vegetation and there is much evidence of a buildup of material from the recent high water period. this crevasse has maintained a -10' plus as an average depth throughout.

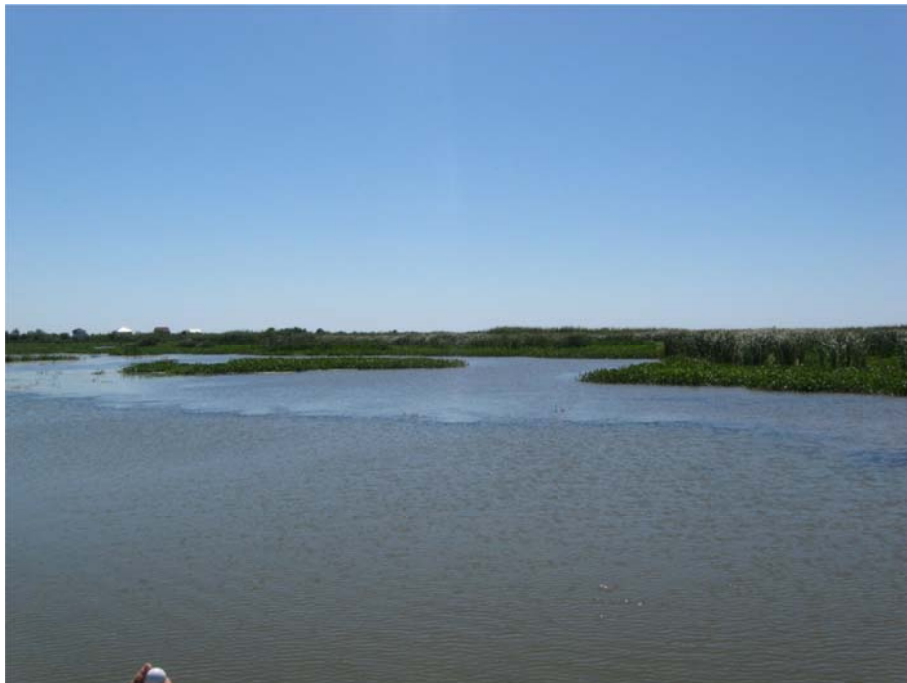
Crevasse No. NC-1, (view 2) Vegetated spoil deposition in inside bay area, and also large amounts of heavy sediments.

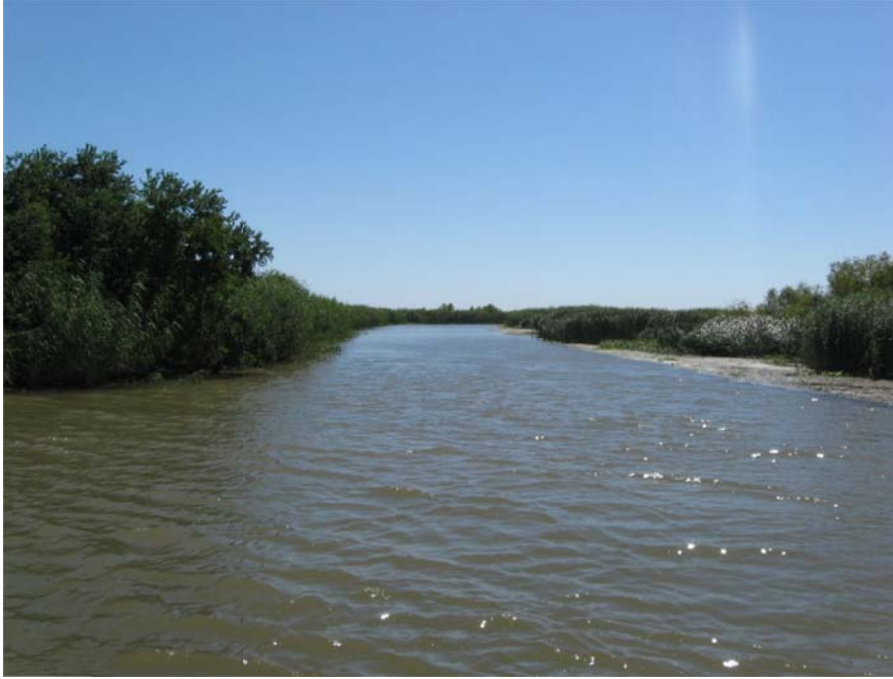
- C. Crevasse No. 9: (2,200 ft. X 75 ft. X -8.0 ft. NAVD 88) Good flow is being maintained in this dog-leg shaped previously dredged crevasse (1999). Its location allows for swift currents during the present high river stages. Soundings indicate that this crevasse has maintained 75% of its original depth throughout its length. The spoil deposition from this cut is very heavily vegetated and seems to have increased in size by the sediments flowing into the area.

Crevasse No. 9, (view 1) From Pass-a-Loutre looking south into crevasse. Original width has been maintained.

Crevasse # 9	Very Good	None	2,200 ft X 75 ft by -8.0' NAVD 88	Appendix B	Good flow is being maintained by this dog-leg shaped crevasse. It appears, from the flow velocity, that good water depth (average -7') is being maintained throughout its length carrying much needed river sediments into the bays. Dredge spoil from the crevasse has vegetated very well throughout.
Crevasse # 11	Very Good	None	2,600 ft X 100 ft by -8.0' NAVD 88	Appendix B	This re-dredged crevasse maintains a good flow throughout its length and appears to be carrying much needed river sediments into the interior marsh areas. There is no evidence of logs and stumps that were so prevalent during the dredging. Spoil has heavily vegetated throughout the interior areas and bays of this location.
Crevasse # 12	Good	None	2,000 ft X 75 ft by -8.0' NAVD 88	Appendix B	Currents are moderate to swift through this crevasse, despite it being located off of the main channel. There is evidence of sediments being carried into the marsh areas, and the spoil from the crevasse excavation has vegetated very heavily. This crevasse has maintained an overall average depth of -5' and is functioning very well.

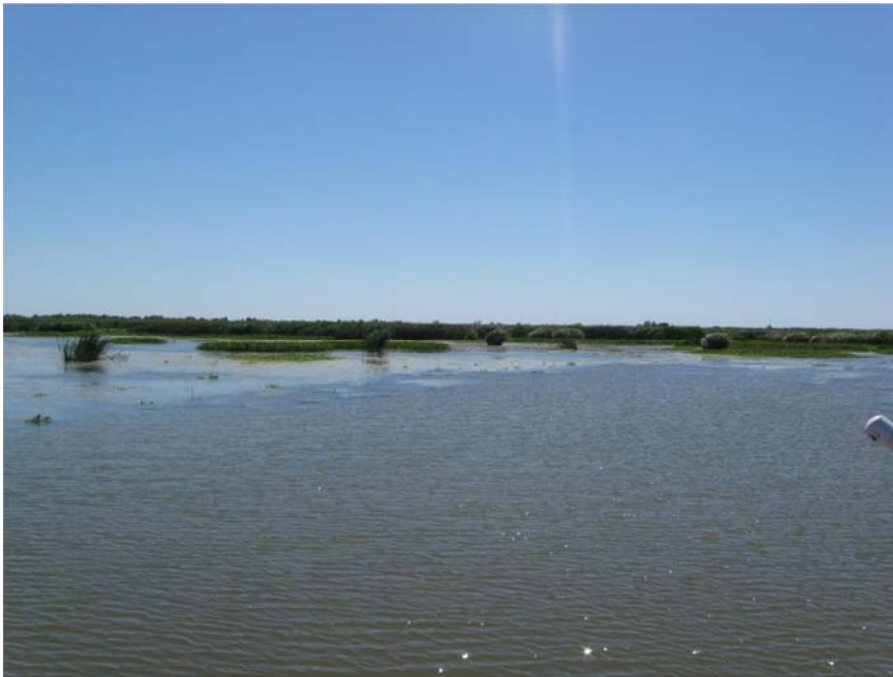
Crevasse No. 9, (view 2) Crevasse end looking at spoil area vegetation and huge amounts of sediments from the pass.

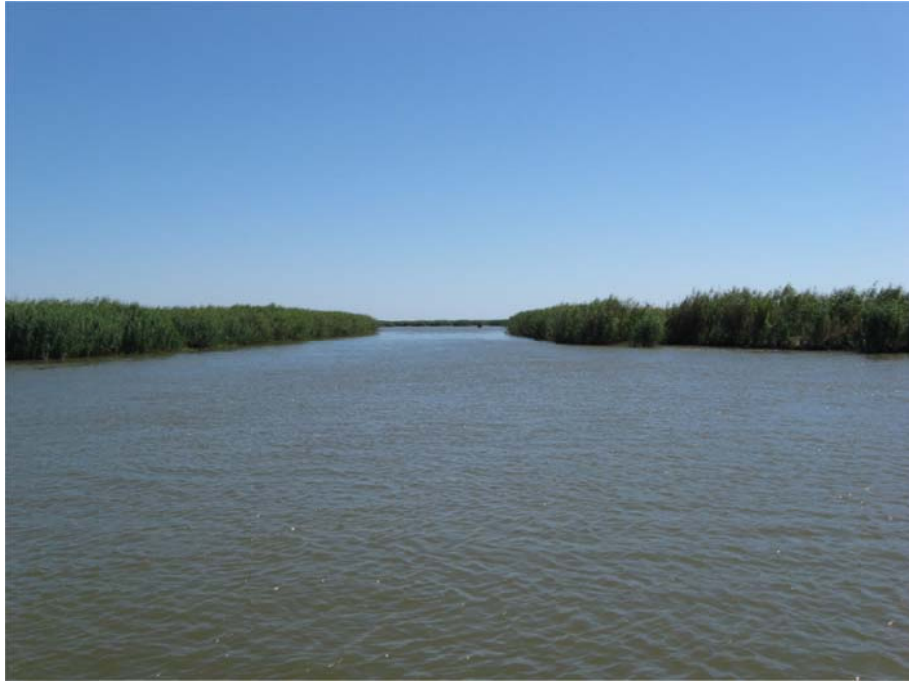
- B. Crevasse No. NC-3: (1,400 ft. X 100 ft. X -8.0 ft. NAVD 88) This is the second of the two new 2005 crevasses and the only one on Main Pass. It is functioning very well, and flowing with a very swift current bringing much needed sediments into the interior bays. Our soundings show that the crevasse is maintaining its original depth throughout its channel length and the spoil from the crevasse dredging has completely vegetated. New spoil deposits from this high water season can also be seen in the inner bay.

Crevasse No. NC-3, (view 1) Looking into crevasse from South Pass showing heavy vegetation on both banks.

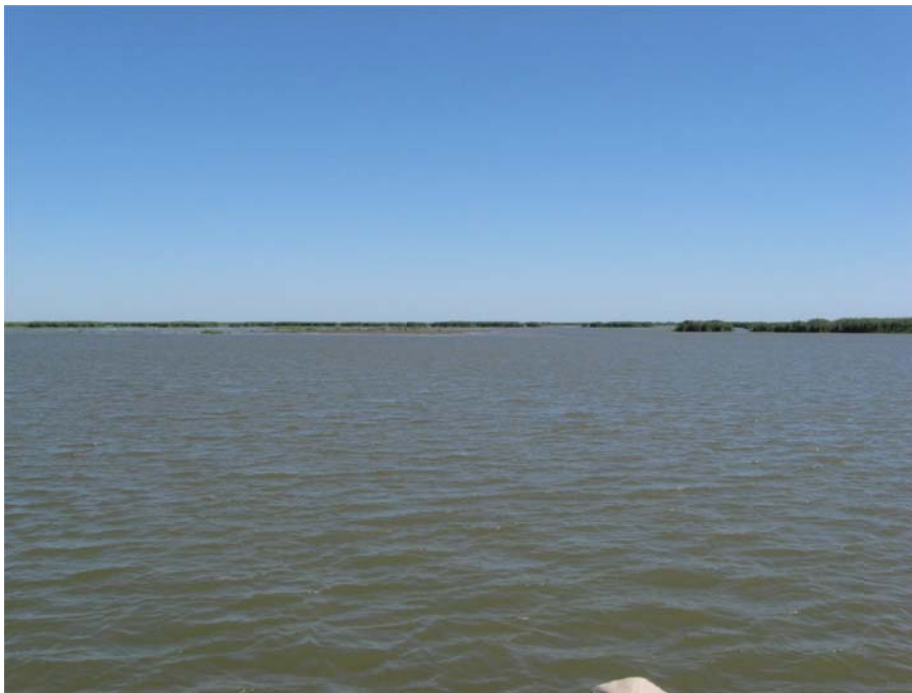
Crevasse No. NC-3, (view 2) Inside crevasse looking east into open bays. Notice heavy material buildup in center of view. This crevasse has maintained all of its original dimensions.

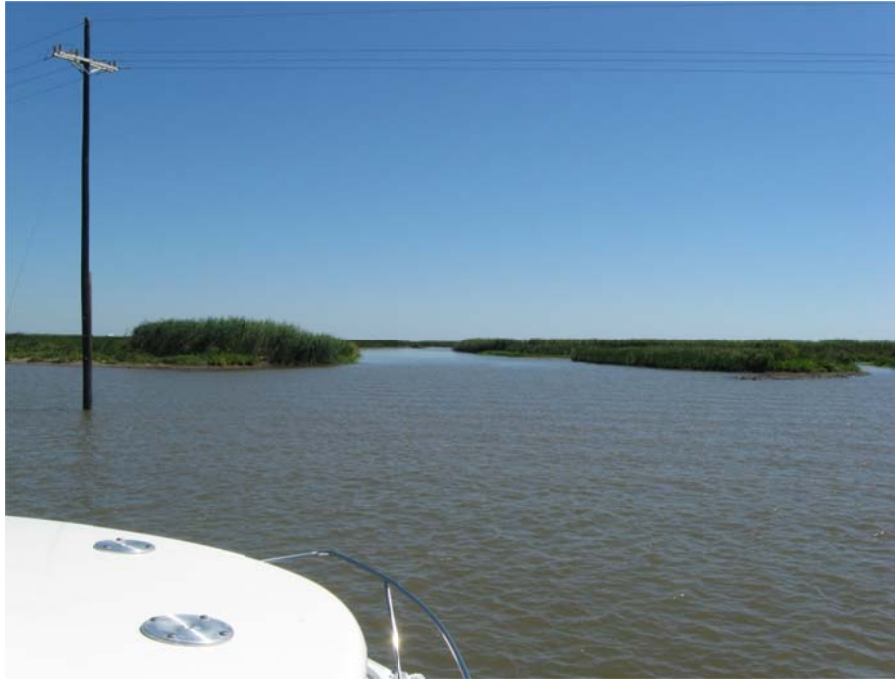
- F. Crevasse No. 81: (1,200 ft. X 100 ft. X -8.0 ft. NAVD 88) This crevasse is located off of Baptiste Colette in the Delta Wildlife Management Area. The current in the crevasse is strong, since it is located in close proximity to the Mississippi River. Despite soundings indicating that the mouth of this crevasse has silted up from the large amounts of sediments moving into the cut by the river currents, there is still some sediments being carried into the interior marsh area.

Crevasse No. 81, (view 1) Looking south from Baptiste Collette channel. Material build-up at channel edge prevented the inspection team from entering the channel.

Crevasse # 81	Poor	None	1,200 ft X 100 ft by -8.0' NAVD 88	Appendix B	This crevasse is located on the south bank of Baptiste Collette just off of the Miss. River. Due to its location, it is receiving strong current and heavy sediment loads. The spoil from the crevasse excavation has vegetated very nicely; however, it's location causes it to shoal up at the mouth during the first high river and renders it inefficient for the long term.

As a result of the inspection, the team concluded that all project features are functioning and should continue to do so without any immediate maintenance; however, abnormal high river stages, during the past three seasons, caused more than normal shoaling in the Southwest Pass channel. This was brought on by more Mississippi River dredging by the Corps of Engineers and the deposition of that material in the flowage in Pass-a-Loutre. This additional shoal material, combined with the high river flows, added to the sediments introduced into the pass and then into the crevasses areas. Those amounts of sediments were noticeable during the inspection and are contributing highly to the success of this project. These high sediment loads also contributed to the amount of shoaling that occurred in the Crevasses. We could most likely forego cleaning/dredging out any of the crevasses in the coming year and instead plan to conduct maintenance dredging in 2012 perhaps along with some new sites in the PALWMA. OCPD and NMFS have identified two existing locations, NC-1 & 12, and one new location south of NC-1 identified by LDWF as the Ducks Unlimited Canal, where maintenance dredging could be done soon. We will soon meet with LDWF to determine more additional sites that would be agreeable to all parties. It would be more feasible to have 5 or 6 sites that can be dredged (i.e. more benefits for the cost) rather than mobilizing equipment for fewer sites. Therefore; it is recommended that no immediate action be taken for maintenance at this time, but instead initiate plans to investigate/survey some additional areas to be done in 2012. It is also recommended that we not return to Baptiste Collette to either maintain or dredge new crevasses at this time since the additional sites can be found in the Pass-a-Loutre area. There is such an abundance of currents and sediments funneled through this distributary, that these crevasses tend to shoal up very quickly within the first high water period after dredging rendering them inefficient for the long term (5-years plus) such as those in the Pass-a Loutre area.

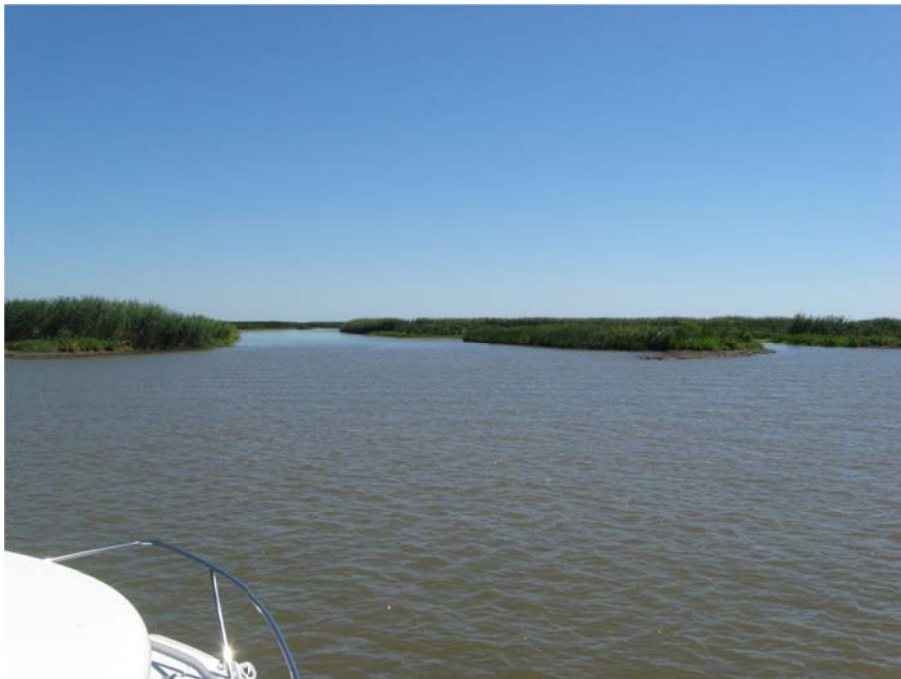
Crevasse No. 81, (view 2) Crevasse showing heavy amount of vegetated spoil area and newly deposited sediments.
