**2008 Operations, Maintenance,
and Monitoring Report**

Sabine Structure Replacement

State Project Number CS-23
Priority Project List 3

July 2008
Cameron Parish

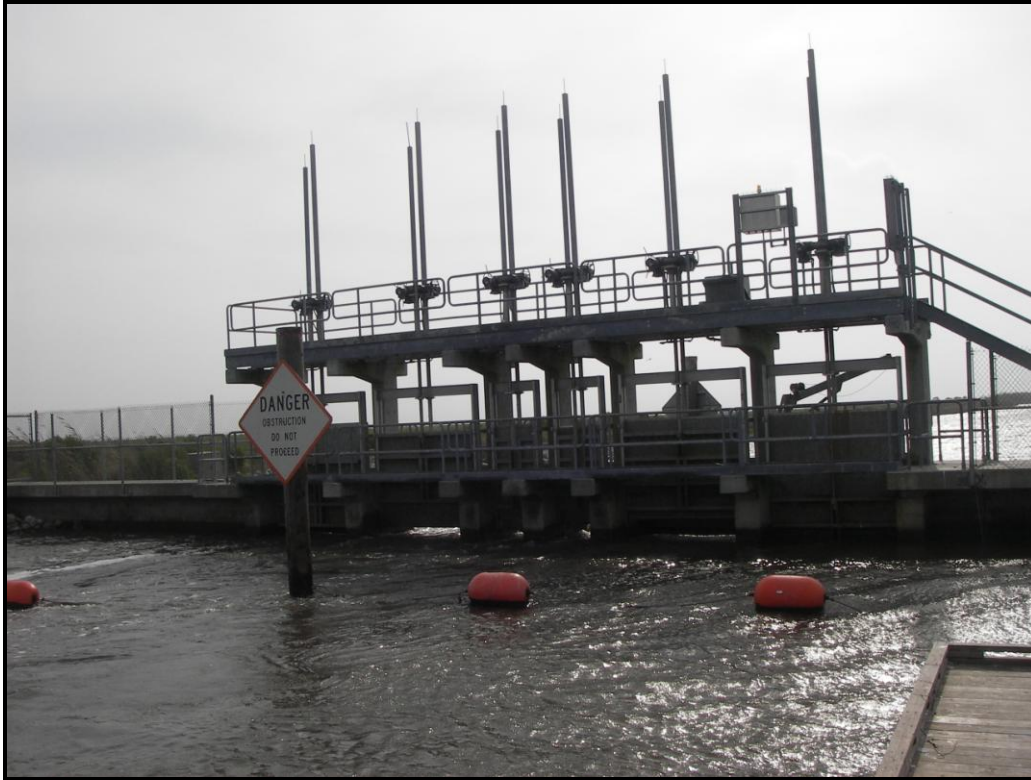
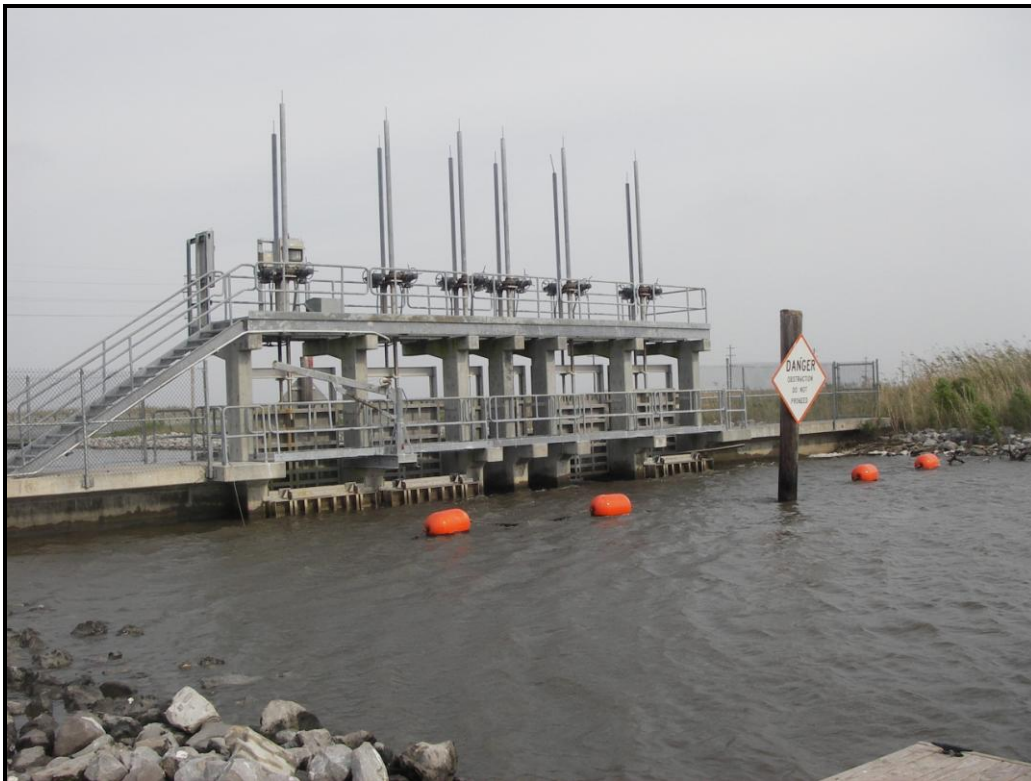
This structure is still not operable due to damage from Hurricane Rita in 2005. The security chain link fence has been replaced as described in the maintenance section above. The trash and debris on and around the structure has been cleaned up by others. The structure will require maintenance work to repair the gates with dual stem operation, repair the actuators, add reinforcement to flanges, update electrical system, install bird excluder devices, and install lighting (Photos: Appendix B, Photos 1-2)

Photo No.1, Inside view of Hog Island Gully Structure.

Photo No. 2, Lake side view of Hog Island Gully Structure.

Item	Condition	Physical Damage	Corrosion	Photo #	Observations and Remarks
Steel Bulkhead / Caps	N/A				
Steel Grating	Good				
Gates	Fair	Yes		1 & 2	Alignment problems.
Electrical	Poor	Yes			All electrical components demolished.
Hardware					
Fencing	Good				Chain link fence and posts replaced in June 2006.
Timber Piles	Good				
Timber Wales	N/A				
Actuators	Fair				All actuators will have to be taken apart and serviced.
Cables	Good				
Signage / Supports	Good				
Rip Rap					
Rock Dike	Good				
W.W. Reinf.					
Earthen Embankment	N/A

The Hog Island Gully and West Cove structures will require maintenance work to repair the gates with dual stem operation, repair the actuators, add reinforcement to flanges, update electrical system, install bird excluder devices, and install lighting. The Headquarters' Canal structure will require maintenance work to replace the electrical controls and repair the actuator on one of the gates.

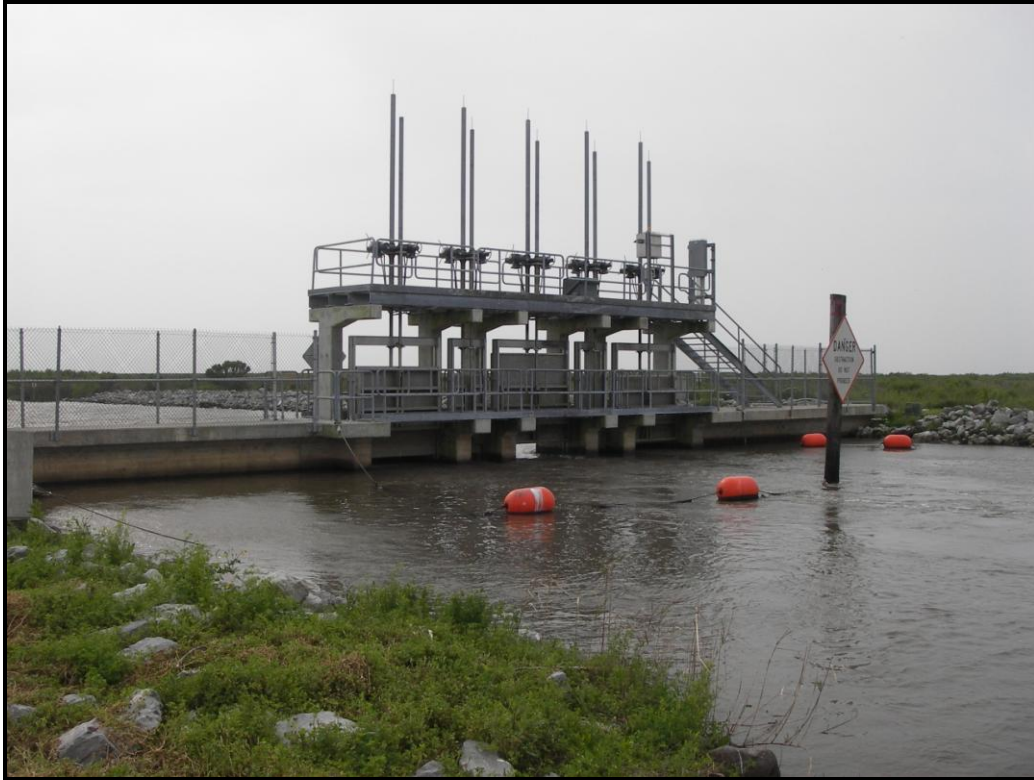
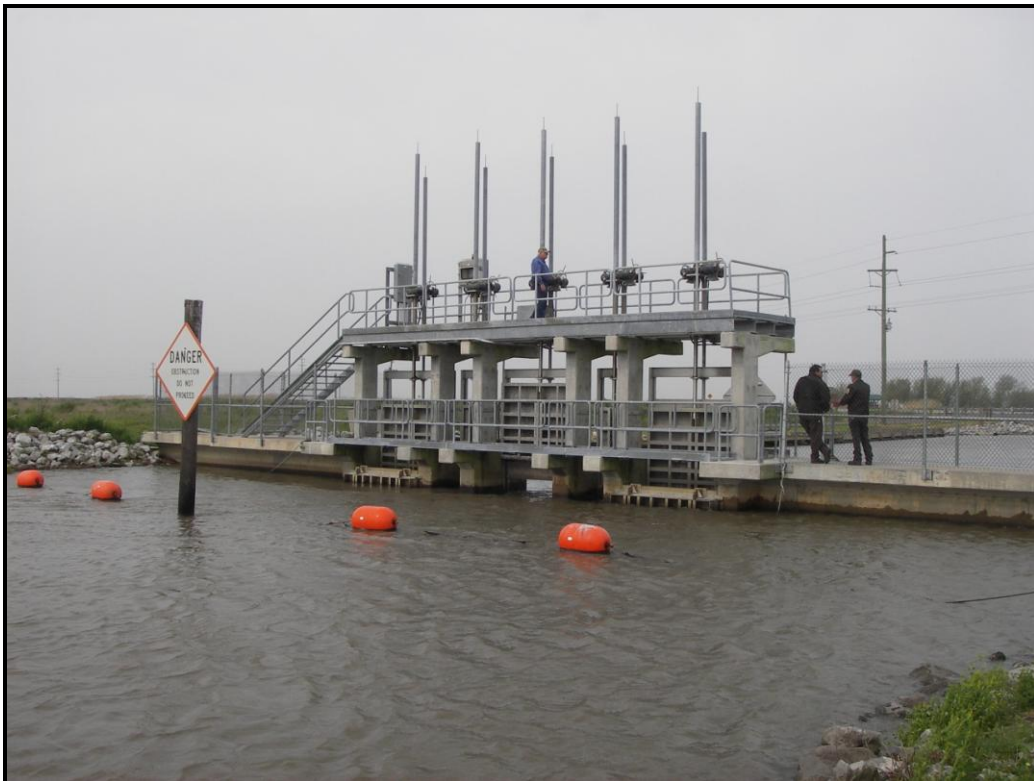
This structure is still not operable due to damage from Hurricane Rita in 2005. The security chain link fence has been replaced as described in the maintenance section above. The trash and debris on and around the structure has been cleaned up by others. The structure will require maintenance work to repair the gates with dual stem operation, repair the actuators, add reinforcement to flanges, update electrical system, install bird excluder devices, and install lighting (Photos: Appendix B, Photos 3-4).

Photo No. 3, Inside view of West Cove Structure.

Photo No. 4, Lake side view of West Cove Structure.

Item	Condition	Physical Damage	Corrosion	Photo #	Observations and Remarks
Steel Bulkhead / Caps	N/A				
Steel Grating	Good				
Gates	Fair	Yes		3 & 4	Alignment problems.
Electrical	Poor	Yes			All electrical components demolished.
Hardware/Stairs	Good				
Fencing	Good				Chain link fence and posts replaced in June 2006.
Timber Piles	Good				
Timber Wales	N/A				
Actuators	Fair				All actuators will have to be taken apart and serviced.
Cables	Good				
Signage / Supports	Good				
Rip Rap					
Rock Dike	Good				
W.W. Reinf.					
Earthen Embankment	N/A

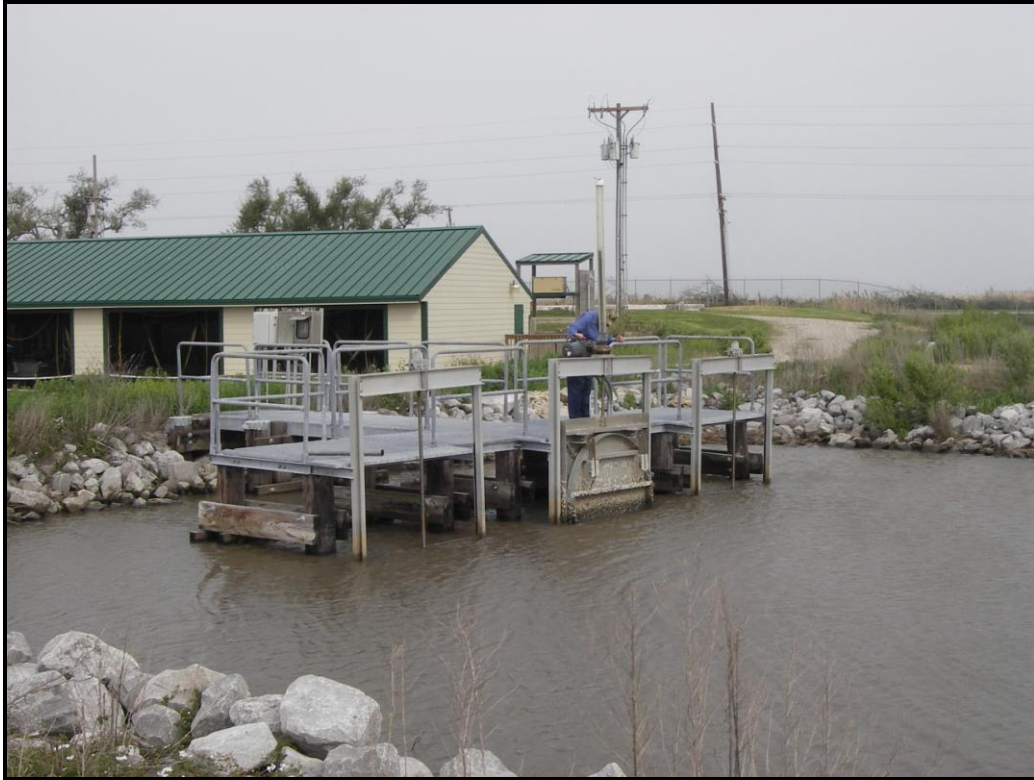
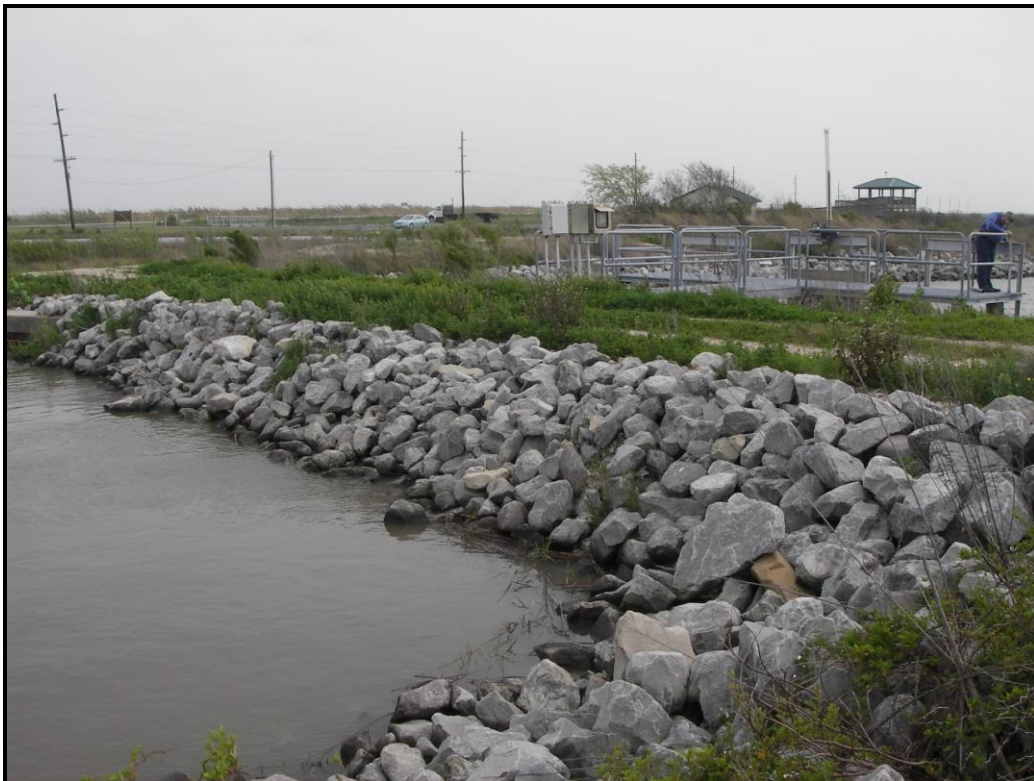
This structure is still not operable due to damage from Hurricane Rita in 2005. The trash on and around the structure has been cleaned up by others. The structure will require maintenance work to replace the electrical controls and repair the actuator on one of the gates (Photos: Appendix B, Photos 5-6).

Photo No. 5, Inlet side of Headquarters Structure.

Photo No. 6, Outlet side of Headquarters Structure.

Item	Condition	Physical Damage	Corrosion	Photo #	Observations and Remarks
Steel Bulkhead / Caps	N/A				
Steel Grating	Good				
Gates	Fair	Probable		5 & 6	Possible alignment problems with gates and/or stems.
Electrical	Poor	Yes			All electrical components demolished.
Hardware	Good				
Timber Piles	Good				
Timber Wales	Good				
Actuators	Fair	Yes			The actuator will have to be taken apart and serviced.
Cables	N/A				
Signage / Supports	N/A				
Rip Rap					
Rock Dike	Good				
W.W. Reinf.					
Earthen Embankment	N/A
