**2010/2011 Annual Inspection
Report**

**SOUTH WHITE LAKE
SHORELINE PROTECTION
PROJECT
(ME-22)**

State Project Number ME-22
Priority Project List 12

March 24, 2011
Vermilion Parish

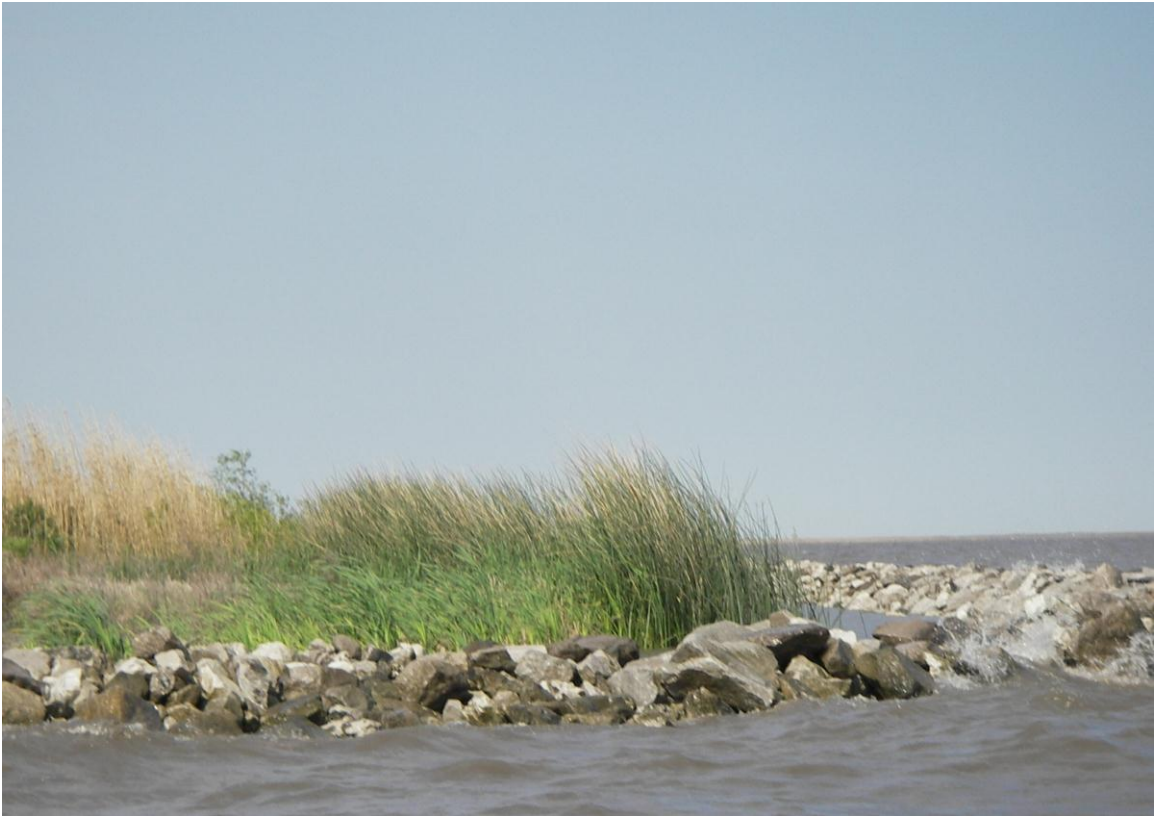
The rock dike is in excellent post construction condition. The same few low areas that were noticed during previous inspections along Bear Lake where there was some initial settling during construction has stabilized and the dike is still functional in these areas. They will continue to be monitored during future inspections. Signage along the entire project is also in good condition. A few signs are leaning and one is completely missing. The spoil bank material placed behind the rock dike generated from the flotation excavation is nearly covered in natural vegetation. (Photos: Appendix B, Photo 1)

Photo No. 1, typical section of rock dike

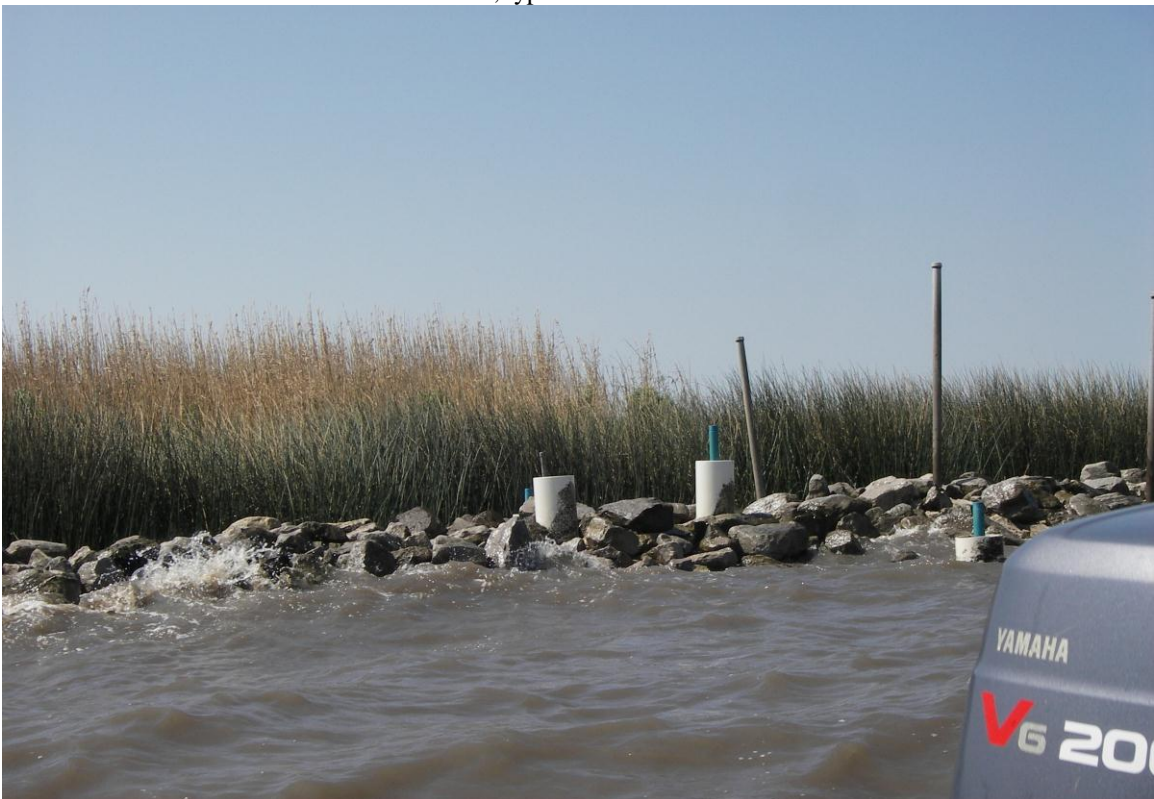
The six different demonstration areas are in good condition and do not appear to look any different than the rest of the project as far as crown width, dike elevation and side slopes. However, there are two areas where some of the rock has been displaced by Hurricane Ike. The various instrumentation devices at each demonstration section are intact. (Photos: Appendix B, Photo 2)

Photo No. 2, test section
