**2010/2011 Annual Inspection
Report**

**BOSTON CANAL/VERMILION
BAY SHORE RESTORATION
PROJECT
(TV-09)**

State Project Number TV-09
Priority Project List 2

April 12, 2011
Vermilion Parish

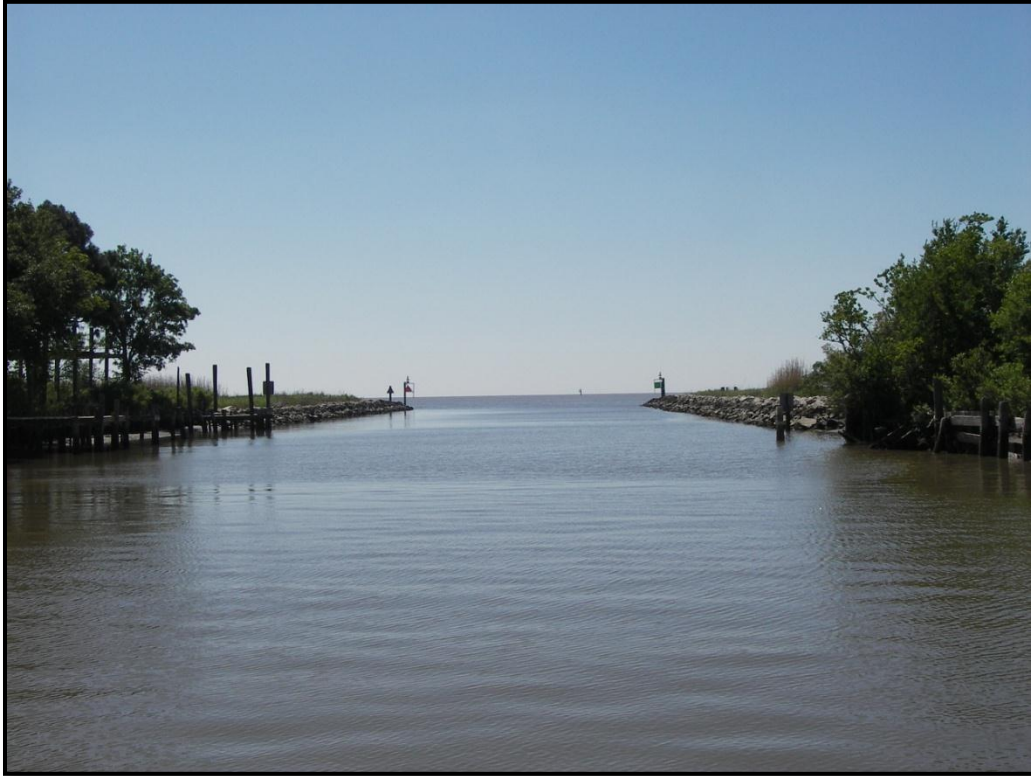
For the most part, the rock dikes are in excellent post construction condition. The water was extremely low at the time of the inspection and there is no apparent toe scour or rock displacement. The shoreline at the western end of the western dike where it ties into the

Vermilion Bay shoreline has not significantly worsened. A small gap left during original construction appears to have caused this problem. While the situation is similar on the southeast tie-in, it is not as severe. No gap was left on this end during construction. Recommendations made to repair these gaps during the O & M inspection of June 2003 have been reconsidered due to costs and logistics associated with such repairs. These areas have been and will continue to be closely monitored, and should the situation significantly worsen, steps will be taken to close/stabilize these areas. Signage and associated pilings are stable and functioning. (Photos: Appendix B, Photos 1 - 3)

Photo No. 1, View of Boston Canal at the bay shore looking South

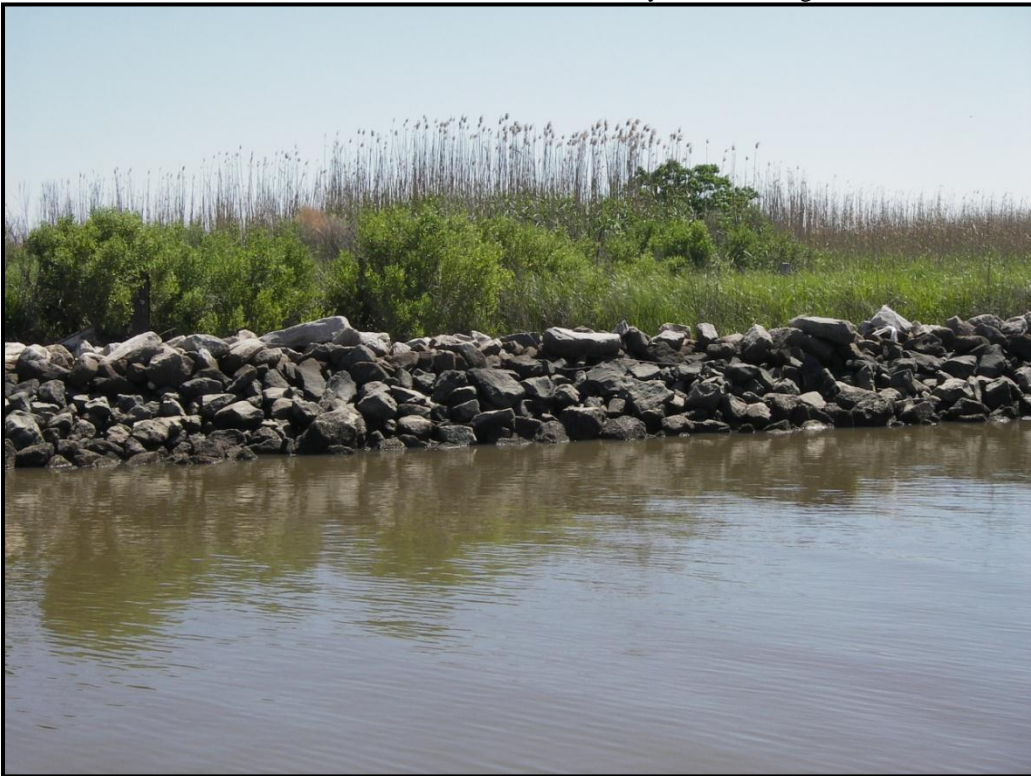
Photo No. 2, Close up view of the rock dike and vegetation behind the dike

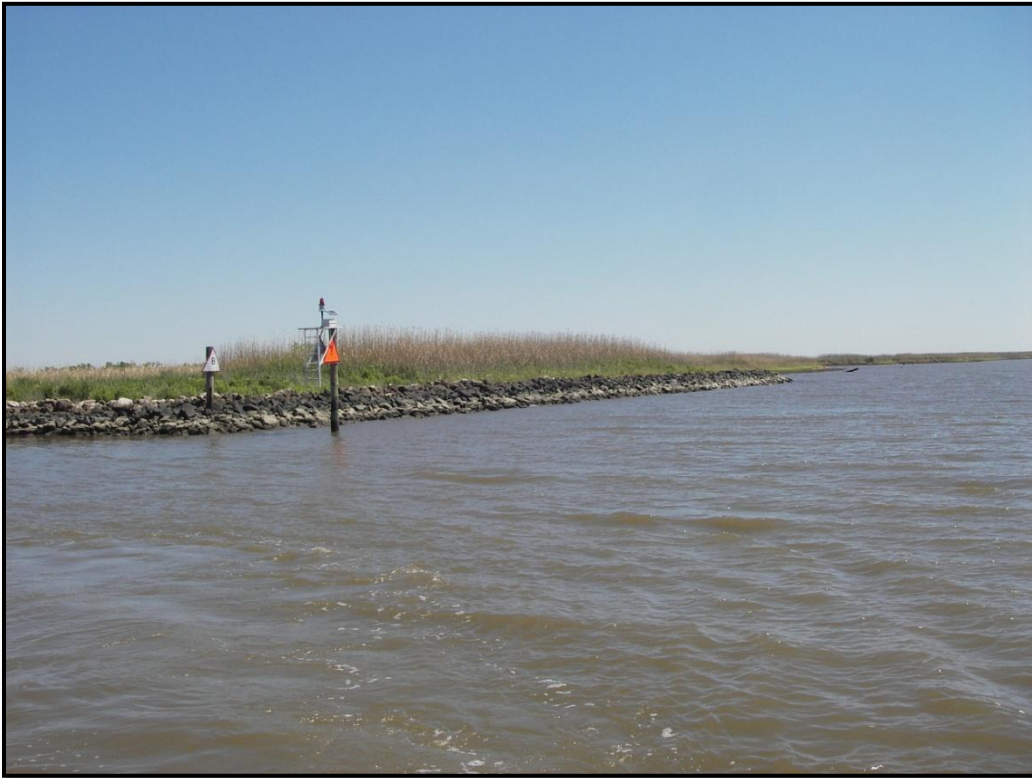
Photo No. 3, View of eastern rock dike

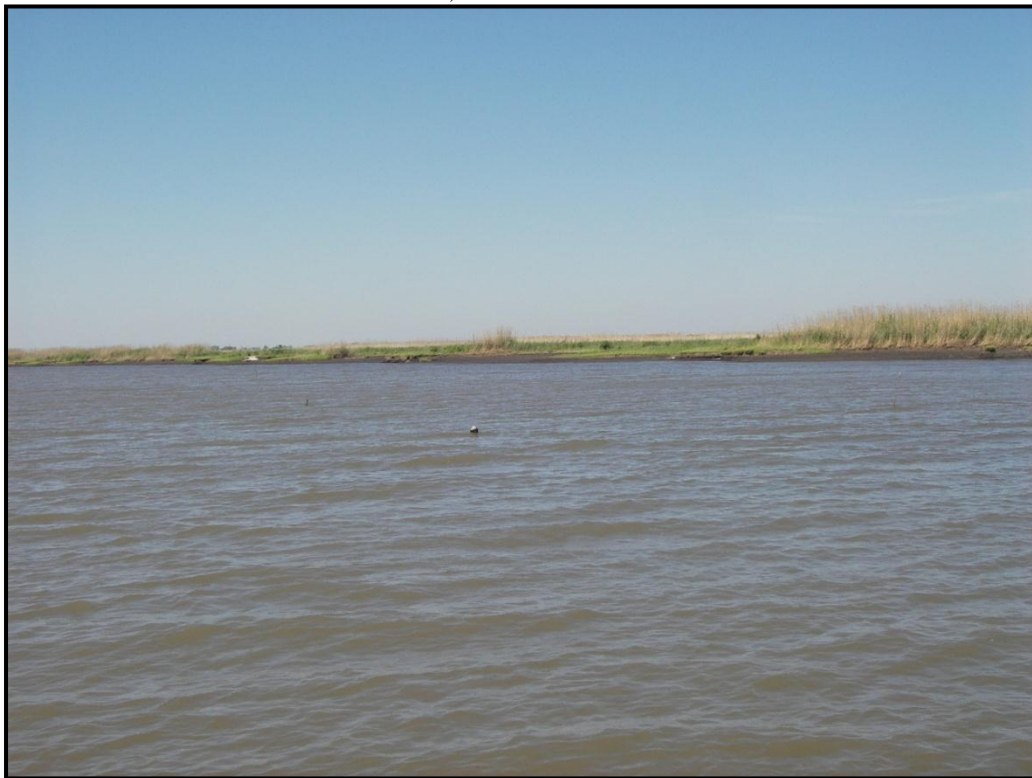
The shoreline plantings were not directly inspected on this trip due to time and wave constraints. All vegetation in the area adjacent to the mouth of the Boston Canal, including the vegetation behind the rock dikes, is in good condition. (Photos: Appendix B, Photo 4)

Photo No. 4, Typical view of vegetative plantings along the bay shore
