**2010/2011 Annual Inspection
Report**

**LITTLE VERMILION BAY
SEDIMENT TRAPPING
PROJECT (TV-12)**

State Project Number TV-12
Priority Project List 5

February 22, 2011
Vermilion Parish

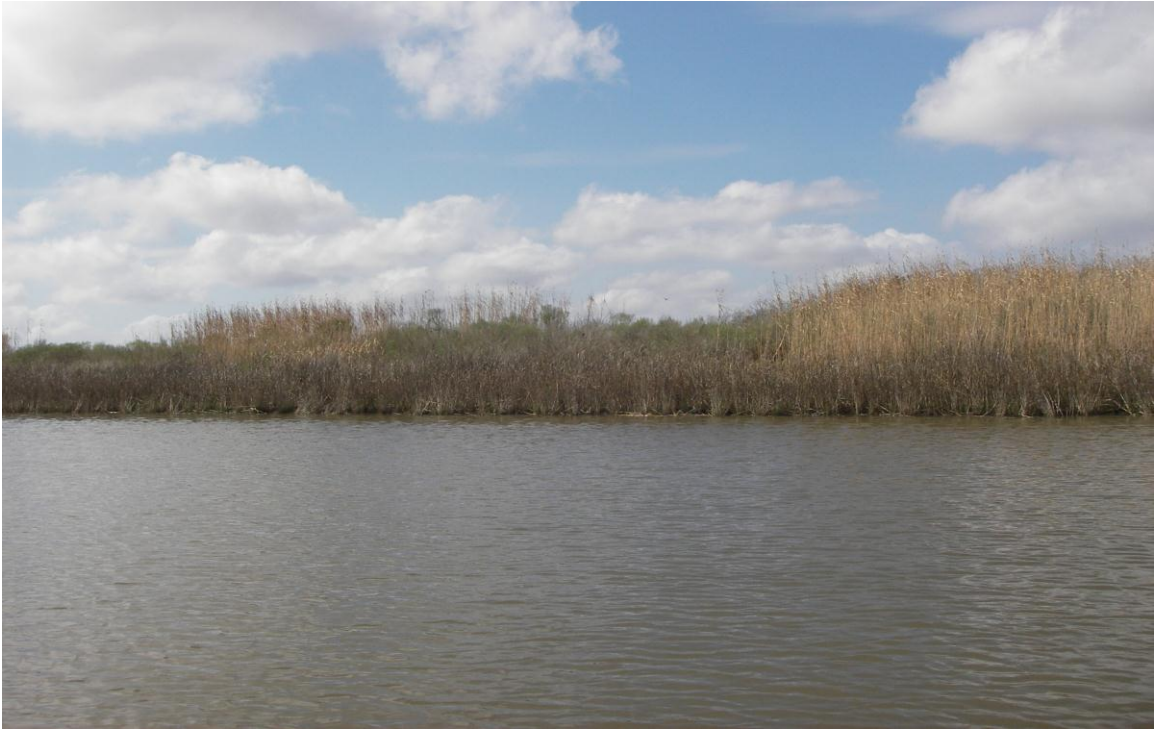
Photo No. 1—typical terrace

Item	Condition	Physical Damage	Corrosion	Photo #	Observations and Remarks
Steel Bulkhead / Caps	N/A				
Steel Grating	N/A				
Stop Logs	N/A				
Hardware	N/A				
Timber Piles	N/A				
Timber Wales	N/A				
Galv. Pile Caps	N/A				
Vegetation	Good				
Signage /Supports	N/A				
Rip Rap (fill)	N/A				
Earthen Embankment (terraces)	Excellent			1,2	Terraces are in good condition, although some erosion is occurring.

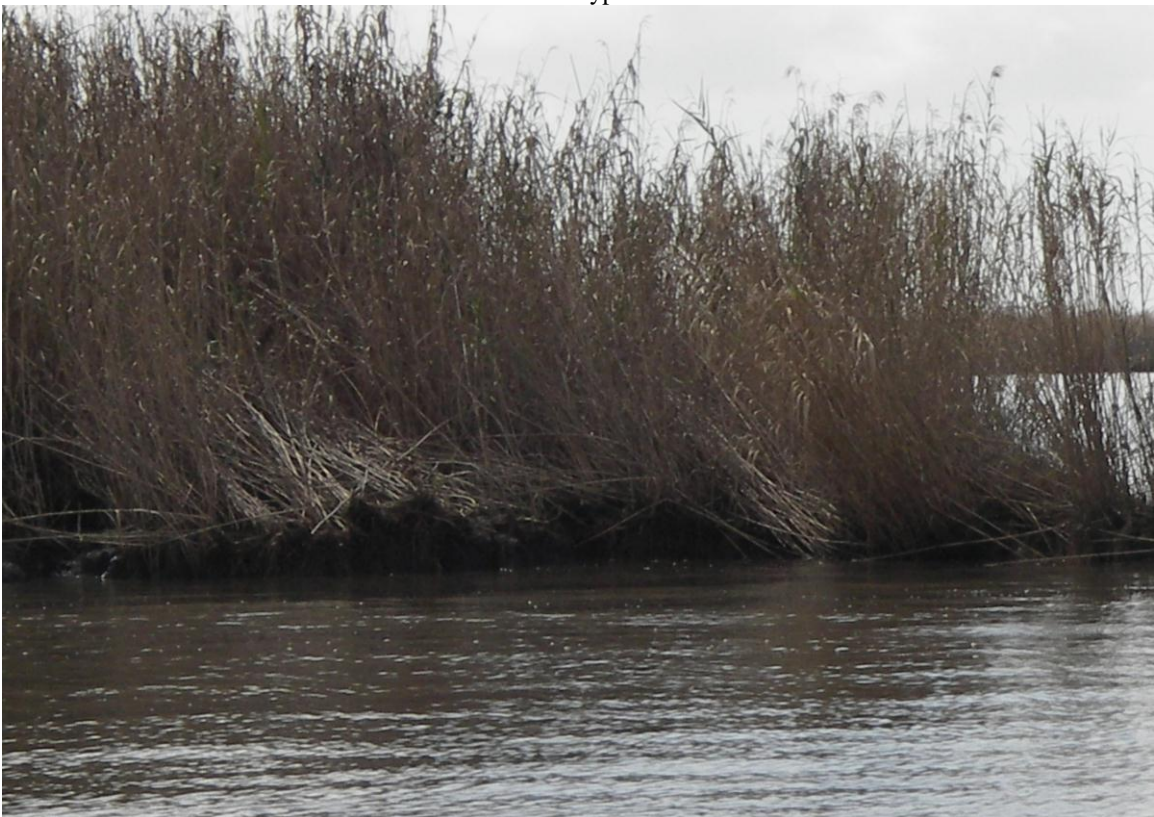
The terraces are in very good condition with the exception of the terraces nearest Freshwater Bayou Canal (FWB) and the southern most sacrificial terrace. Only three terraces remain on this southern row. Debris as well as sediment is in the borrow canal making travel along here very difficult. The terraces nearest FWB continue to erode as the bankline along Freshwater Bayou continues to worsen. It was decided after this inspection to request funding to place

Photo No. 2—cut bank on terrace near Freshwater Bayou Canal

rock in the opening of the bay at it's intersection with FWB. This opening will need to be narrowed to a width of 100 feet to allow access for oilfield traffic. The bank on both sides of this opening will also need to be hardened with rock. The expense of this recommended action will exceed the currently approved project funds. Surveys will be performed during the fall of 2011 in order to prepare a more detailed estimation of the costs associated with this action. (Photos: Appendix B, Photos 1-2)
