**Coastal Protection and Restoration  
Authority of Louisiana**

**2010/2011 Annual Inspection  
Report**

**LAKE PORTAGE LAND  
BRIDGE PROJECT  
(TV-17)**

State Project Number TV-17  
Priority Project List 8

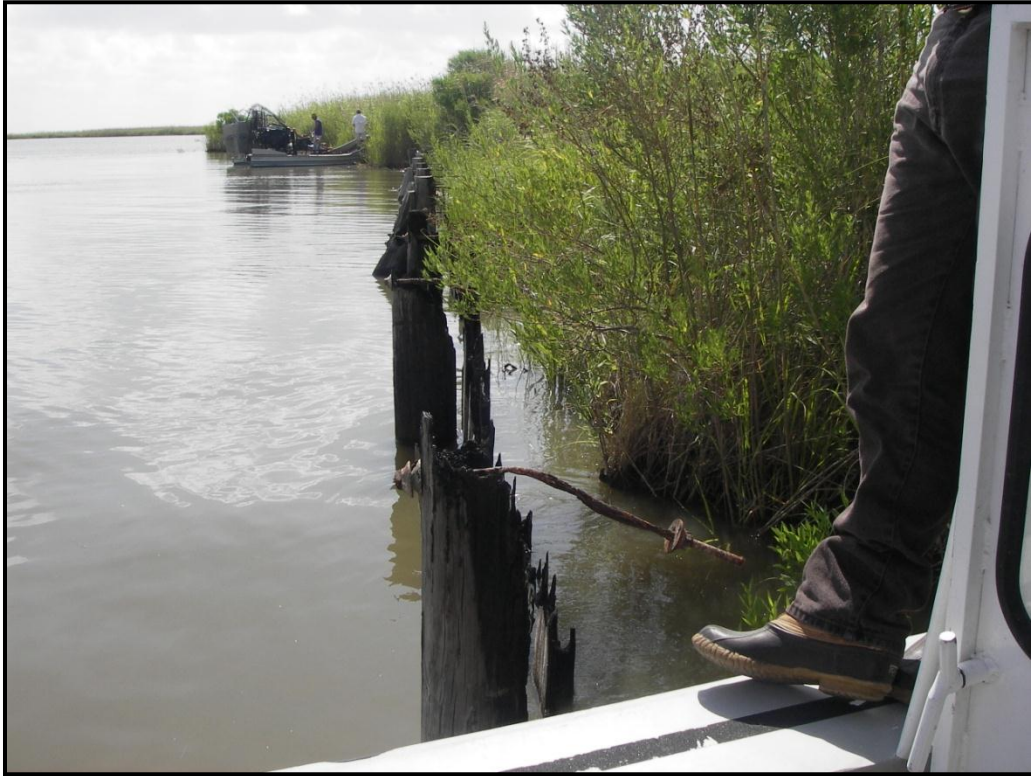
Area 1 is in good condition and vegetation has continued to expand from the containment banks moving towards the center of the channel and is 100 per cent vegetated. As a result of the inspection of Area 1, OCPR and NRCS agree that no corrective actions will be required this year. An aerial photo taken by Edmond Mouton of LDWF shows the pipeline canal has established a healthy vegetative stand. (Photos: Appendix B, Photo 1, 2, 8).

Photo 1, Area 1, Timber bulkhead.

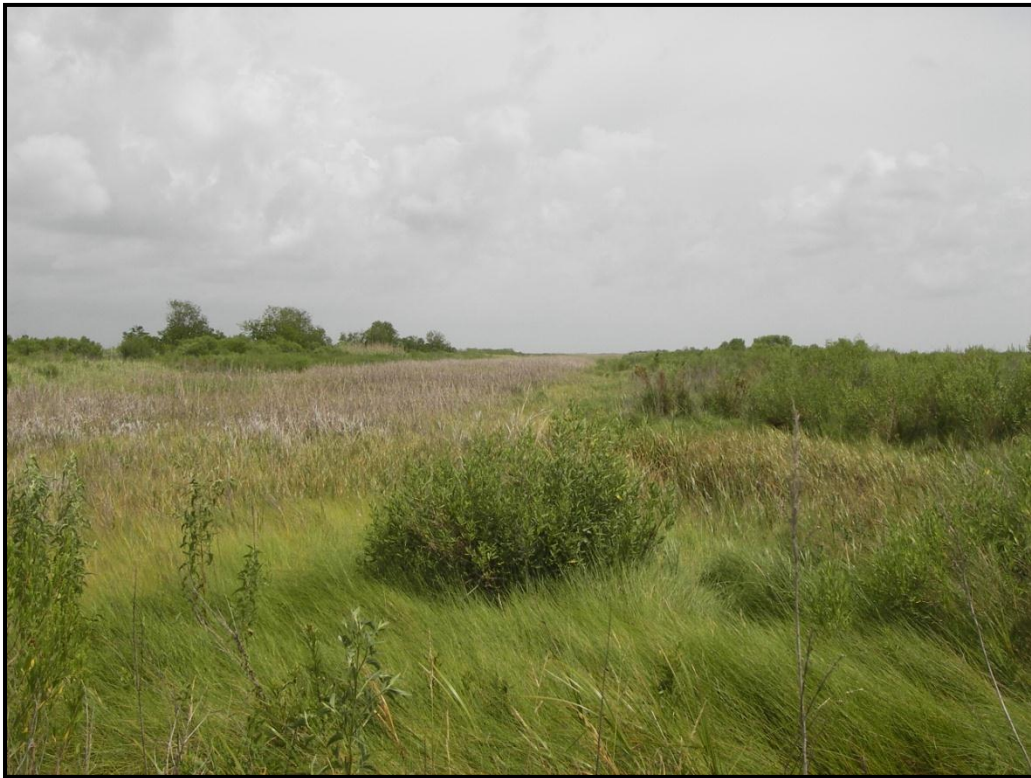
Photo 2, Area 1, View of vegetative cover looking North from earthen plug.

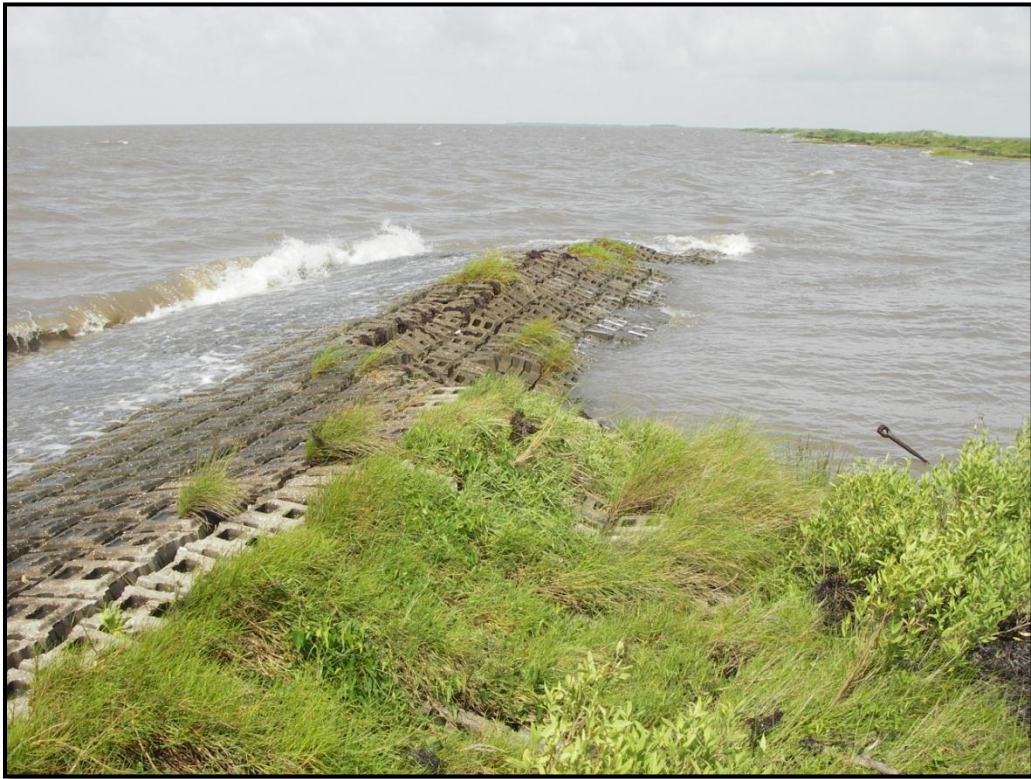
Area 2 is also in good condition and is fully vegetated, such that this reach was preexisting with additional dredge material added through this project to fill in any trevasses. Some erosion at the ends of the concrete mats along the Gulf shoreline has occurred over time and part of the mat system is showing signs of failure. Although the concrete mat system is not a feature to be maintained as part of this project, this area is experiencing erosion that may threaten the integrity of the overall project. Therefore, OCPR and NRCS agree that maintenance may be required at sometime in the future. (Photos: Appendix B, Photos 3, 4, 5, 6, 8).

Photo 3, Area 2, West side of concrete mats.

Item	Condition	Physical Damage	Corrosion	Photo #	Observations and Remarks
Timber Bulkhead / Caps	Good				
Steel Grating	N/A				
Salinity Readings					
Concrete Mats	Good			3, 4, 5	Some erosion each side of concrete mats along Gulf shoreline.
Timber Piles	Good				
Timber Wales	N/A				
Galv. Pile Caps	N/A				
Vegetation	Good			2, 6	Area 3 fully vegetated, Area 2 existing vegetation, Area 1 fully vegetated.
Signage / Supports	Good				
Rip Rap (fill)	N/A				
Earthen Embankment	Good				
Dredge Spoil	Good				Slight settlement.
What are the conditions of the existing levees?				Good	
Are there any noticeable breaches?				No	
Settlement of rock plugs and rock weirs?				N/A	
Position of stoplogs at the time of the inspection?				N/A	
Are there any signs of vandalism?				No

Overall, the Lake Portage Land Bridge Project is in good condition and functioning as designed. However, the erosion problem occurring at the Gulf shoreline will need to be addressed. Preliminary survey work to develop an accurate estimate of costs was performed in 2008 and a subsequent request made to CWPPRA for additional funds. The Task Force decided that monitoring of the shoreline should continue and opted not to take any action at this time.

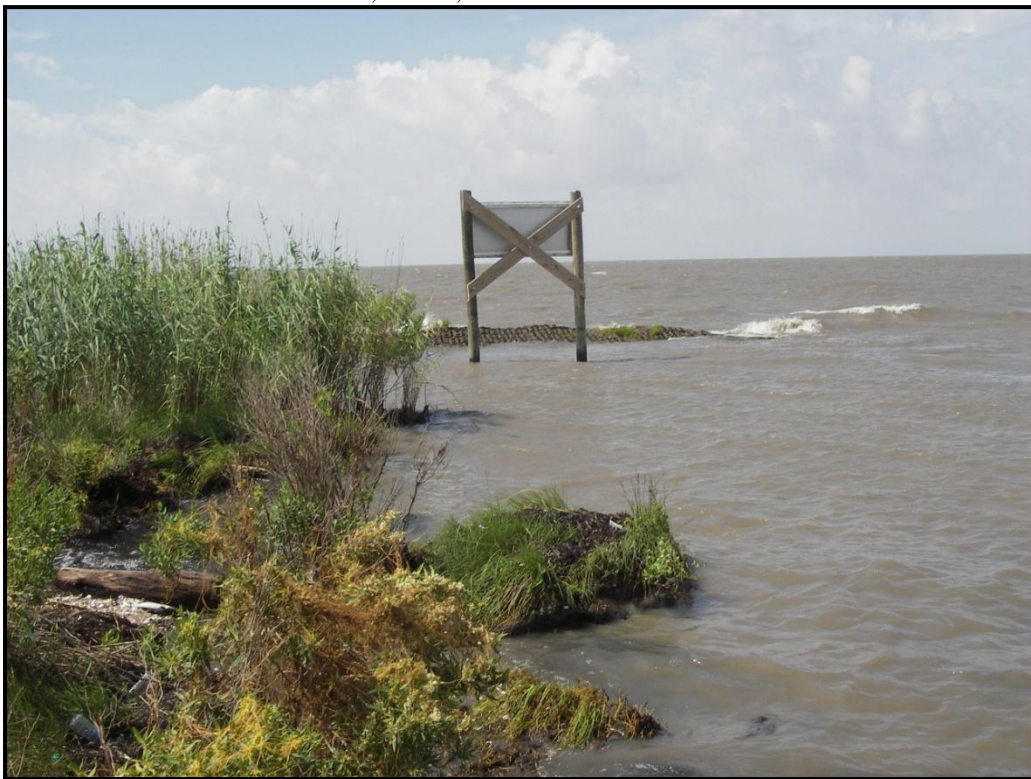
Photo 4, Area 2, Close up view of erosion on west side of concrete mats.

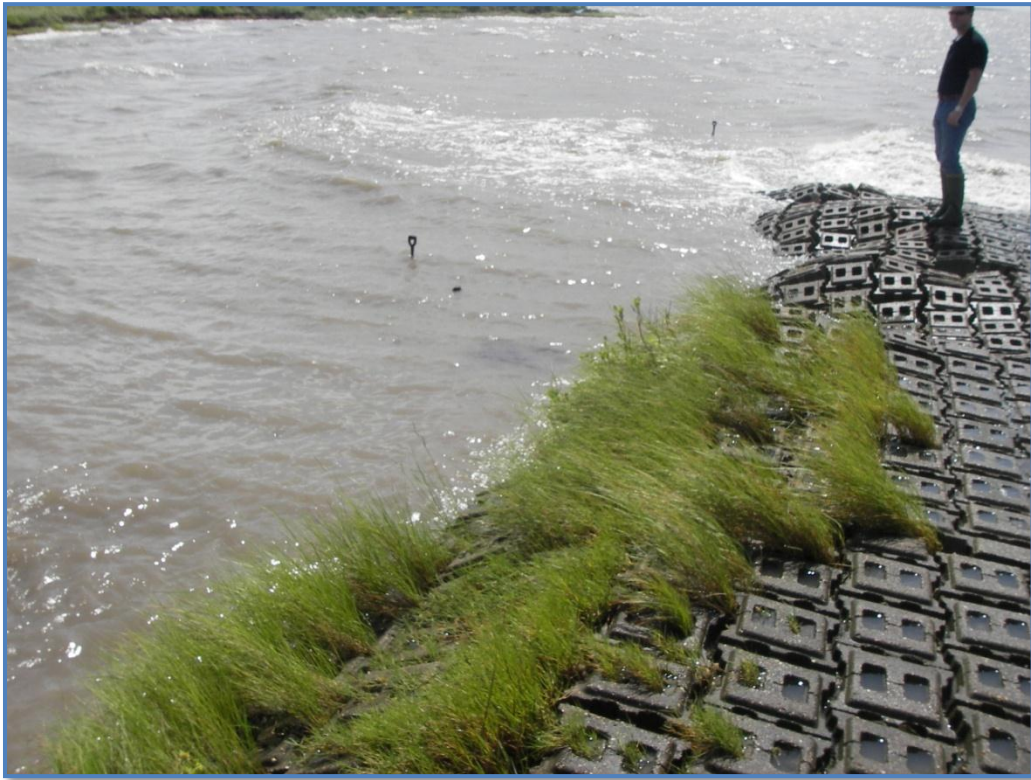
Photo 5, Area 2, East side of concrete mats.

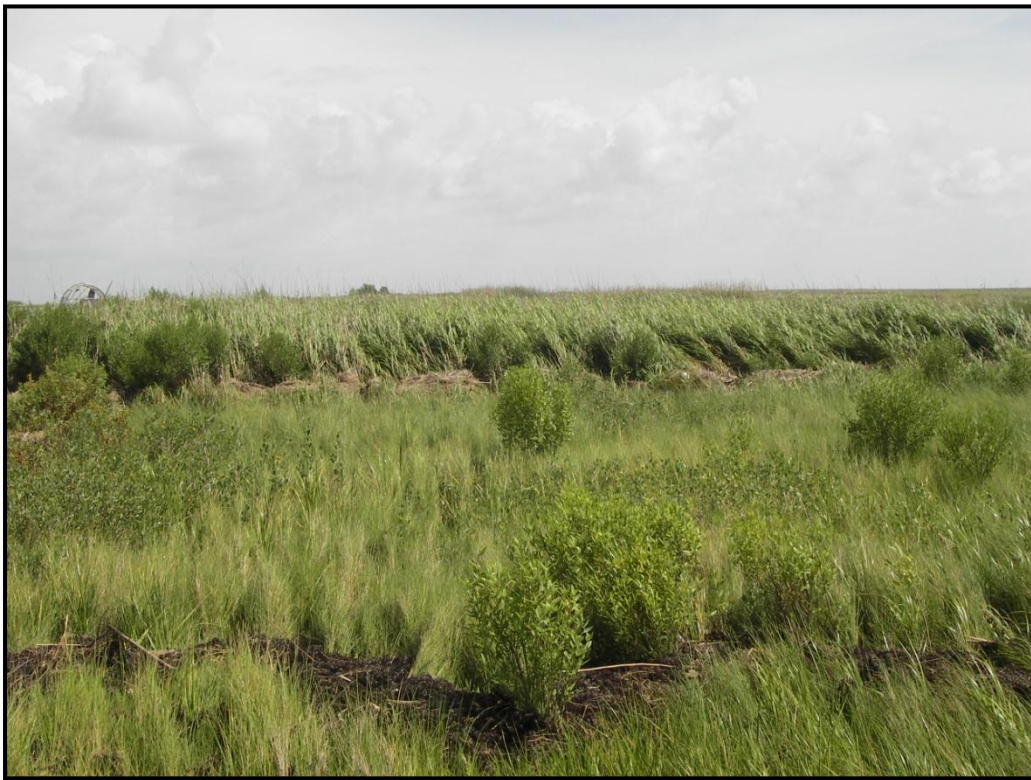
Photo 6, Area 2, View looking north.

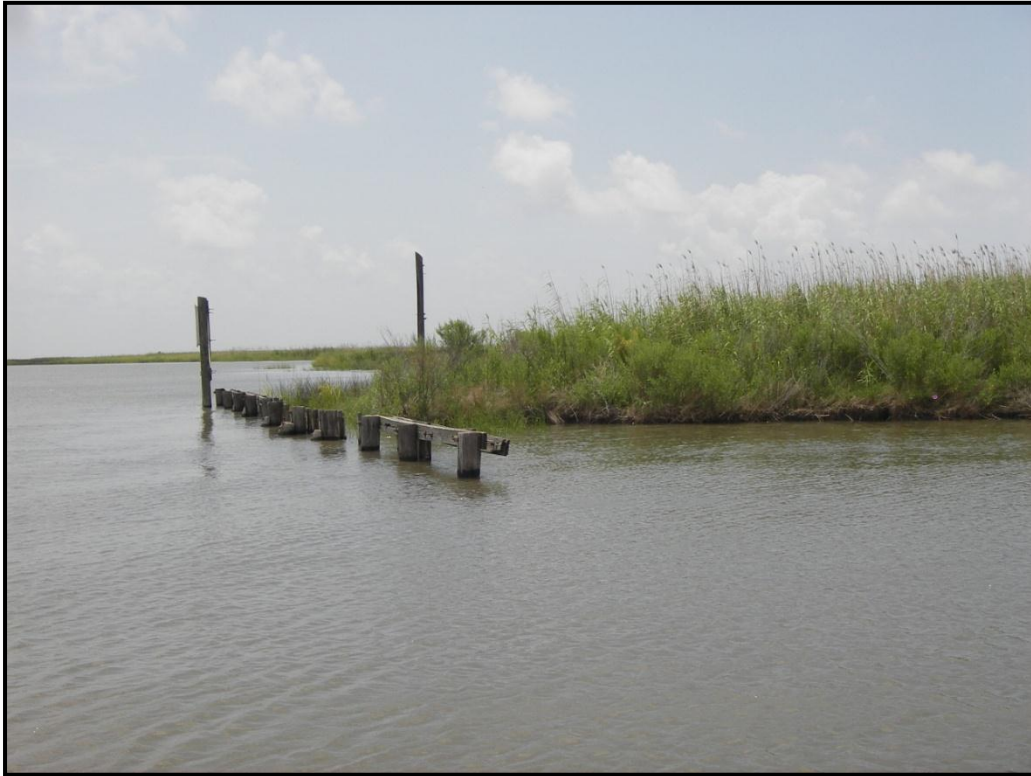
Area 3 also is in good condition. The northern part of this reach is fully vegetated, mainly due to the fact that this reach was constructed first, and has been in place since May, 2003. There is some minor erosion occurring on each side of the northern timber bulkhead which will need to be monitored on future annual inspections. OCPR and NRCS agree that this area is in good condition and no maintenance will be required at this time. (Photos: Appendix B, Photos 7).

Photo 7, Area 3, near bulkhead on north end.

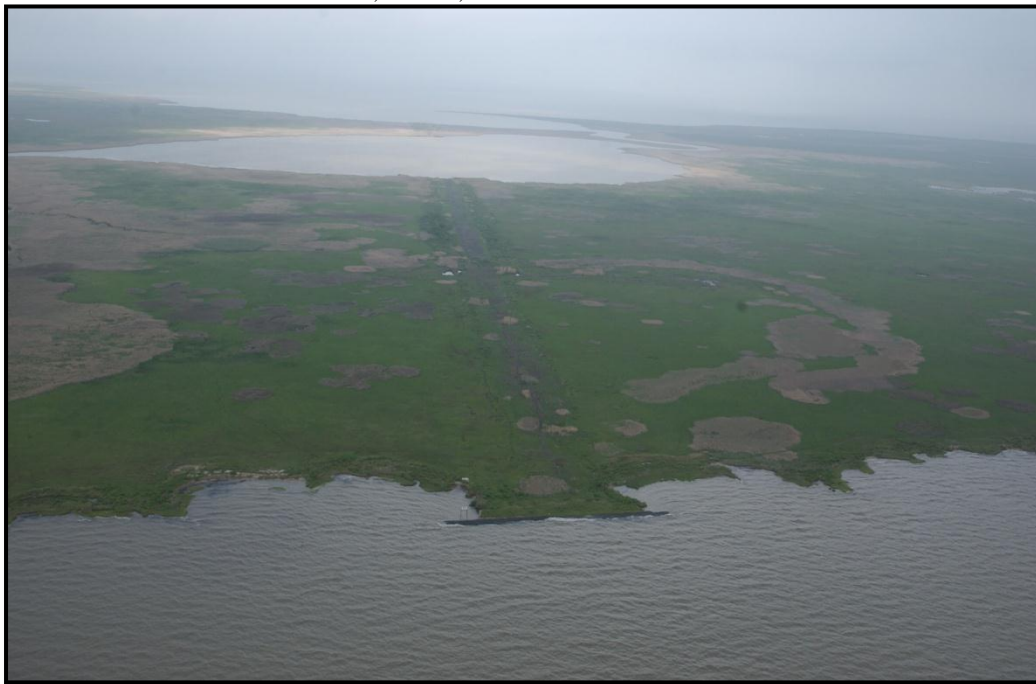
Photo 8, Areas 1 & 2, Ariel view from Gulf of Mexico looking north to Lake Portage
