**2010/2011 Annual Inspection
Report**

**HUMBLE CANAL HYDROLOGIC
RESTORATION PROJECT
(ME-11)**

State Project Number ME-11
Priority Project List 8

March 24, 2011
Cameron Parish

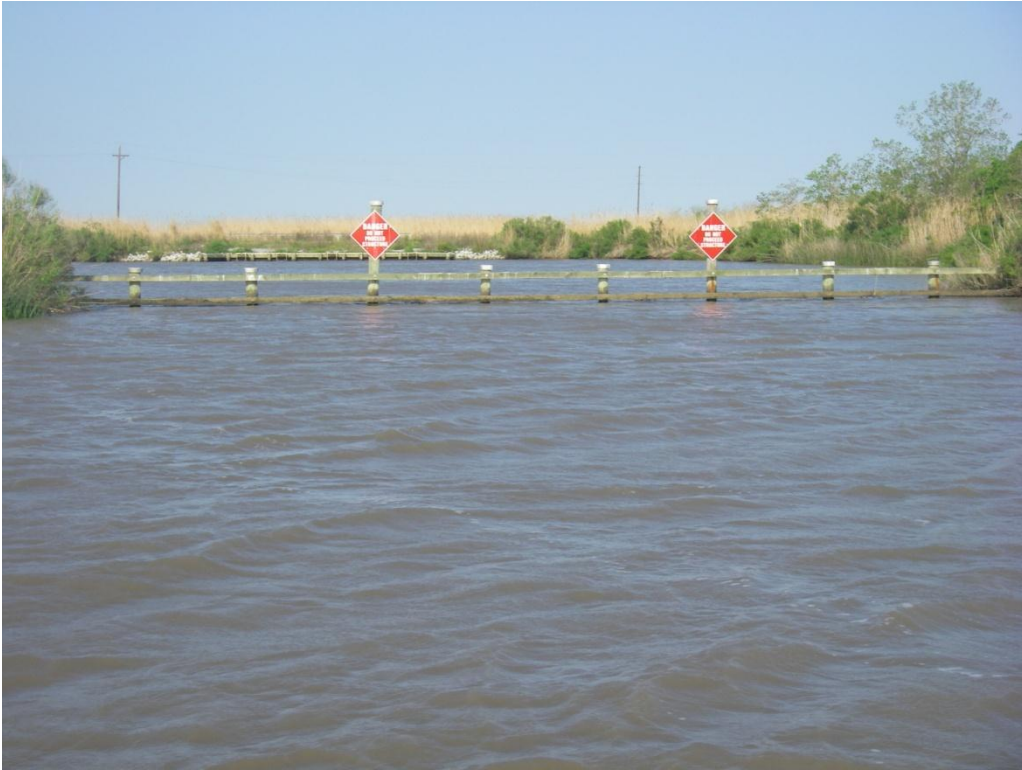
The structure is in excellent condition and the warning signs were recently replaced as part of a maintenance event. (Photos: Appendix B, Photo 1)

Photo No. 1, Marine barrier with signage.

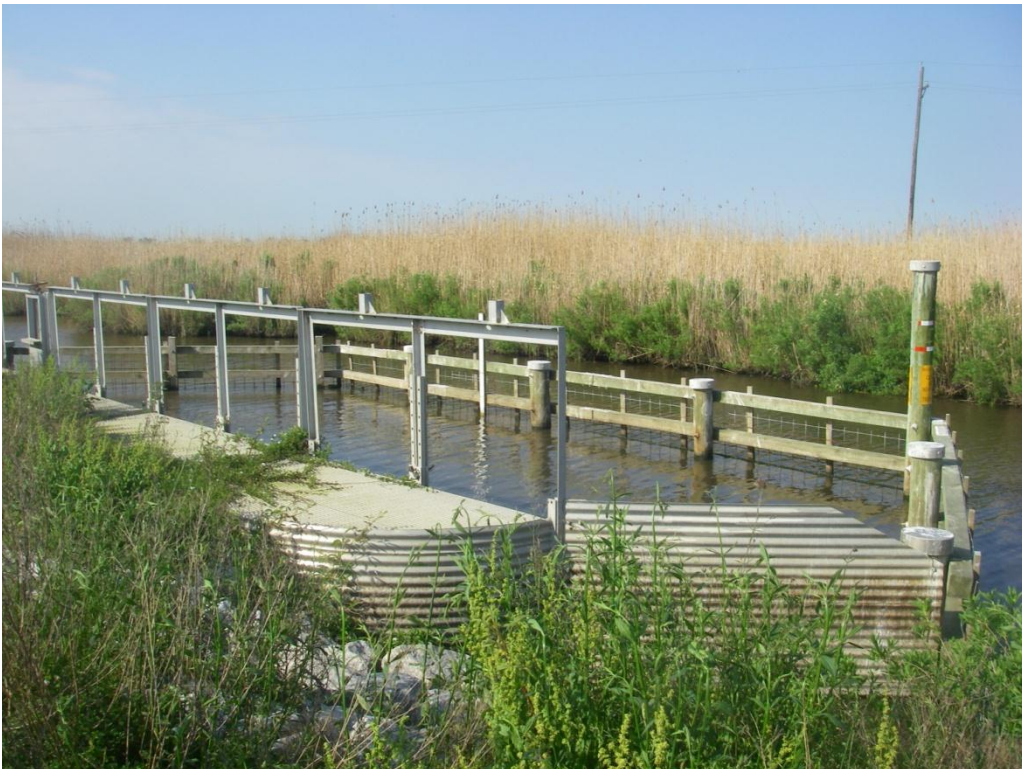
This feature is in good condition and also was part of the recent maintenance event to replace all of the wire fence material as well as repair of the hyacinth wooden pilings and bracing. (Photos: Appendix B, Photo 2)

Photo No. 2, Inlet side of structure

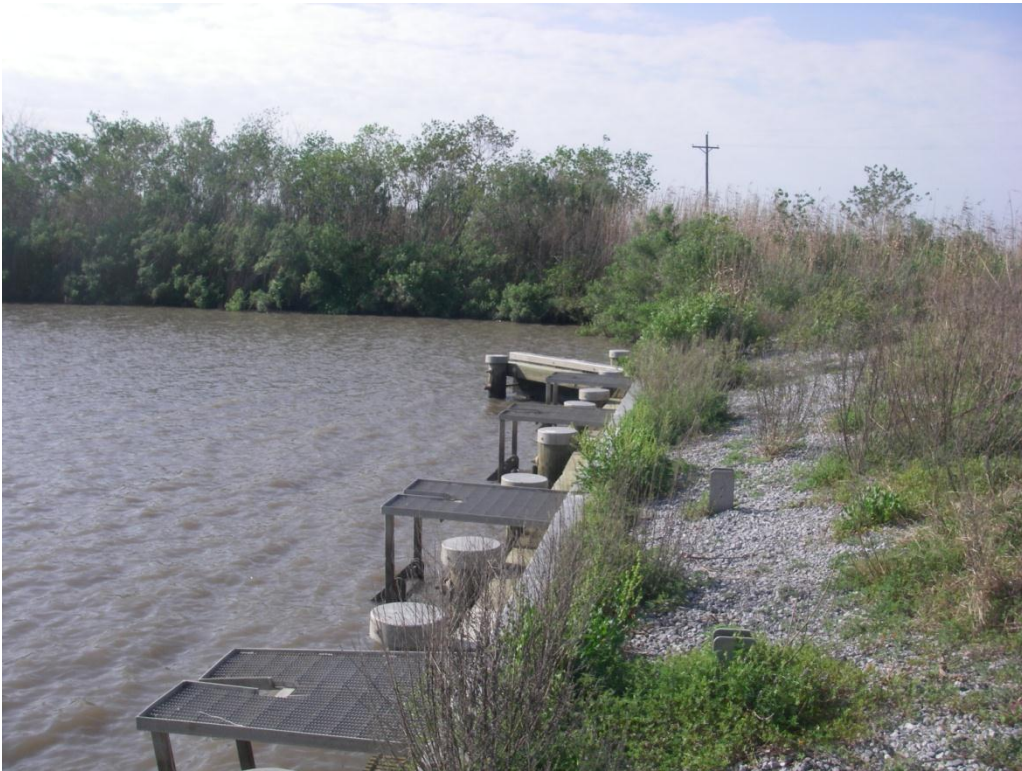
Overall, the structure is in good post construction condition. As part of the recent maintenance event rock armor was placed on the ends of the wingwalls on the inlet and outlet side of the structure. Crushed stone aggregate was also placed on the top portion of the structure. M & M Electric hired the services of a diver to check and clear out all flapgates. Several items were found wedged in the gates including a portion of an old lifting arm. Miscellaneous repairs were made to the flap gates, stoplogs and locking arms. Southside Machine fabricated an aluminum storage box for locking arms and stoplogs and was placed on Miami Corporation property off of Little Chenier Road. This storage box was added to the contract as a means to prevent vandalism. (Photos: Appendix B, Photo 3)

Photo No. 3, Outlet side of structure
