**2010/2011 Annual Inspection
Report**

**FRESHWATER BAYOU CANAL
BANK STABILIZATION
PROJECT (ME-13)**

State Project Number ME-13
Priority Project List 5

April 12, 2011
Vermilion Parish

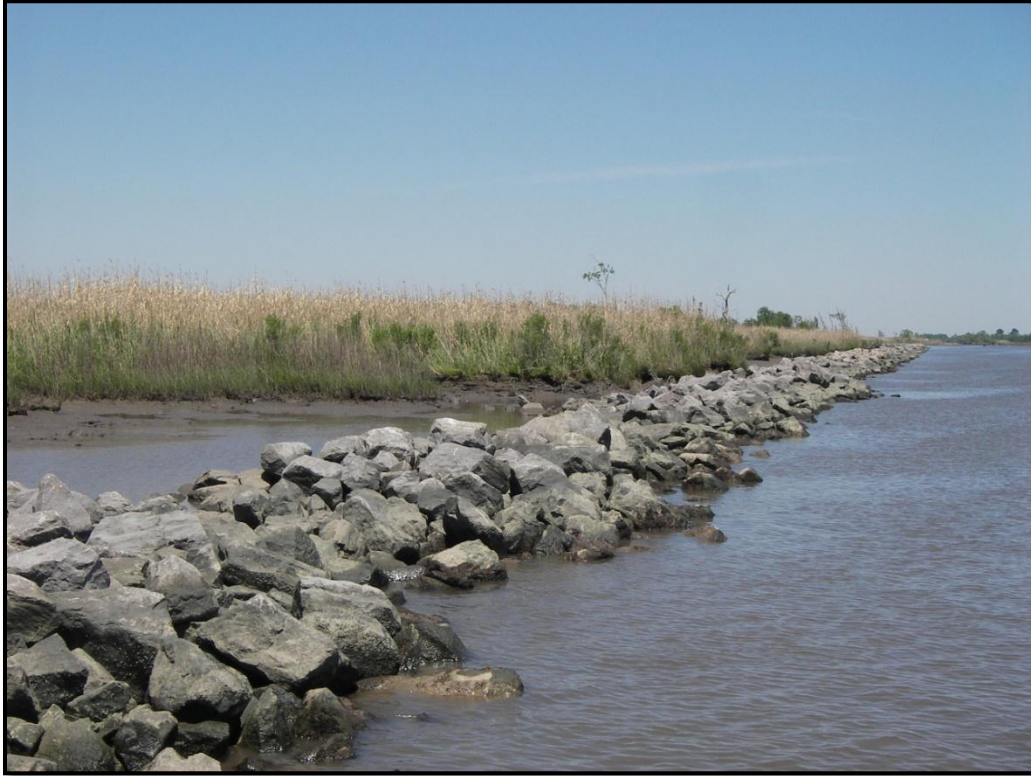
Photo No. 1, Typical rock dike

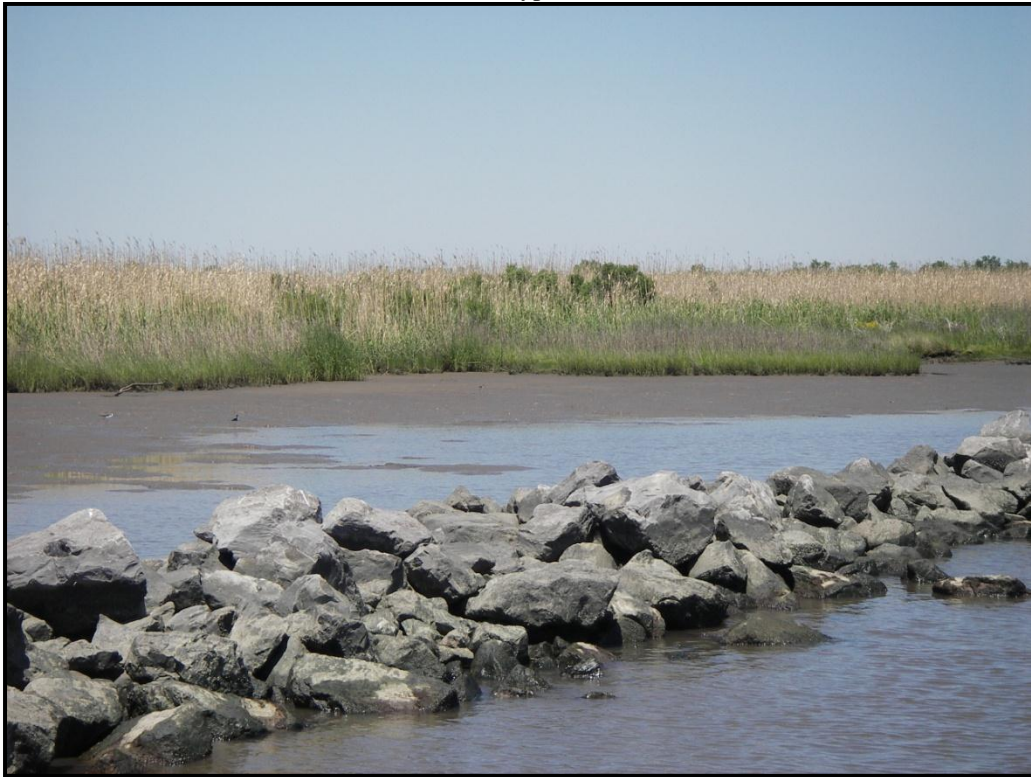
Photo No. 2, View showing accretion behind rock dike

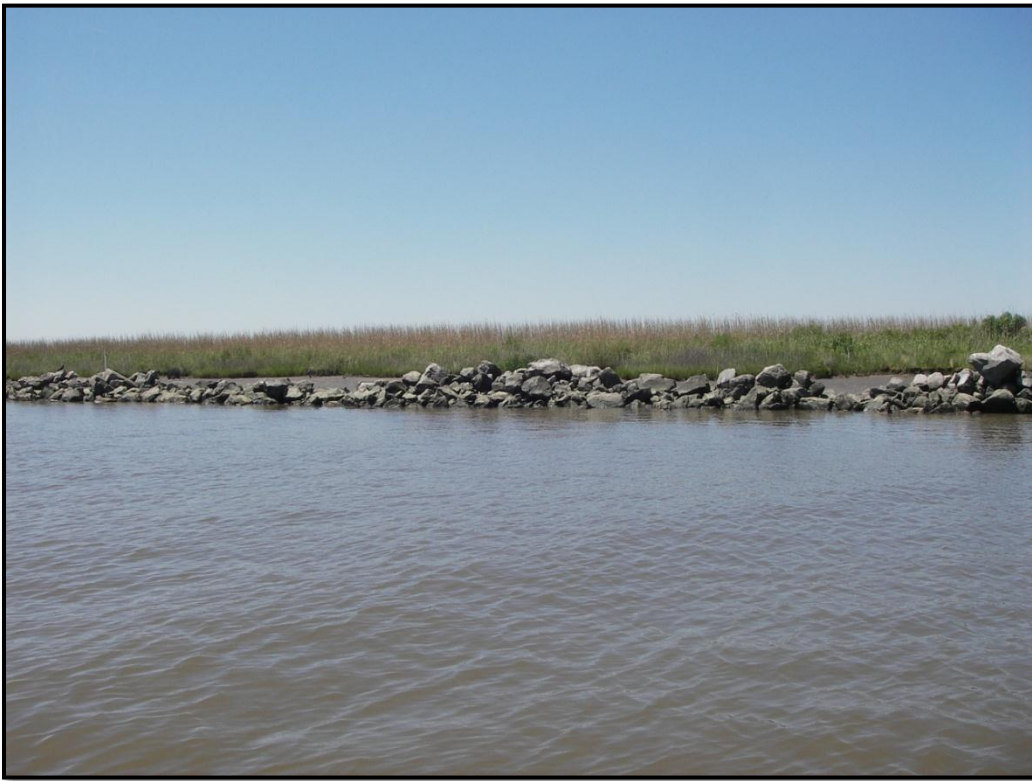
The inspection revealed the 9,130 linear feet of foreshore rock dike repaired in the 2005 maintenance project is in good condition. The additional 7,000 linear feet of foreshore rock dike has numerous sections that are below elevation 4.0 NAVD and have recently been surveyed by NRCS personnel. An estimate will be prepared and a funding request submitted to CWPPRA in the fall of 2011 to restore these sections of rock dike to their original elevation. (Photos: Appendix B, Photos 1-3)

Photo No. 3, View of typical low area showing stable bank behind dike as well as low sections of dike

Item	Condition	Physical Damage	Corrosion	Photo #	Observations and Remarks
Steel Bulkhead / Caps	N/A				
Steel Grating	N/A				
Stop Logs	N/A				
Hardware	N/A				
Timber Piles	N/A				
Timber Wales	N/A				
Galv. Pile Caps	N/A				
Cables	N/A				
Signage /Supports	N/A				
Rip Rap (fill) (foreshore dike)	Good			1,2,3	Recent maintenance work to restore dike to constructed elevation is still in good condition. A few low areas exist along rock dike.
Earthen Embankment	N/A

Overall the Freshwater Bayou Canal Bank Stabilization Project is in good condition and appears to have stabilized the erosion of the Freshwater Bayou Canal Bankline. The project area shoreline averaged an erosion rate of -0.03 ft/yr from 1998 to 2009 while the reference area eroded at -7.92 ft/yr. The highest rate of erosion occurred at the north end of reference area 2 where the shoreline retreated 158.8 ft over the time period. The above mentioned 7,000 linear feet of foreshore rock will require a maintenance event FY12-FY13 after the anticipated funding approval in FY11.
