**2011 Operations, Maintenance, and
Monitoring Report**

**Grand-White Lake Land Bridge
Protection**

State Project Number ME-19
Priority Project List 10

May 2011
Cameron Parish

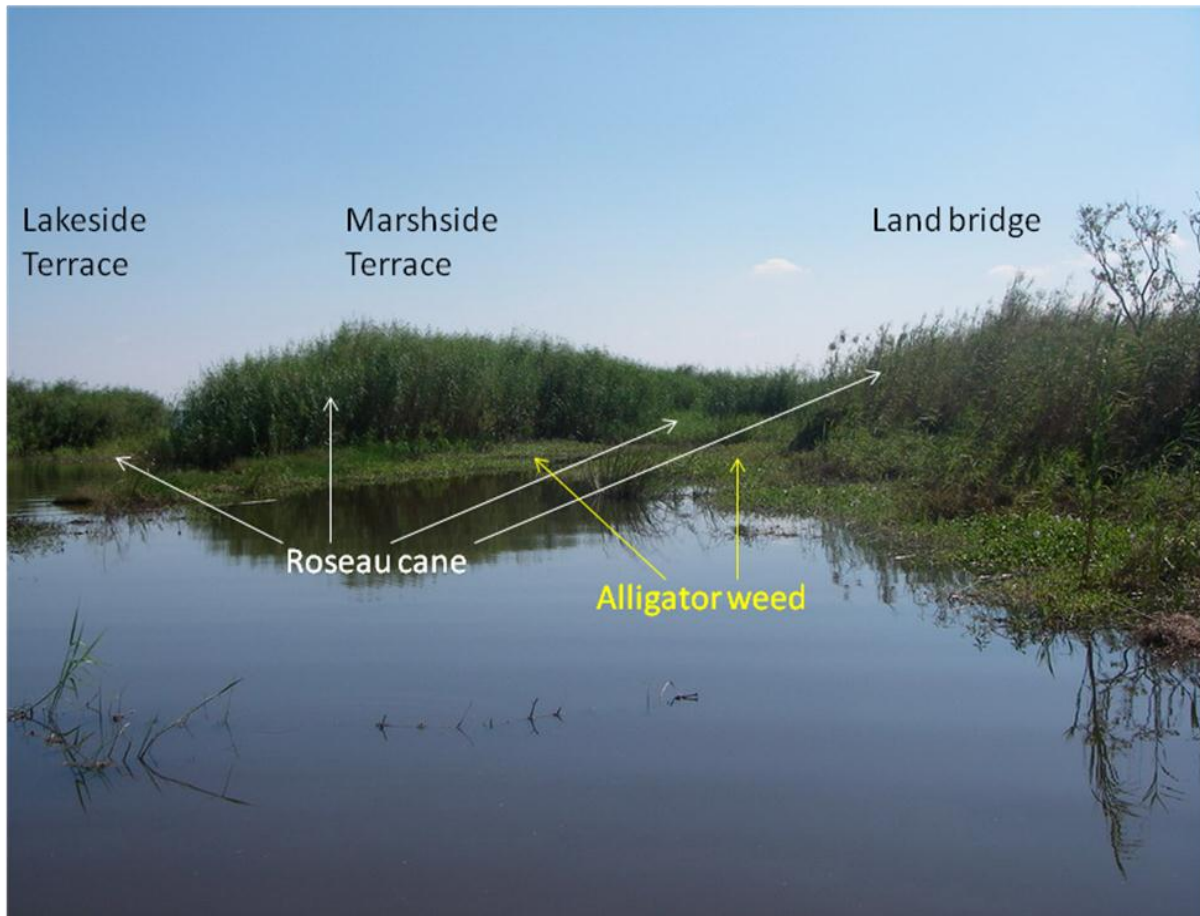
Picture 1. Vegetation along Collicon Lake expands as terrace and land-bridge vegetation merge. At the time of this photograph (October 21, 2008) the vegetation between the land-bridge and terrace was floating; therefore, the vegetative expansion was not included in the shoreline change analysis. If the merging vegetation anchors into the soil below, then it will be considered emergent and define the vegetated shoreline of the land bridge.

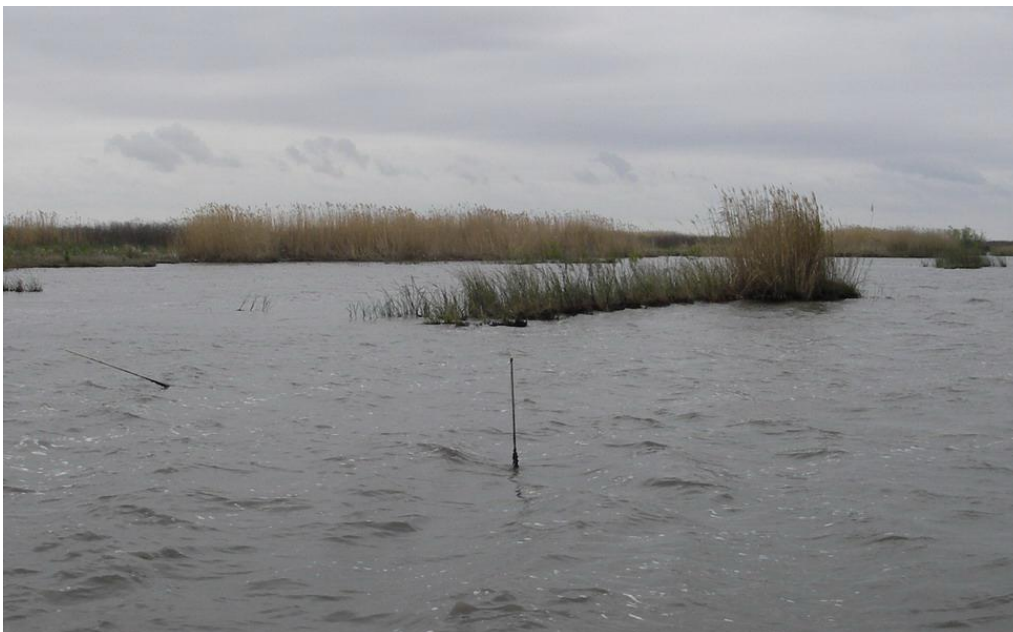
Picture 2. Many terraces have eroded since construction, especially the lakeside terraces (e.g. LS42) which were intended to be sacrificial and buffer the marshside terraces. Note the cane poles that mark the original corners of the terrace. Picture was taken on March 24, 2010.

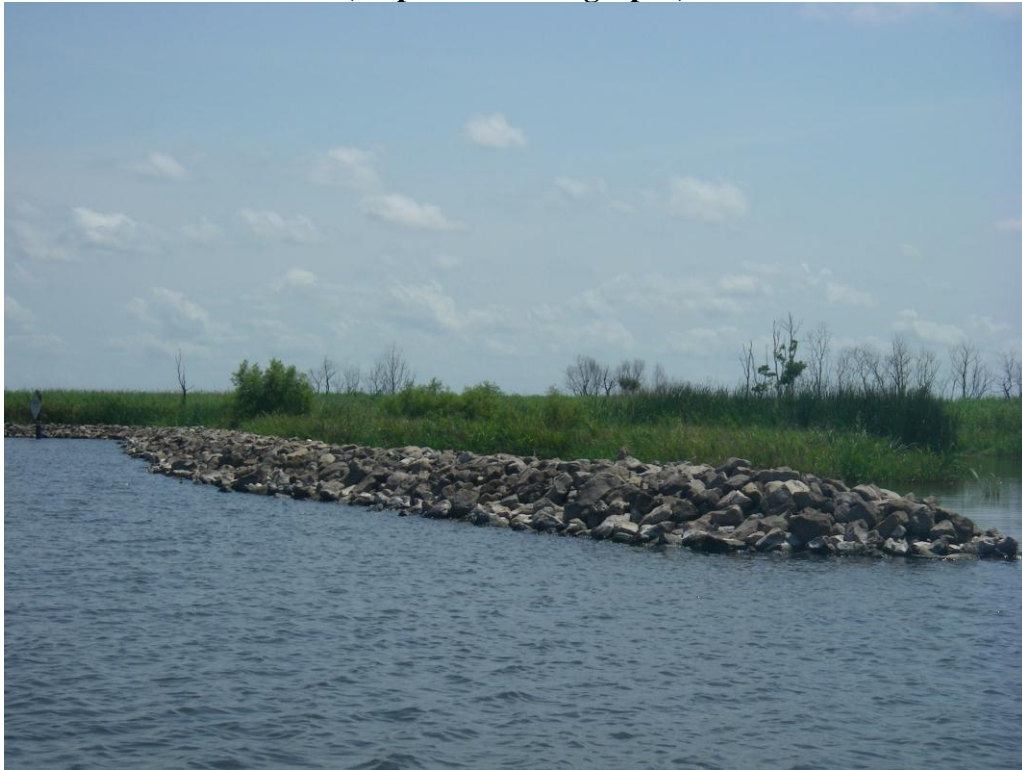
Photo 1, Typical rock dike.

The foreshore rock dike feature is in excellent condition. No maintenance is required at this time. (Photos: Appendix B, Photo 1)

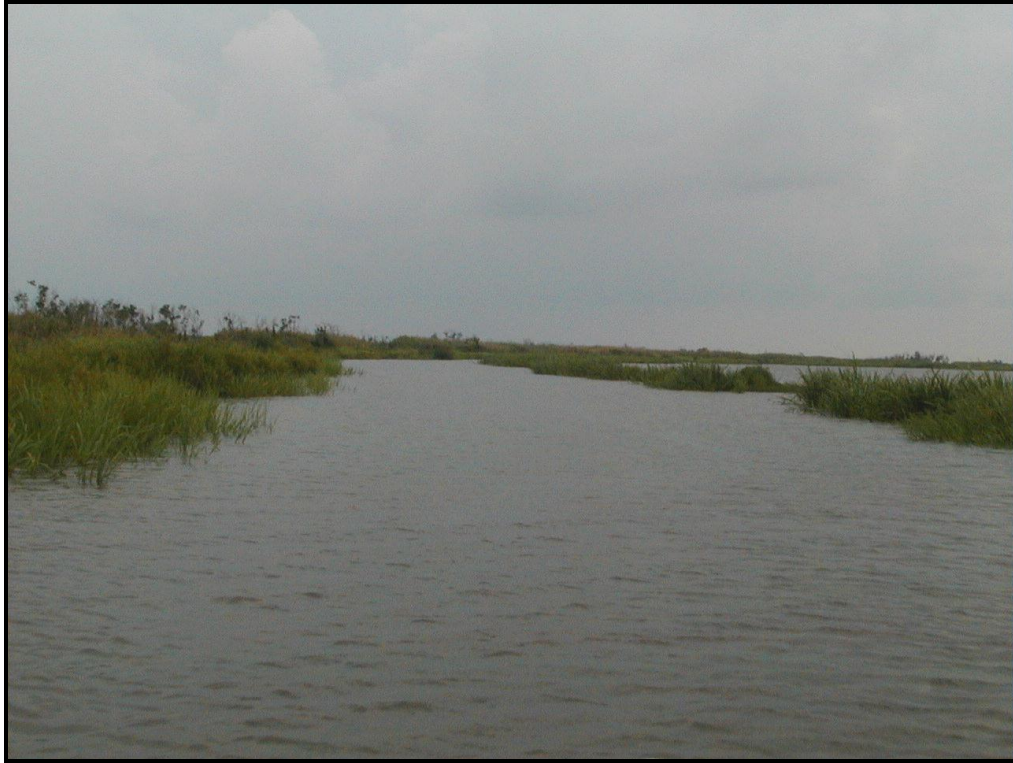
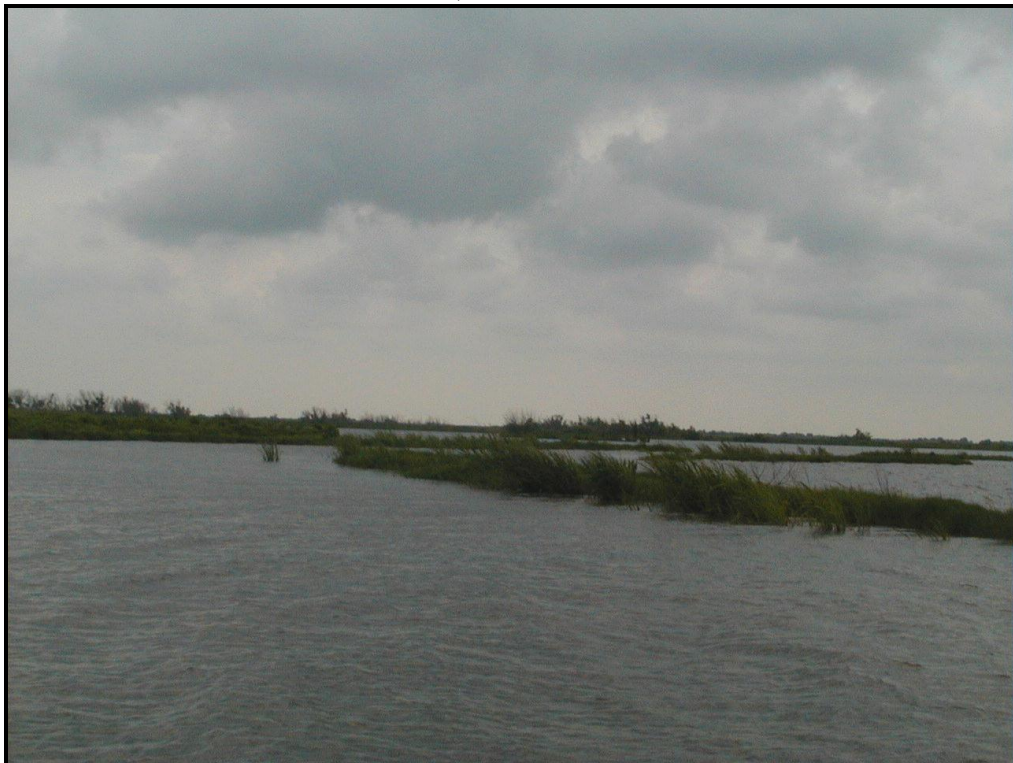
Marsh side and lake side earthen terraces along Collicon Lake continue to experience erosion, with the lake side sacrificial terraces being more severe. Original giant cutgrass plantings along the marsh side terraces were visible. (Photos: Appendix B, Photo 2)

Photo 3, Earthen terraces.

Item	Condition	Physical Damage	Corrosion	Photo #	Observations and Remarks
Steel Bulkhead / Caps	N/A				
Steel Grating	N/A				
Stop Logs	N/A				
Hardware	N/A				
Timber Piles	N/A				
Timber Wales	N/A				
Galv. Pile Caps	N/A				
Cables	N/A				
Signage / Supports	N/A				
Rip Rap (fill)					
Rock Dike	Good			1 & 2	Rock dike is in very good shape.
Earthen Terraces	Fair			3 & 4	Terraces will require vegetative planting.

Overall, the foreshore rock dike feature of the Grand-White Lake Landbridge Project is in excellent condition and is functioning as designed, however there is still concern about the erosion of the sacrificial terraces on Lake Collicon. Consideration will be given for a possible maintenance event to armor these terraces into the future.

Armoring the lakeside slope of terraces along Collicon Lake should be considered to prevent future shoreline erosion.
