**Coastal Protection and Restoration  
Authority of Louisiana**

**2010/2011 Annual Inspection  
Report**

**CAMERON/CREOLE  
WATERSHED HYDROLOGIC  
RESTORATION PROJECT  
(CS-17)**

December 9, 2010  
Cameron Parish

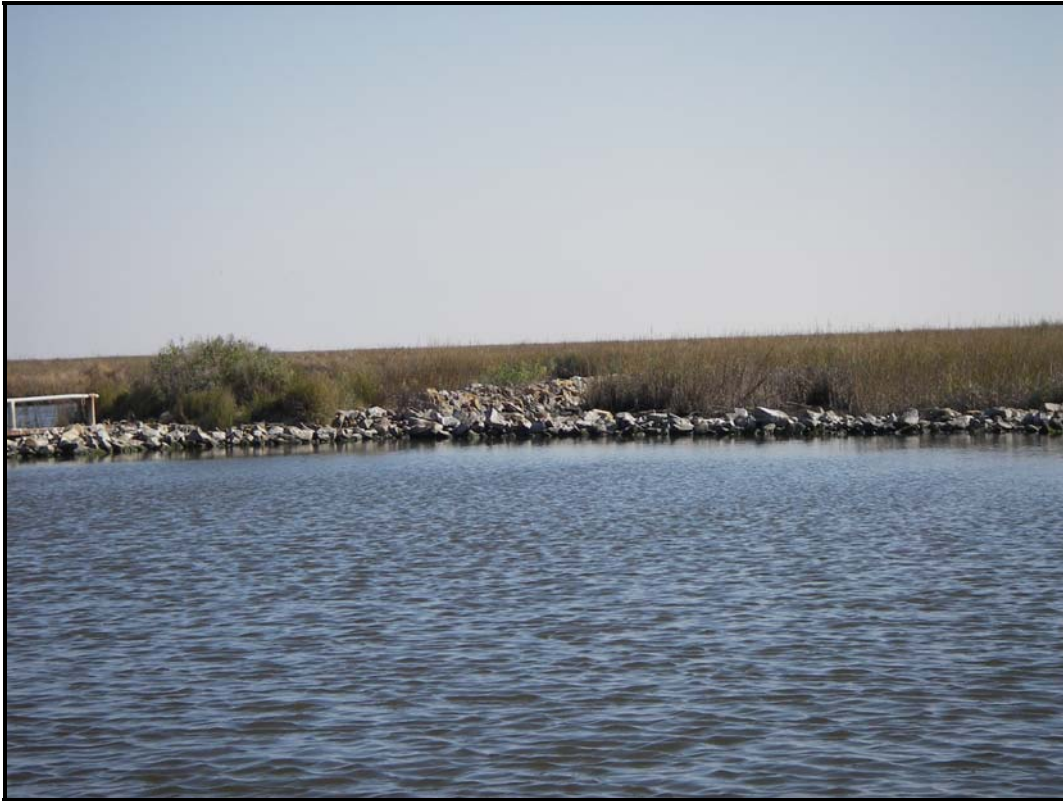
Overall this structure is in good condition. The west boat guide has been removed from the structure assumed to be by vandals. Warning signs, swing gate and top rail are still visible. The recent maintenance event performed in 2009 to armor the ends of the sheet pile wall has been effective and looks in good condition. The sheet pile wall is showing signs of deterioration and will be monitored during future inspections. (Photos: Appendix B, Photos 1-3).

**Photo 1**, Grand Bayou Weir, view of rock east side.

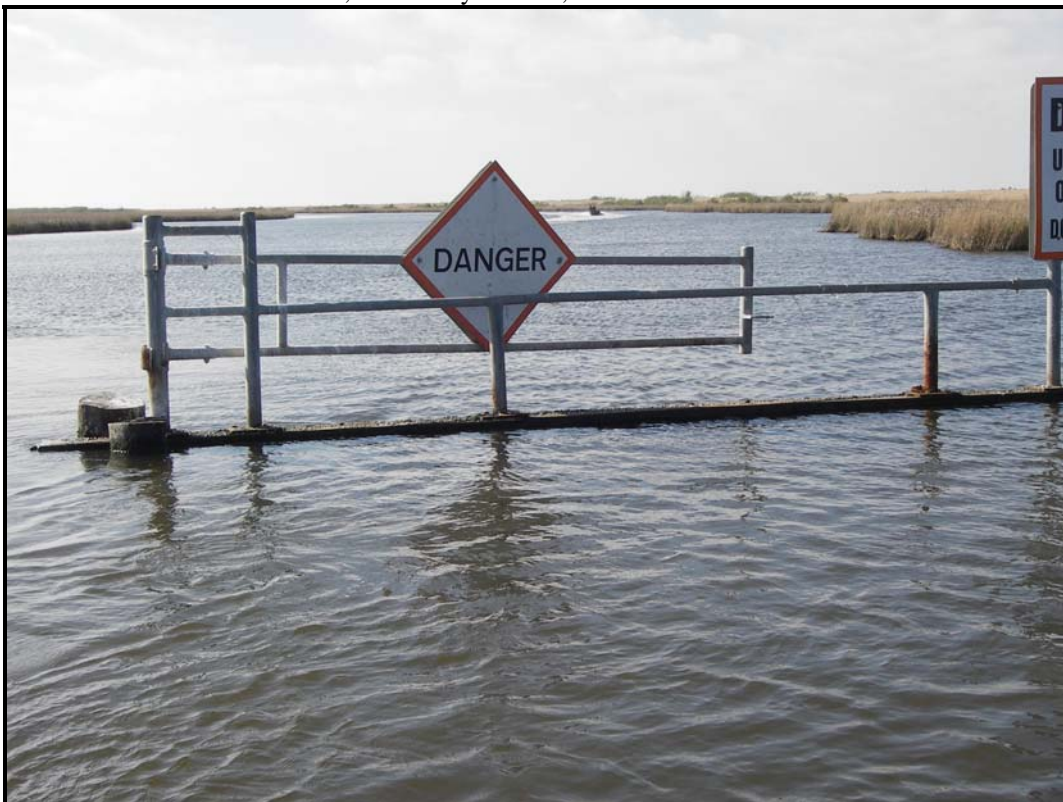
**Photo 2**, Grand Bayou Weir, close up view showing missing boat guide west side.

Item	Condition	Physical Damage	Corrosion	Photo #	Observations and Remarks
Steel Bulkhead / Caps	Fair			1	
Steel Grating	N/A				
Stop Logs	N/A				
Hardware	Fair				
Boat Guides	Fair			2	West boat guide missing.
Timber Wales	N/A				
Galv. Pile Caps	Fair				
Cables	N/A				
Signage / Supports	Good			1	
Rip Rap (Rock Armor)	Good			3	
Eathern Embankment	Good

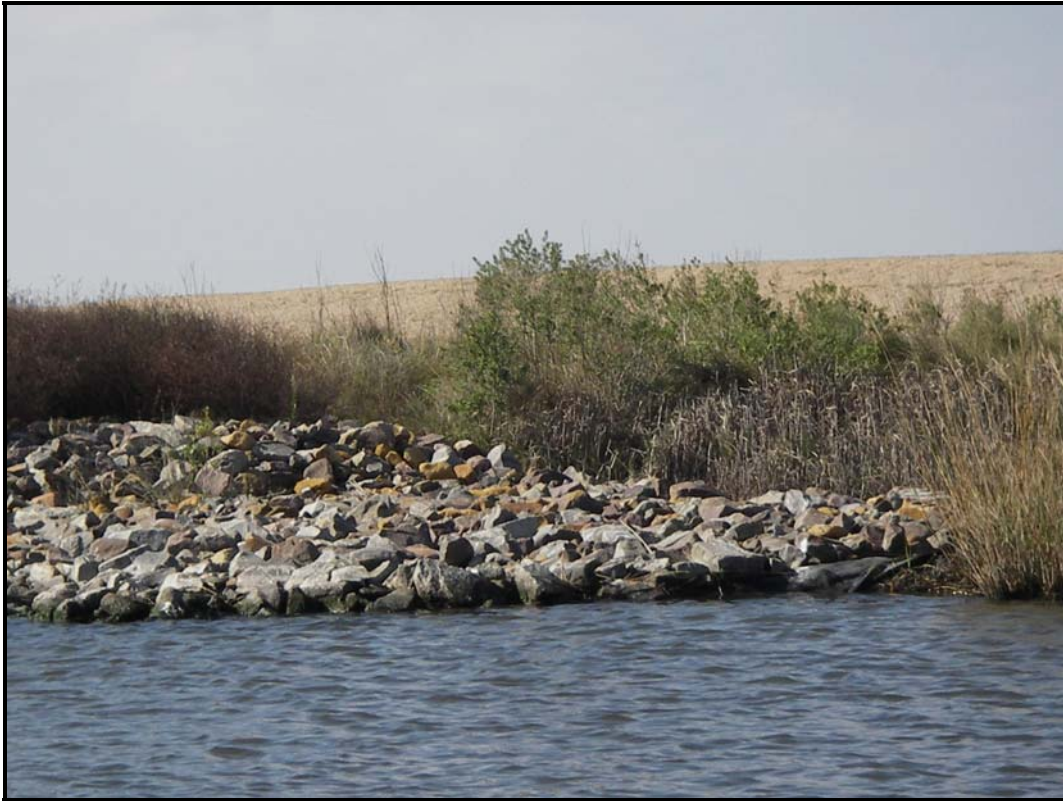
**Photo 3**, Grand Bayou Weir, view showing rock armor on west side.

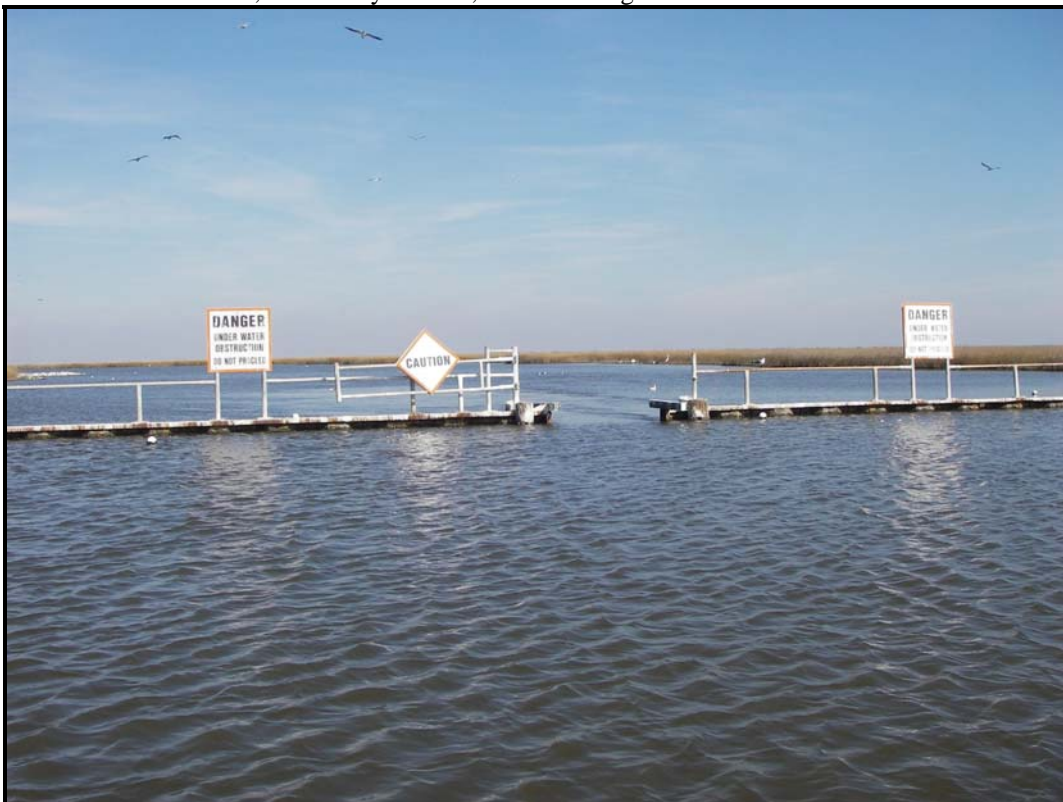
Overall the structure is in good condition. Both boat guides remain on the structure. Warning signs and top railing are still visible. The recent maintenance event performed in 2009 to armor the ends of the sheet pile wall has been effective and looks in good condition. The sheet pile wall is showing signs of deterioration and will be monitored during future inspections. (Photos: Appendix B, Photos 4-6).

**Photo 4**, Mangrove Weir, view looking north.

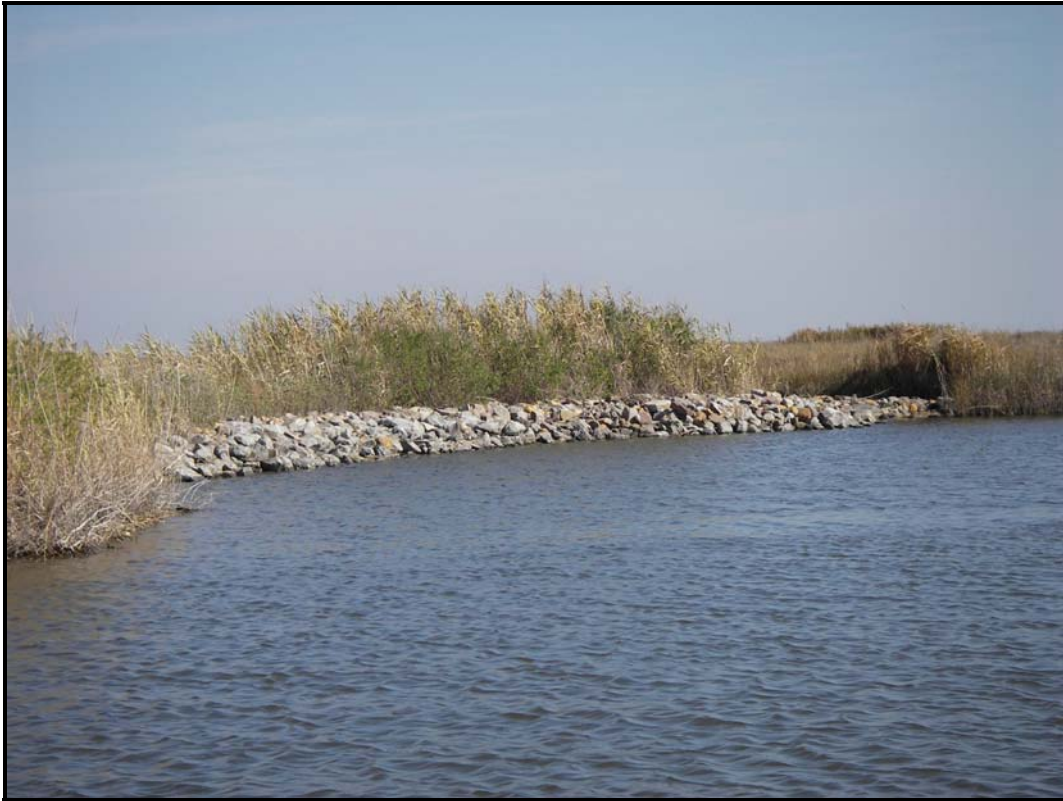
**Photo No. 5,** Mangrove Weir, view of rock armor east side.

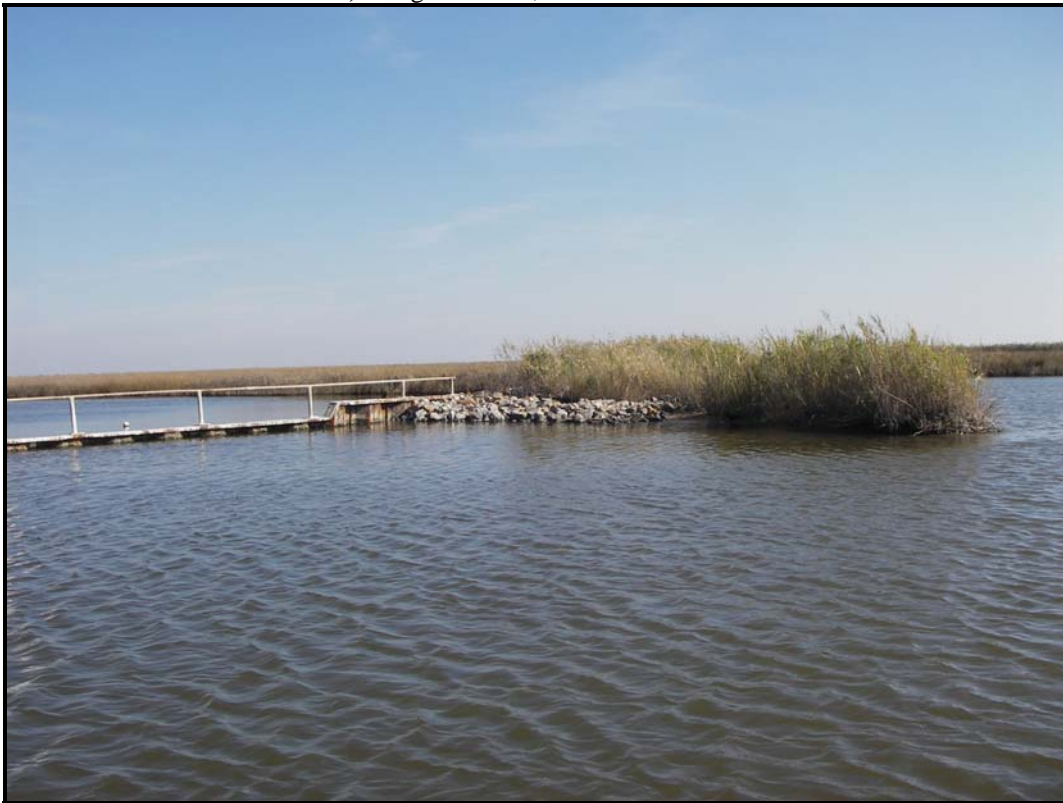
**Photo No. 6,** Mangrove Weir, view of sheet pile wall.
