**2010/2011 Annual Inspection
Report**

**SABINE REFUGE STRUCTURE
REPLACEMENT PROJECT
(CS-23)**

State Project Number CS-23
Priority Project List 3

January 20, 2011
Cameron Parish

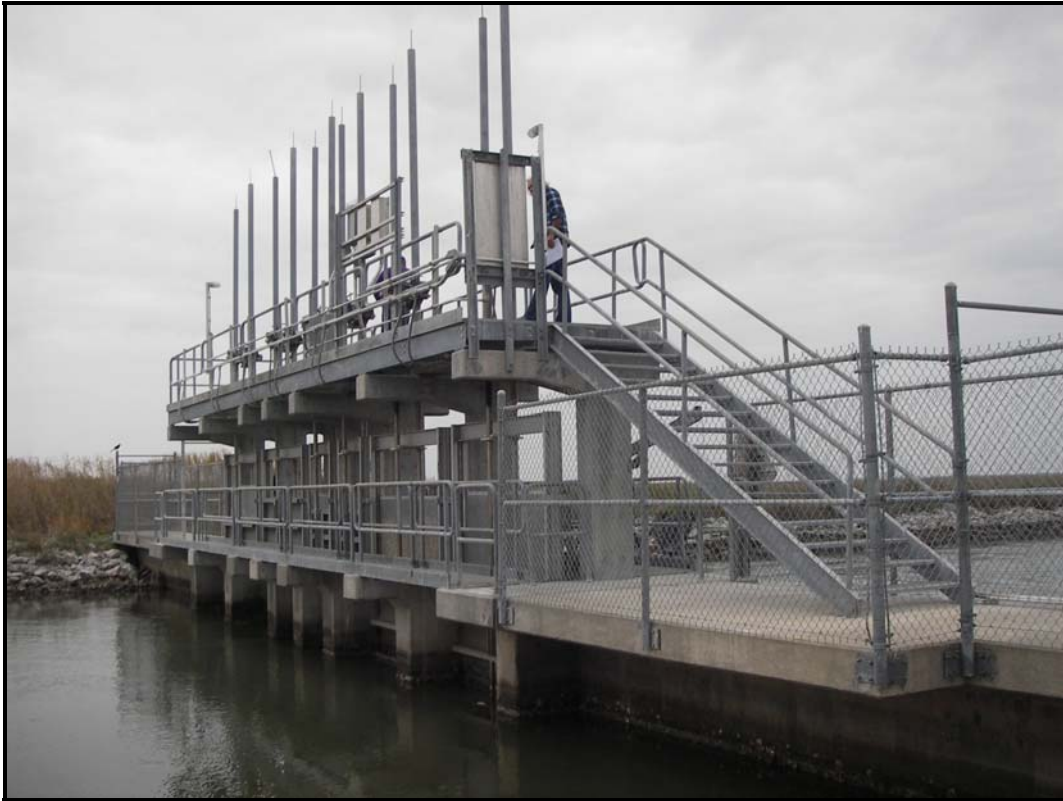
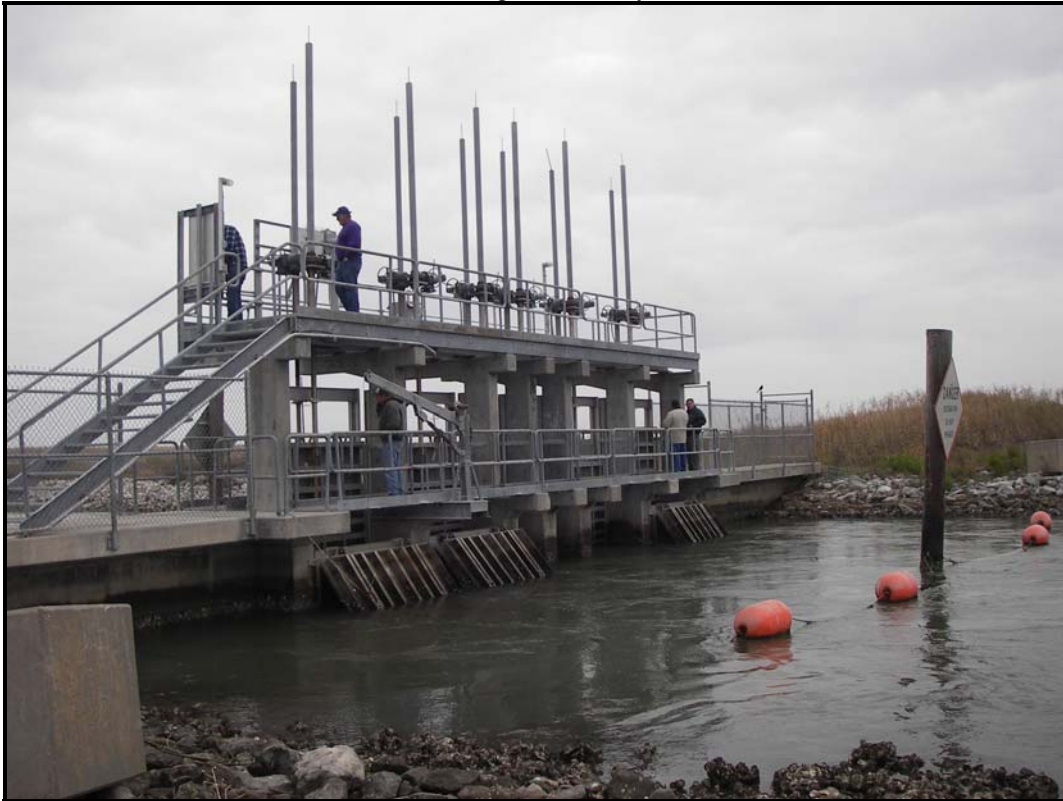
The chain link fencing has recently been replaced after Hurricane Ike. The remainder of the structure is in the same condition as post Hurricane Rita and Hurricane Ike. Some electrical repairs have been made by TVA in 2007. (Photos: Appendix B, Photos 1 - 2)

Photo No. 1, Hog Island Gully Structure

Photo No. 2, Hog Island Gully Structure

Item	Condition	Physical Damage	Corrosion	Photo #	Observations and Remarks
Steel Bulkhead / Caps	N/A				
Steel Grating	Good				
Gates	Fair	Yes		1 & 2	Alignment problems.
Electrical	Good				All electrical components recently upgraded by TVA.
Hardware	Poor				
Fencing					
Timber Piles	Good				
Timber Wales	N/A				
Actuators	Fair				All actuators will have to be taken apart and serviced.
Cables	Good				
Signage / Supports	Good				
Rip Rap					
Rock Dike	Good				
W.W. Reinf.					
Earthen Embankment	N/A

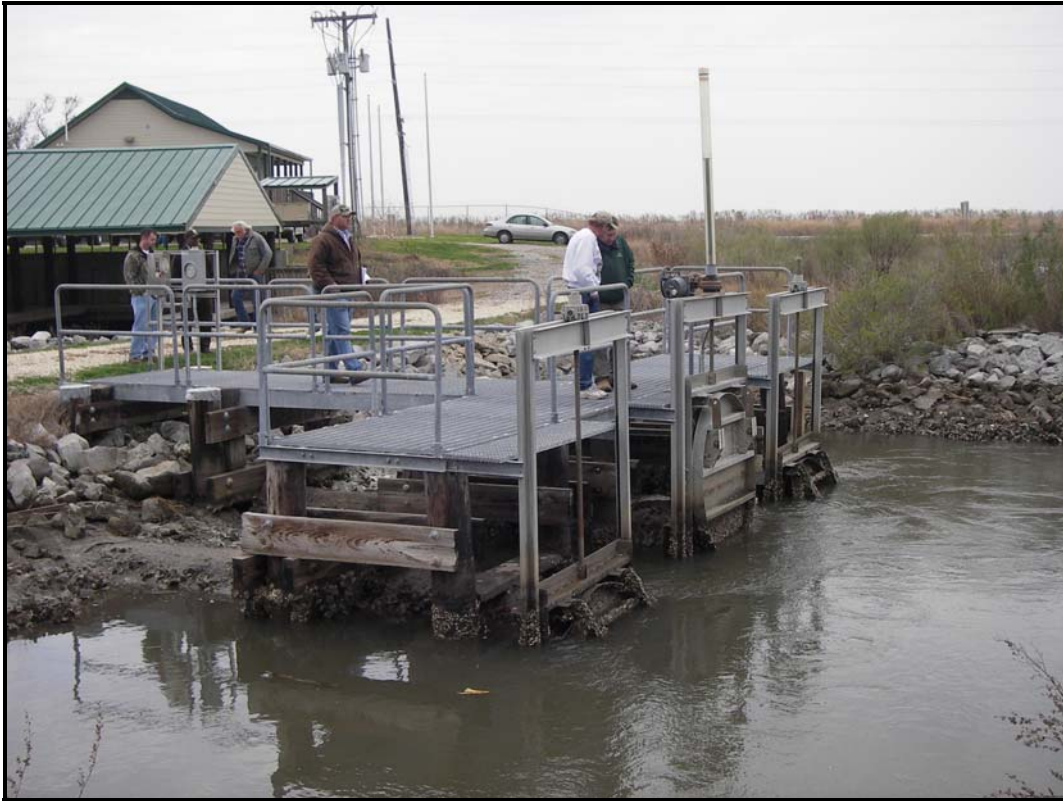
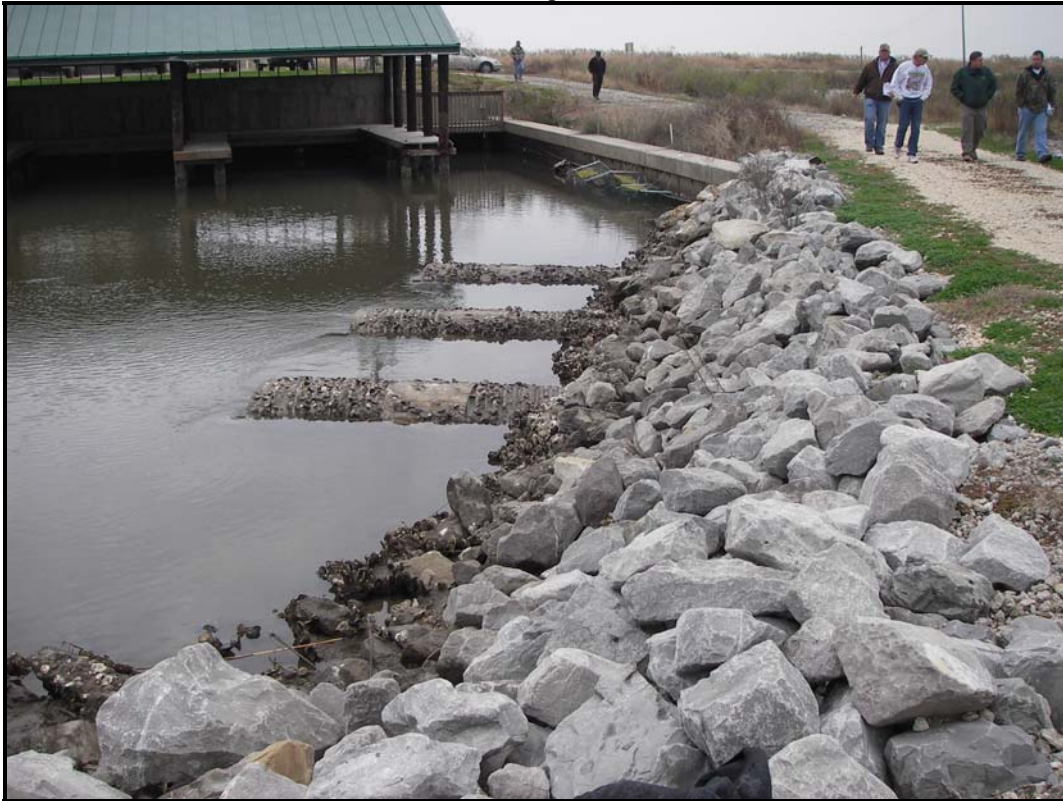
This site went completely under water as described in General Observations above. The center gate appears to be leaning slightly. No other damages appear to be present than those that existed pre-storm and which were being worked on by TVA. (Photos: Appendix B, Photos 3-4).

Photo No. 3, Headquarters Structure

Photo No. 4, Headquarters Structure

Item	Condition	Physical Damage	Corrosion	Photo #	Observations and Remarks
Steel Bulkhead / Caps	N/A				
Steel Grating	Good				
Gates	Fair	Probable		3 & 4	Possible alignment problems with gates and/or stems.
Electrical	Poor	Yes			All electrical components demolished.
Hardware	Good				
Timber Piles	Good				
Timber Wales	Good				
Actuators	Fair	Yes			The actuator will have to be taken apart and serviced.
Cables	N/A				
Signage / Supports	N/A				
Rip Rap					
Rock Dike	Good				
W.W. Reinf.					
Earthen Embankment	N/A

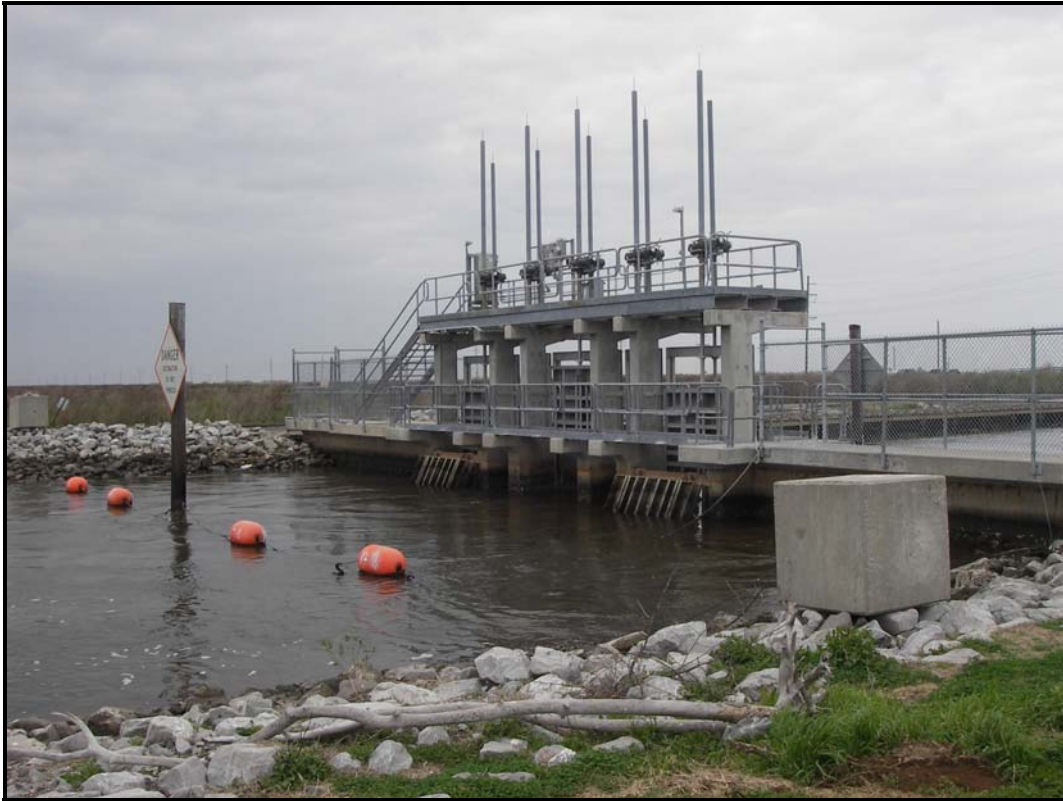
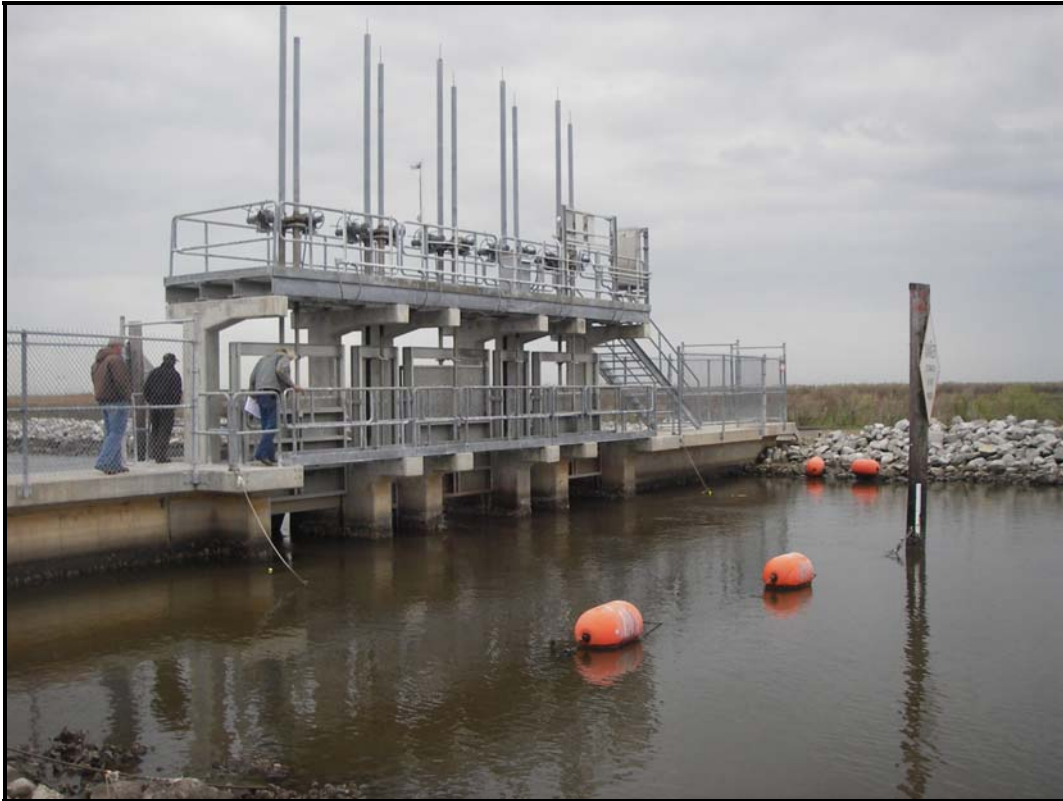
Photo No. 5, West Cove Canal

Photo No. 6 West Cove Canal

Item	Condition	Physical Damage	Corrosion	Photo #	Observations and Remarks
Steel Bulkhead / Caps	N/A				
Steel Grating	Good				
Gates	Fair	Yes		5 & 6	Alignment problems.
Electrical	Good	Yes			All electrical components recently upgraded by TVA.
Hardware/Stairs	Poor			7	North stairway has erosion occurring beneath it.
Fencing	Good				
Timber Piles	Good				
Timber Wales	N/A				
Actuators	Fair				All actuators will have to be taken apart and serviced.
Cables	Good				
Signage / Supports	Good				
Rip Rap					
Rock Dike	Good				
W.W. Reinf.					
Earthen Embankment	N/A

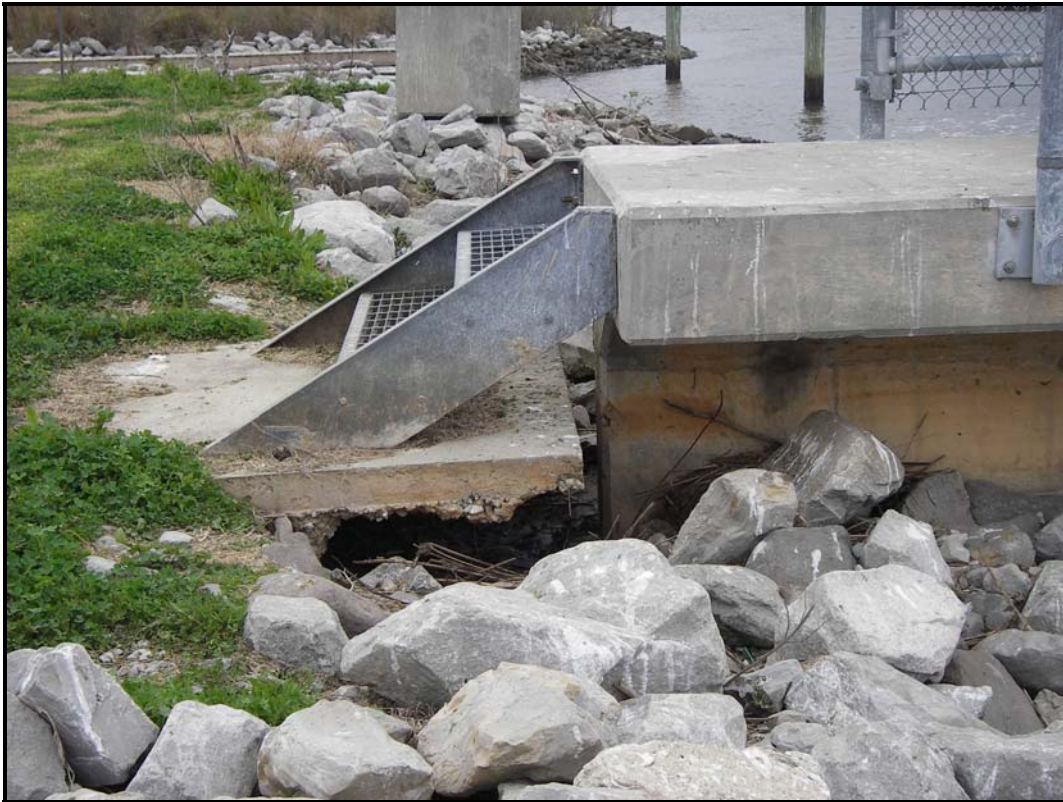
Photo No. 7 West Cove Canal

The chain link fencing has recently been replaced after Hurricane Ike. The remainder of the structure is in the same condition as post Hurricane Rita and Hurricane Ike. Some electrical repairs have been made by TVA in 2007. The north access stairway to the structure has erosion occurring beneath and will need to be addressed in the upcoming maintenance event. (Photos: Appendix B, Photos 5-7).
