**2007 Operations, Maintenance,
and Monitoring Report**

**LAKE CHAPEAU SEDIMENT
INPUT AND HYDROLOGIC
RESTORATION, POINT AU FER
ISLAND**

State Project Number TE-26
Priority Project List 3

June 15, 2007
Terrebonne Parish

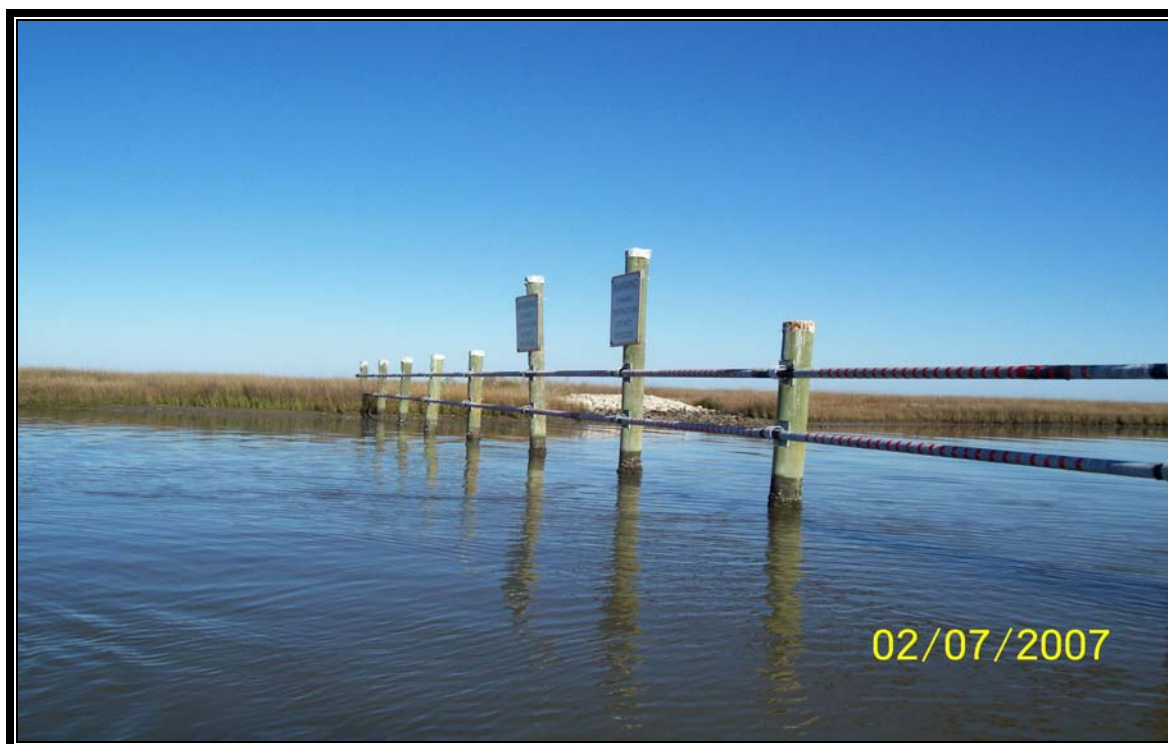
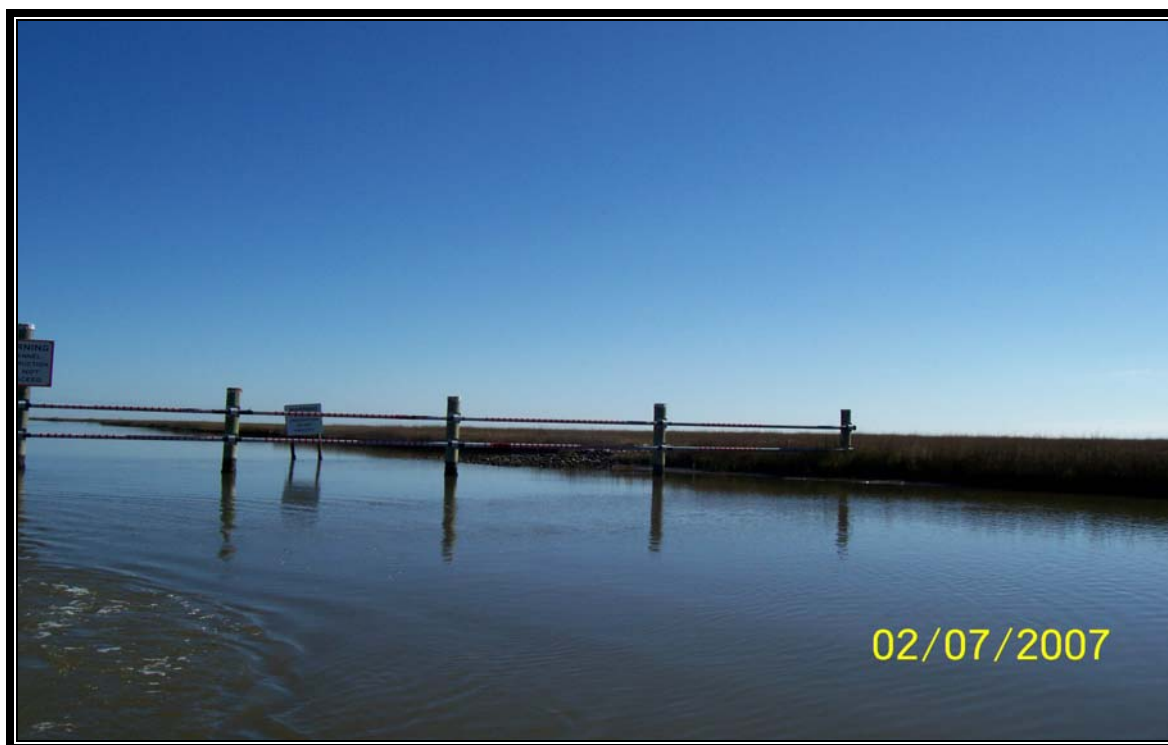
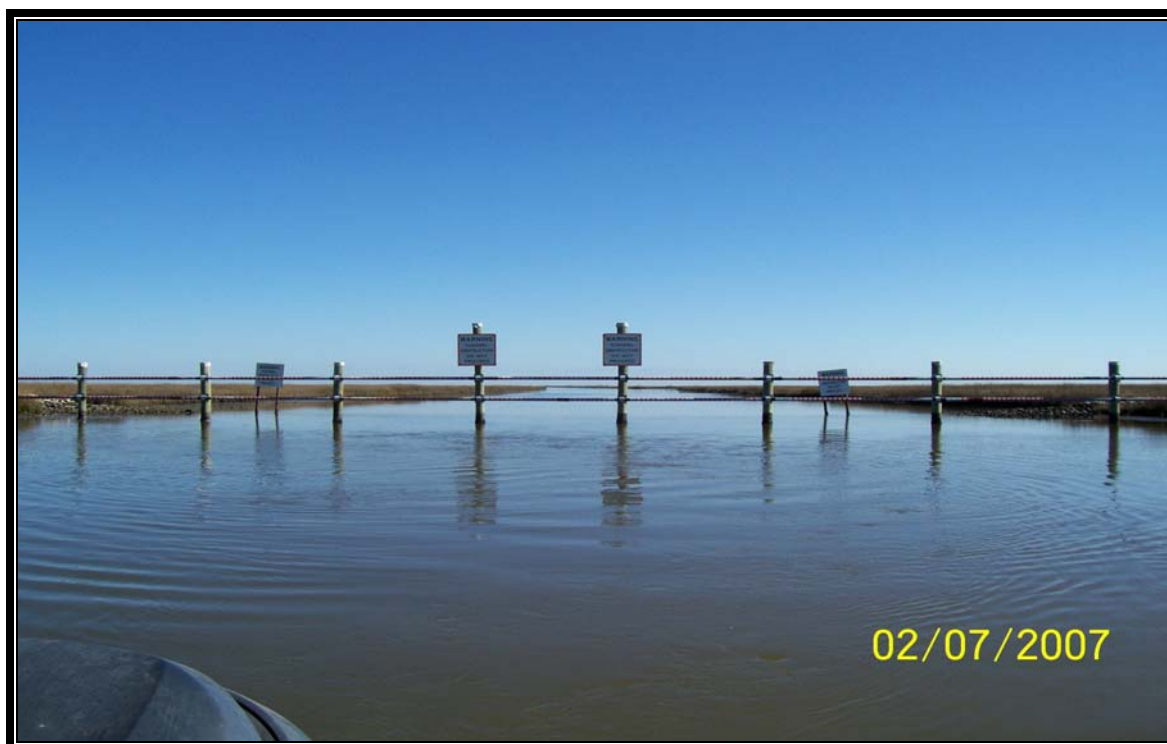
Overall, the rock weir and tie-ins to the earthen embankments appeared to be in good condition with no apparent erosion of the tie-ins to the canal banks (Appendix A; Photos 1-3). The warning signs and timber pile barricade system appeared to be in good condition. No maintenance will be required at this site. The existing water gauge located near this site (TE-26-03) indicated that the water level at 9:45 a.m. was approximately -0.10 ft NAVD88. Due to the location of the barricade system, we were unable to approach the structure to determine the depth of water above the weir. The latest field data available on the elevation of the rock weir was collected from a survey performed by Acadian Engineers of Eunice, La., in June 2004. The average elevation of the weir was determined to be -1.53 ft NAVD88. The design elevation for Site No.1, as shown on the construction drawings, is 0.0 ft NGVD29 or -0.14 ft NAVD88 (Corpscon conversion). Therefore, the difference in elevation observed in the field and the designed height is -1.39 ft. Since no as-built drawings were produced following construction, the design elevation was used for comparison.

Photo 1 - (Structure No. 1) - Rock weir and timber barricade structure looking north.

Photo 2 - (Structure No. 1) - Rock weir and timber barricade structure looking east.

Photo 3 – (Structure No. 1) – Rock weir and barricade structure looking northeast.

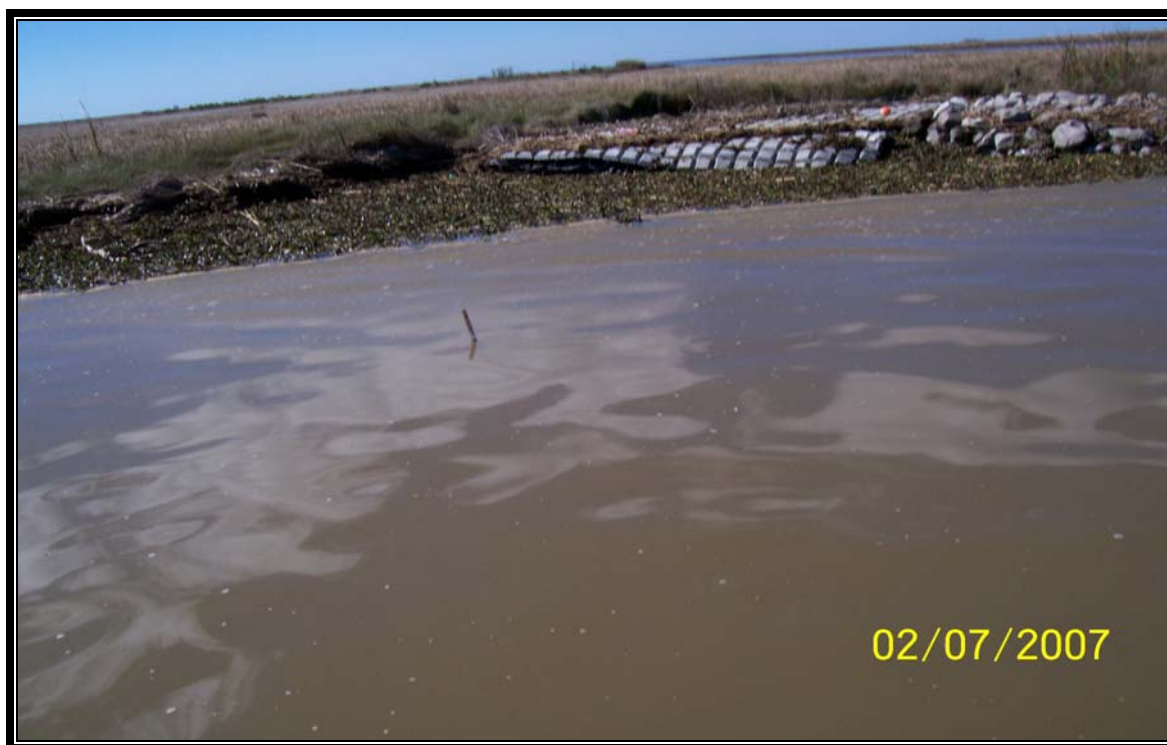
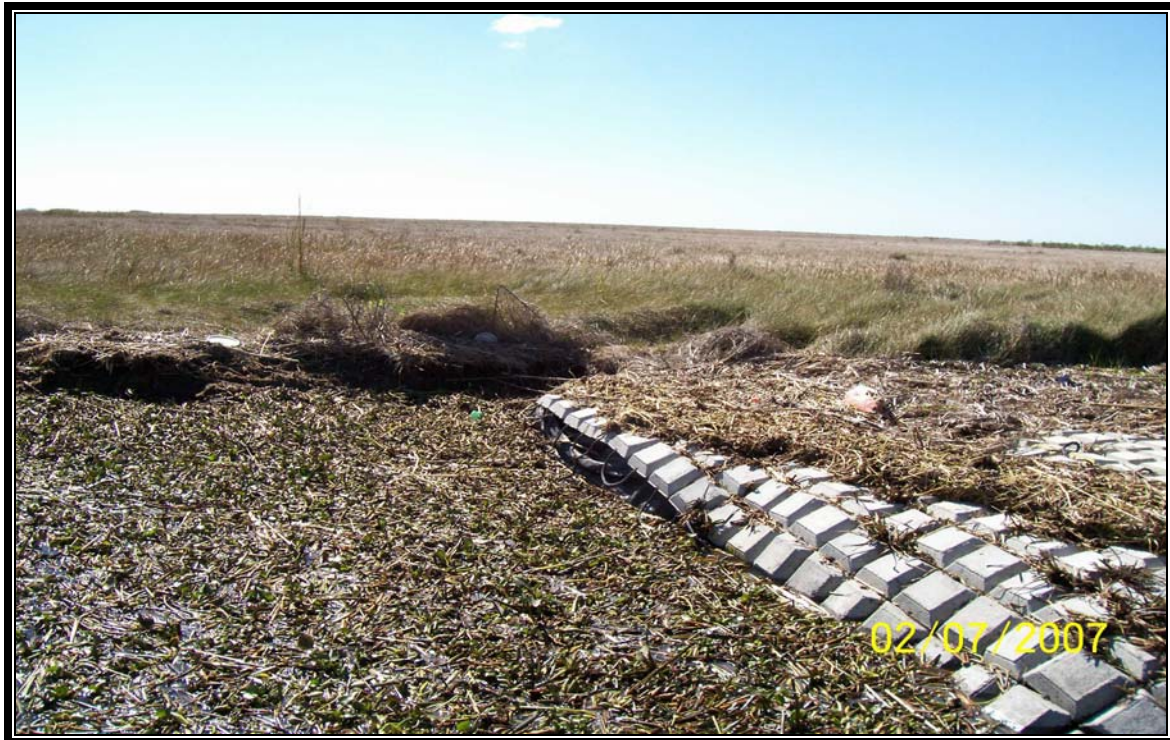
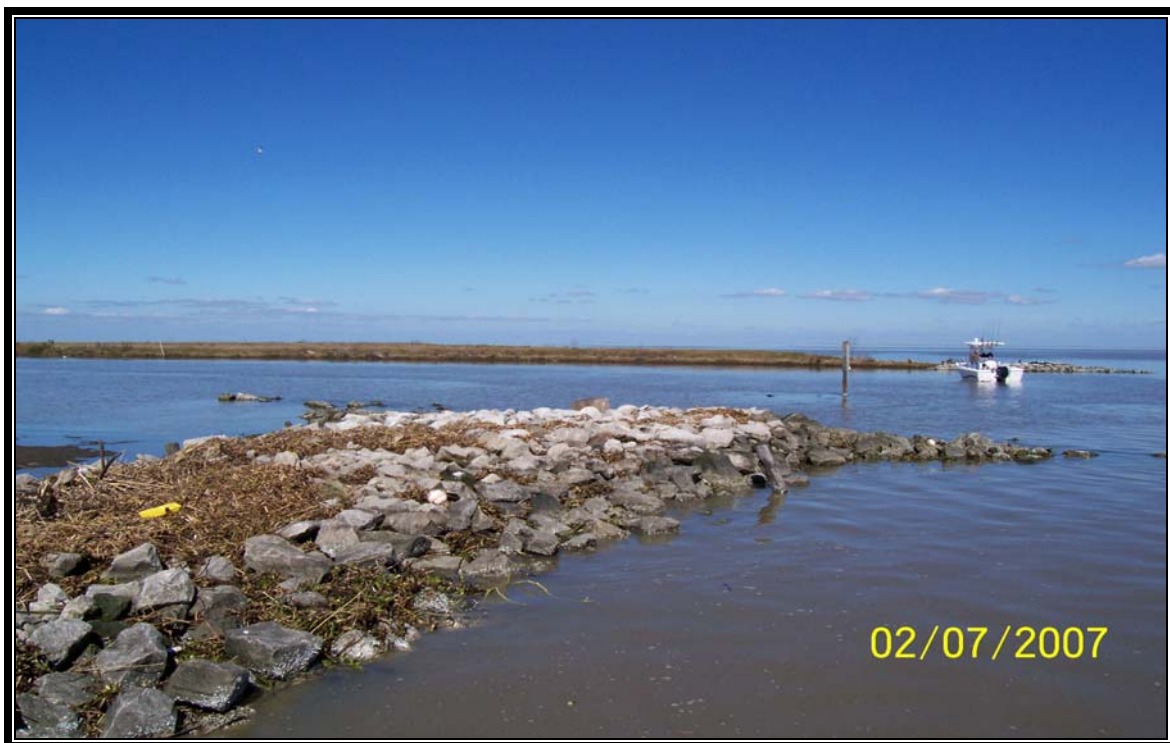
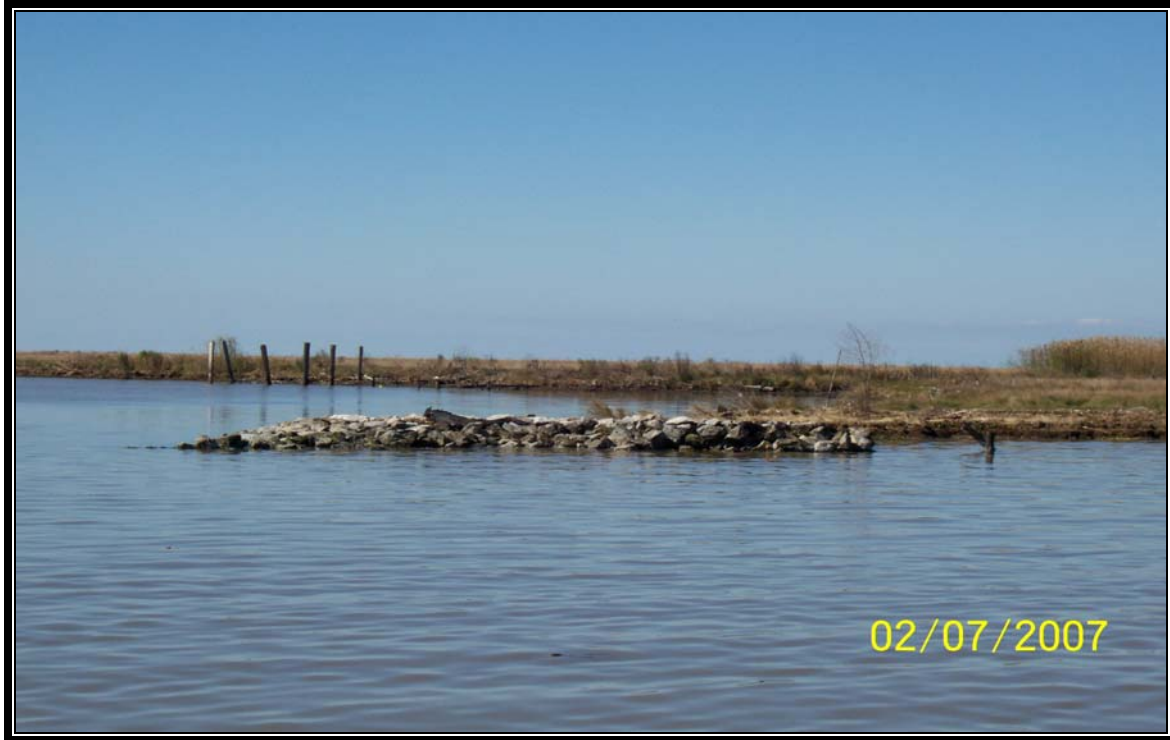
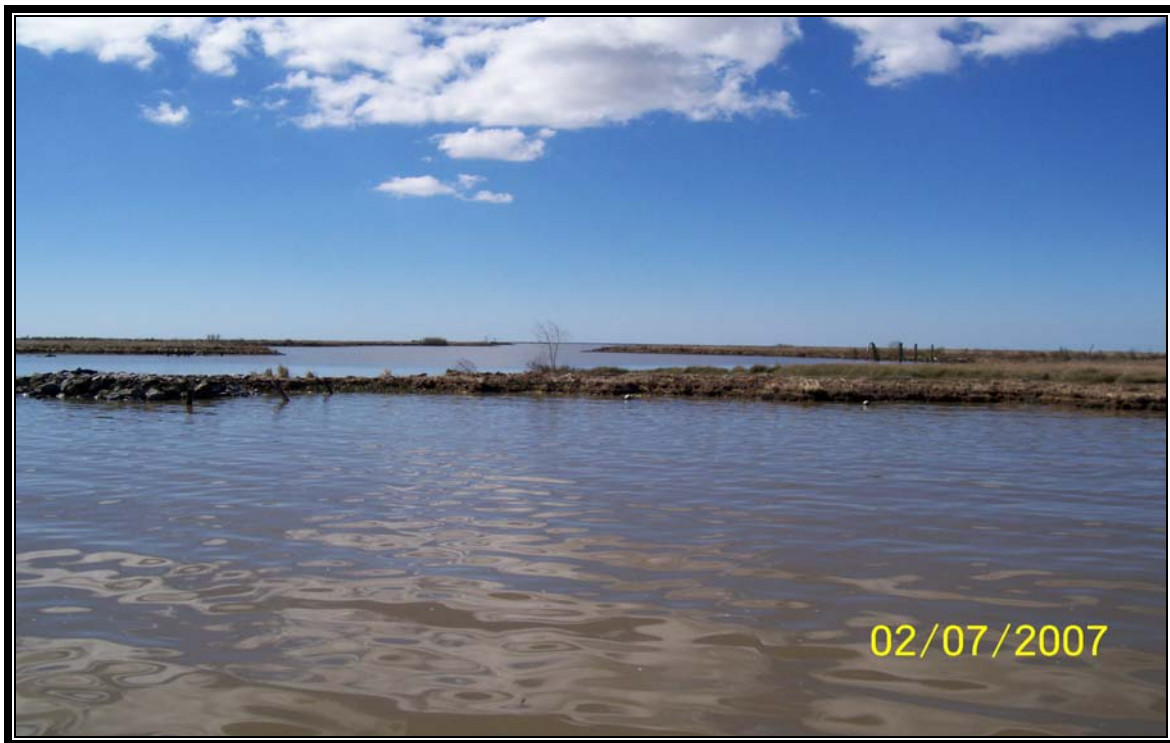
The rock weir was found to be in fair condition with no obvious settlement or displacement of the rock rip rap. The earthen embankment tie-ins, however, were in poor condition with moderate to severe erosion on the northern end of the rock embankment (Appendix A; Photos 4 through 8). The marsh in this area has eroded back to the face of the rock embankment, leaving the potential for a breach to occur around the structure as erosion persists. The marsh on the south side of the structure has also experienced significant erosion, although not as severe as the north side. Based on our observations, it is highly probable that the north side of the structure will breach within the coming year and will require maintenance. The warning signs and supports were in good condition other than slight fading of the orange trim and black lettering. Since this is a rock weir with boat bay, no barricade system exists. It is recommended that the rock embankment be extended northward to an area of more stable marsh. From the maintenance survey performed in June 2004, the elevation of the weir at Structure No. 3 was measured at -5.15 ft NAVD with the original design height of the crest at -4.17 NAVD (-4.0 ft NGVD on plans). The difference between the weir elevation measured in 2004 and the design elevation is approximately -0.98 ft.

Photo 4 – (Structure No. 3) – Articulated concrete mats tie-in to marsh on south side.

Photo 5 – (Structure No. 3) – Articulated concrete mats tie-in to marsh on south side.

Photo 6 – (Structure No. 3) – Rock weir on the south side of the structure.

Photo 7 – (Structure No. 3) – Rock weir tie-in to marsh on the north side of structure.

Photo 8 – (Structure No. 3) – Rock weir tie-in to marsh on the north side of the structure.

As outlined in the inspection results section, the marsh on the northern end of Structure No. 3 has eroded back to the face of the rock embankment and is in danger of breaching in the near future. Based on our observations and knowledge of erosion problems in this area, we recommend that a maintenance plan be initiated for the extension of the rock dike northward to more stable marsh. In Appendix B, LDNR has prepared a cost estimate for this work, including engineering, design, construction, and construction oversight services.

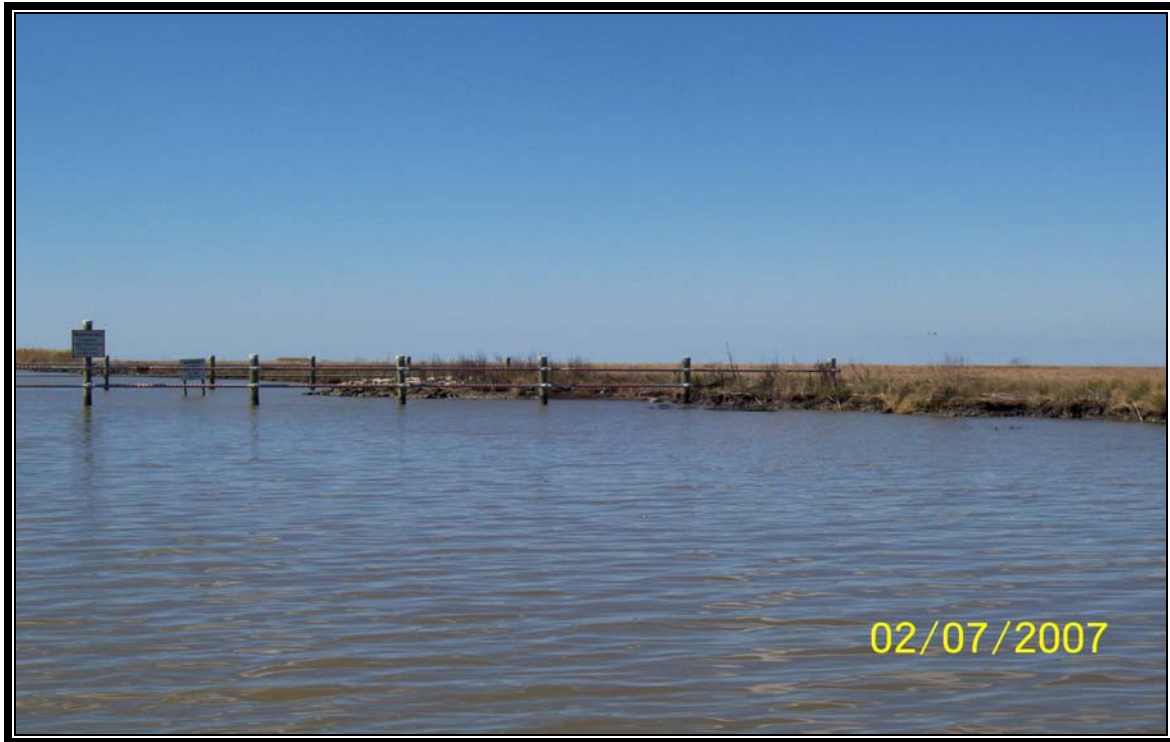
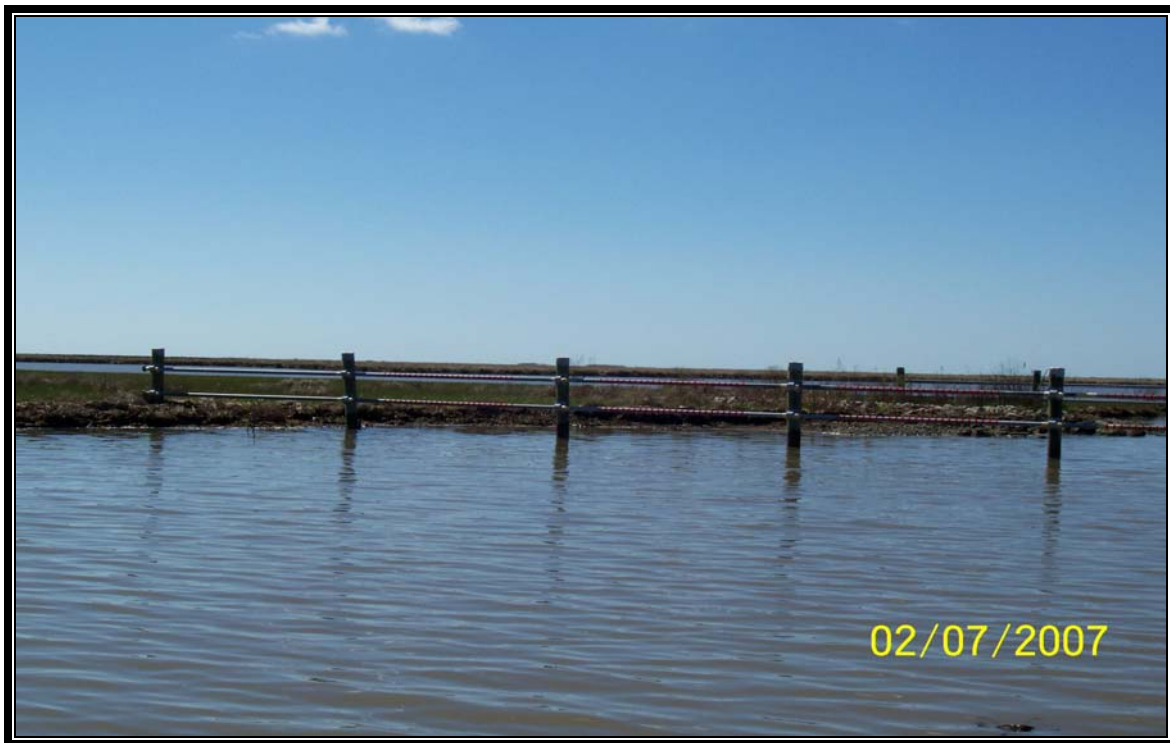
The rock weir appeared to be in good condition (Appendix A; Photos 9 and 10). The rock tie-ins, earthen embankments, timber barricade system, signs, and supports were also in good condition. As reported on previous inspections, the two (2) center pilings installed under the timber barricade project on the eastern side of the structure were found to be unstable. LDNR will continue to monitor the stability of these pilings. The average elevation of the rock weir was determined to be approximately -1.29 ft NAVD88 from a survey performed in 2004 profiling the structure. With a design elevation of -0.16 NAVD88 (converted using Corpscon), it was determined that the structure had settled approximately 1.13 ft NAVD88 from the original design elevation.

Photo 9 – (Structure No. 4) – Rock weir and timber barricade system looking west.

Photo 10 – (Structure No. 4) – Rock weir and timber barricades looking south.

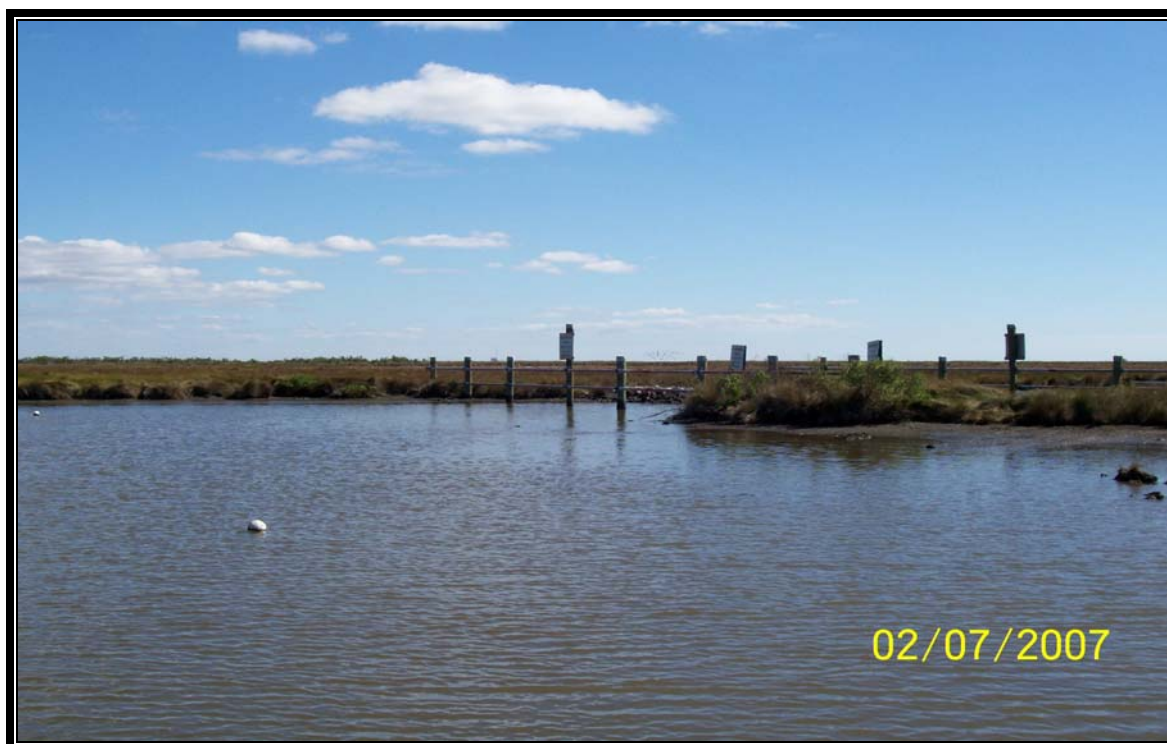
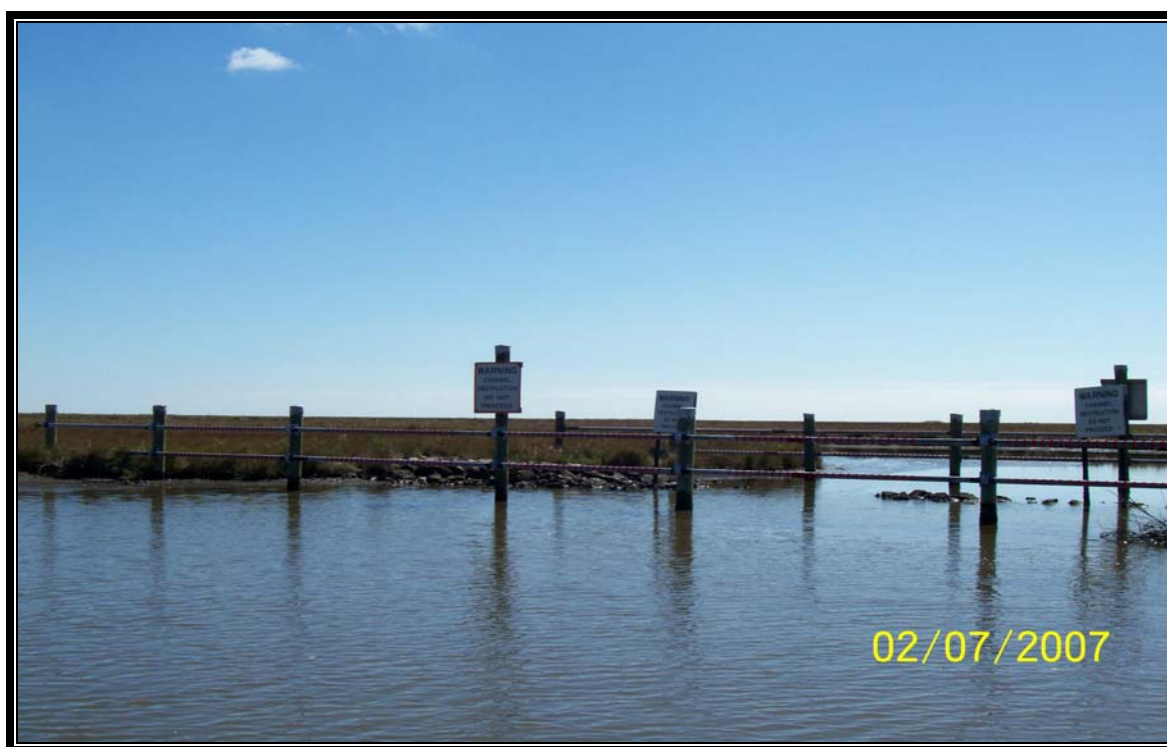
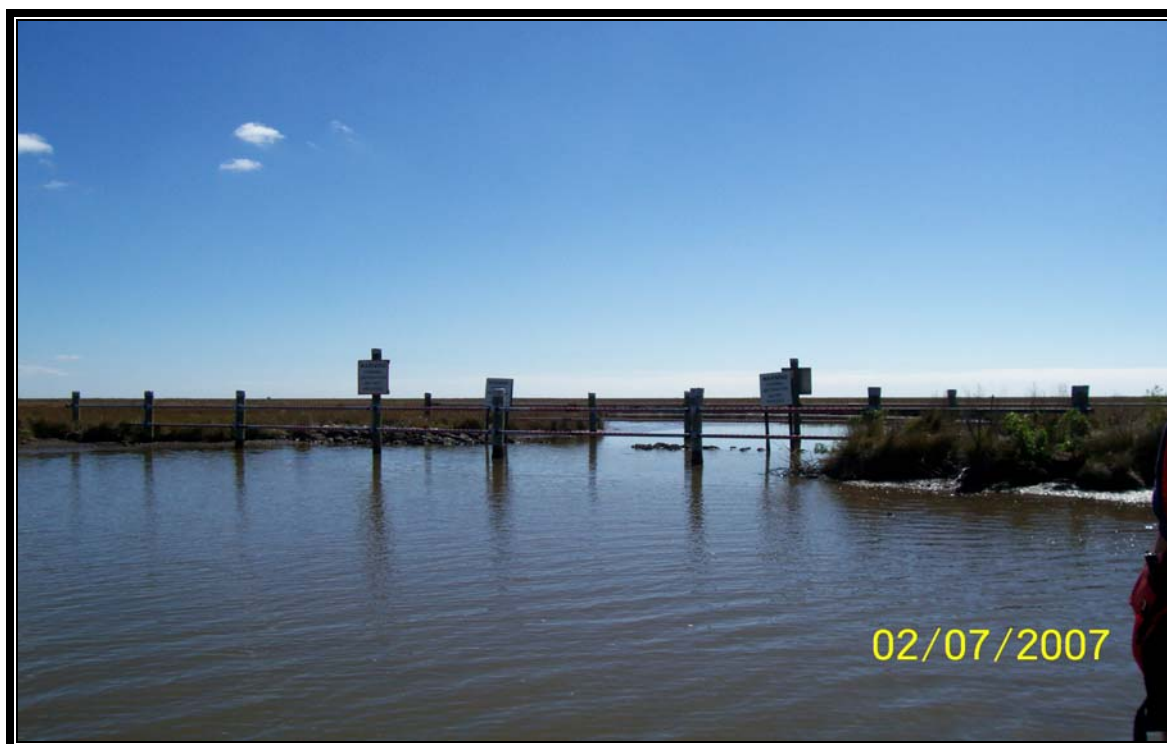
Rock weir, tie-ins, earthen embankments, barricade system, warning signs, and supports all appeared to be in good condition (Appendix A; Photos 11 through 13). The water level in the channel adjacent to the structure was very low at the time of the inspection, with a portion of the rock weir exposed. In 2004, a profile survey indicated that the average elevation of the rock weir was approximately -0.28 ft NAVD88. It was estimated, based on the design elevation of -0.14 ft, that the structure had settled an average of 0.14 ft. Since no as-built survey was conducted, it is assumed that the rock weir was constructed to the design elevation on the plans.

Photo 11 – (Structure No. 5) – Rock weir and barricade system looking southeast.

Photo 12 – (Structure No. 5) – Rock weir and barricade system looking southeast.

Photo 13 – (Structure No. 5) – Rock weir and timber barricade system looking southeast.

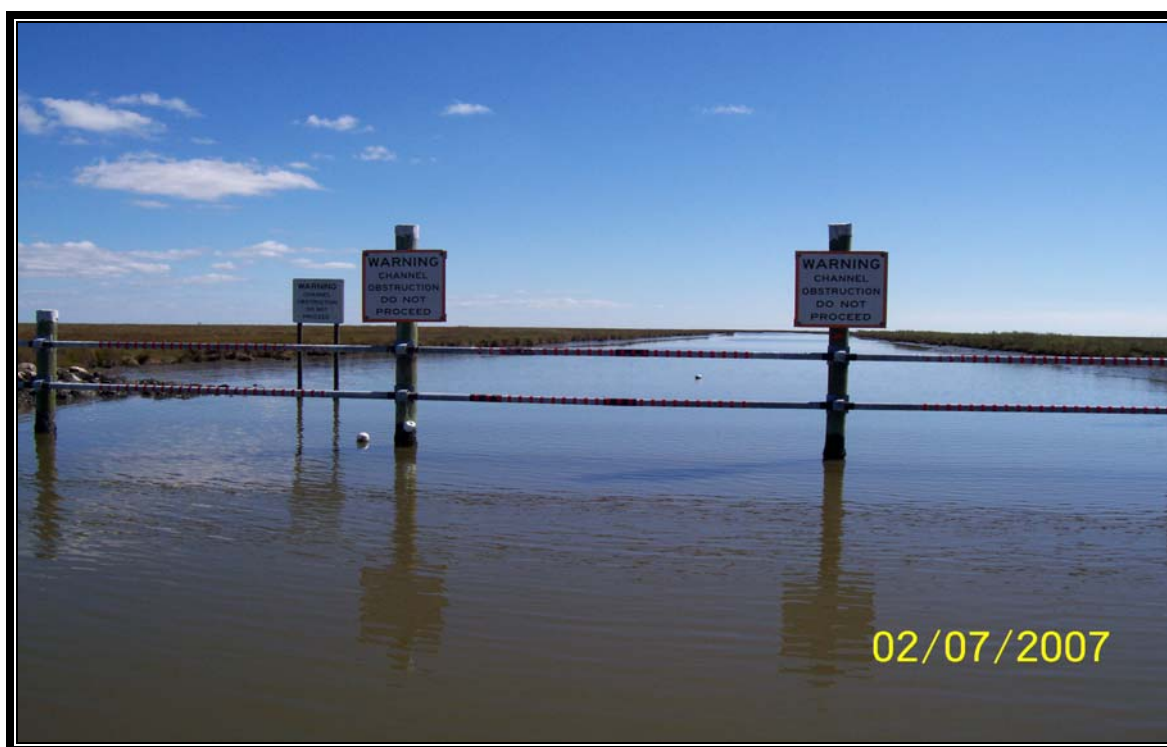
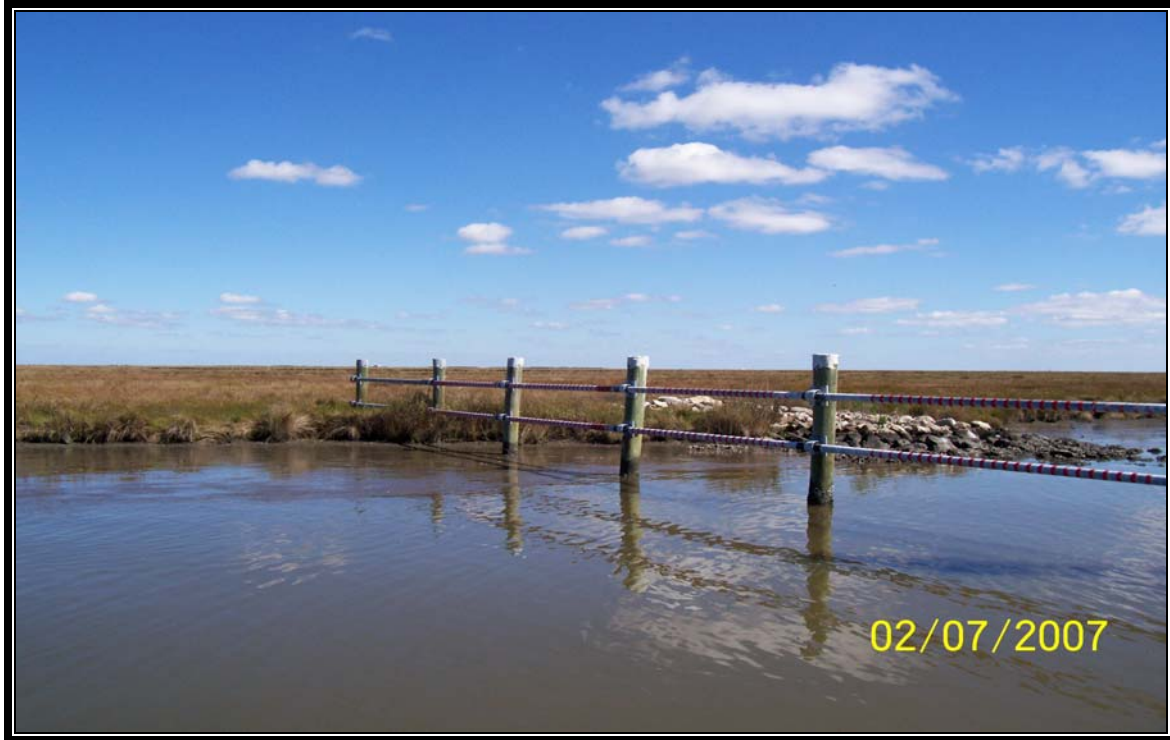
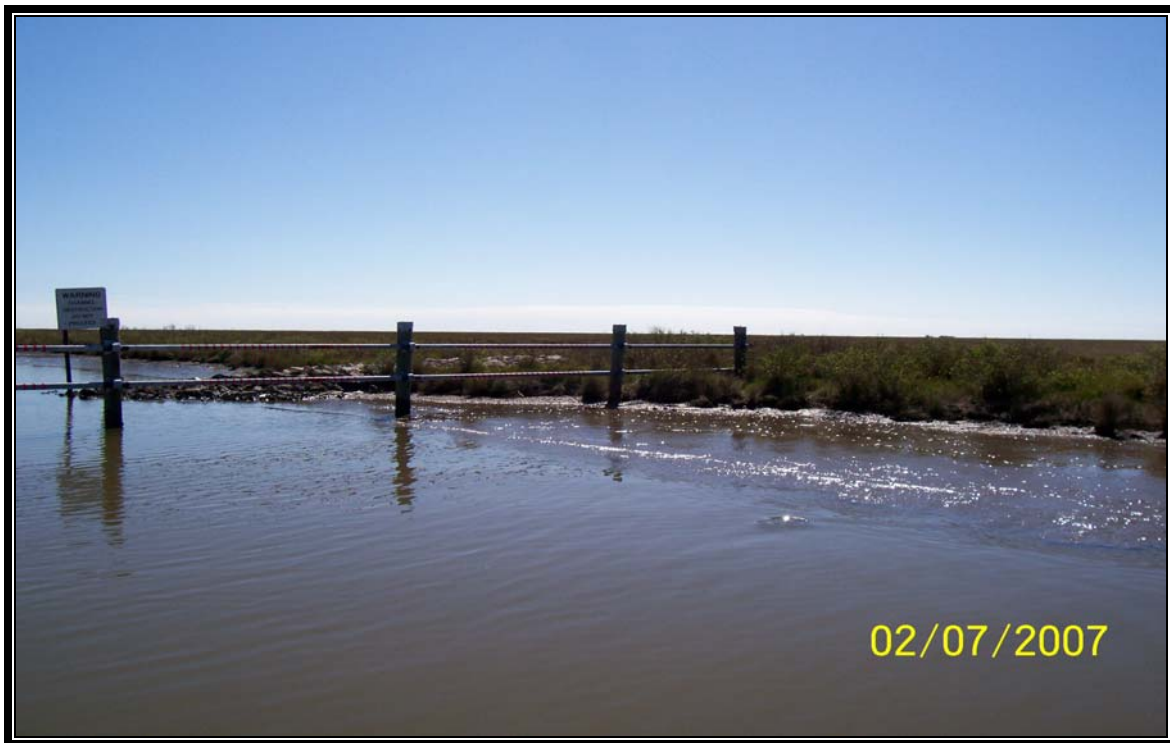
Rock weir, tie-ins, earthen embankments, barricade system, signs, and supports were in good condition with no obvious damage or deficiencies (Appendix A; Photos 14 through 16). The rock weir was designed to an elevation of 0.0 ft. NGVD29 (-0.13 ft NAVD88 – Corpscon conversion). From the 2004 survey profile, it was determined that the average elevation of the rock weir was at an elevation of -1.25 ft NAVD88. The difference between the design elevation and measured elevation indicates an average settlement of approximately 1.12 ft.

Photo 14 – (Structure No. 6) – Rock weir and timber barricade system looking southeast.

Photo 15 – (Structure No. 6) – Rock weir and timber barricade system looking northeast.

Photo 16 – (Structure No. 6) – Rock weir and barricade system looking south.

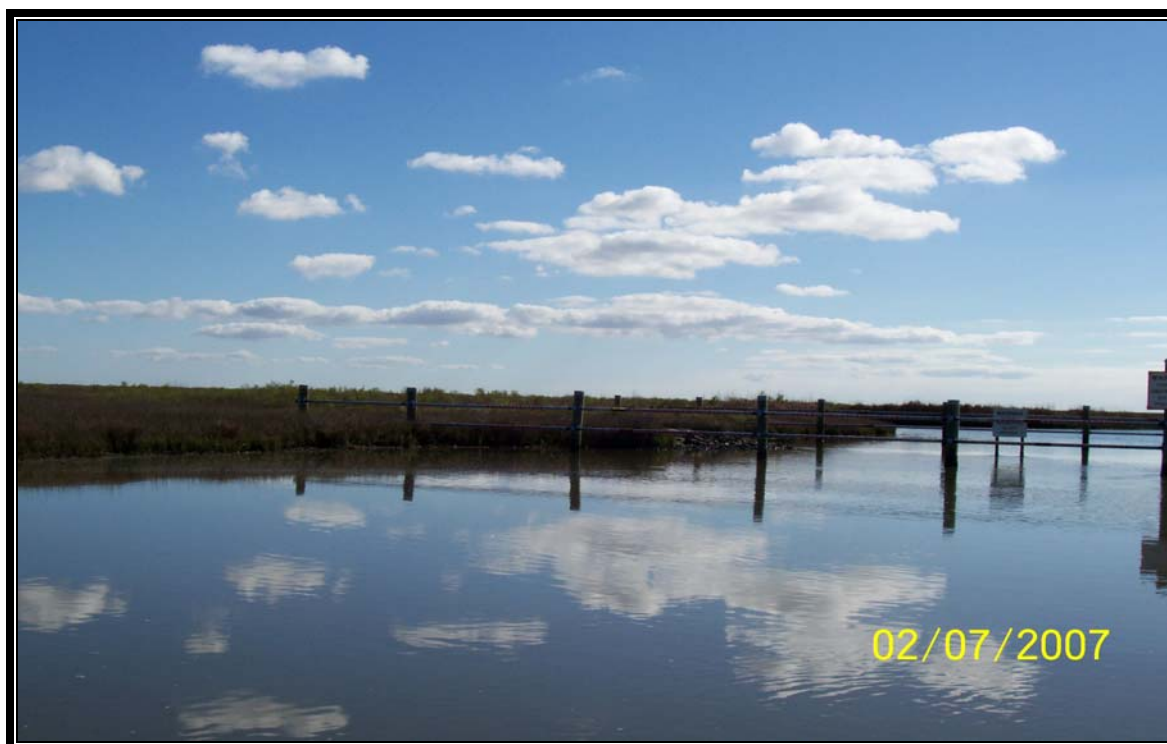
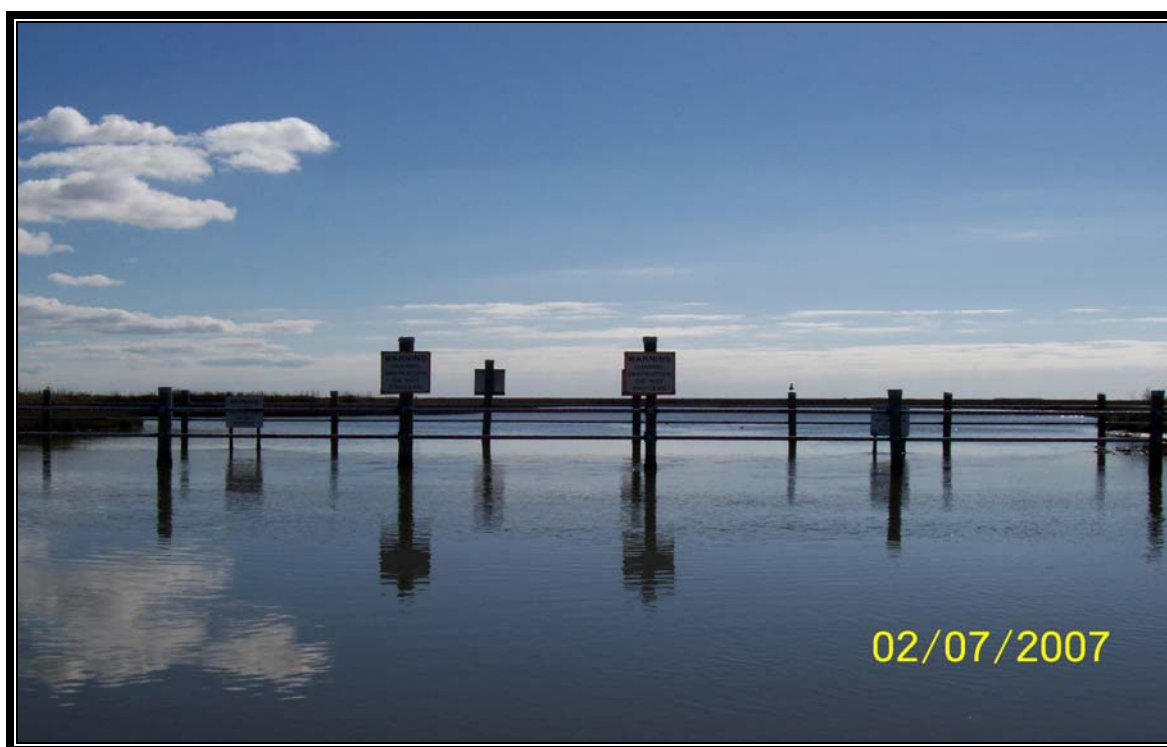
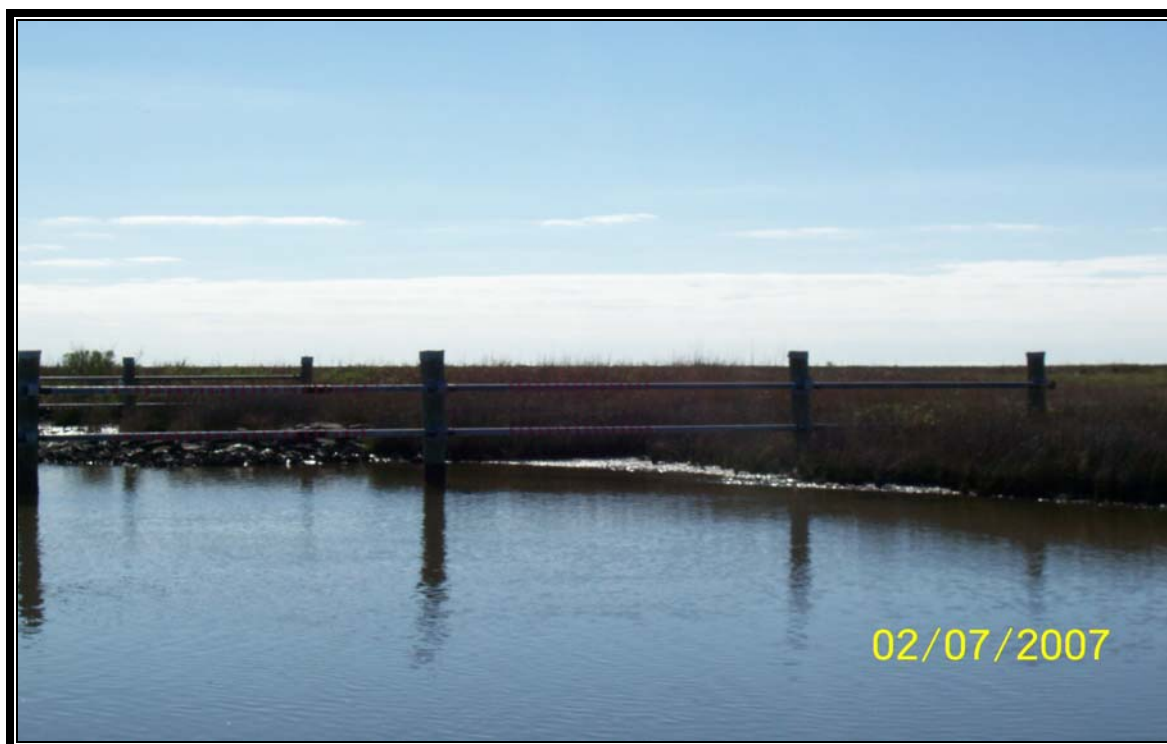
The rock tie-ins, earthen embankments, timber barricade system, and signs and supports at Structure No. 7 were all in good condition with no apparent damage or breaching of earthen tie-ins (Appendix A; Photos 17 through 19). The survey profile of the rock weir taken in 2004 indicated that the average elevation of the weir was determined to be -1.80 ft NAVD88. The design weir elevation as shown on the construction drawings was 0.0 ft NGVD29 or -0.14 ft NAVD88 using the Corpscon conversion. It is estimated that the weir had settled approximately 1.66 ft by the difference in the design elevation and the measured height.

Photo 17 – (Structure No. 7) – Rock weir and barricade system looking northeast.

Photo 18 – (Structure No. 7) – Rock weir and barricade system looking east.

Photo 19 - (Structure No. 7) - Rock weir and barricade system looking south.

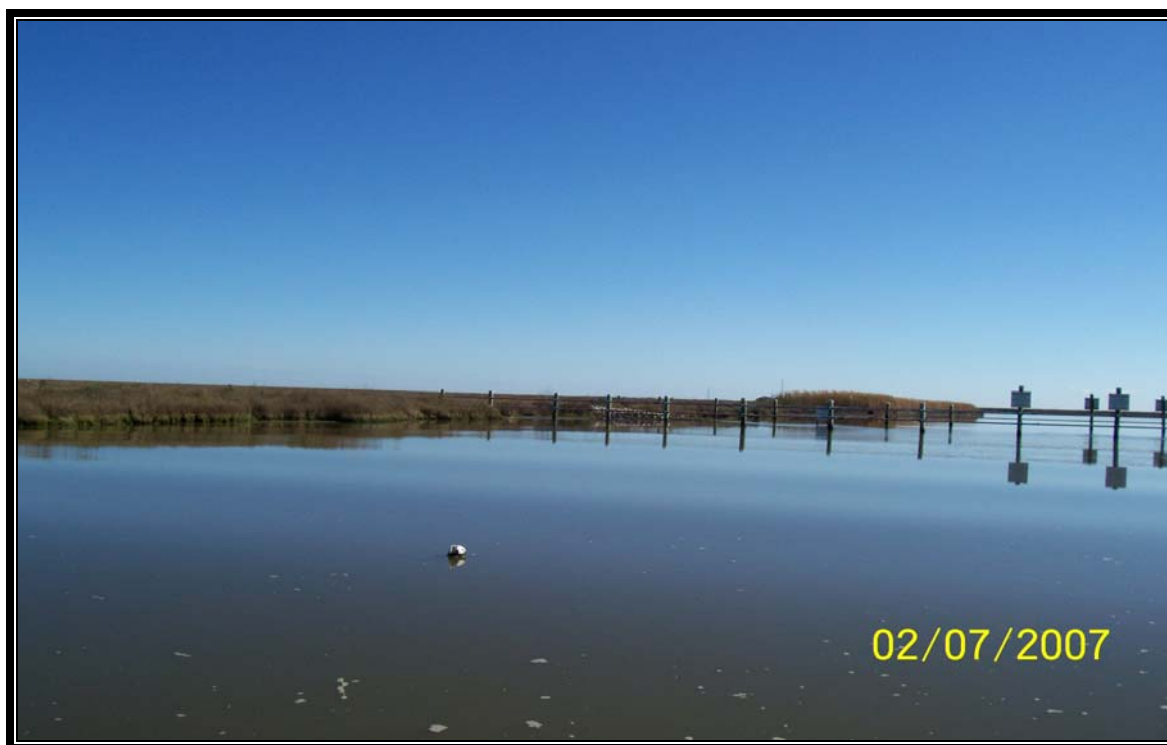
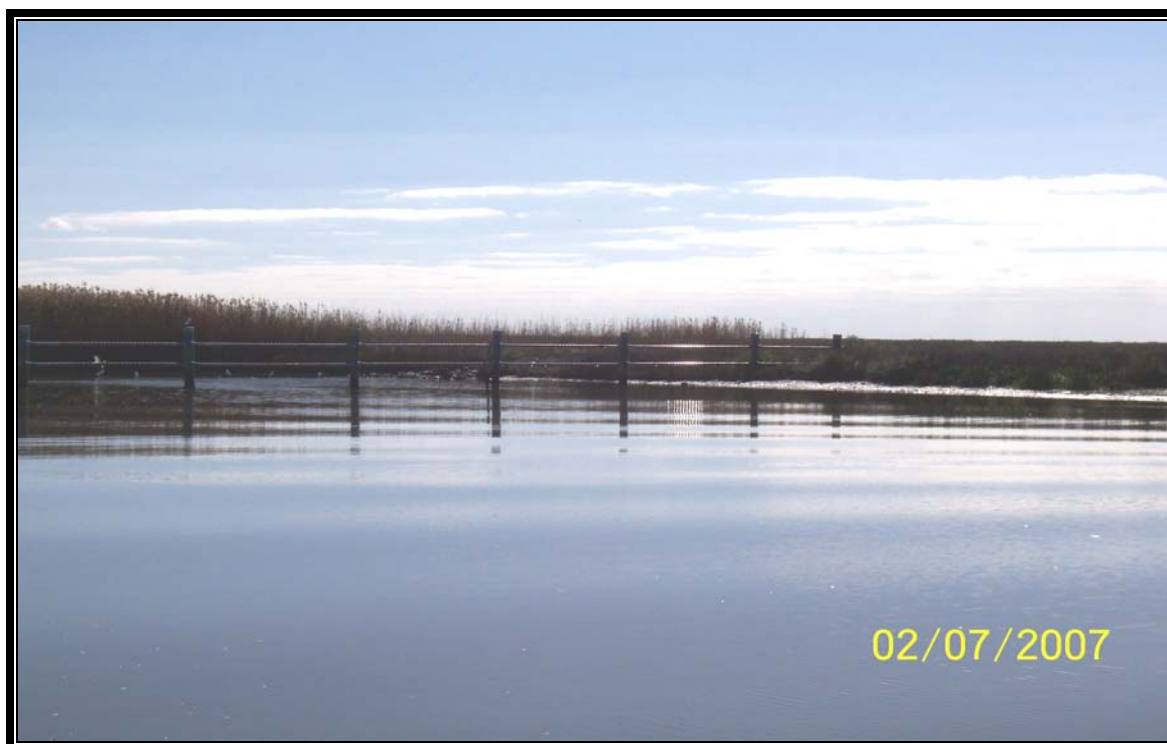
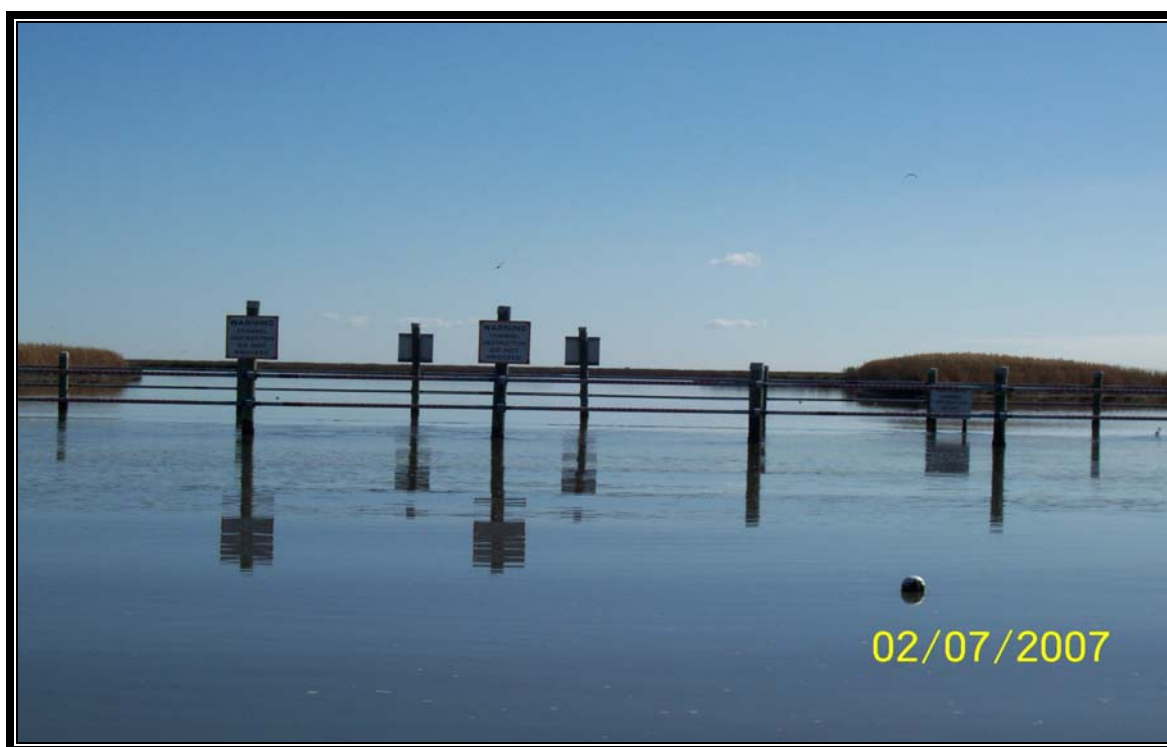
The rock tie-ins, earthen embankments, timber barricade system, signs and supports at structure No. 9 appeared to be in good condition (Appendix A; Photos 20 through 22). The 2004 profile survey of this structure measured an average elevation of -1.80 ft NAVD88. The design weir elevation for Structure No. 9 was -0.14 ft NAVD88 (0.0 ft NGVD29 on plans). The difference between the weir elevation observed in the field and the design elevation is approximately 1.66 ft.

Photo 20 - (Structure No. 9) - Rock weir and barricade system looking northeast.

Photo 21 – (Structure No. 9) – Rock weir and barricade system looking south.

Photo 22 – (Structure No. 9) – Rock weir and barricade system looking southeast.

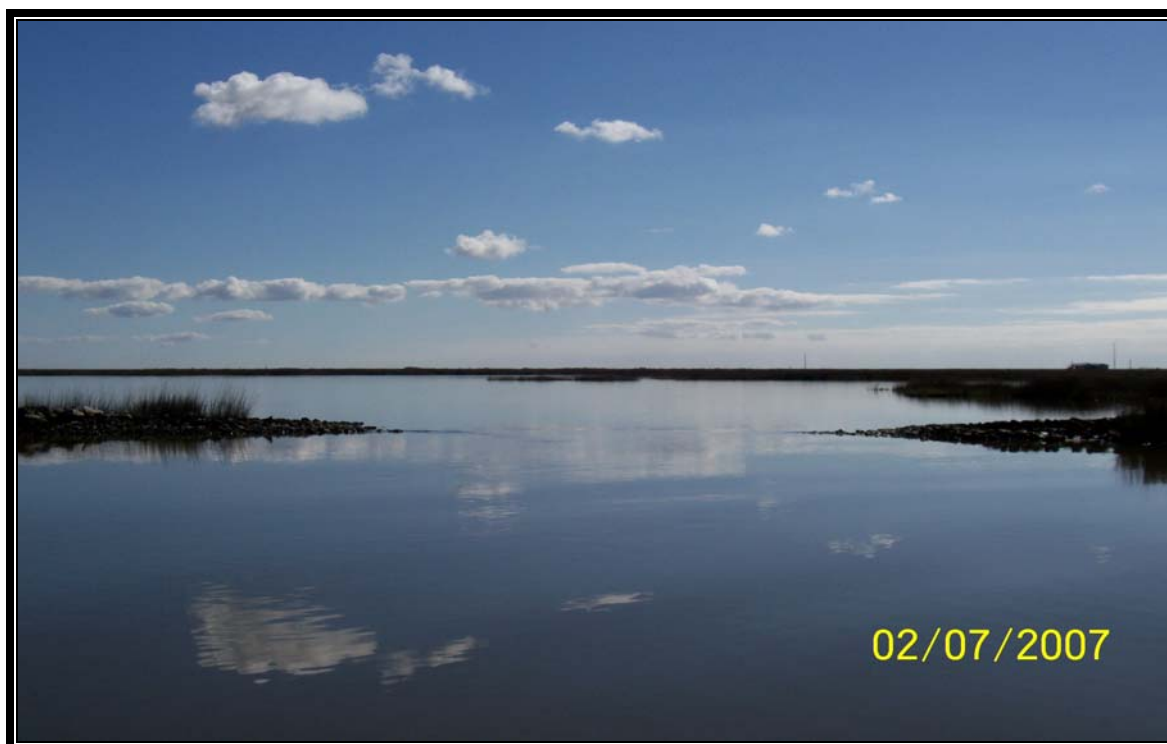
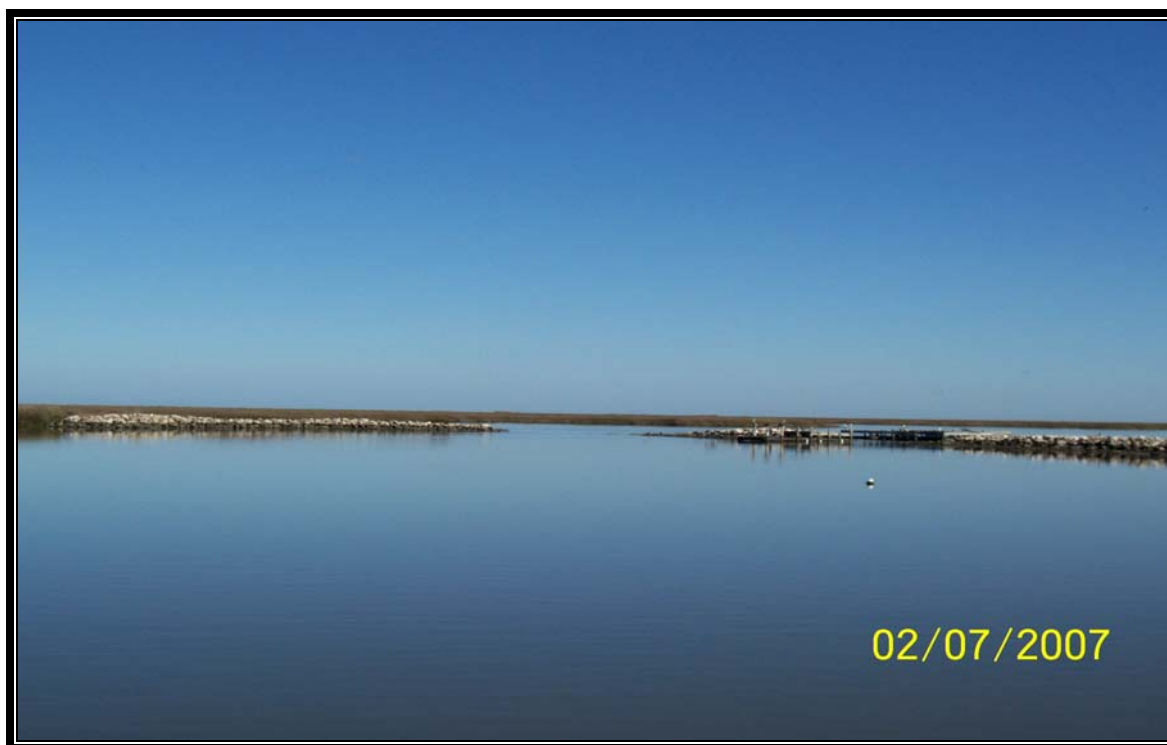
Photo 23 – (Breach 3) – Breach in rock lined bank along oilfield canal.

Photo 24 – (Breach 3) – Opening in rock dike at the end of an existing oilfield canal.
