**State of Louisiana
Coastal Protection and Restoration Authority**

2011 Operations, Maintenance, and Monitoring Report

Bayou Chevee Shoreline Protection (PO-22)

June 2011
Orleans Parish

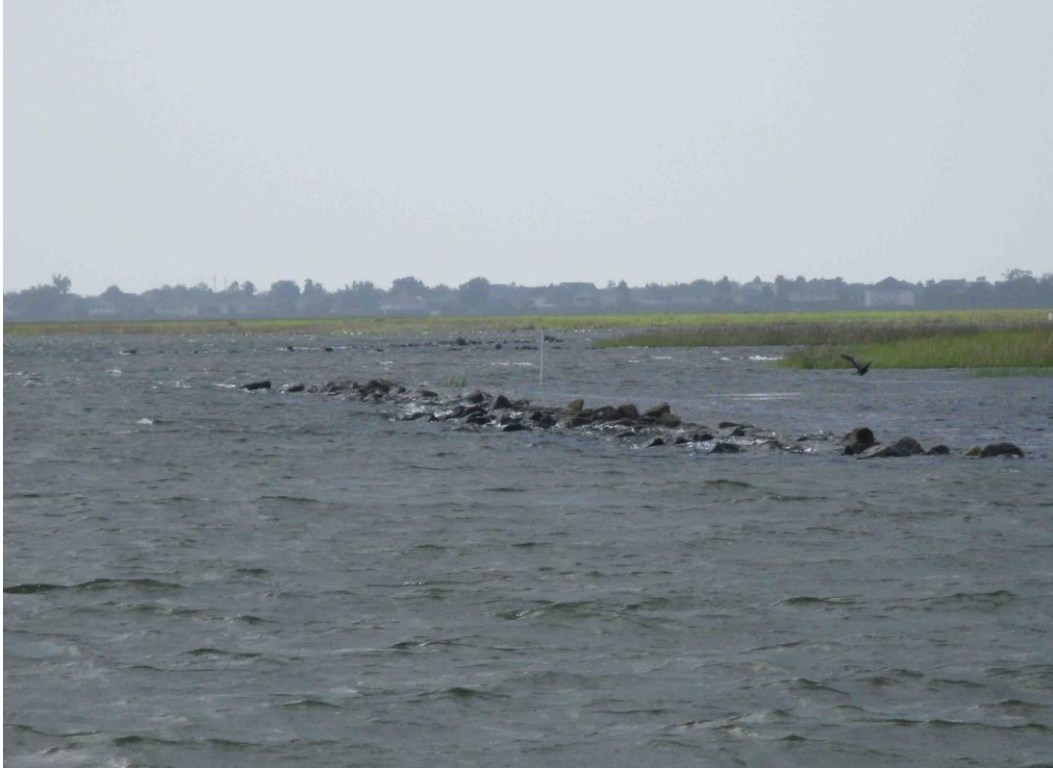
There was no visible damage to the dikes. The southern reach and the southern portion of the northern reach are showing noticeable signs of settlement. The northern portion of the northern reach is still at an acceptable grade.

While the water level was higher than normal, the settlement of approximately 70% of the project feature was evident (photo 1). At some points it was below the water level and at most it was just above. The northern section of the project is still at an acceptable elevation to provide shoreline protection (photo 2), however the majority of the project is low enough that it is providing little or no protection to the shoreline from normal and abnormal tidal actions.

Photo #1 – A low portion of Southern Reach.

Add rock to low sections of dike.

A maintenance lift is necessary to raise the elevation of the portions of the rock dike that have settled. Portions of the rock dike are no longer providing adequate shoreline protection due to settlement. Consider extending the rock dike at the South end to Chef Menteur Pass to reduce the rapid erosion occurring along this stretch of shoreline.

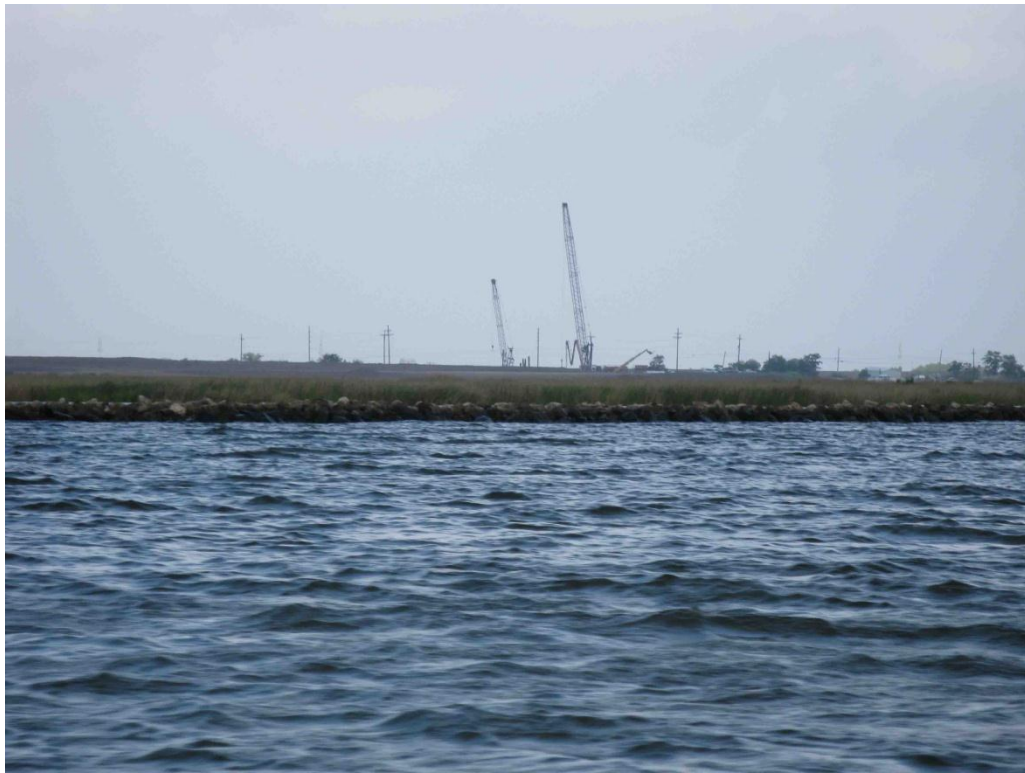
Photo #2 – Acceptable portion of Northern Reach.
