# **2011 Operations, Maintenance, and Monitoring Report**

# **Jonathan Davis Wetland Restoration** (BA-20)

State Project Number BA-20 Priority Project List 2

November 2011 Jefferson Parish

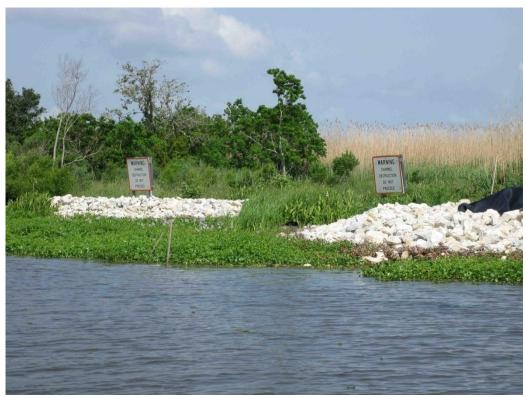
Photo #1 – Structure #14

Approximately 80% of this structure has been repaired. Two breaches were still present at the time of the inspection (Photo #1). Additional repair of this structure was made during CU4 construction.

Item	Condition	Physical Damage	Corrosion	Photo #	Observations and Remarks
Signage and supports	Good			1	Observations:  80% of the repairs have been completed at this time. Looks good.
Armored Plug	Good			1	
Earthen Embankment	Fair			1	
located in a pipelin of GIWW and Site NGVD. The rock fil	on: 138 linear ft. of e channel north of E 13. The crest of the lled plug contains 2,	rock rip-rap armored Bayou Perot, west of E plug was constructed 580 tons of rock fill ar s are located through	Bayou Barataria I to an elevatior nd 1,346 tons of

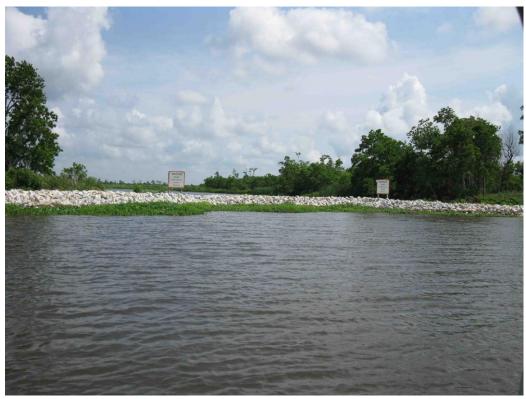
<u>Photo #2 – Structure #15</u> 51

All maintenance has been completed on this structure during construction of CU4. The boat bay has been filled, converting this structure to a plug, and everything is in good condition (Photo #2).

Item	Condition	Physical Damage	Corrosion	Photo #	Observations and Remarks
Signage and supports	Good			2	Observations: The maintenance work is completed and this is now a channel plug structure.
Armored Plug	Good			2	
Earthen Embankment	Good			2	Remarks:
Construction Uni Structure Descript	i <b>t No.1</b> ion: Rock Riprap Cl	hannel Plug

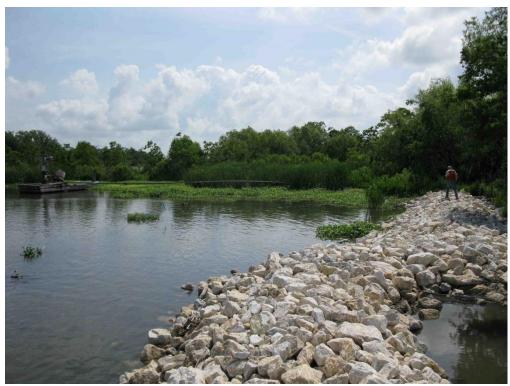
Photo #3 – New Rock to Structure #16 (under vegetation)

Structure 16 was difficult to inspect due to the amount of vegetation growing on the structure (Photo #3). It is assumed that this structure has stabilized due to the conditions of the channel and the structure signage. The new construction has tied this structure in with the rest of the Construction Units and it is recommended that there be no maintenance work at this time.

ltem	Condition	Physical Damage	Corrosion	Photo #	Observations and Remarks
Signage and supports	Good			3	
Armored Plug	Fair			3	Observation: There have been no changes since the last inspection. Maintenance not needed at this time.
Earthen Embankment	Good			3	
Construction Uni	it No.1				Remarks:
Construction Unit No.1 303 linear ft. of rock rip-rap armored rock filled plug located in a pipeline channel north of Bayou Perot, west of Bayou Barataria, east of the GIWW and Site 15. The crest of the plug was constructed to an elevation of +4.0 ft. NGVD. The rock filled plug contains 6,483 tons of rock fill and 1,766 tons of rock rip-rap armor. Two (2) aluminum warning signs are located through the rock plug embankment.

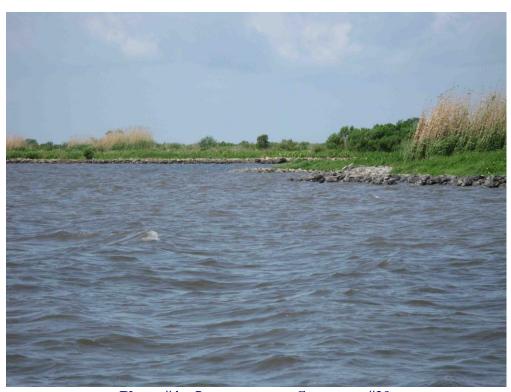
Photo #4 – Low spot near Structure #20

The rock dike along the northern shore of Bayou Rigolettes appears to be in good condition. There is some noticeable settlement near the western end of this feature (Photo #4). Any maintenance work required will be completed in a future maintenance event.
