2011 Operations, Maintenance, and Monitoring Report

Point Au Fer Island Hydrologic Restoration (TE-22)

State Project Number TE-22
Priority Project List 2

July 2011
Terrebonne Parish

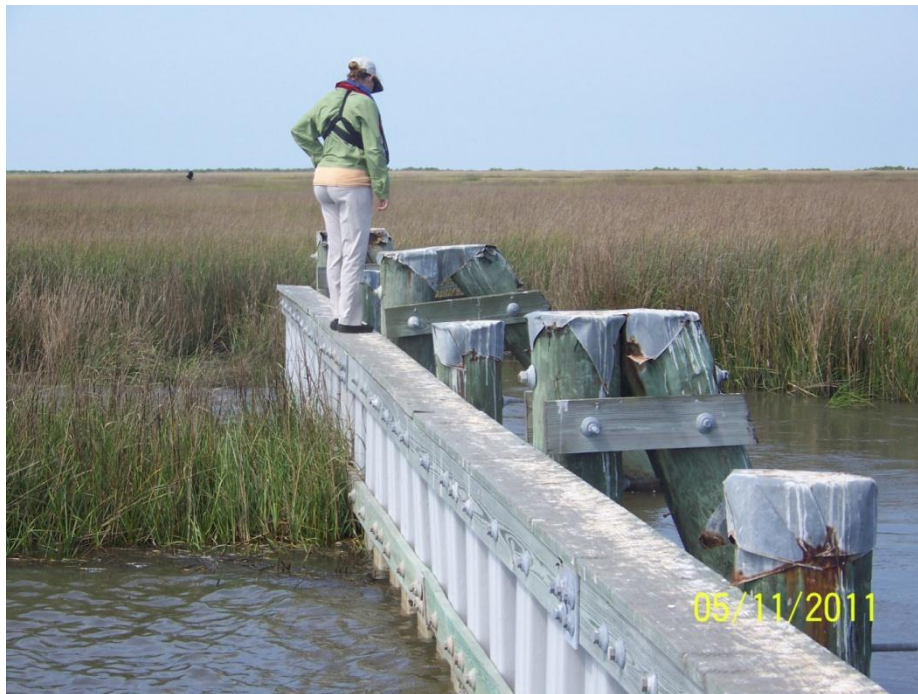
Photo #2: view of vinyl section on southwest end of Plug No. 8 from on top of the structure, looking southwest

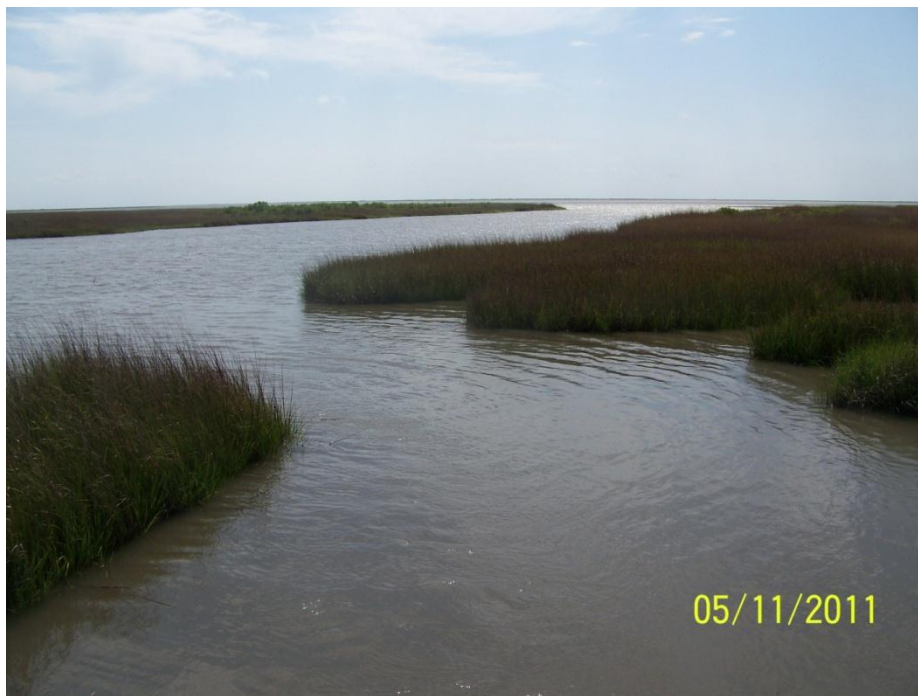
The timber bulkhead and vinyl sheet pile extension are in good condition. There is an existing breach around the southern end of the structure that occurs adjacent to the sheetpile. In addition the Submar scour mats placed on the southern end of the structure are no longer visible. It is assumed that these sections were undermined from the water rushing through the breach and may lie somewhere on the bottom of the breach. The embankment tie-in on the north side of the structure has no signs of erosion or breaching. The warning signs and supports were in good overall condition. There are no recommendations for corrective action at this time, but the structure and breach should be monitored during future inspections for further deterioration.

Photo #4: view of pre-existing breach on southwest end of Plug No. 8 from on top of the structure, looking east

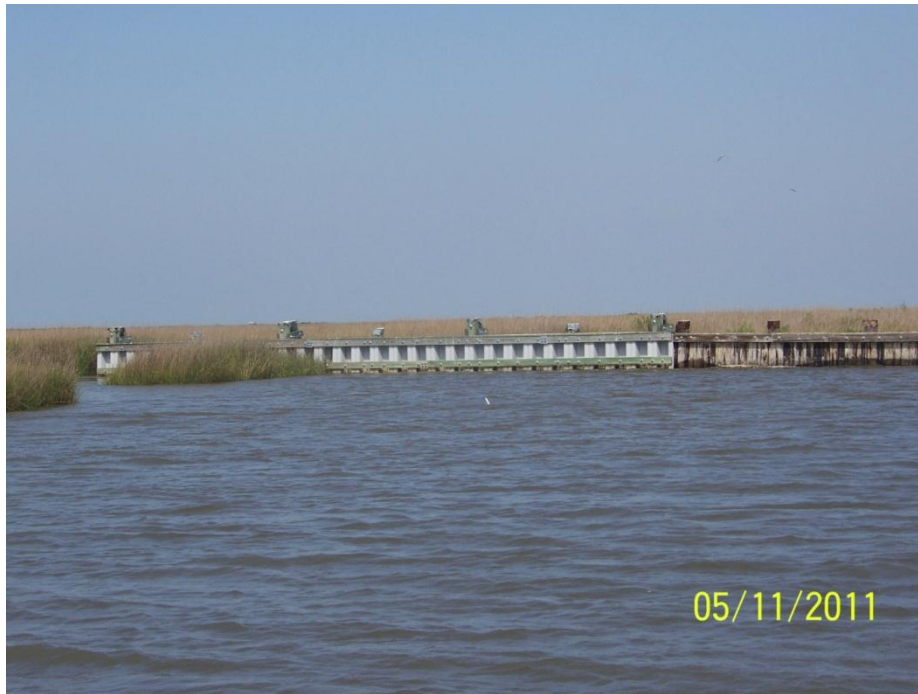
Photo #7: view of vinyl section on southwest end of Plug No. 8, looking northwest

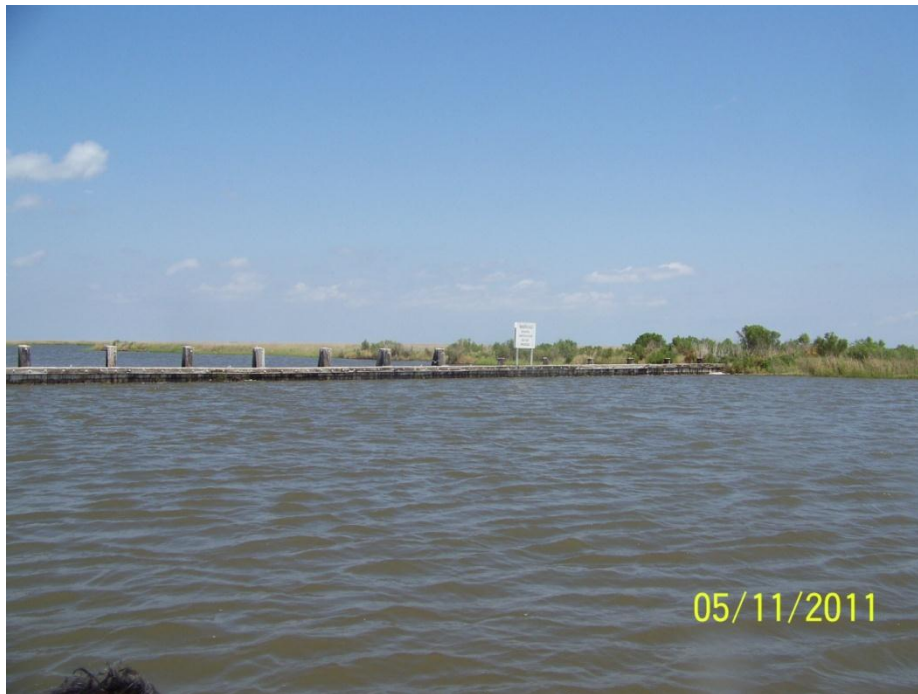
breaching. The warning signs and supports are also in good condition. Although the timber bulkhead and its tie-ins have no defects, the structure is considered ineffective due to a large breach (approximately 50 feet) on the south side of the structure which allows tidal flow around Plug No. 2. There are no recommendations for corrective action at this time due to construction access constraints.

Photo #14: view of timber bulkhead Plug No. 2 from Hester Canal, looking west

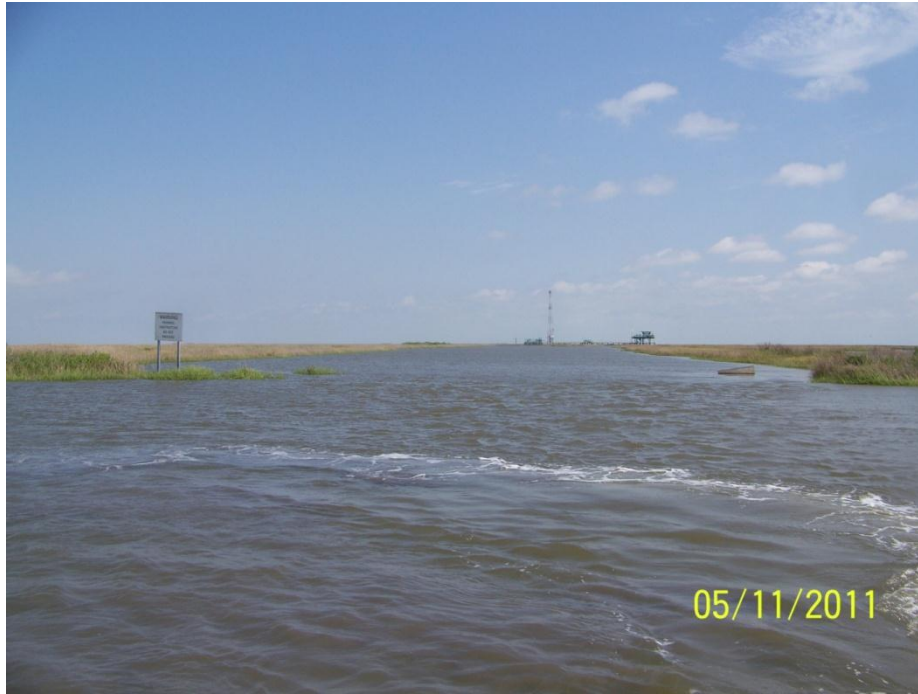
The shell Plug No. 3A located in Transco Canal just north of Hester Canal is in poor condition. As previously reported, the shell plug has eroded in the center of the structure leaving the plug crest below water elevation at the time of the inspection. According to the as-built and construction plans, the shell plug was constructed to elevation +4.0 NGVD. The embankment tie-ins are in good condition and have no signs of erosion or breaching. The west warning sign and supports are also in good condition, but the east sign and support is missing. At this time repairing the shell plug is not recommended due to construction access constraints; however, this plug should continue to be monitored on future site visits.

Photo #21: view of shell Plug No. 3A from Transco Canal, looking north

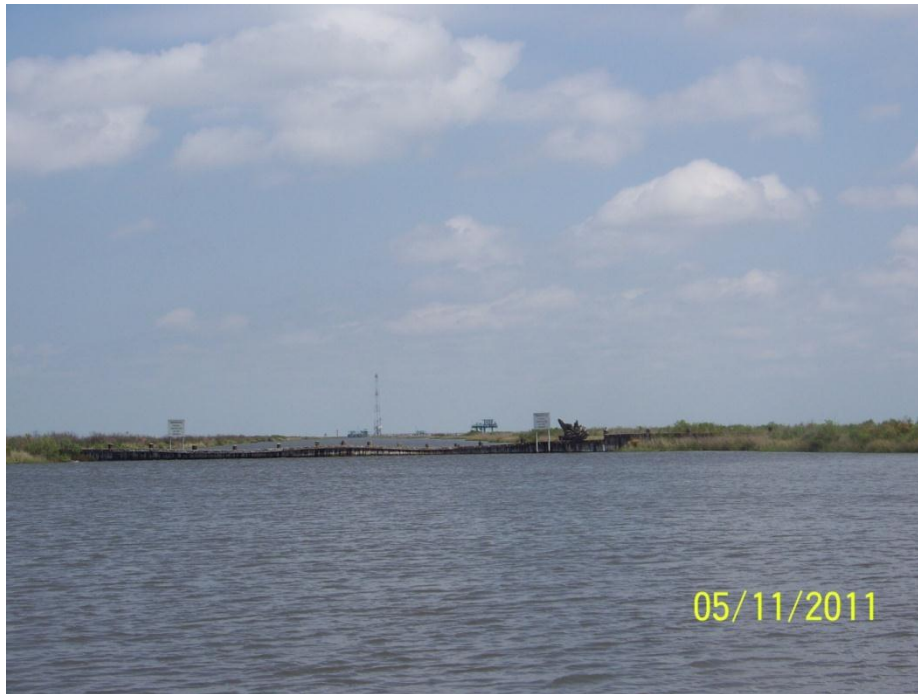
The timber bulkhead Plug No. 6 showed signs of deflection (wavy pattern across canal) shortly after construction. During this annual inspection, the deflection is more apparent than what was observed during the construction. The embankment tie-ins appear intact with no signs of erosion or breaching. There is a separation of the bulkhead (or missing board) near the embankment tie-in on the east side of the structure. This separation has been observed to allow small amounts of water to pass through the bulkhead. The warning signs and supports appear to be in overall good condition. There are no recommendations for corrective actions at this time, but the condition of the structure should continue to be monitored on future site visits.

Photo #27: complete view of Plug No. 6 from Transco Canal, looking north

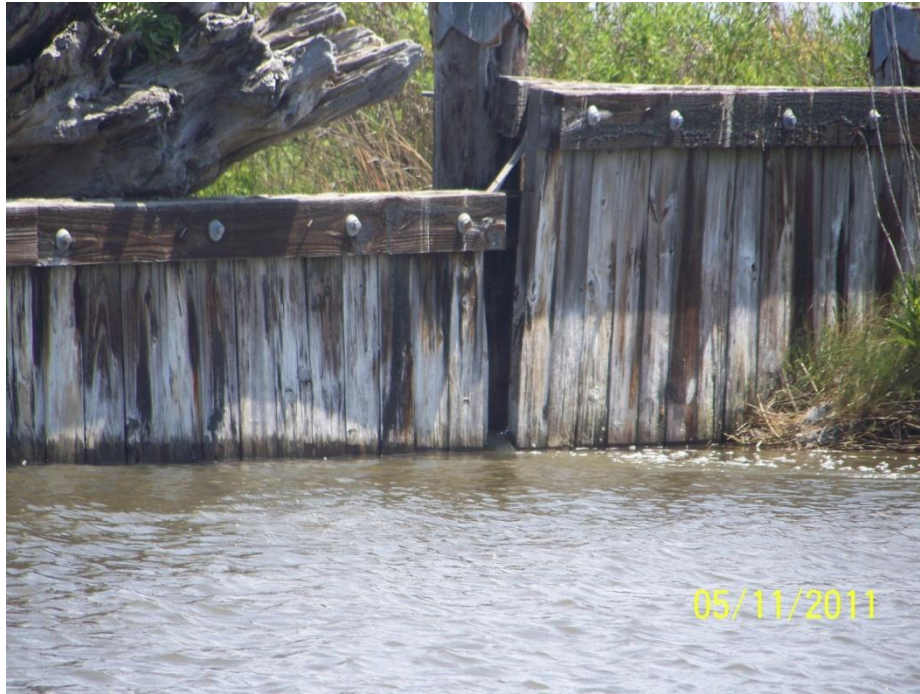
Photo #31: view of separated bulkhead on Plug No. 6, looking north

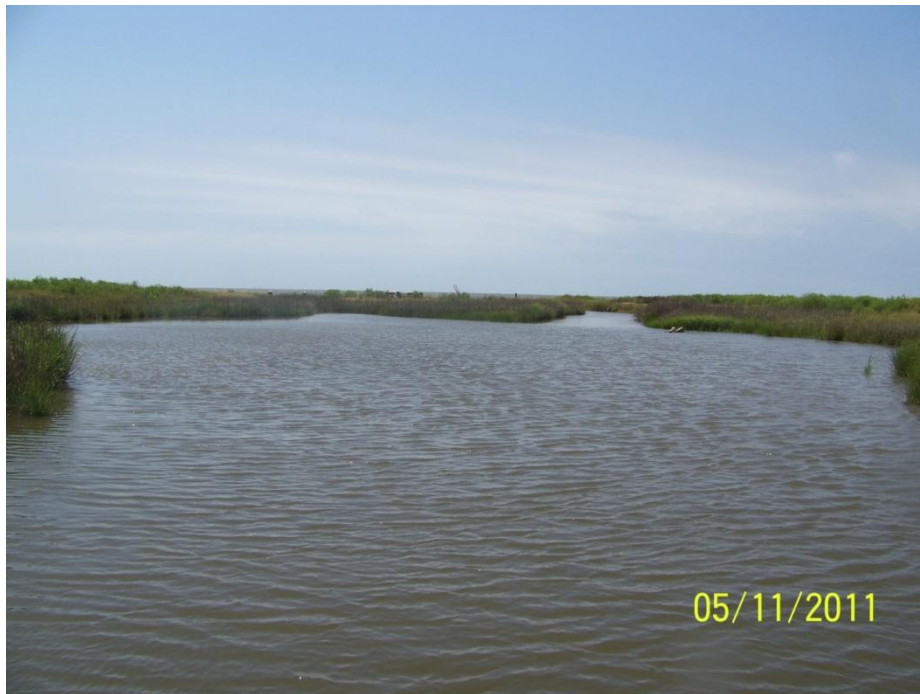
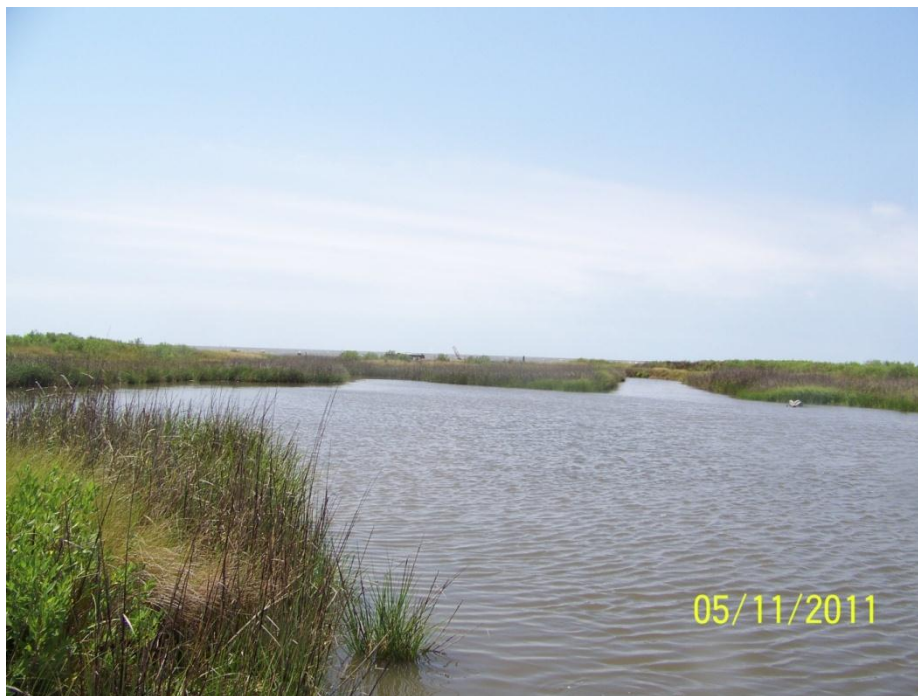
The shell Plug No. 4 is also in poor condition. As previously reported, the structure has been eroded below the waterline for several years. No corrective action is recommended at this time, instead maintenance efforts have been focused on Plug 4A (Transco Canal bulkhead) located at the Gulf of Mexico approximately 200 feet south of Plug No. 4.

Photo #32: view of shell Plug No. 4 from Transco Canal, looking south

Photo #34: view of shell Plug No. 4 from Transco Canal, looking south

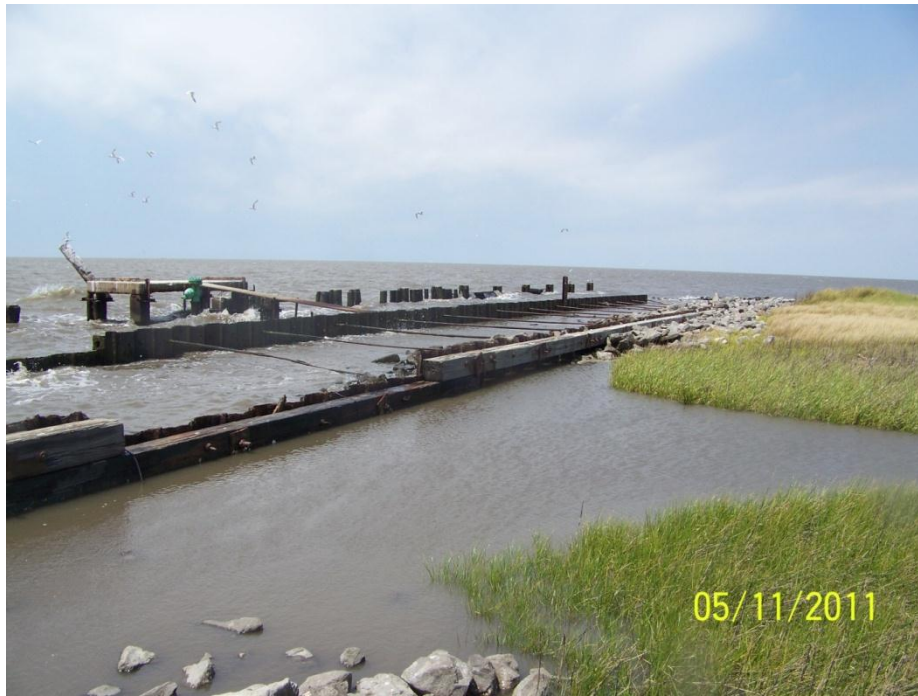
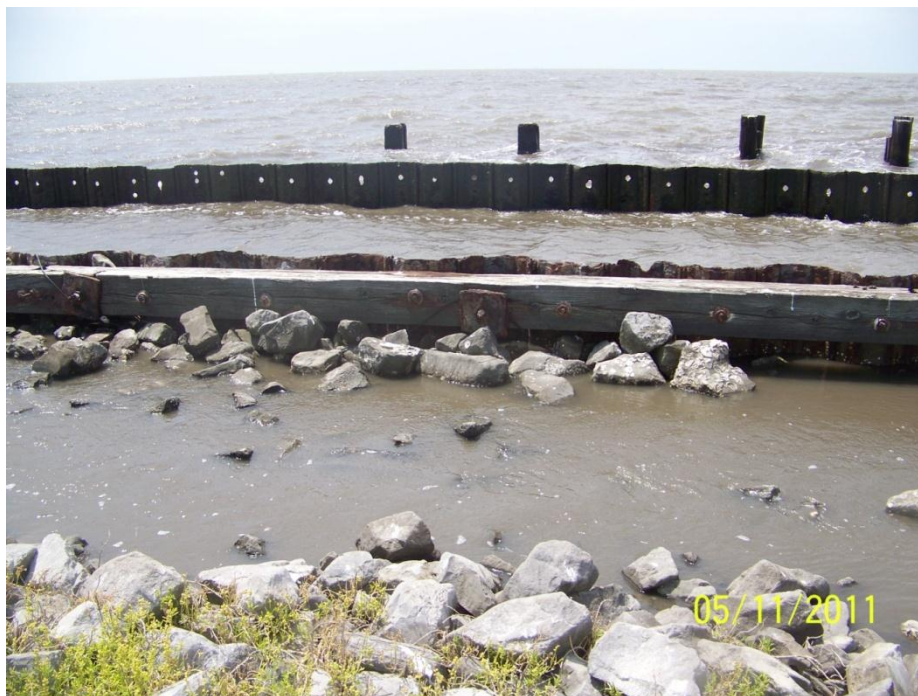
The erosion directly behind the mats on the east side of the structure has been slowed or halted since the maintenance rock lift in 2005. Material has been accumulated behind the rock lift and that deposited material is now vegetated. But, shoreline erosion continues to be observed at the east embankment tie-in. On the other end of the structure, the west mats have settled and are over washed during normal tidal events. In addition, due to erosion around the embankment tie-in the mats no longer connect to the shoreline. This allows tidal exchange behind the mats similar to the east end before the 2005 maintenance. At the existing Transco bulkhead, tidal exchange occurs between the Gulf and Transco Canal where water passes behind the bulkhead and over the rocks into the canal. This has been observed in previous inspections but seems to be increasing. The steel sheetpile and tie-rods are heavily corroded and should continue to be monitored.

Photo #35: view of Plug No. 4A just north of existing Transco Pipeline bulkhead, looking southwest

Photo #36: view of Plug No. 4A just north of existing Transco Pipeline bulkhead, looking south

In 2010 it was recommended to survey the area for comparison to the as-built construction drawings to determine the best course of action to prevent breaching of the Gulf into the Canal. At the time of the inspection and report, this survey is in progress, and is expected to be completed later this summer 2011. Also, preliminary recommendations include a rock lift and dike extension back to the shoreline in the west, and an extension and rock lift on the 2005 extension dike in the east.

At Plug No. 4A (Transco at Gulf) in order to address the continued erosion at the west shoreline tie-in, behind the west mats, and at the east shoreline tie-in, a survey was recommended in the 2010 Annual Inspection Report. At the time of the 2011 inspection and report, this survey is in progress and is expected to be completed later this summer 2011. Based on the results of the survey, maintenance recommendations may include constructing a rock lift on the west mats, closing off the connection

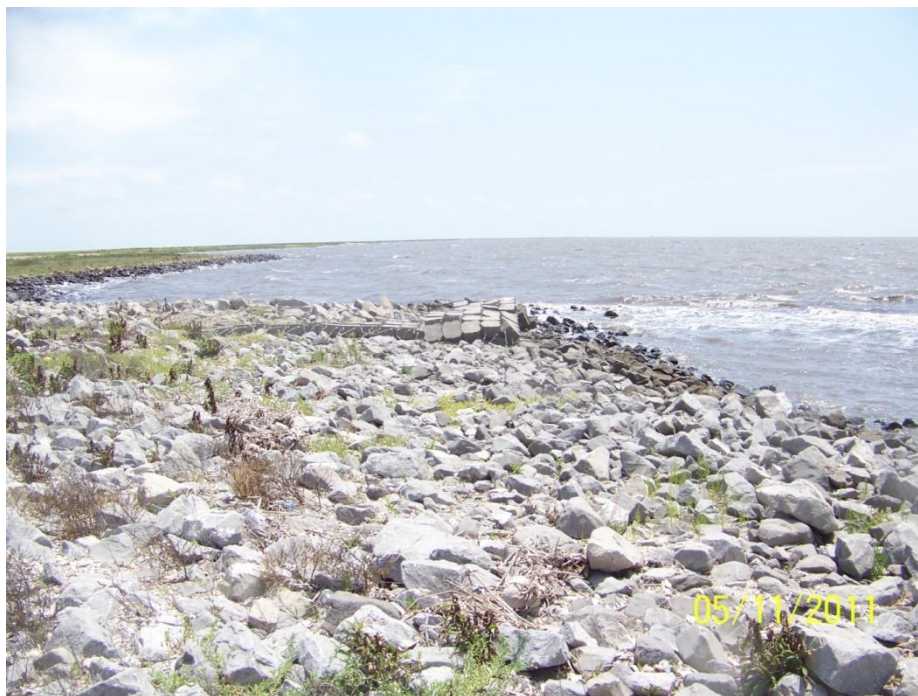
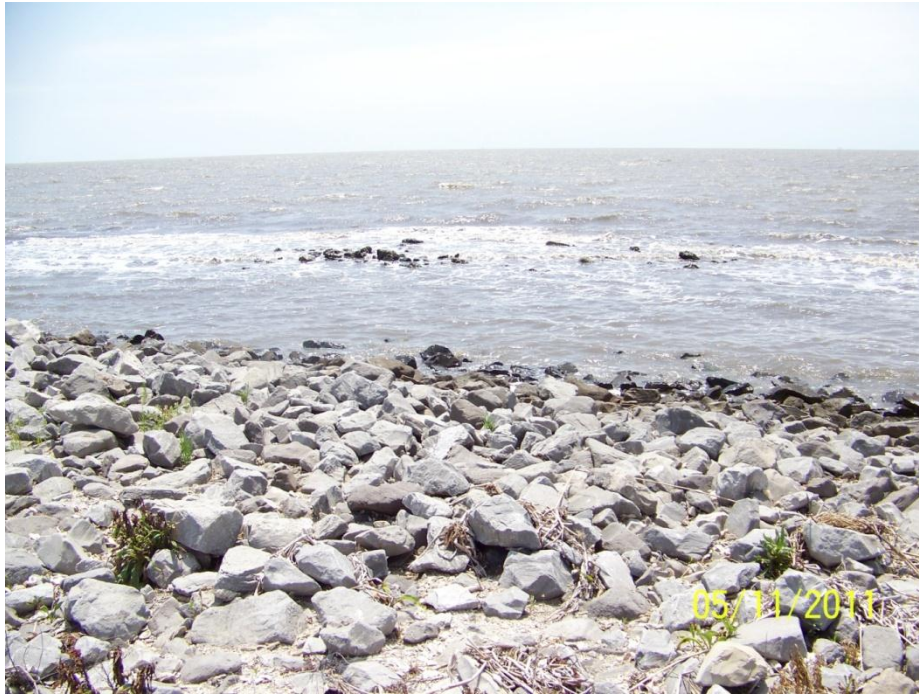
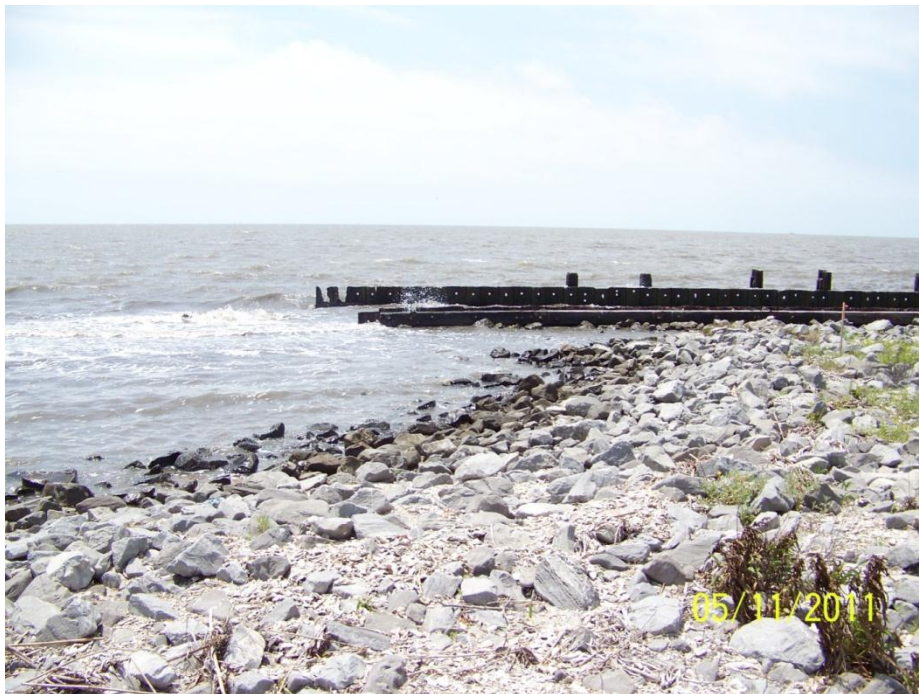
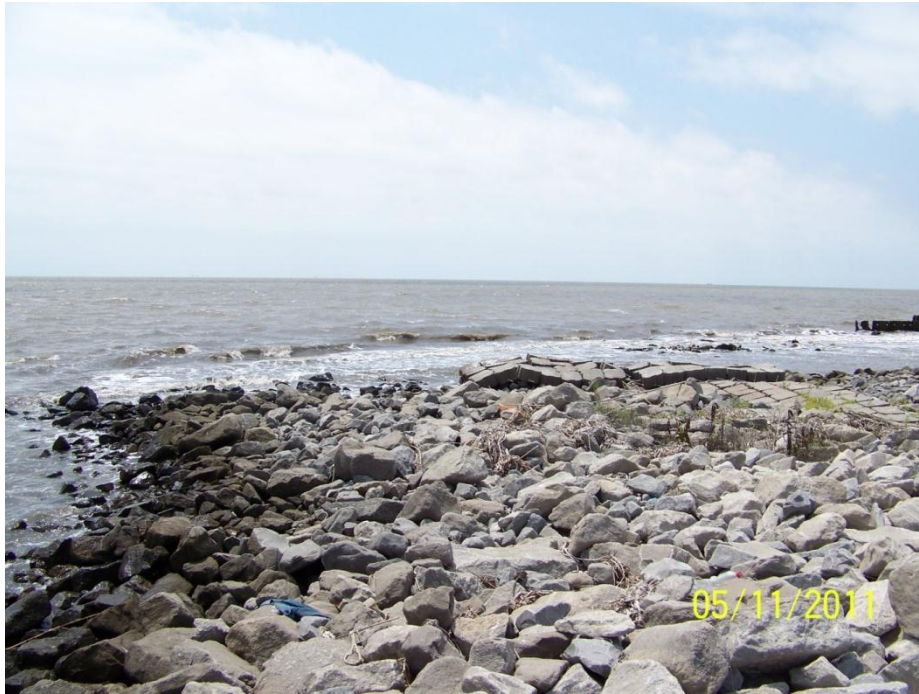
Photo #42: view of rock placed on top of Petraflex mats located east of Plug No. 4A, looking east

Photo #43: view of rock placed on top of Petraflex mats located east of Plug No. 4A, looking southeast

Photo #44: view of rock placed on top of Petraflex mats located east of Plug No. 4A, looking south

Photo #45: view of rock placed on top of Petraflex mats located east of Plug No. 4A, looking south

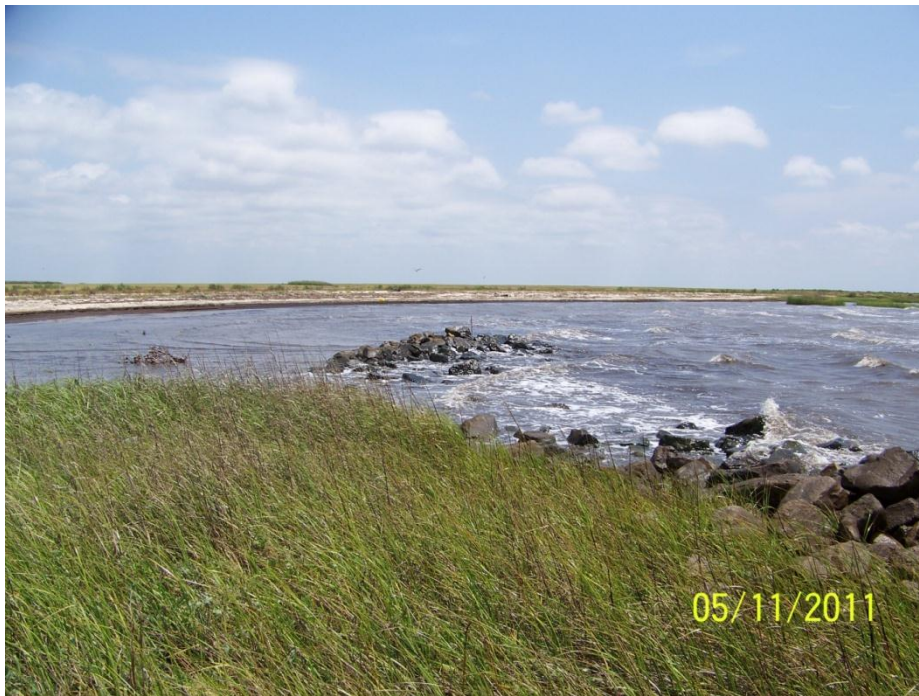
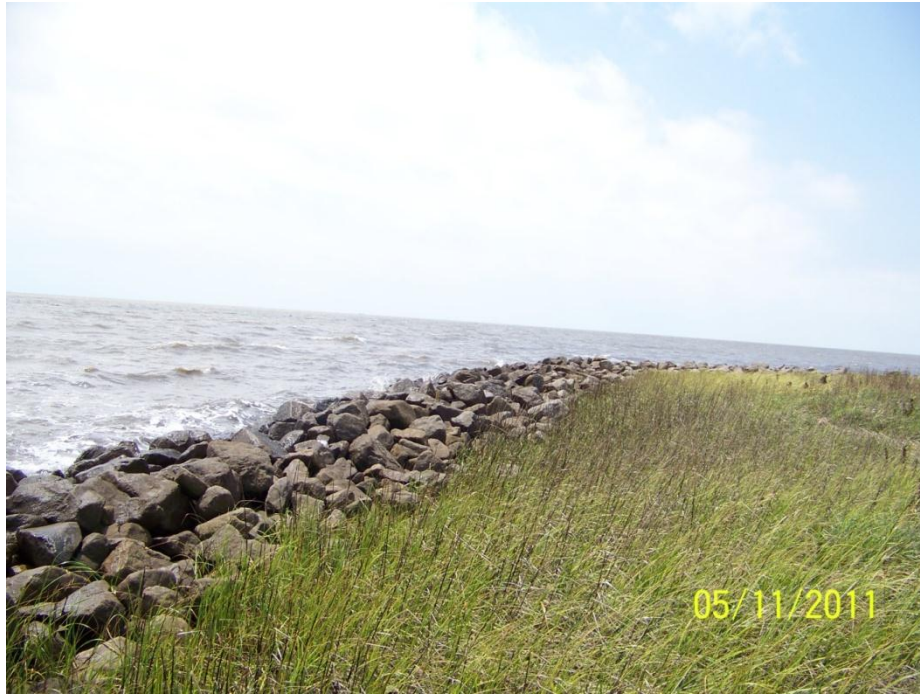
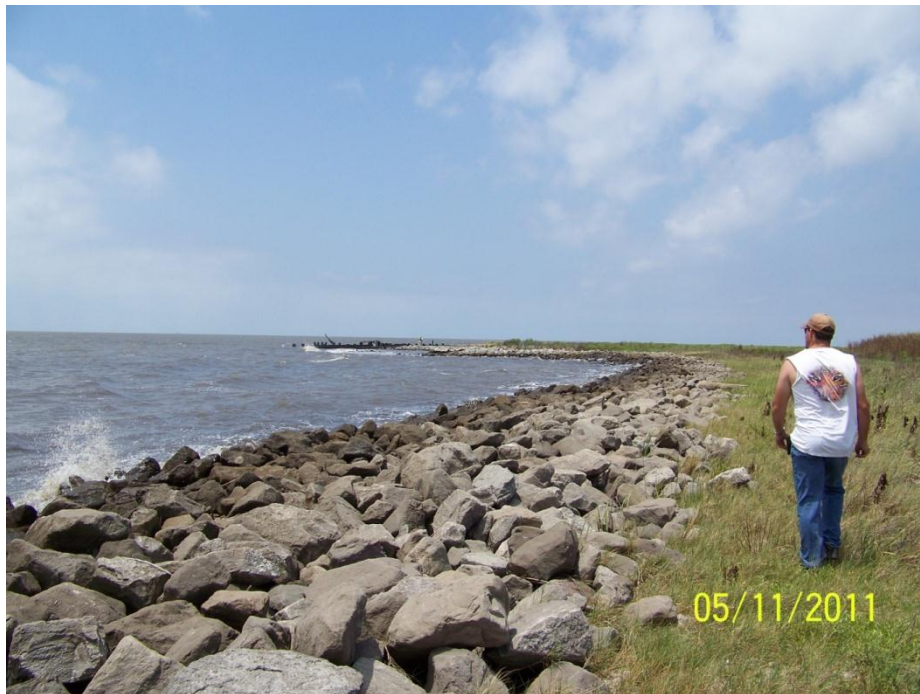
Photo #46: view from east end of Plug No. 4A rock dike, looking east

Photo #47: view from east end of Plug No. 4A rock dike, looking south

Photo #48: view from east end of Plug No. 4A rock dike, looking west

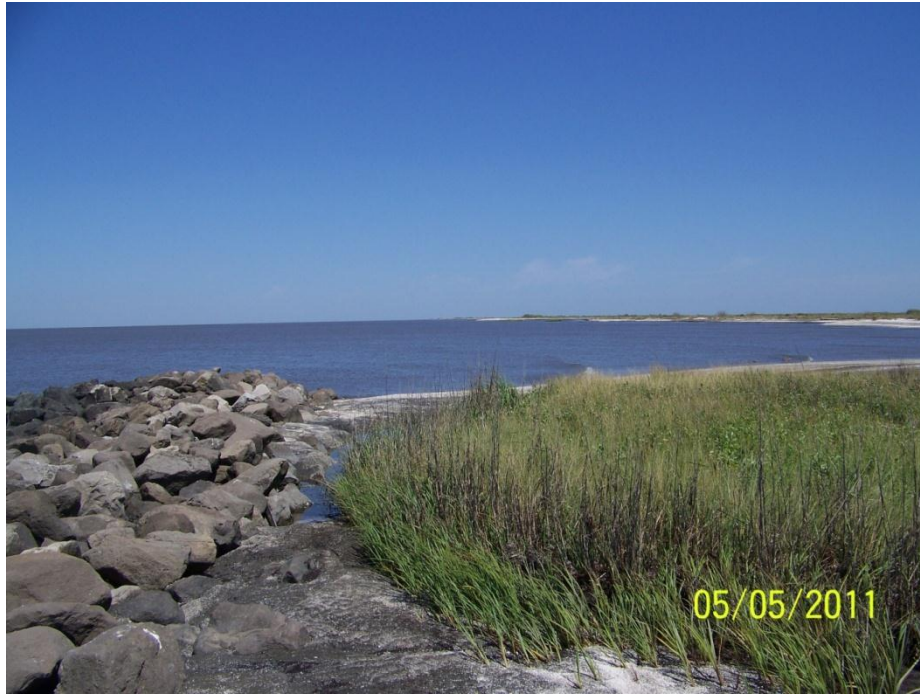
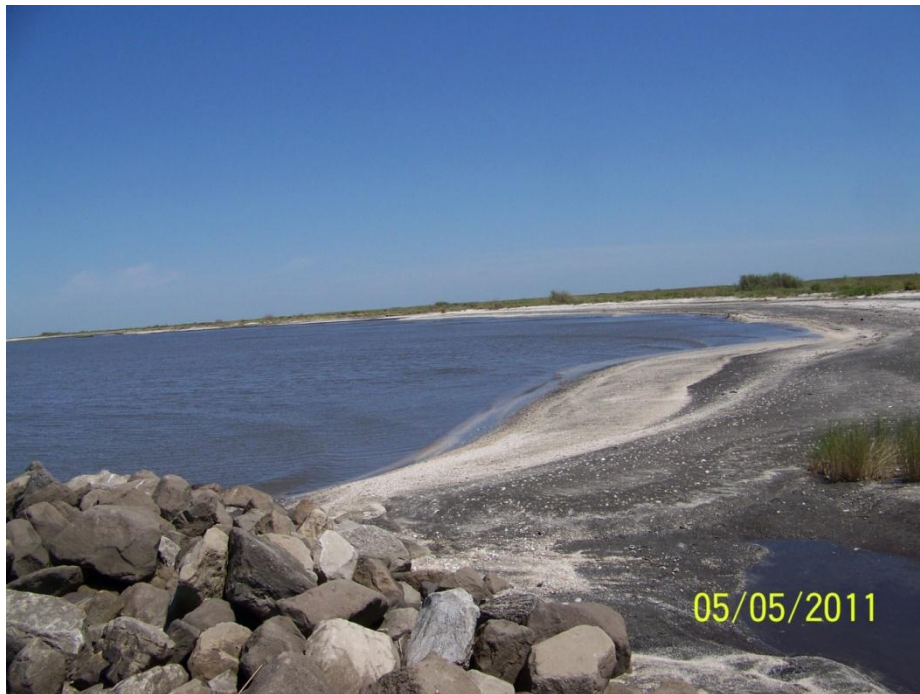
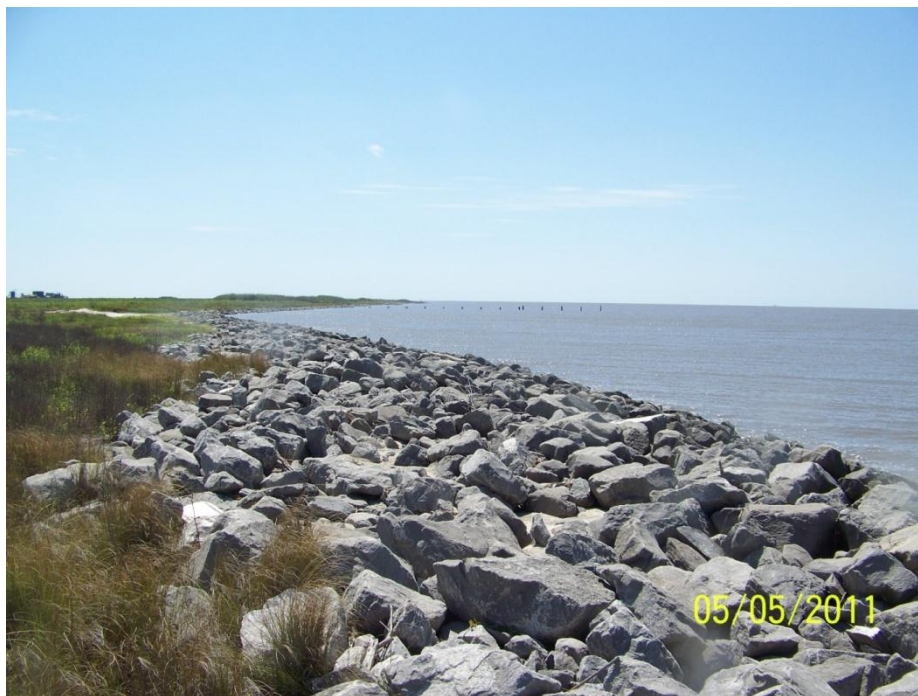
The rock dike along Area 5 of Phase III appeared to be in good condition with no noticeable settlement of the structure. Beyond the west end of the dike, erosion of the beach face has increased and the shoreline has moved inland. Consequently tidal exchange is now occurring behind the mats, and erosion of the shoreline behind the mats was observed. In 2010 it was recommended to survey the area for comparison to the as-built construction drawings to determine the best course of action to prevent breaching of the Gulf into the Canal. At the time of the inspection and report, this survey is in progress, and is expected to be completed later this summer 2011.

Photo #49: view of the west end of Shoreline Protection Phase III rock wall, looking west

Photo #50: view of the west end of Shoreline Protection Phase III rock wall, looking west

Photo #52: view of Shoreline Protection Phase III rock wall, looking east

For the Phase II and III rock dikes, several areas appear to be low. Also, the Gulf shoreline continues to erode where the project rock terminates. This is true of the Phase III Area 4 and Area 5 rock dike. A survey was recommended in the 2010 Annual Inspection Report. At the time of the 2011 inspection and report, this survey is in progress and is expected to be completed later this summer 2011. Based on the results of the survey, maintenance recommendations may include a rock lift along low areas of the dike and extension of the ends back to the shoreline (See Appendix C).

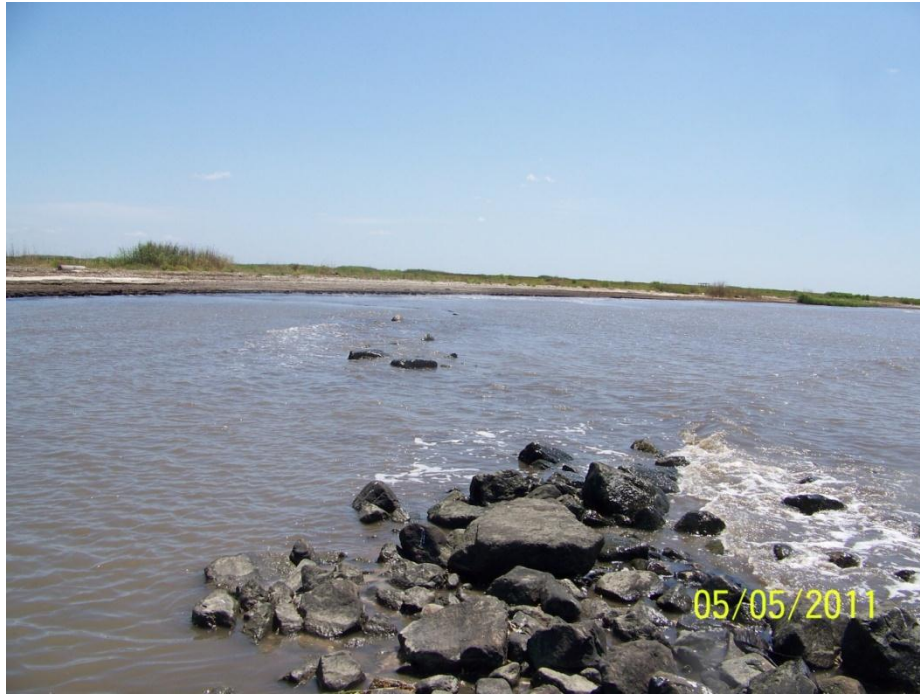
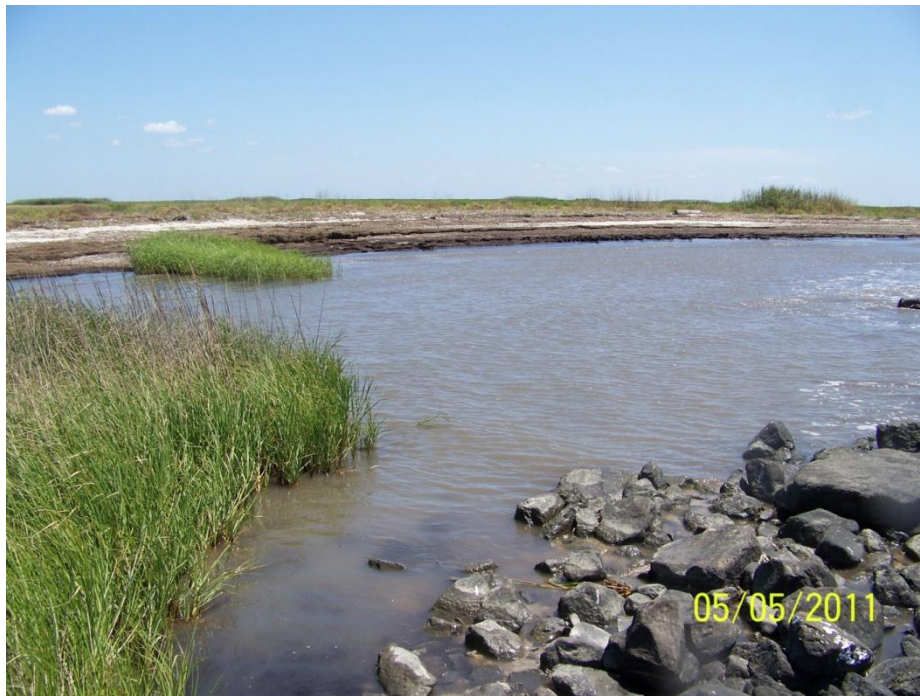
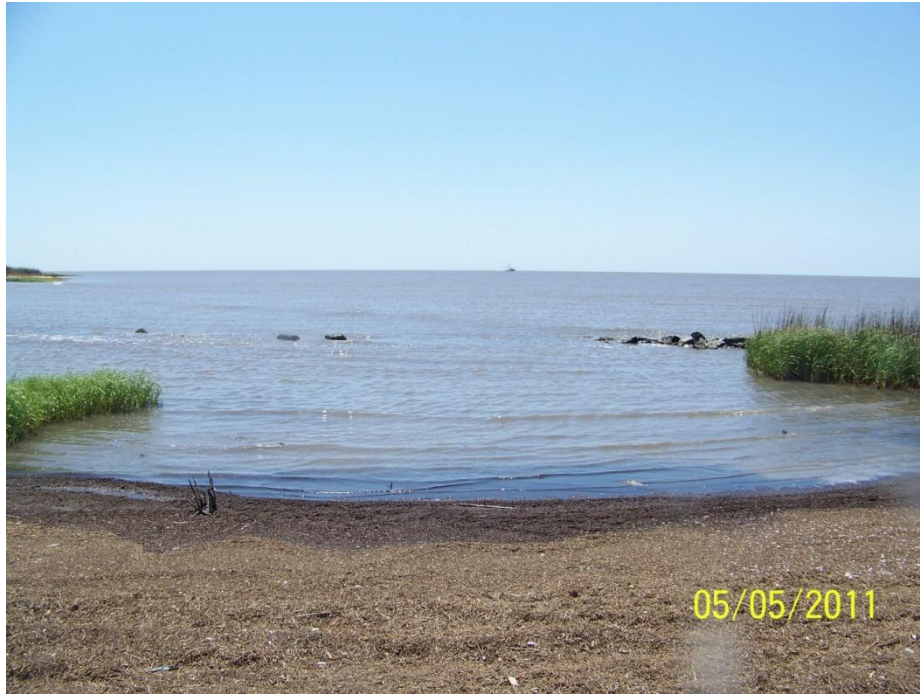
The rock dike along Area 4 of Phase III appeared to be in good condition with no noticeable settlement of the structure. Beyond the east end of the dike, erosion of the beach has increased and the shoreline has moved further north. As a result, there is some erosion at the end of the dike and now tidal exchange can occur behind the dike. In 2010 it was recommended to survey the area for comparison to the as-built construction drawings to determine the best course of action to prevent breaching of the Gulf into the Canal. At the time of the inspection and report, this survey is in progress, and is expected to be completed later this summer 2011.

Photo #53: view of the east end of Shoreline Protection Phase III rock wall, looking east

Photo #54: view of the east end of Shoreline Protection Phase III rock wall, looking north

Photo #55: view of the east end of Shoreline Protection Phase III rock wall, looking south

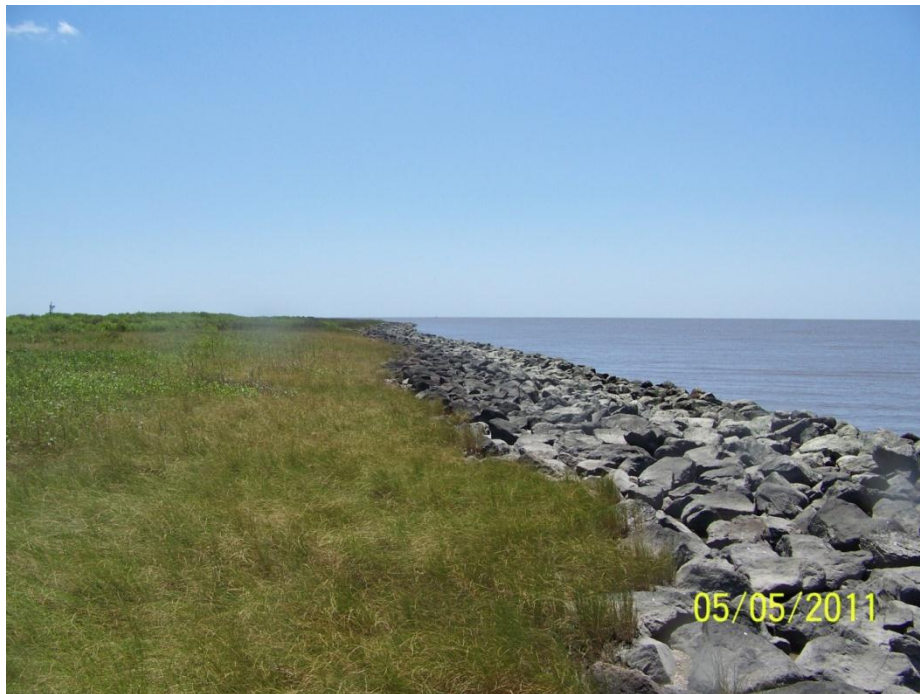
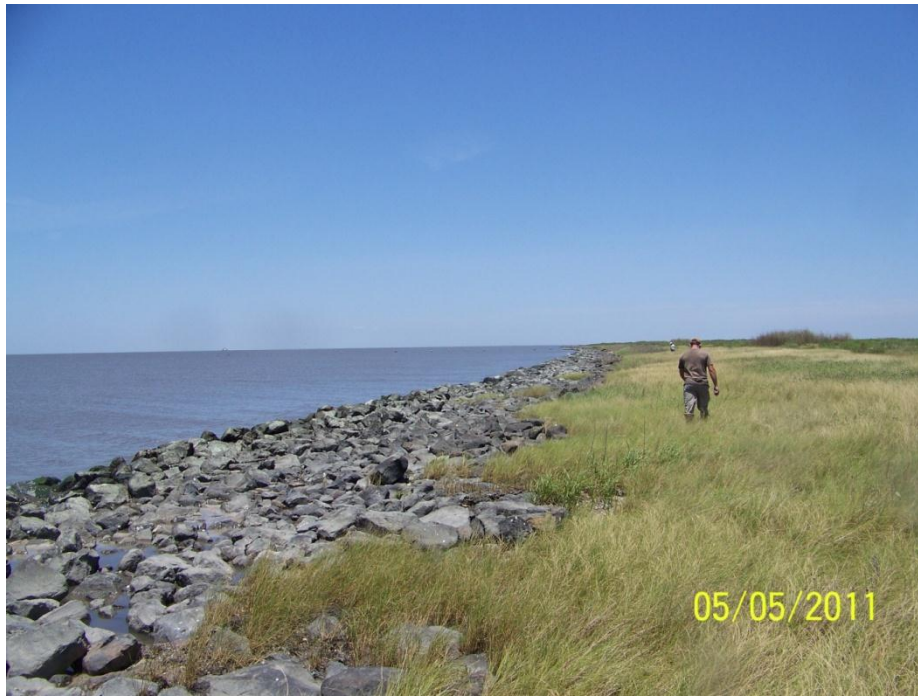
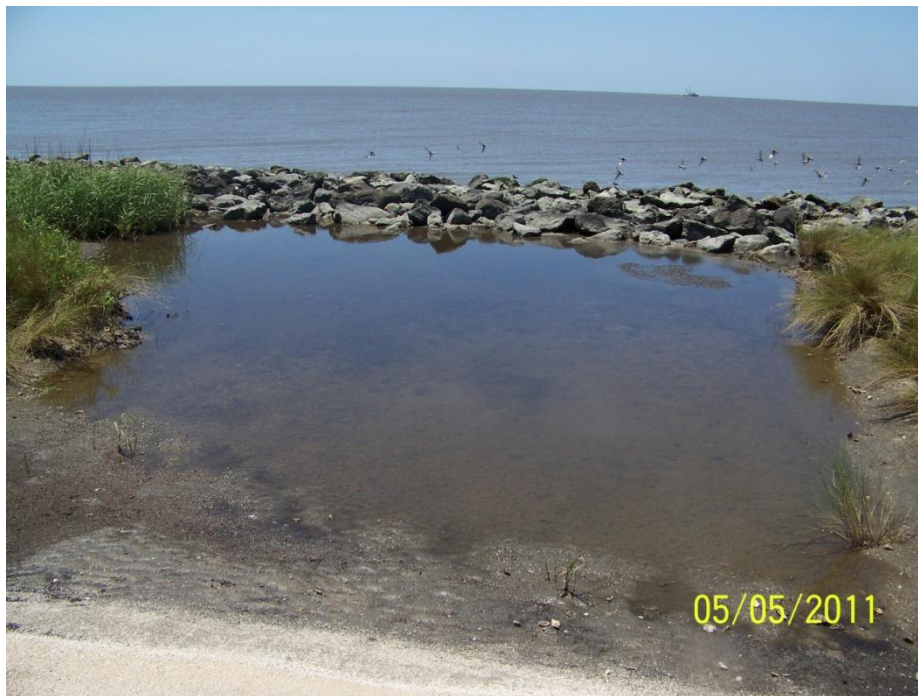
As previously reported, several areas of the rock dike appear to be low as well as narrow along the south bank of Mobil Canal. In 2010 it was recommended to survey the area for comparison to the as-built construction drawings to determine the best course of action to prevent breaching of the Gulf into the Canal. At the time of the inspection and report, this survey is in progress, and is expected to be completed later this summer 2011.

Photo #62: view of Shoreline Protection Phase II rock dike, looking east

Photo #63: view of Shoreline Protection Phase II rock dike, looking west

Photo #64: view of tidal pool behind Shoreline Protection Phase II, looking south
