## 2011 Operations, Maintenance, and Monitoring Report

### Lake Chapeau Sediment Input and Hydrologic Restoration, Point Au Fer Island (TE-26)

State Project Number TE-26  
Priority Project List 3

August 2011  
Terrebonne Parish

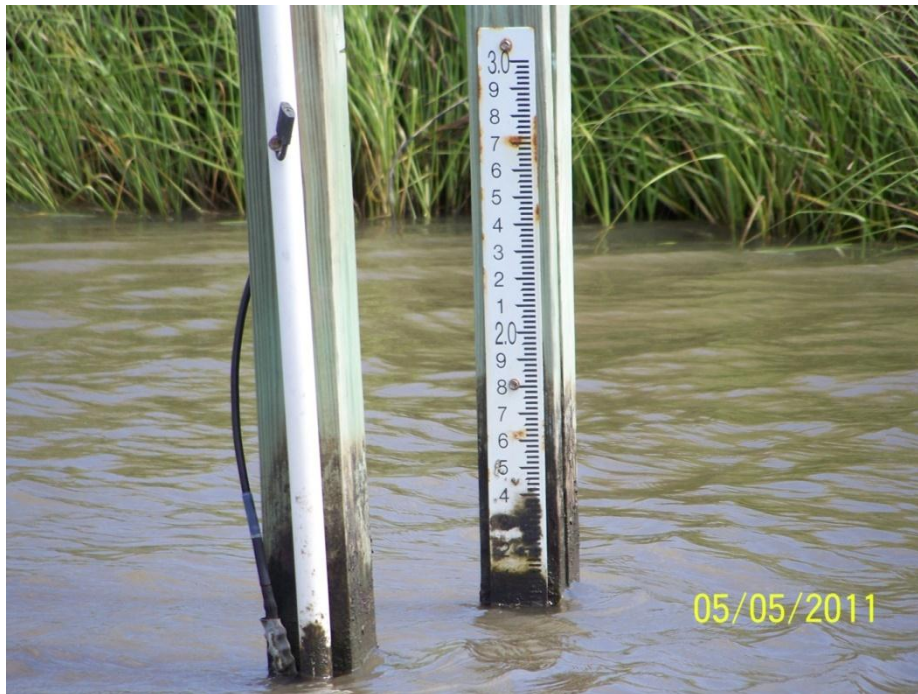
Photo #1: Staff gauge TE26-07 located near Site No.1 used to determine water level during inspection

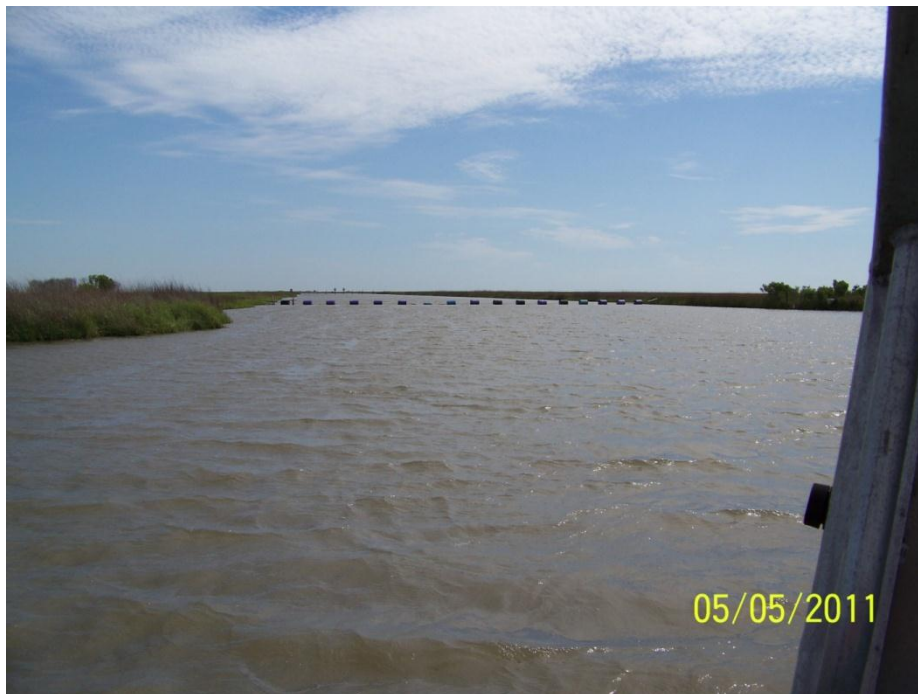
A close inspection of Site No.1 was not possible due to a floating gate located approximately 500' southwest of the rock weir, preventing access to the canal. The rock weir appeared to be in good overall condition. There are no visible signs of erosion or breaching around the embankment tie-ins. The timber barricade system and warning signs also appeared to be in good overall condition. Two (2) timber piles were identified in the 2009 Annual Inspection to be missing their protective galvanized cap. Due to the floating gate, we were unable to get close enough to the structure to determine if these timber piles have experienced any deterioration due to weathering. The latest elevation data available from the 2004 survey profile of the structure indicates that the crest of the rock weir has settled approximately 1.39' since 1999. The newly set TE26-07 data recorder station, located approximately 600' from the structure, was reading a tide level of 1.0' NAVD88 at 10:25 AM, the time of the inspection of Site No. 1. (Appendix A, Photos 1 - 6)

Photo #2: View of floating gate restricting access to Site No. 1, looking northeast

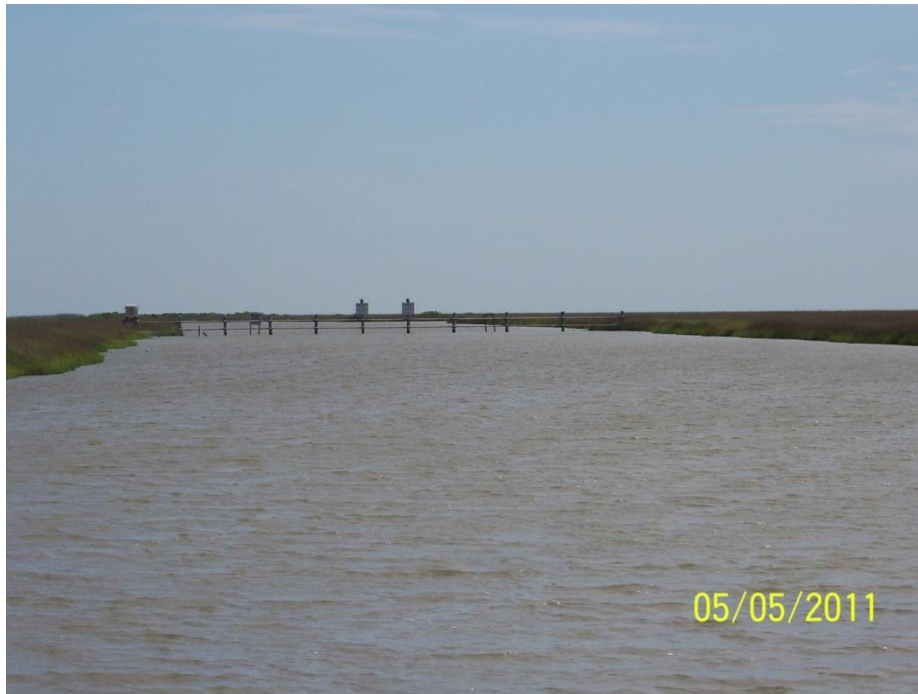
Photo #3: View of Site No. 1 in oil field access canal off of Locust Bayou, looking northeast

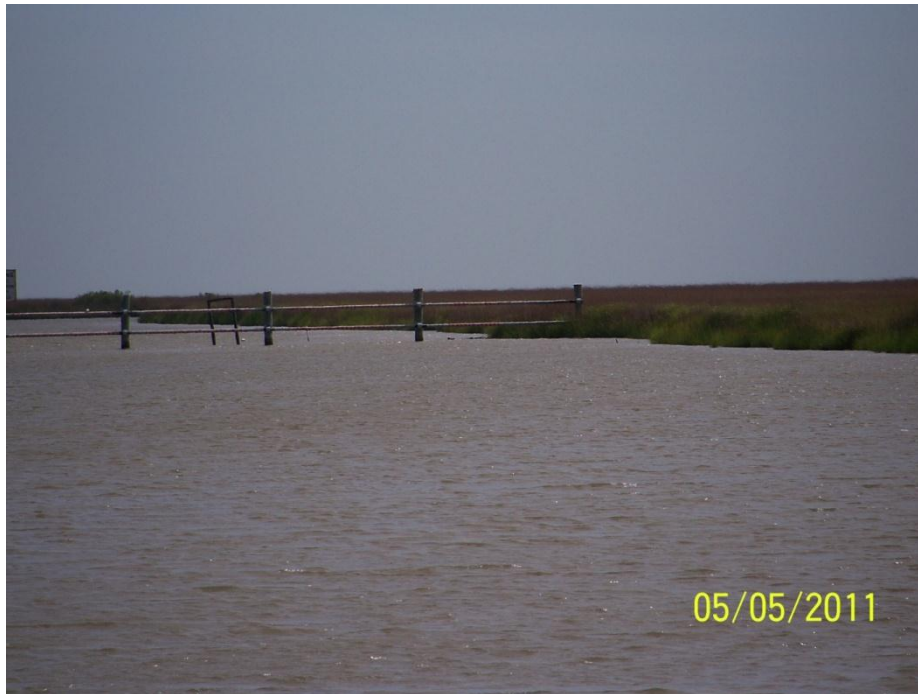
Photo #5: View of Site No. 1 embankment tie-in on southeast side of structure, looking northeast

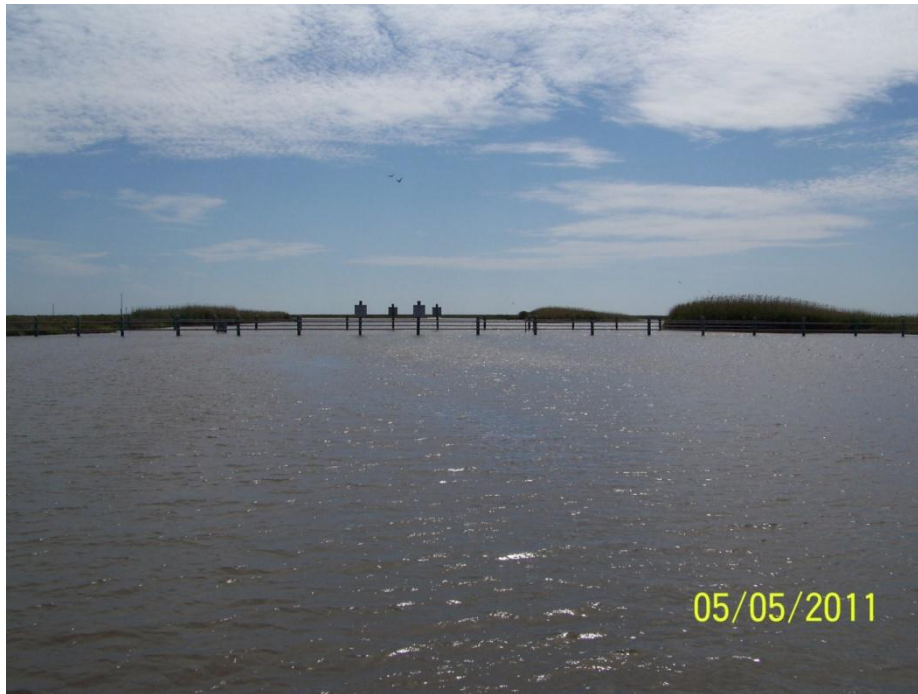
The Site No.9 rock weir was in good overall condition. There are no visual signs of erosion or breaching around the embankment tie-ins. There is one timber supporting the pipe barricade

Photo #7: View of Site No.9 rock weir, looking east

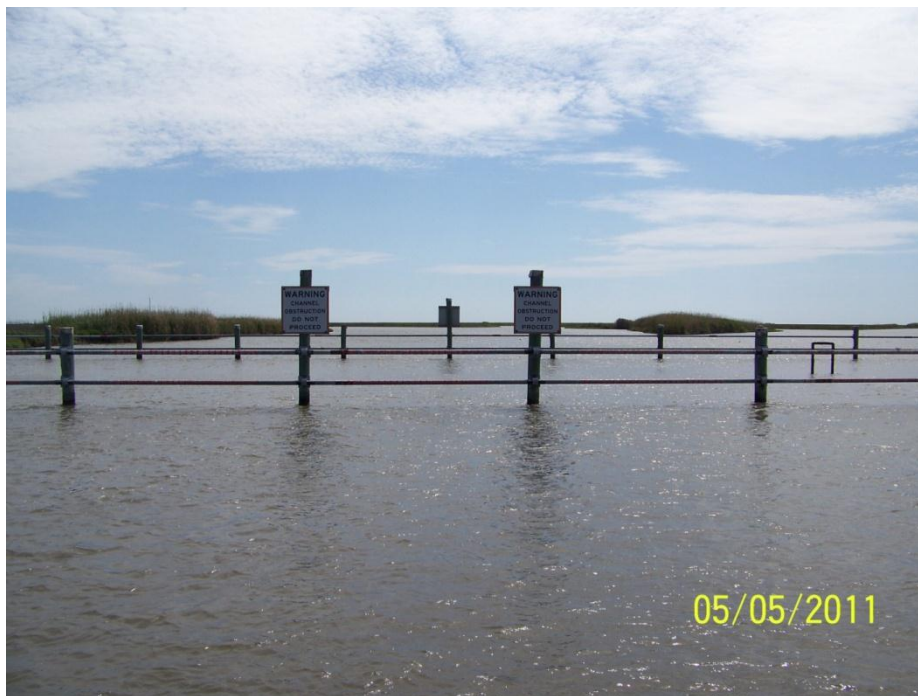
Photo #8: close up view of Site No.9 rock weir, looking east

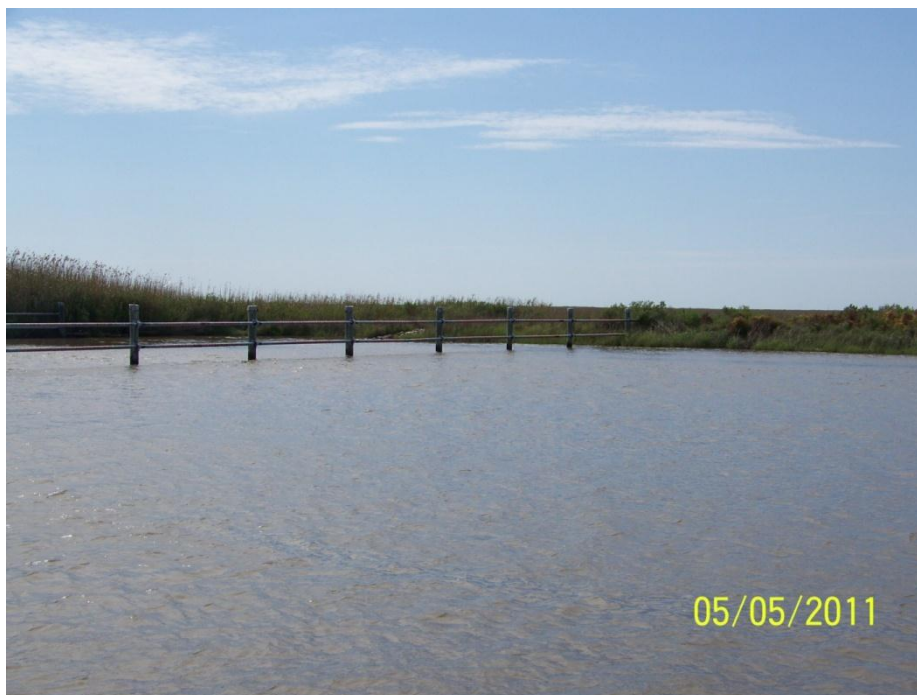
Photo #9: View of embankment tie-ins on the south side of Site No.9, looking southeast

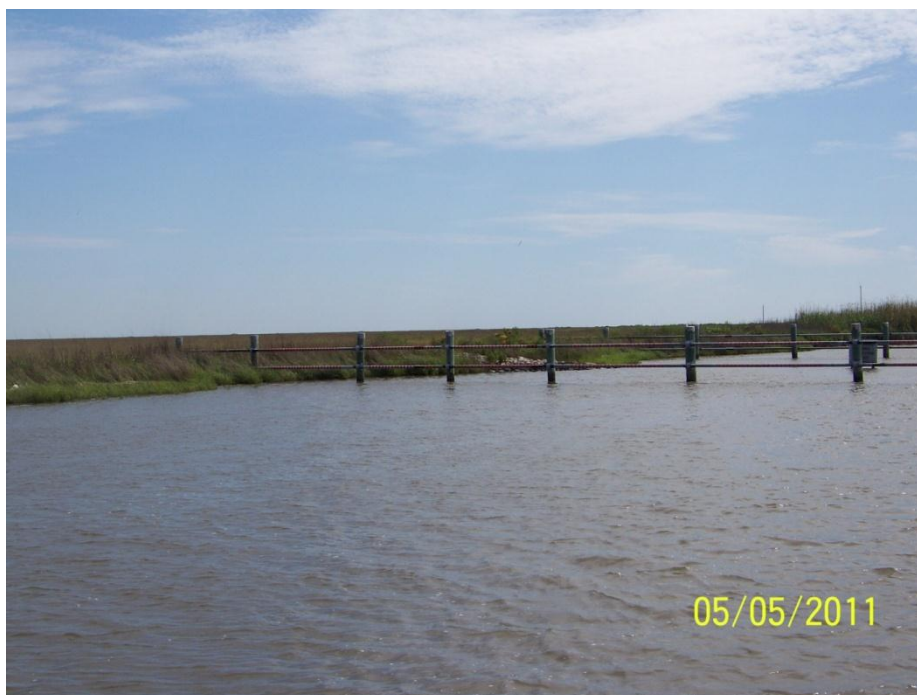
Photo #10: View of embankment tie-ins on the north side of Site No.9, looking northeast

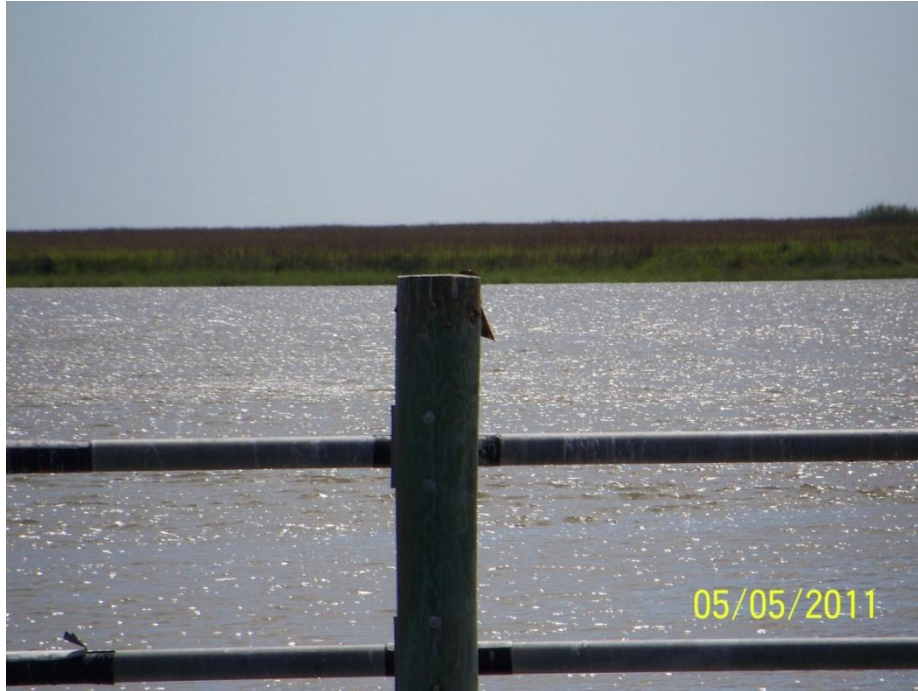
Photo #11: Close up view of missing piling cap on support timber of Site No.9, looking east

that is missing its galvanized cap. At this time there is no recommendation for maintenance, however this area will continue to be monitored to determine if corrective actions are needed. The rest of the timber barricade system shows no sign of corrosion or deterioration due to weathering. The warning signs and supports have no apparent damage and appear to be in good condition. Based on a survey profile of the rock weir in 2004, the structure has settled approximately 1.7' from its designed elevation. (Appendix A, Photos 7 - 11). There is a small breach in the south canal bank near Site No.9 (located at point N29° 17m 4.4s W91° 17m 1.7s). Due to the location and the size of the breach, it not believed to be detrimental to the structure and that the rock weir is operating as designed. At this time there are no recommendations for corrective actions, but this site will continue to be monitored during future inspections to determine if the breach enlarges and requires maintenance.

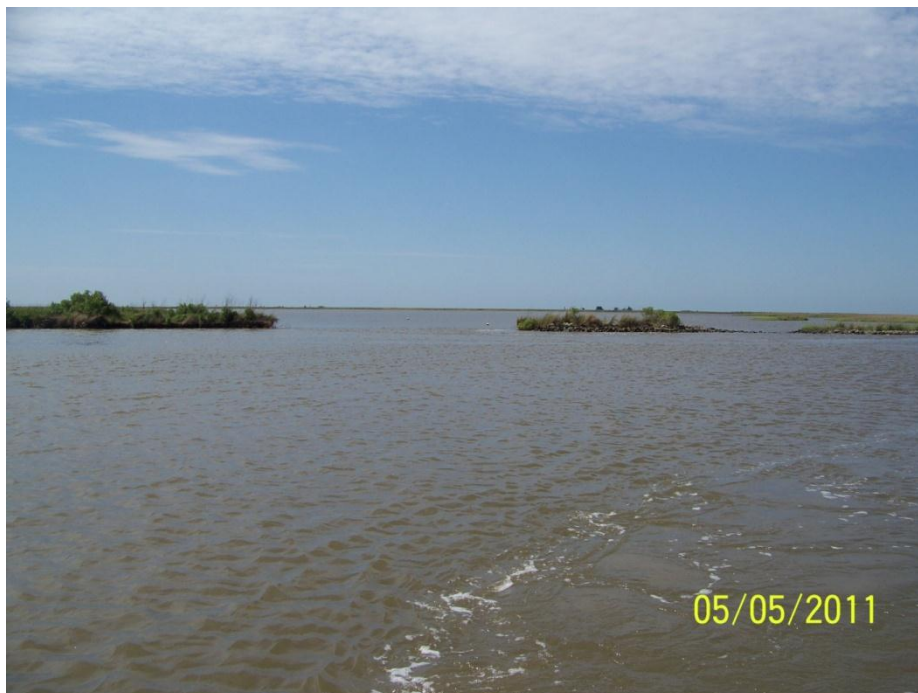
Photo #12: View of breach located on the south bank near Site No.9, looking south

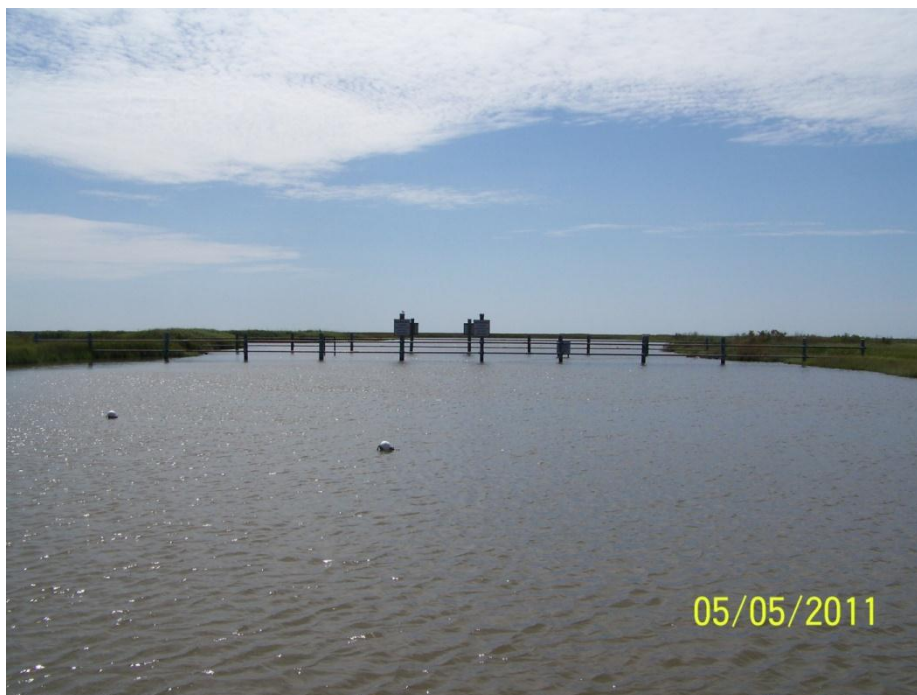
The Site No.7 rock weir was in good overall condition. There are no visual signs of erosion or breaching around the embankment tie-ins. The timber barricade system shows no signs of corrosion or deterioration due to weathering. The warning signs and supports have no apparent damage and appear to be in good condition also. Based on a survey profile of the rock weir in 2004, the structure has settled approximately 1.7' from its designed elevation. (Appendix A, Photos 13 - 16).

Photo #13: View of Site No.7 from Locust Bayou, looking northwest

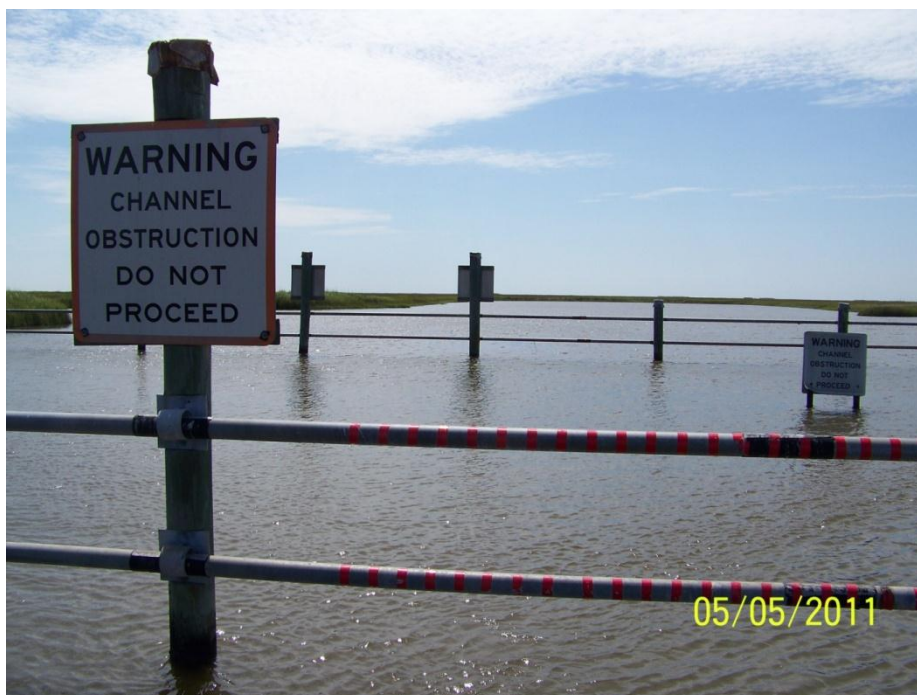
Photo #14: Close up view of warning signs and supports in Site No.7, looking northwest

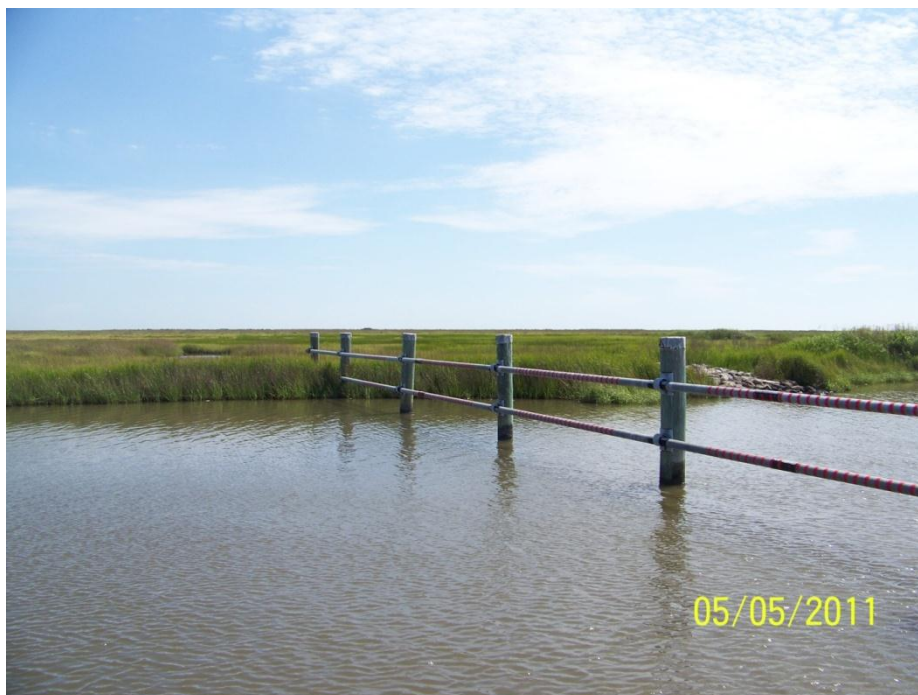
Photo #15: View of embankment tie-in on southwest side of Site No.7, looking west

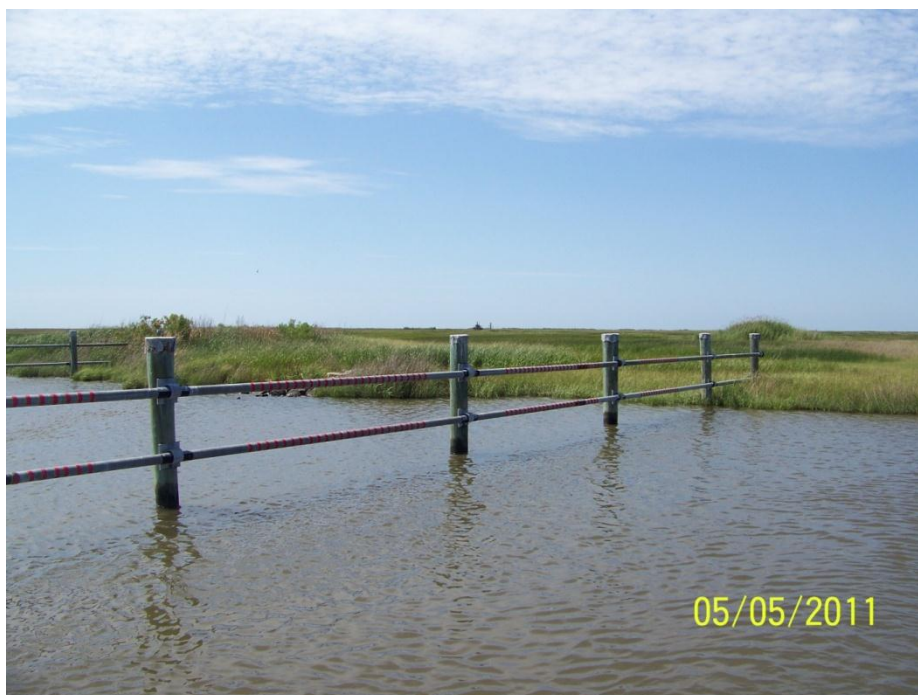
Photo #16: View of embankment tie-in on northeast side of Site No.7, looking north

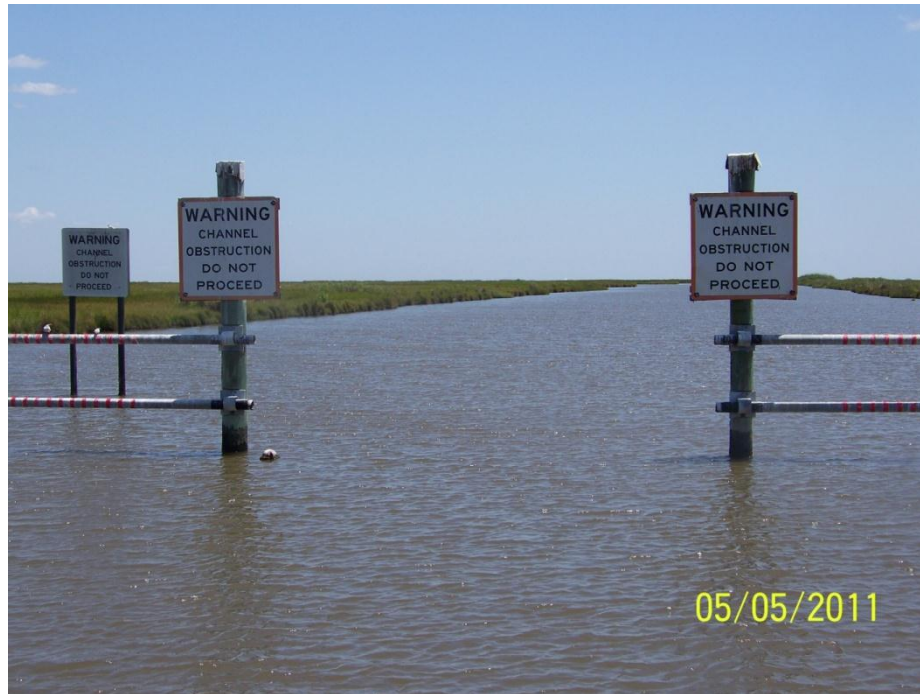
It was discovered during the 2008 Annual Inspection that the timber barricade system in front of the structure had been vandalized. Large sections (approximately 10 feet) on both of the steel pipe cross members had been cut with a torch and are missing. It remains our opinion that an attempt to repair the damage would be unsuccessful; therefore there are no recommendations for corrective actions at this time. Other than the cut sections, the barricade systems is in good condition with no signs of damage or corrosion. The rock weir appeared to be in good overall condition with no signs of erosion or breaching around the embankment tie-ins. The warning signs and supports are also in very good condition. From the 2004 profile survey of the structure, it was determined that the rock weir had settled an average of approximately 1.1 ft. (Appendix B, Photos 18 - 21)

Photo #19: Close up view of warning signs and supports of Site No.6, looking east

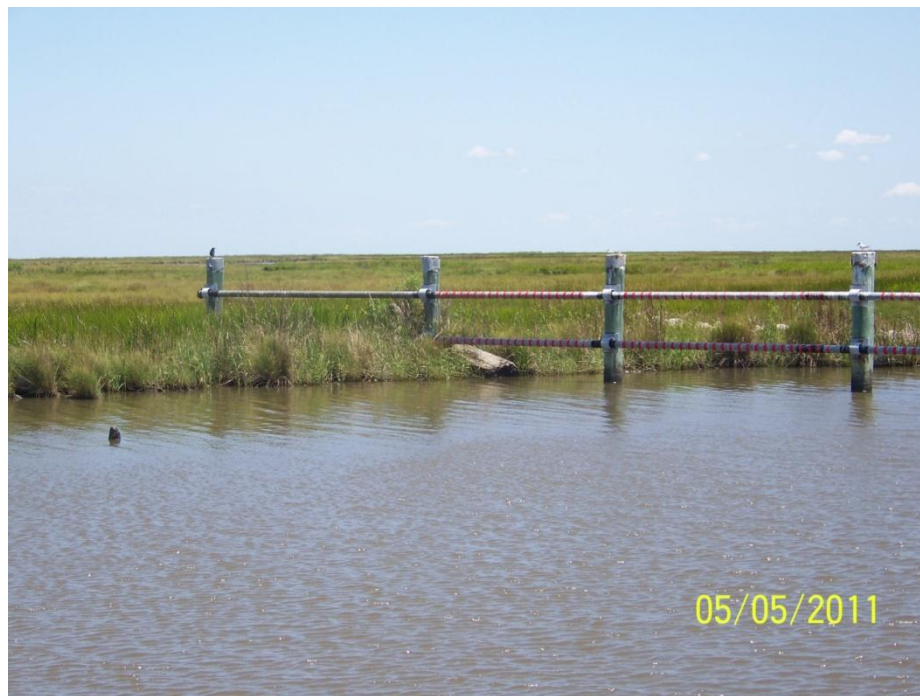
Photo #20: View of embankment tie-in on north end of Site No.6, looking northeast

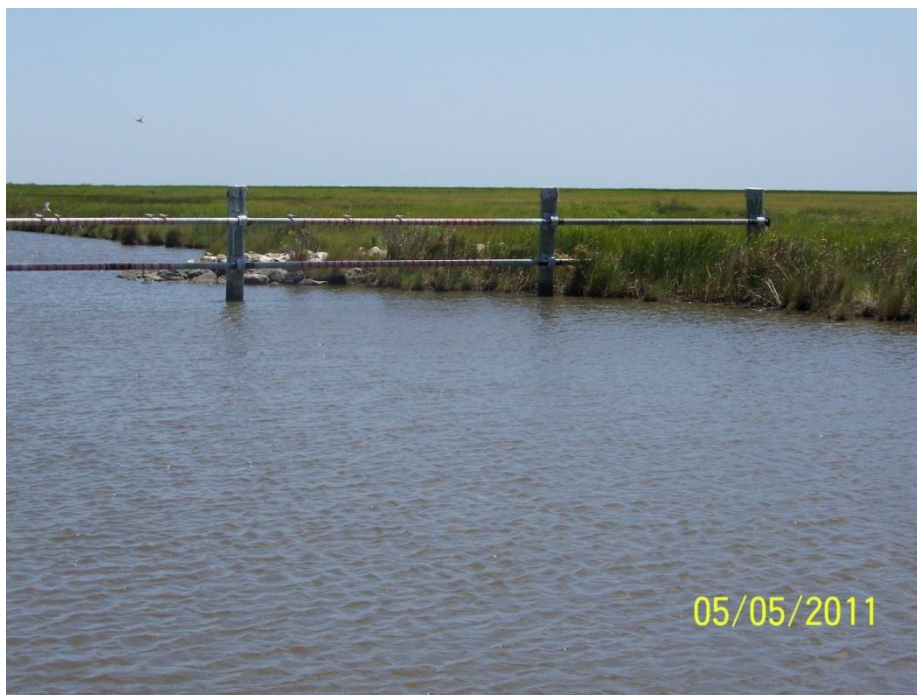
Photo #21: View of embankment tie-in on south end of Site No.6, looking southeast

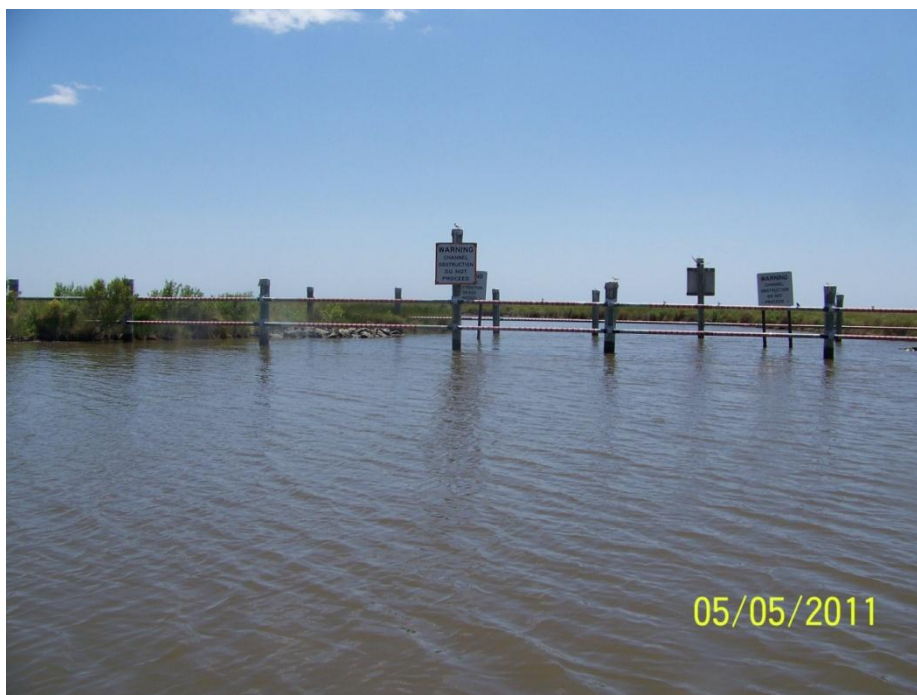
Site No.5 rock weir is in good overall condition. The embankment tie-ins showed no signs of marsh erosion or breaching. The barricade system and timber piles show no sign of damage or corrosion. The warning signs and supports are also in good condition. The latest elevation data from the 2004 survey profile of Structure No.5 indicates that the structure has settled on average of 0.14' from the designed elevation. (Appendix A, Photos 22 - 25)

Photo #22: View of Site No.5 rock weir in oil field access canal, looking east

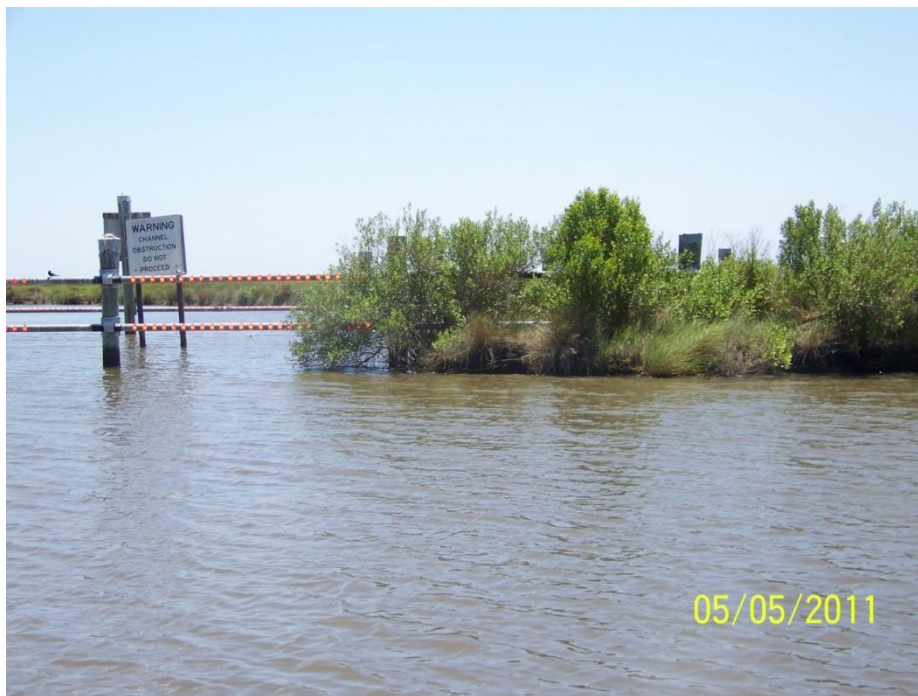
Photo #24: view of embankment tie-in on the south side of Site No.5, looking southeast

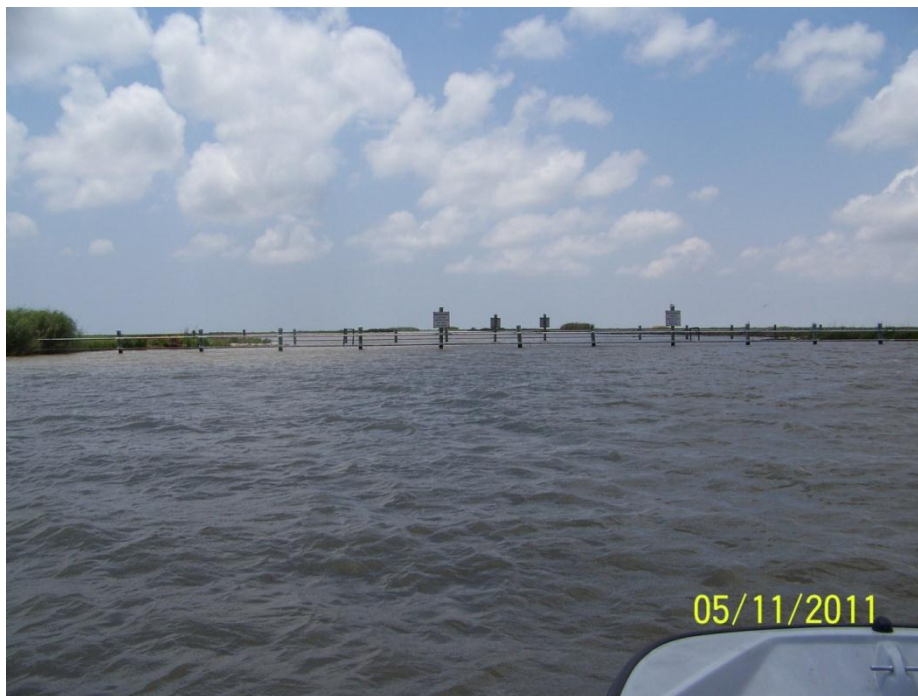
The rock weir appeared to be in good condition with no breaching around the ends. As in previous inspections, we found that the existing marsh connecting the structure to land on the south side of the weir was thin. However it didn't seem that there was any significant erosion since the last inspection. The timber barricade system appears to be in good condition. As previously reported, the two (2) center pilings are slightly unstable thought to be due to inadequate embedment and poor soil conditions. Also, a 10' section of pipe was cut by vandals on the northwest side of the structure. We do not believe the instability or cut section will have a detrimental effect to the structure, therefore there will be no recommendations for repair at this time, but will continue to monitor the situation on future inspections. (Appendix A, Photos 26 - 30)

Photo #26: Overall view of Site No.4 rock weir from Fourleauge Bay, looking west

Site No.4 rock weir appears to be in overall good condition. By comparing the current and past assessments, there seems to be no noticeable erosion along the shoreline. Based on the current short-term shoreline erosion rates, there is a chance Site No.4 will remain intact for the remainder of the project life, barring any extreme storm events. Based on these observations there are no recommendations for corrective actions at this time, but we will continue to monitor the condition of the marsh surrounding Site No.4 to determine the extent of the shoreline degradation.

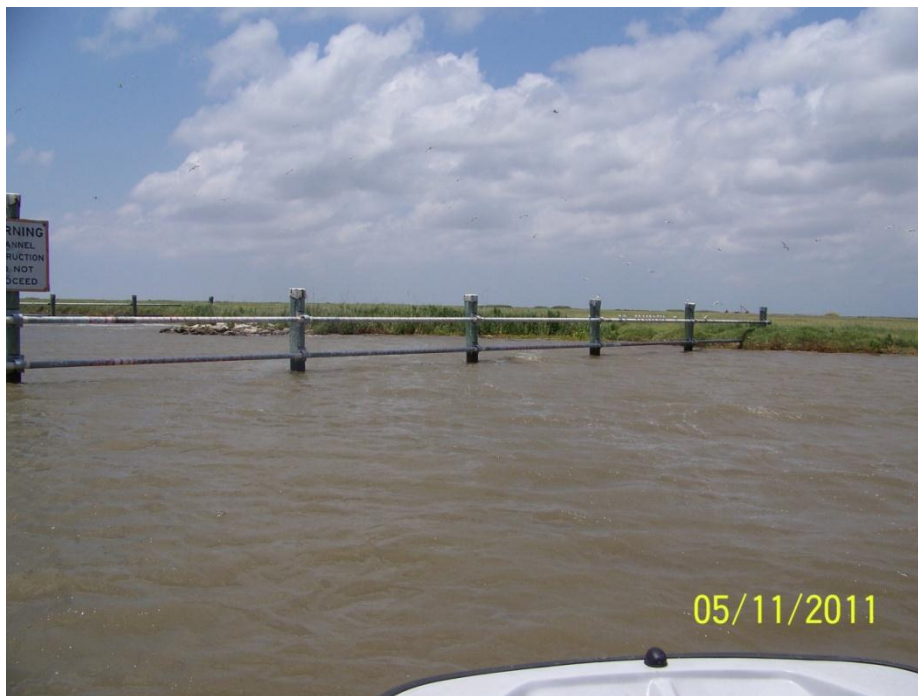
Photo #28: View of embankment tie-in on north side of Site No.4, looking northwest

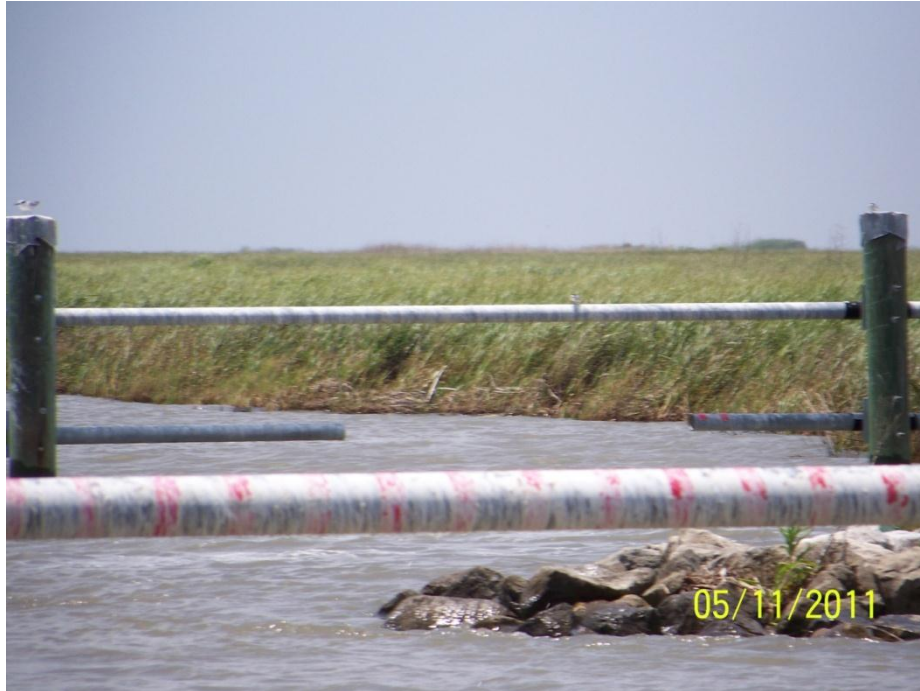
Photo #29: View of missing section of pipe in barricade on northwest side of Site No.4

The structural components of the sites in the interior of the island (Site No. 1, 5, 6, 7 & 9) appear to be in overall good condition. The rock weirs appear to be in good condition with moderate settlement and displacement of the rock material and minor erosion at the bank tie-ins. The timber barricades and warning signs were in good condition, except for the two sections of pipe that were missing from Sites No.4 and 6.

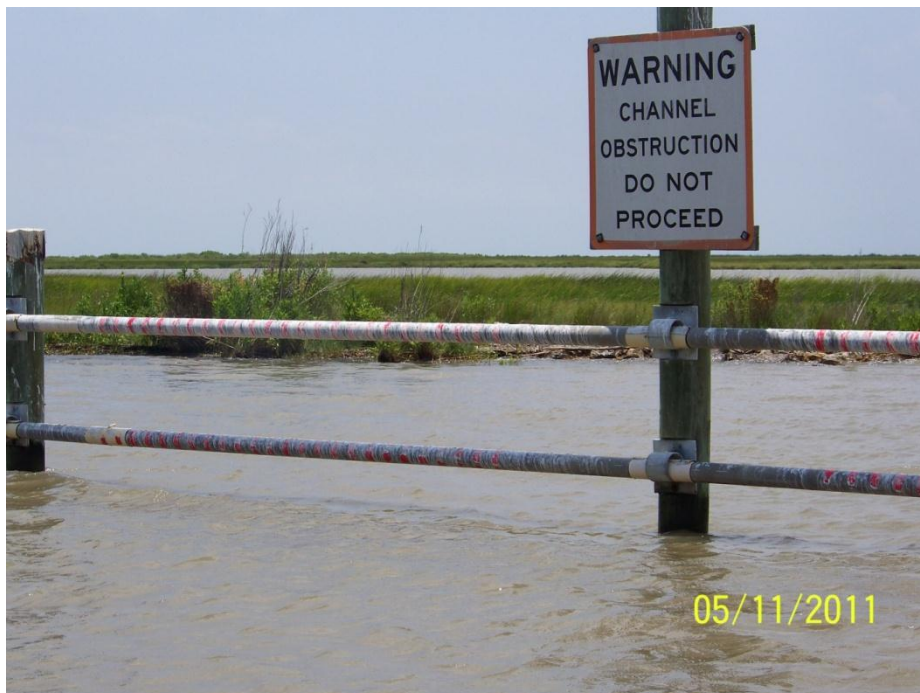
Photo #30: Close up view of warning signs and supports of Site No.4, looking southwest

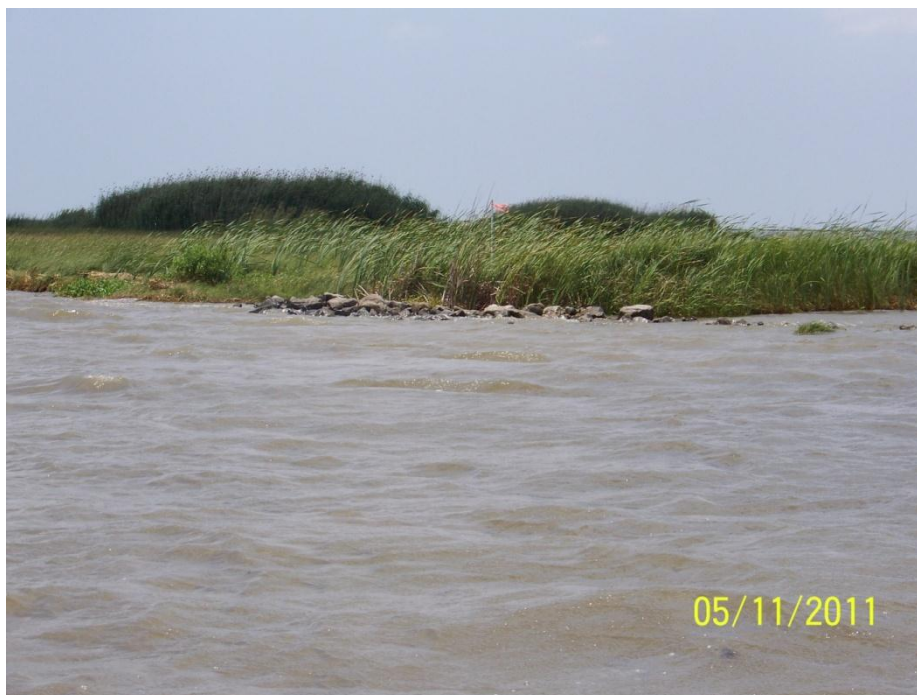
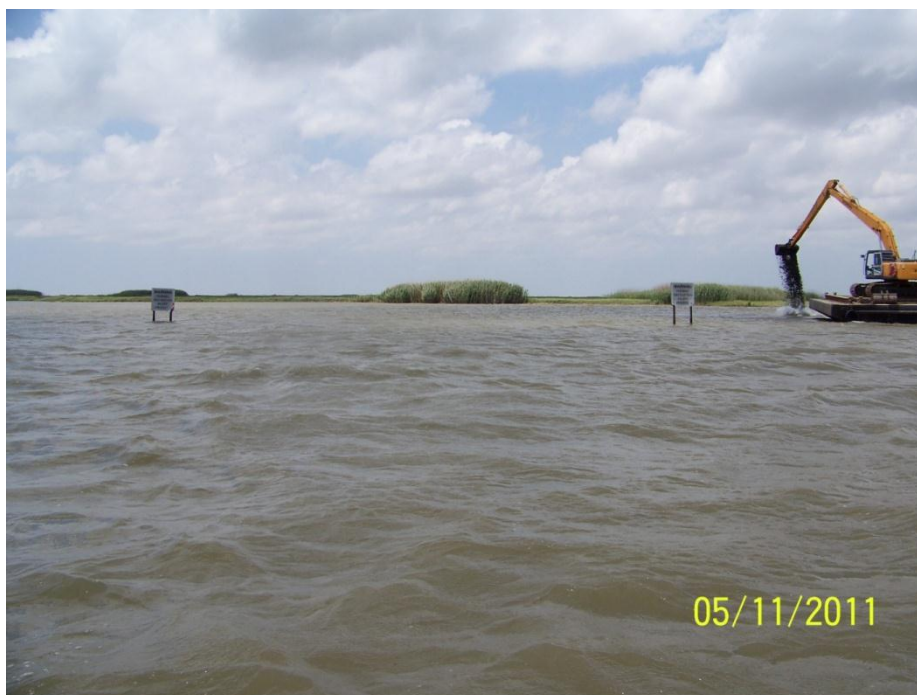
As previously reported, there was a significant breach at the north embankment tie-in and a small breach developing on the southern embankment tie-in. It was determined this structure should not be repaired due to the excessive land loss occurring along the shoreline; with erosion rates exceeding 60 ft/year, it is no longer feasible to maintain the structure. It was decided to degrade the structure to an -8.0' NAVD88 elevation to remove the navigation hazard posed by the rock weir. At the time of the 2011 annual inspection, the degrading of the

Photo #33: View of Site No. 3 Weir Removal in progress at time of inspection

At the time of the 2011 inspection, the degrading of Site No.3 rock weir was in progress. This structure was deemed ineffective due to the extreme erosion around the north end of the rock weir. It was decided the best course of action was to degrade the weir to a -8.0' NAVD88 so that it is no longer a navigational hazard. The degrading of the structure has been completed at the time of this report and Site No.3 will no longer be monitored or maintained as part of project TE-26.
