2011 Closeout Report

Mandalay Bank Protection Demonstration (TE-41) Project

State Project Number TE-41
Priority Project List 9

August 2011
Terrebonne Parish

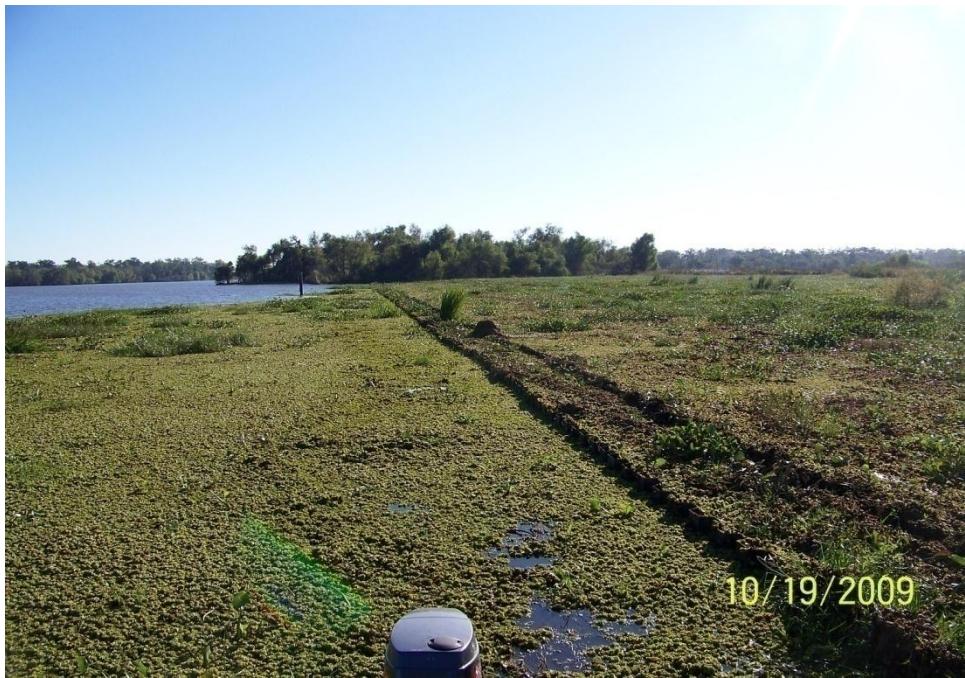
During the inspection, water levels were such that approximately 6 to 9 inches of the sheet pile structures were exposed. No noticeable breaching or major damage to the structures was apparent, and the earthen fill material placed between the double walls did not show signs of erosion. Some minor cracks, splits, and missing tops of sheet pile above the timber waler were observed. Timber walers appeared to be in good condition at all three sites. The galvanized tie rods and timber waler hardware were in good condition with only a minimal amount of corrosion present. The warning signs and support piles were in excellent condition. The bank tie-ins appeared to be in good condition. Overall, the sheet pile structures appear to be intact and do not require any maintenance (Photos 2-6, 12-16 and 59-64; Appendix B).

Photo No.4 – Site V3 – view of fiberglass sheet pile (double) wall structure looking east.

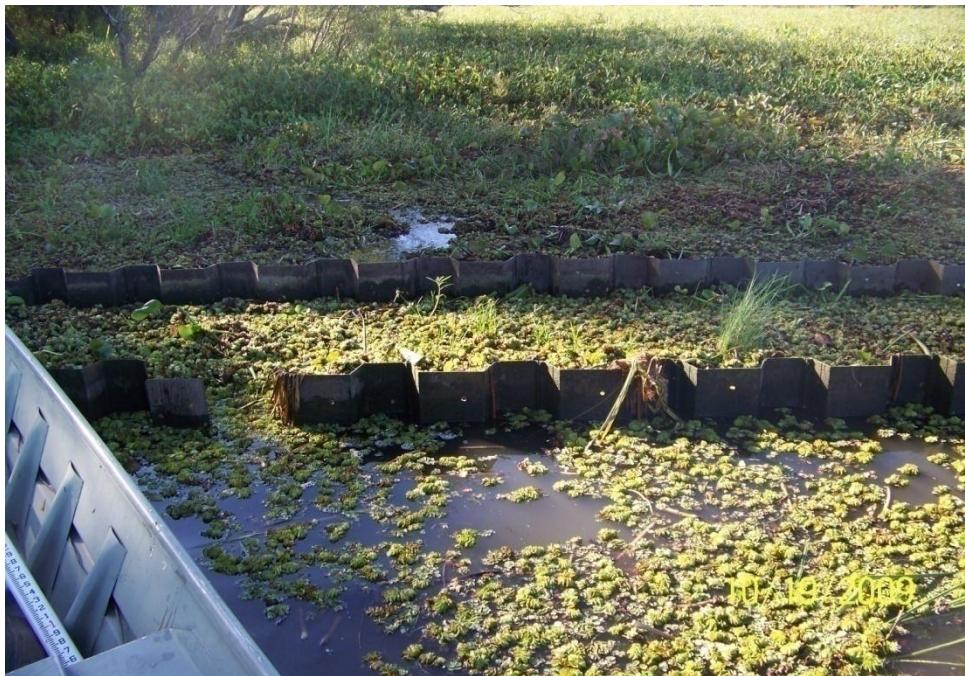
Photo No.6 – Site V3 – close-up view of fiberglass sheet pile (double) wall structure.

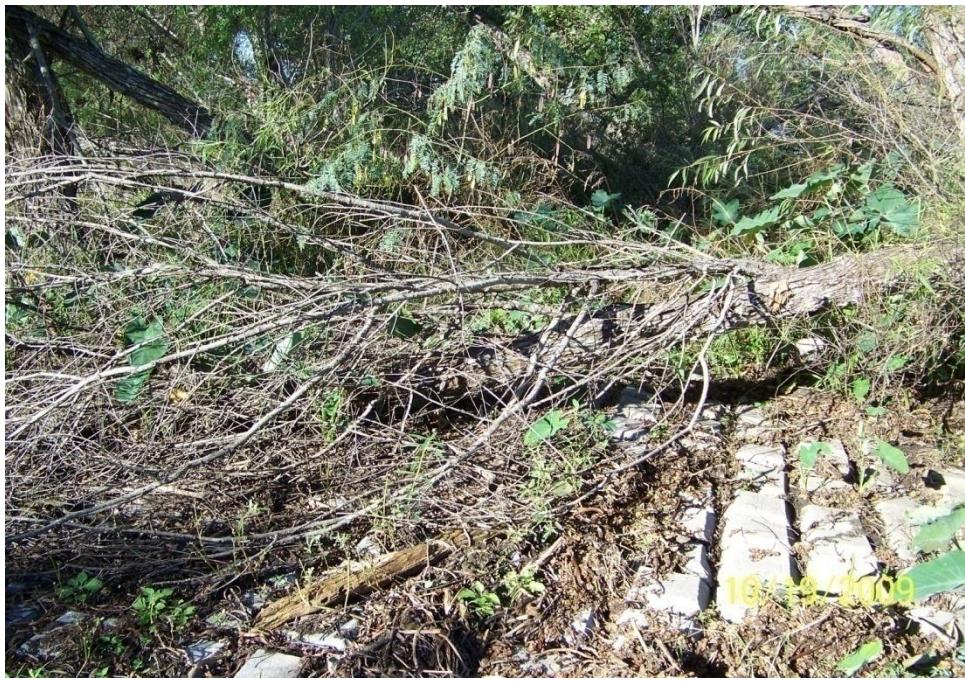
The concrete revetment mats appeared to be in good condition. Material has accreted in front of the Sites A1 and A2. The most accretion has occurred at Site A2 where the extent of vegetated accretion reaches well beyond the warning sign. The bank tie-ins were also in good condition. The warning signs and support piles were in excellent condition. Overall, the armored plugs appear to be intact and do not require any maintenance (Photos 7-11, 23-26 and 41; Appendix B).

Photo No. 8 – Site A3 – close-up of the articulated concrete mats covering the earthen plug.

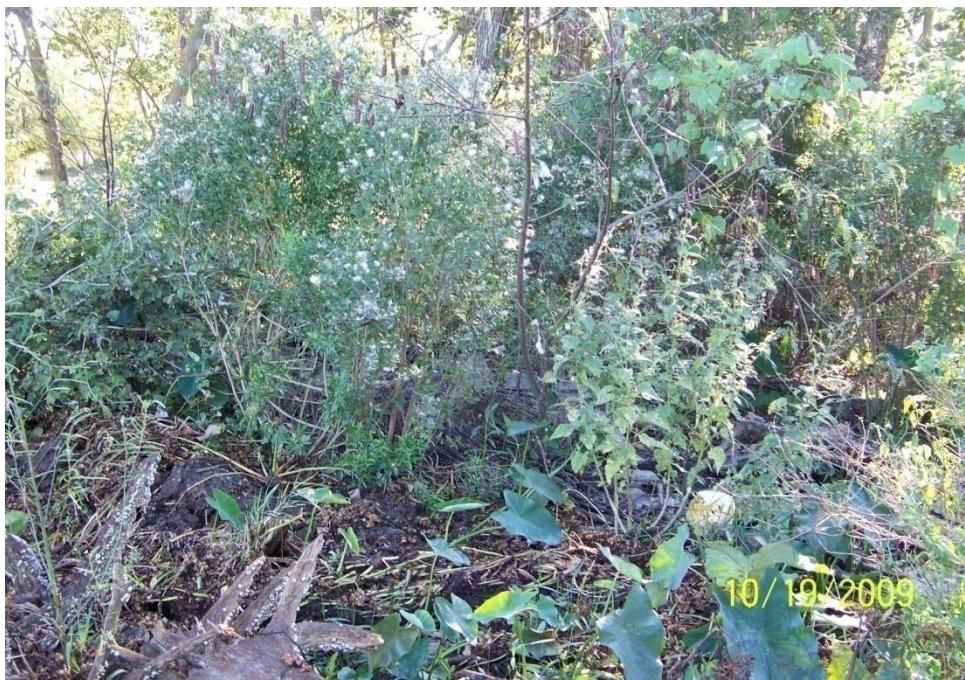
Photo No.10 – Site A3 – view of vegetation covering the armored earthen plug.

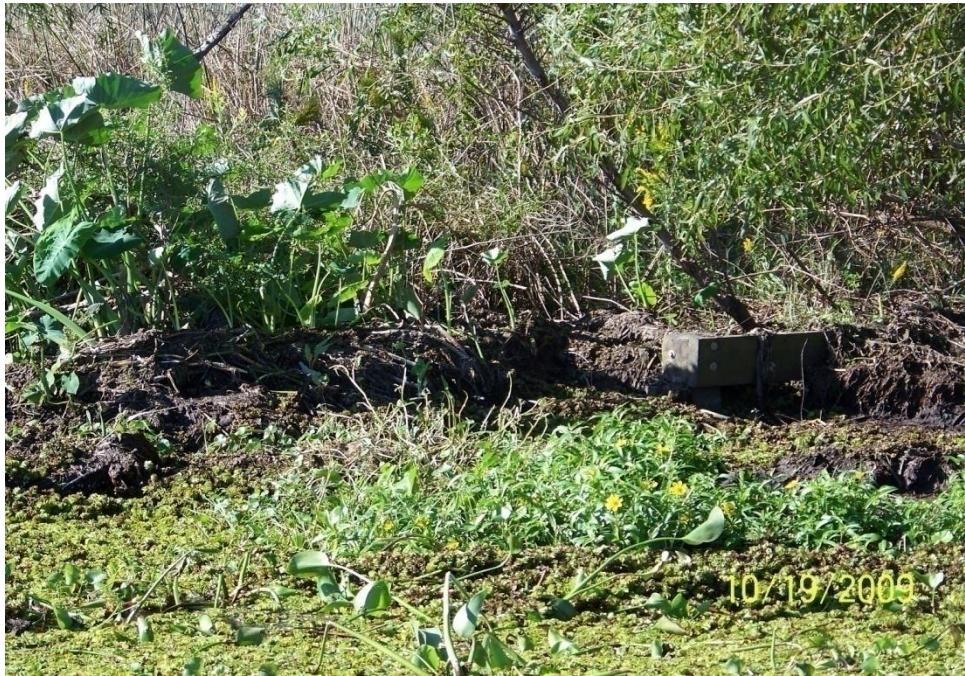
In general, the timber fencing and galvanized hardware at the three sites appeared to be in good condition with no signs of damage. One location of damage was noted however. At Site F2, approximately 7 or 8 fence spans were missing near the middle of the structure. It appears as if a barge struck the fence here. From communication with field personnel, it is believed this occurred in early May 2006. Most of the bank tie-ins were in good condition. The bank has eroded approximately 2' away from the west end of the fence at Site F2. The warning signs and support piles were in excellent condition at Sites F1 and F3. The warning sign support pile at Site F2 was struck by the barge as well and is now leaning with the sign partially submerged. At Site F3, significant accretion has occurred (an average of 10' in front of the structure and up to the bottom of the top cross timber on the structure). This fence site is adjacent to plug Site A2 where extensive accretion of material has occurred. In some locations material has accreted greater than 50' from the old shoreline behind the fence out to the warning sign. In the vertical direction the material has reached the second timber on the fence or higher. As noted in previous inspections, the survival rates of the planted giant cutgrass associated with Fencing Sites appears to still be very low. The only immediate maintenance need is the warning sign at Site F2. Also, consideration should be given to replacement of the damaged fence sections at Site F2. The damage to these sections as well as the length of time since the occurrence should be noted in the demonstration project results (Photos 17-22, 29-30, and 33-40; Appendix B).

Photo No. 20 – Site F3 – view of heavy vegetation and accretion around timber fence structure.

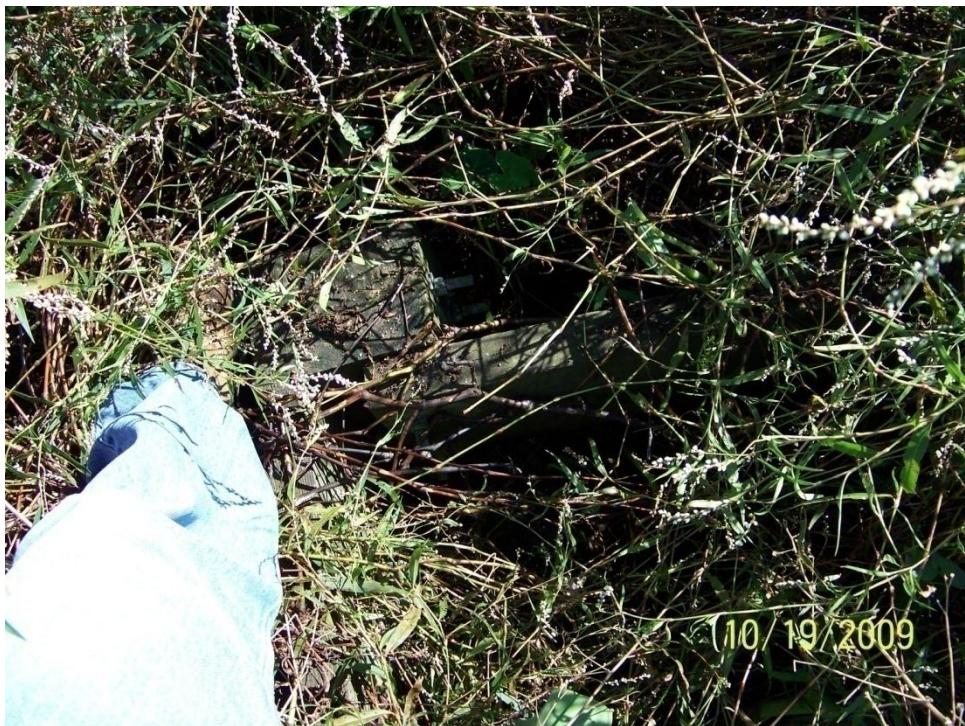
Photo No. 22 – Site F3 – close-up view of accretion around timber fence structure.

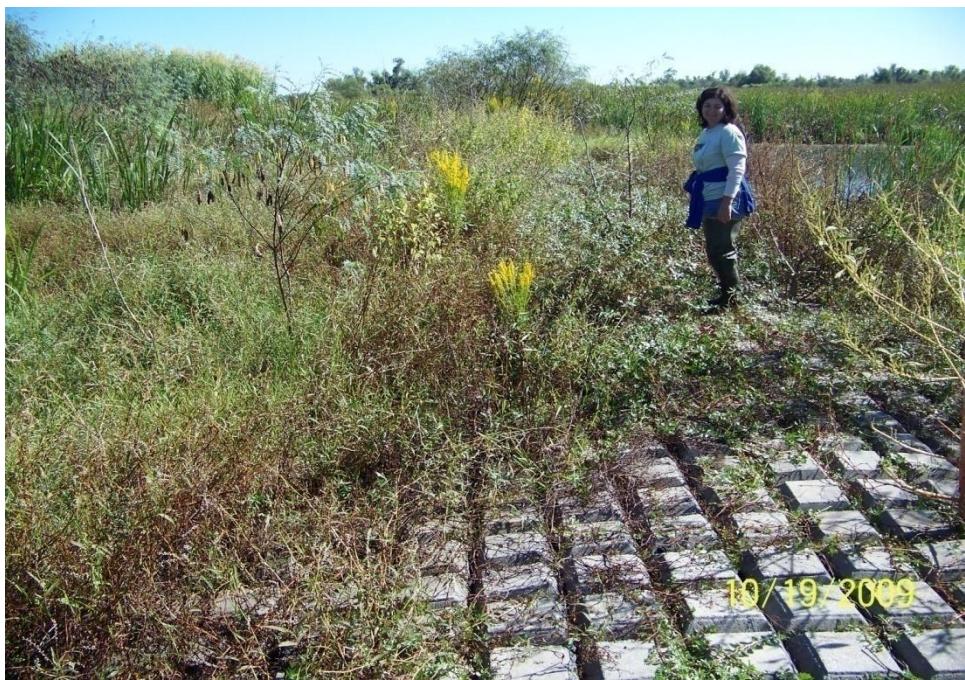
Photo No.24 – Site A2 – view of vegetative growth through the armored earthen plug structure.

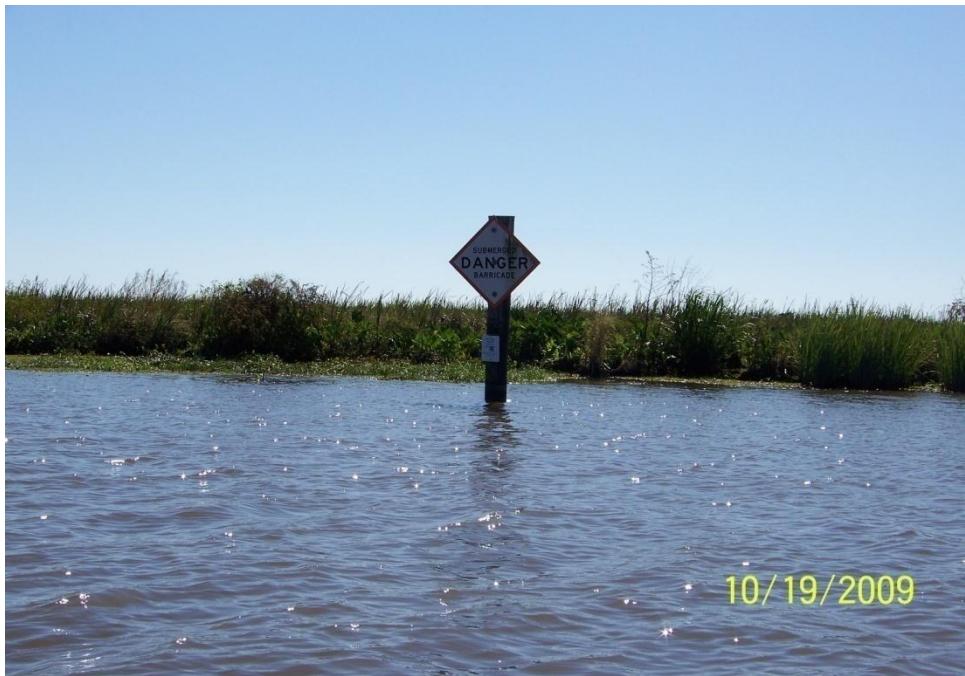
At the adjacent Sites J1 and J2, accretion has occurred, and the A-Jacks (double row) are now covered by well-vegetated, accumulated material. The depth of cover over the A-Jacks was found to be 1' to 2' in some locations (2007 inspection). The extent of vegetated accretion appears to be greater than 200' in some locations as it extends from the old shoreline behind the A-Jacks northward toward the GIWW beyond the warning signs at the two sites. The accreted material is densely vegetated. At Site J3, the water level was just below the tops of the A-Jacks. No accretion has occurred except at the west tie-in where the structure ties into the Site A2 plug. In fact, it appears as if the shoreline may have continued to experience some measure of erosion at this site. The survival rate of the plantings at Site J3 still appears to be the lowest (out of the three sites) as noted in the previous inspection reports. The tie-ins appeared to be in good condition at the three sites. The warning signs and support piles at the three sites were in excellent condition. No maintenance is recommended for the concrete armor unit sites at this time (Photos 27-28, 31-32 and 42-47; Appendix B).

Photo No.27 – Site J3 – Double row A-Jacks units along the shoreline below water surface.

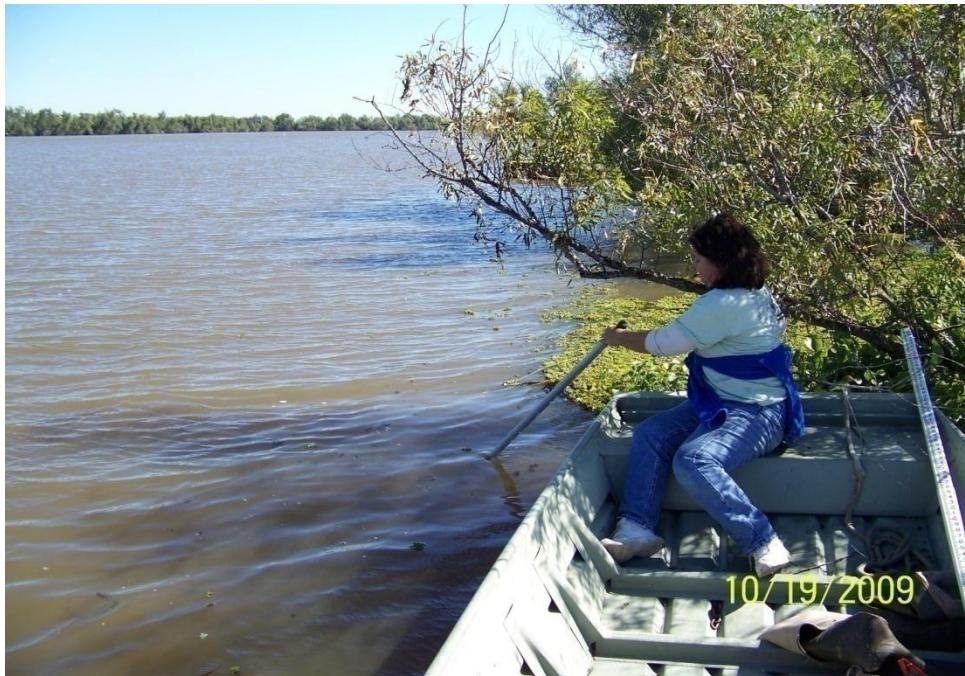
Photo No. 31 – Site J3 – view of submerged double row concrete armoring units.

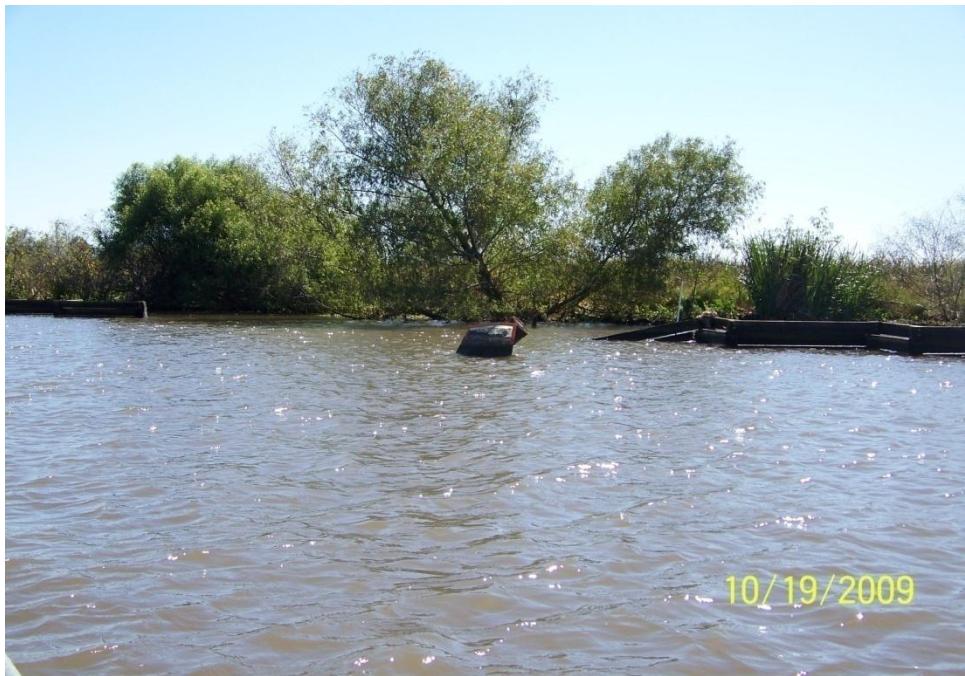
Photo No.33 – Site F2 – view of sign and fence damage by apparent boat collision.

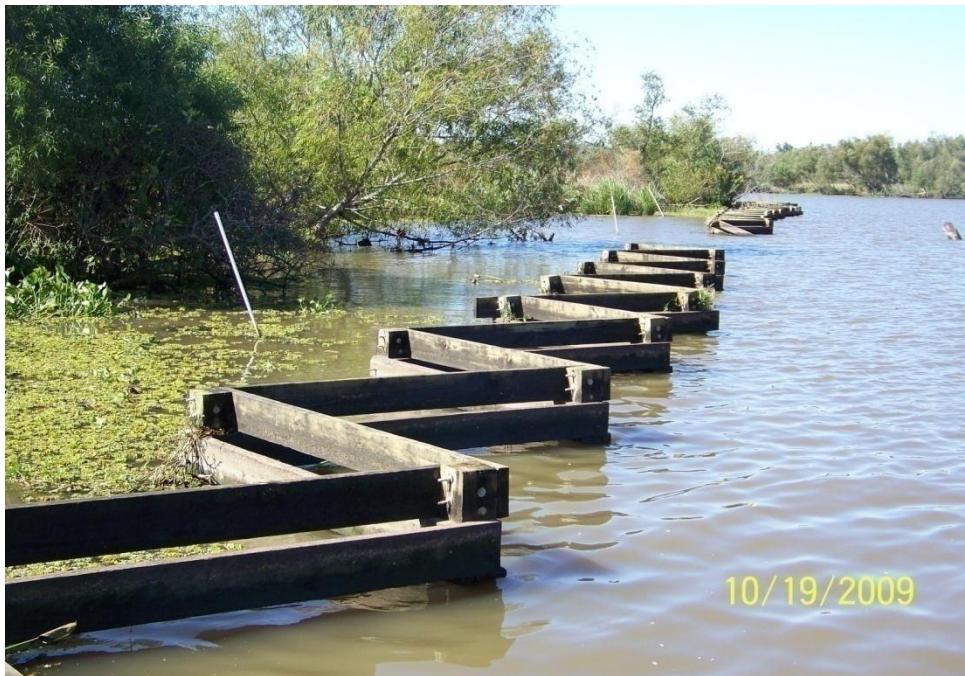
Photo No.34 – Site F2 - view of damaged fence units where a boat collided with the structure.

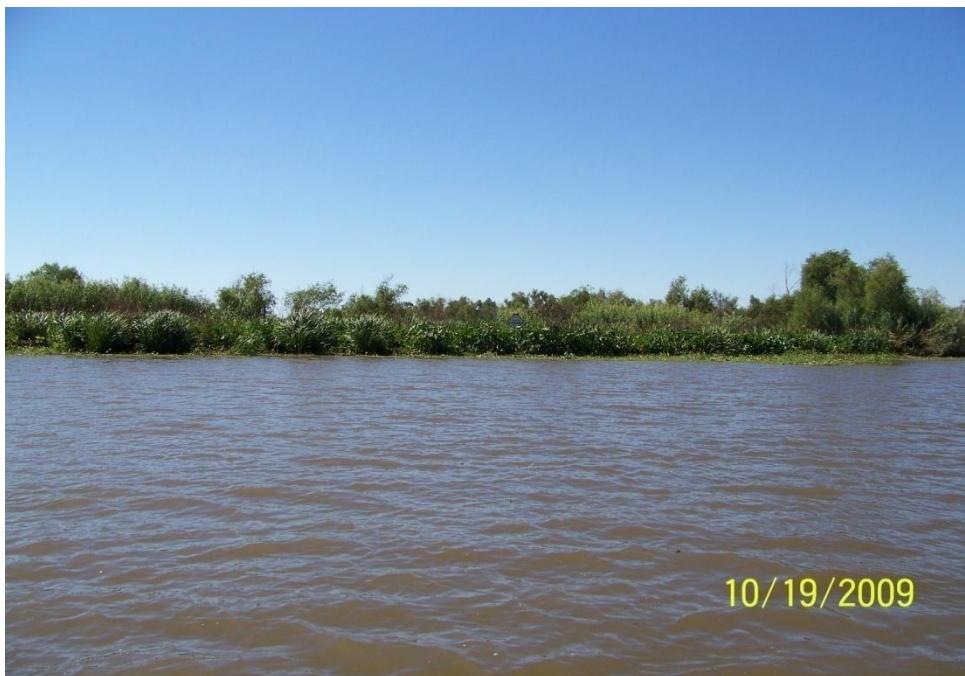
Photo No. 42 - Site J2 – view of double row concrete armoring system and vegetative cover.

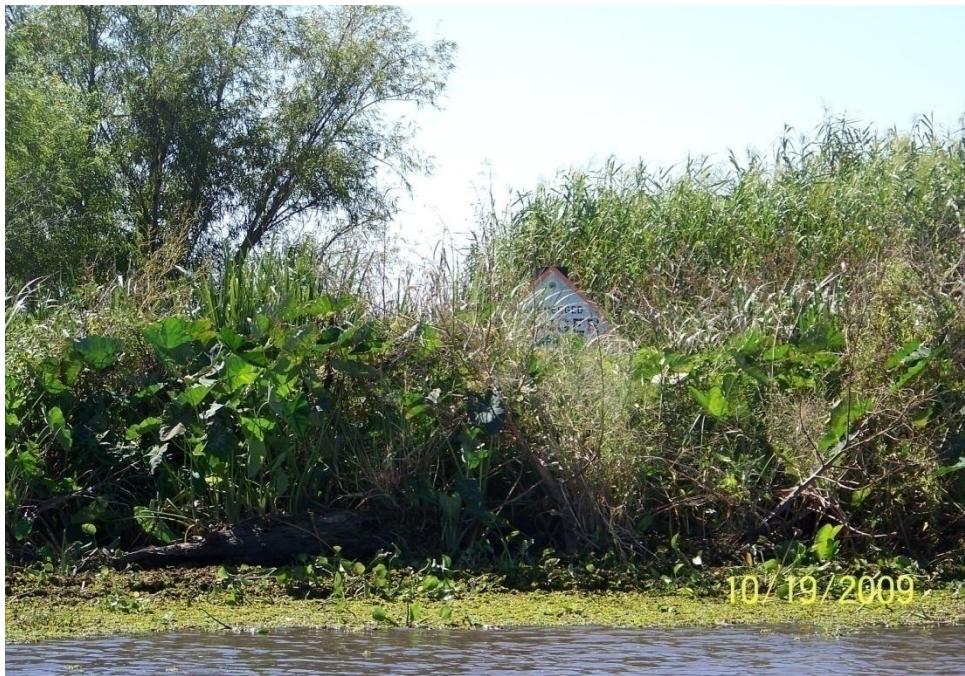
Photo No. 45 - Site J1 – view of vegetation and accretion in front of concrete armoring units.

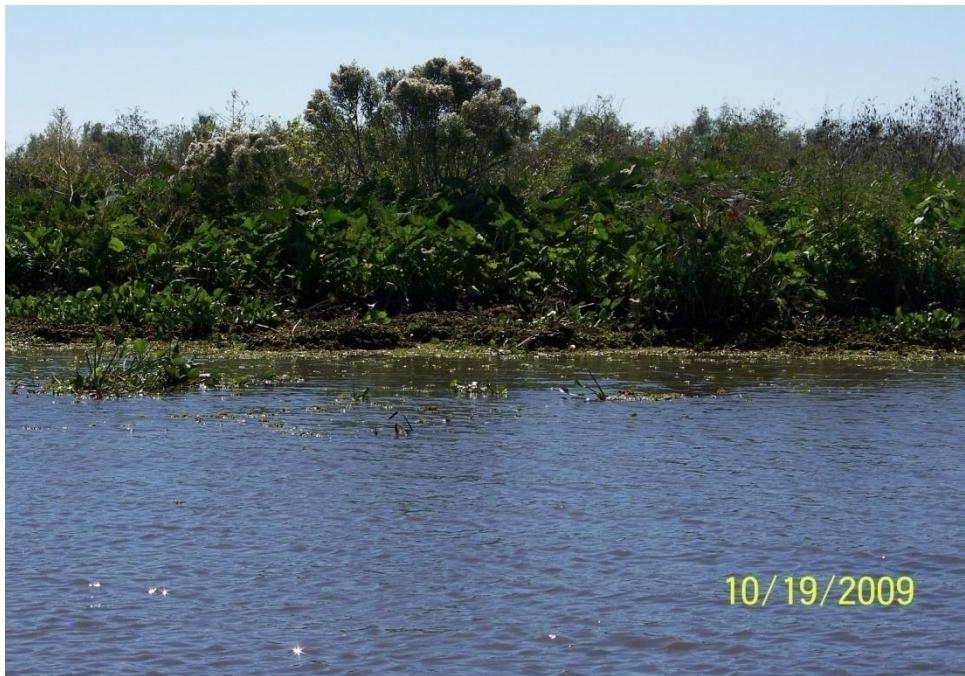
Photo No. 46 – Site J1 – view of accretion in front of double row concrete armoring units.

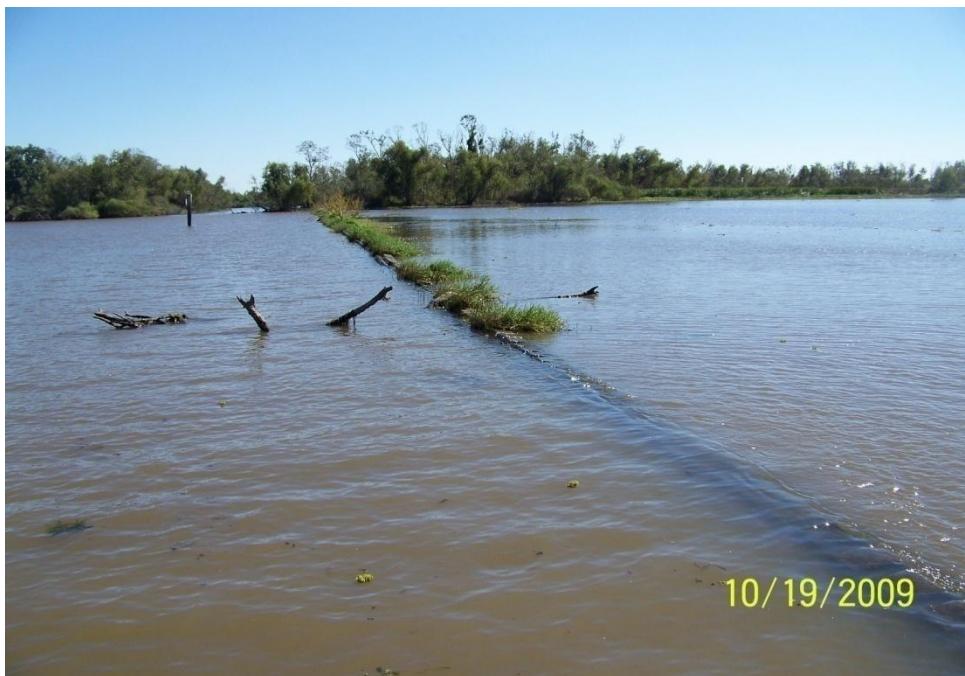
At Sites R1 and R2, increased settlement has occurred in two locations along the revetment mat / pipe system at each site. At the R1 Site, the two low areas are located approximately 40' east of the settlement plate and near the west end. At Site R2, the two low areas are located approximately 25' east of the settlement plate and near the west end. Much of the system west of the settlement plate was just below water elevation at the time of the survey. It should be noted that in these locations of observed settlement at Sites R1 and R2, fill material had to be

placed in order to level the bottom before placement of the fabric, pipe, and mats during construction. No noticeable damage to the structures was apparent. The settlement plate riser pipes appeared to be in good condition. While the settlement plate riser pipe at Site R3 is visually out of plumb, this riser pipe was leaning upon installation. The warning signs and support piles at the three sites were in excellent condition. The bank tie-ins were in good condition with some bank erosion noted. Overall, the revetment mat structures appear to be intact and do not require any maintenance (Photos 48-58, 65-69; Appendix B).

Photo No.50 – Site R1 – view of submerged revetment mats and CPE pipe looking east.

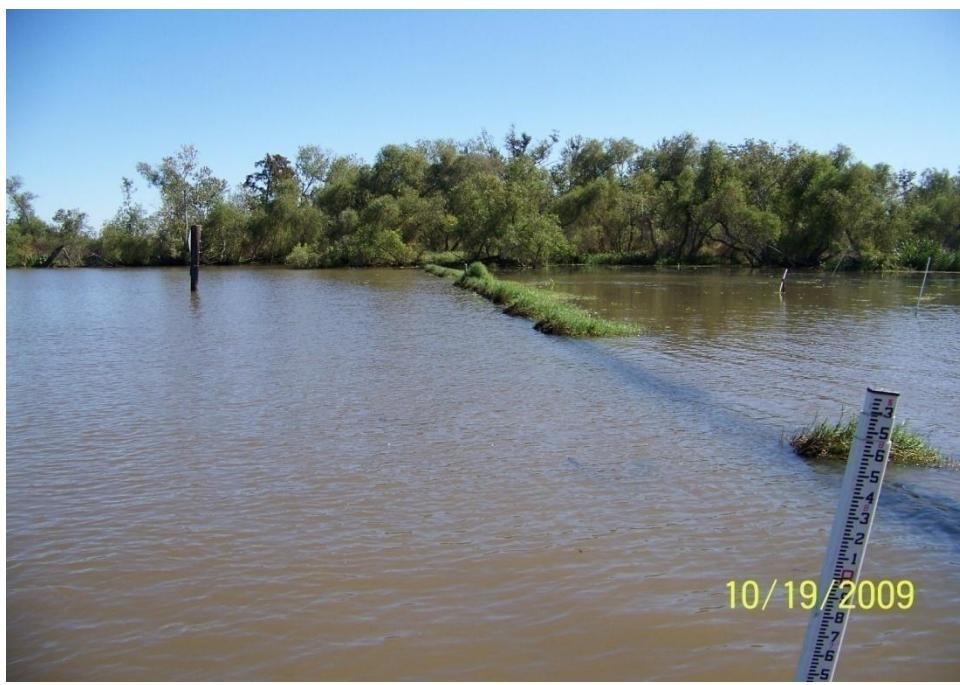
Photo No. 56 – Site R2 – view of settled areas along the elevated shoreline system.

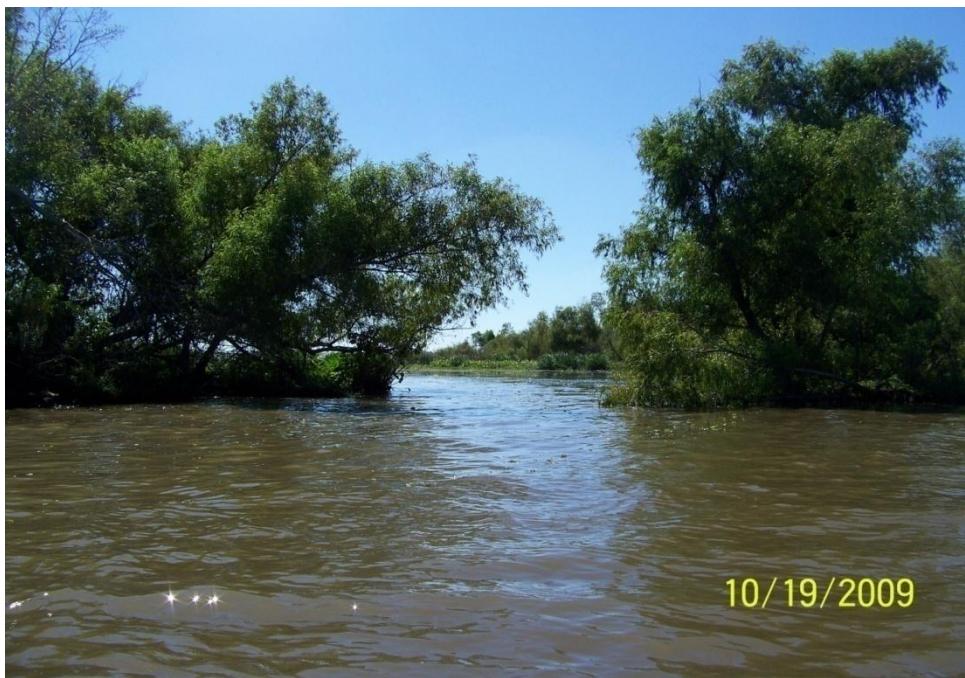
Approximately 75 feet to the east of the east tie-in of Site R1, an existing breach in the bank was plugged with dredged material from the GIWW during construction. This earthen plug has now been breached leaving the bank open again (Photo 70, Appendix B).

Photo No. 70 – Breach in the bank near the earthen plug east of elevated shoreline unit R1.
