**2011 Annual Inspection Report**

**North Lake Mechant Landbridge  
Restoration Project (TE-44)**

State Project Number TE-44  
Priority Project List 10

August 30, 2011  
Terrebonne Parish

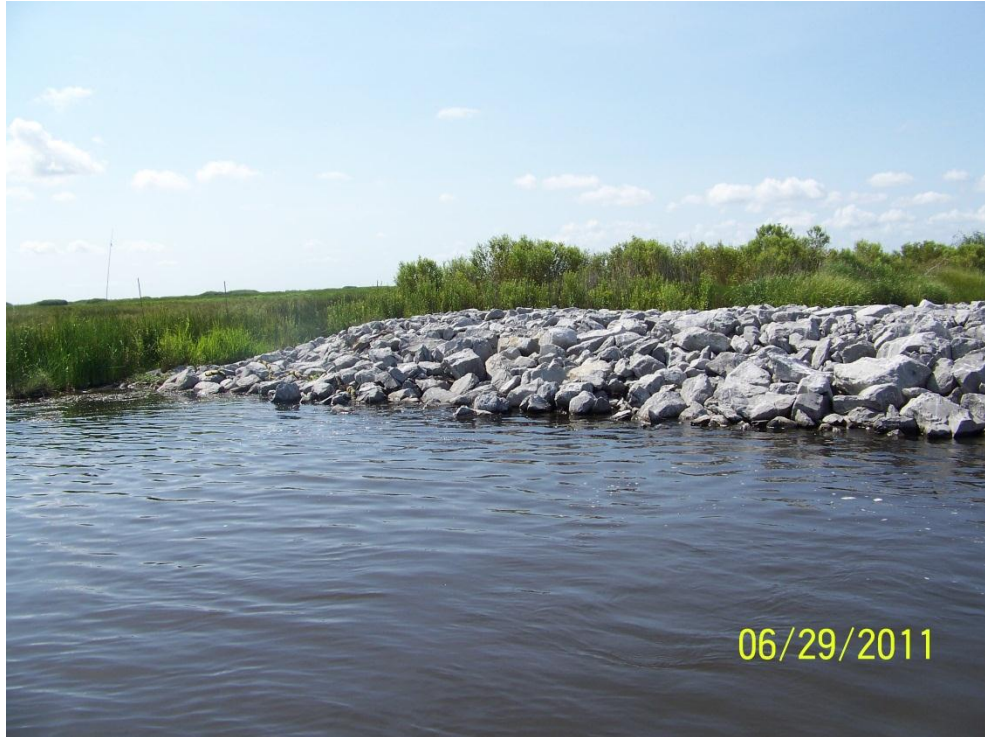
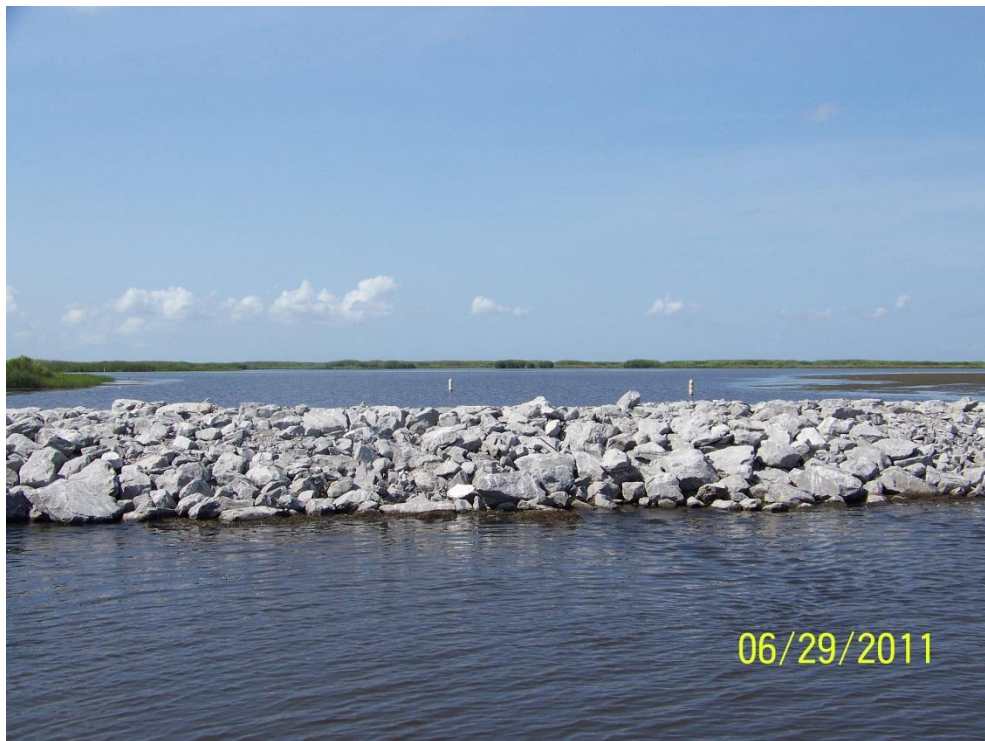
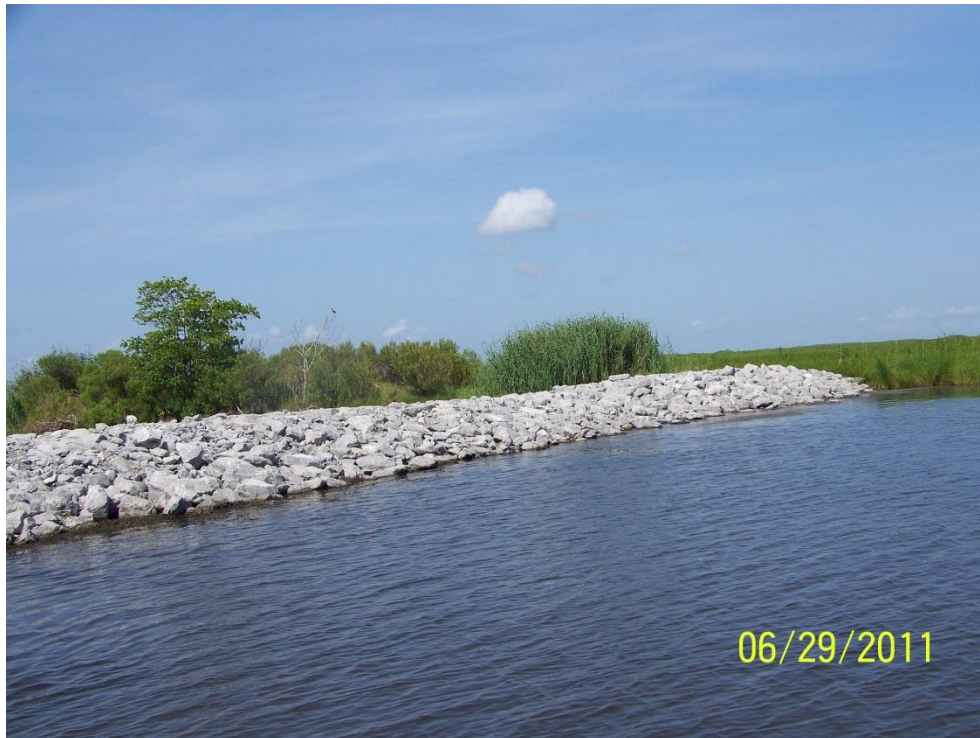
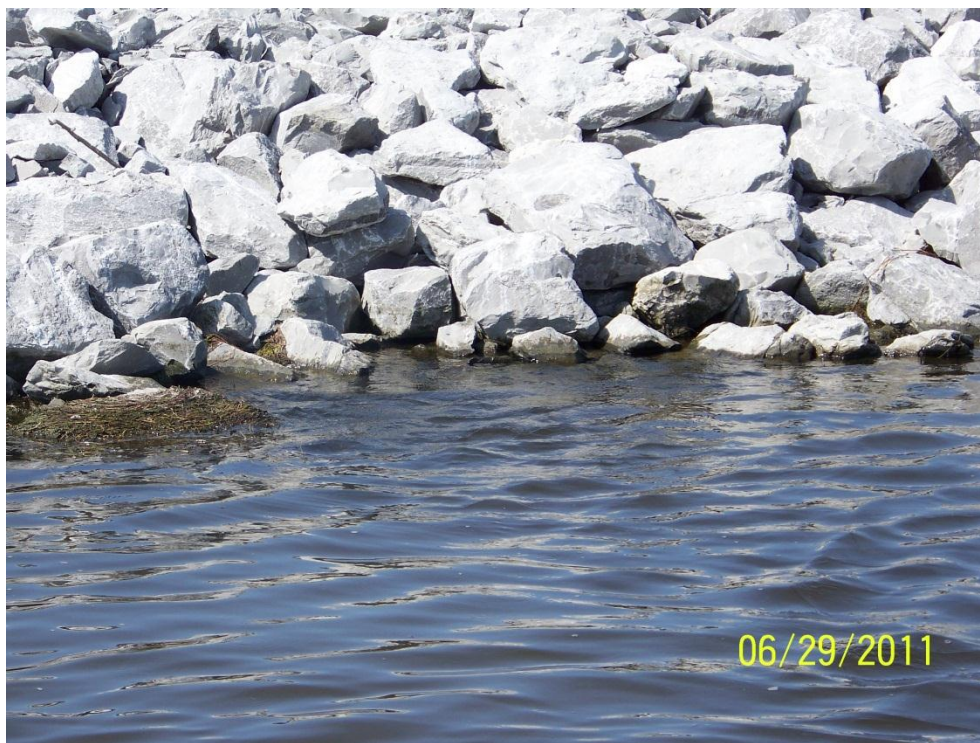
Rock Plug No.1 appeared to be in very good shape. There was no observed settlement or displacement of the rock. There was no erosion or washouts around the embankment tie-ins. There was a very small amount of water transfer through the middle of the structure. Using a water salinity meter, the water flowing through the structure was recorded as having a salinity of 4.82 ppt and the water elsewhere along the north side of the structure as having a salinity of 0.60 ppt. The rock plug is still functioning as designed; therefore there are no recommendations for corrective action at this time.

Picture #1: View of Rock Plug 1 embankment tie-in on the east side of the structure, looking southeast

Picture #2: View from the north side of Rock Plug 1, looking south

Picture #3: View of Rock Plug 1 embankment tie-in on the west side of the structure, looking southwest

Picture #4: Rock Plug 1 allows some tidal exchange through the structure, looking south

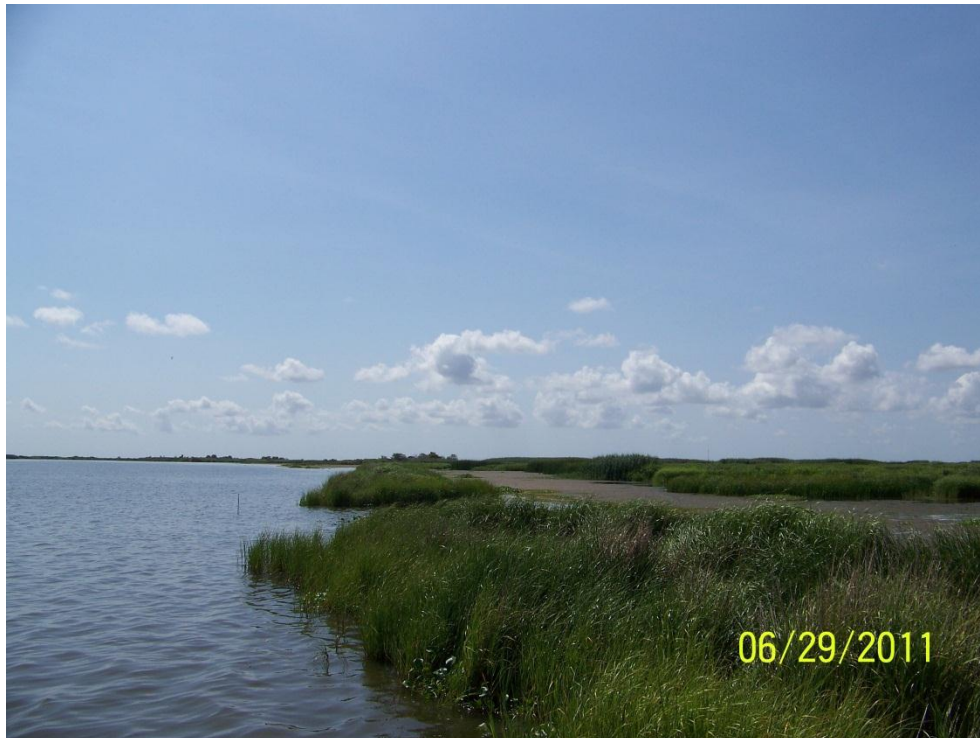
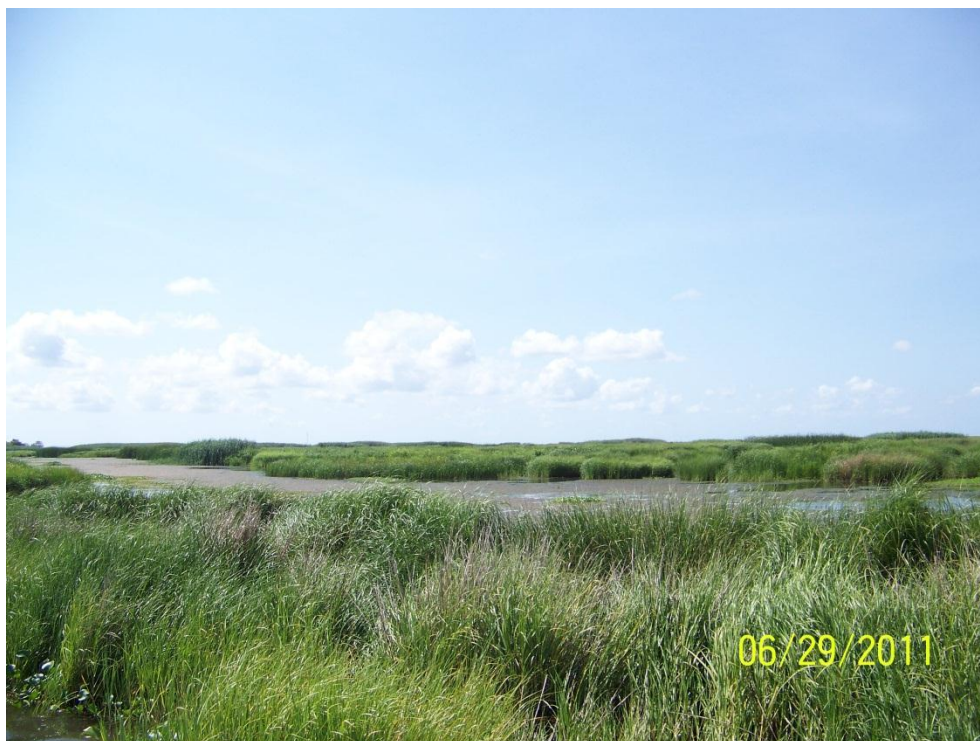
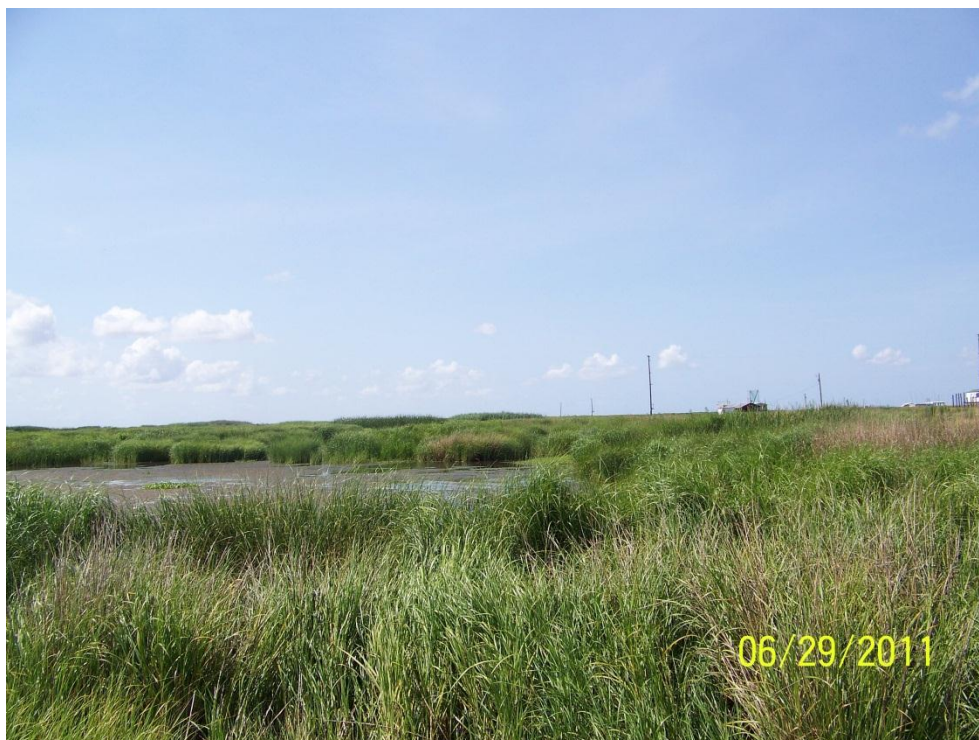
Due to access constraints, all of the fill areas in the project were inspected from the perimeter of the individual areas. From our observations, it appears the fill areas are promoting the growth of vegetation, with the majority of the area being vegetated. Also, there are no signs of extreme settlement of the fill material, as the elevation of the fill area remains fairly consistent with some slight variations as expected. Overall the fill areas appear to be in very good condition and there are no recommendations for corrective actions at this time.

Picture #5: View of earthen dike and Fill Area 6 from Raccourci Bay, looking east

Picture #6: View of earthen dike and Fill Area 6 from Raccourci Bay, looking southeast

Picture #7: View of earthen dike and Fill Area 6 from Raccourci Bay, looking south

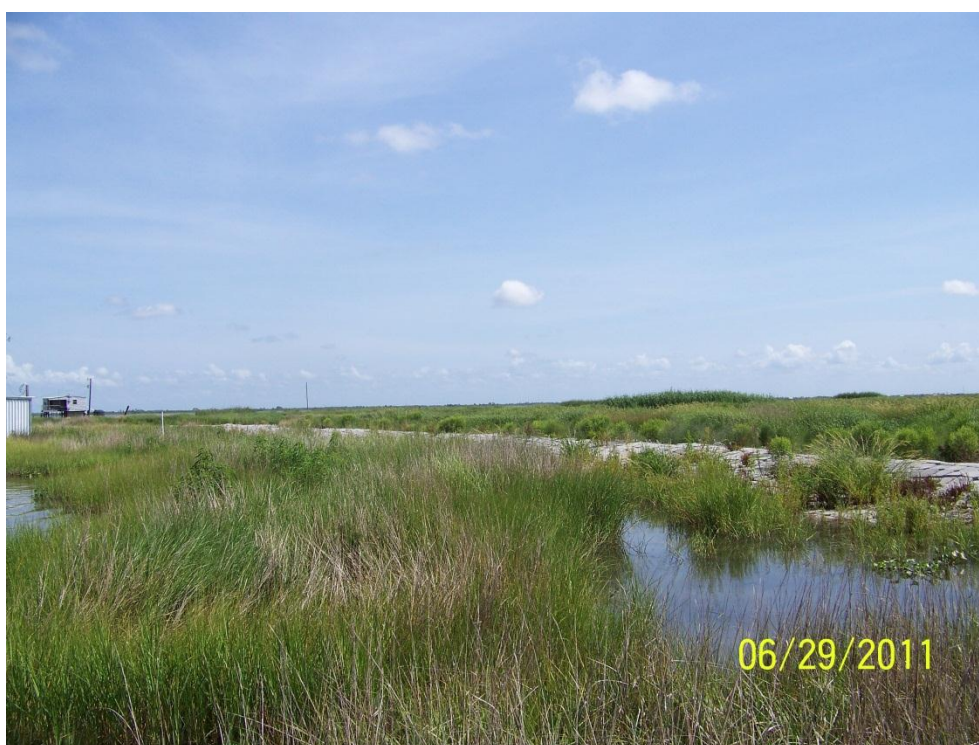
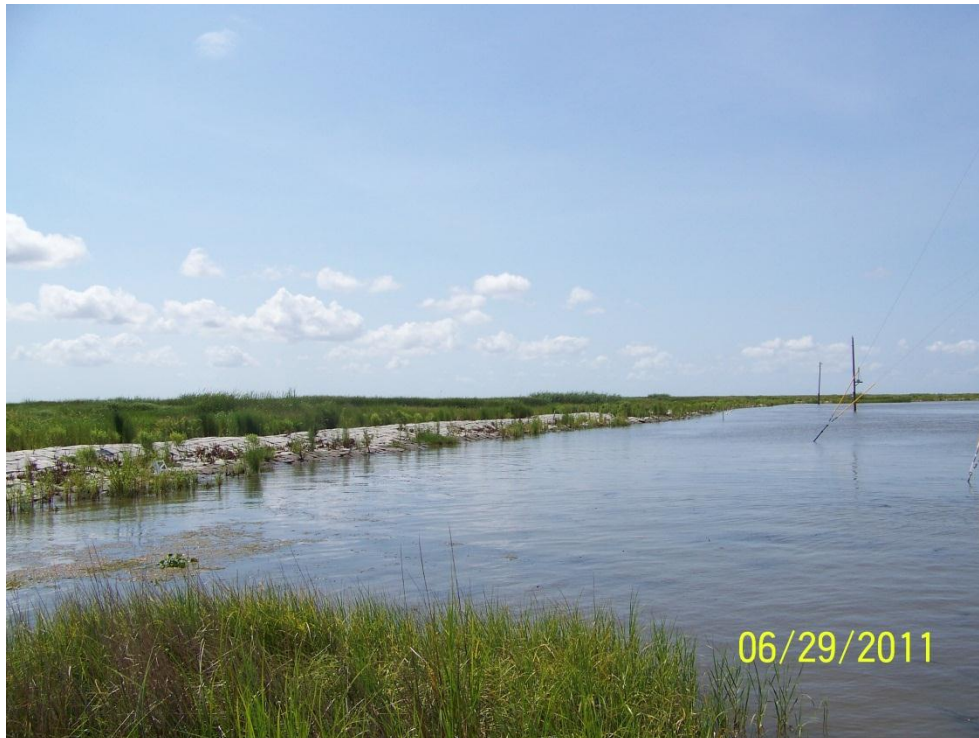
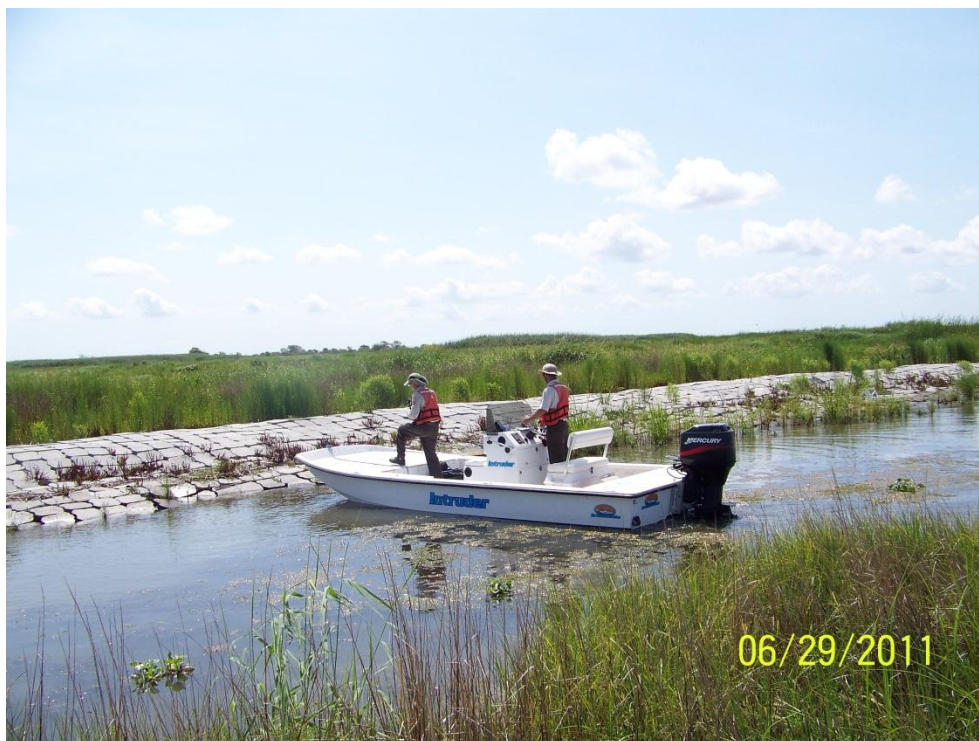
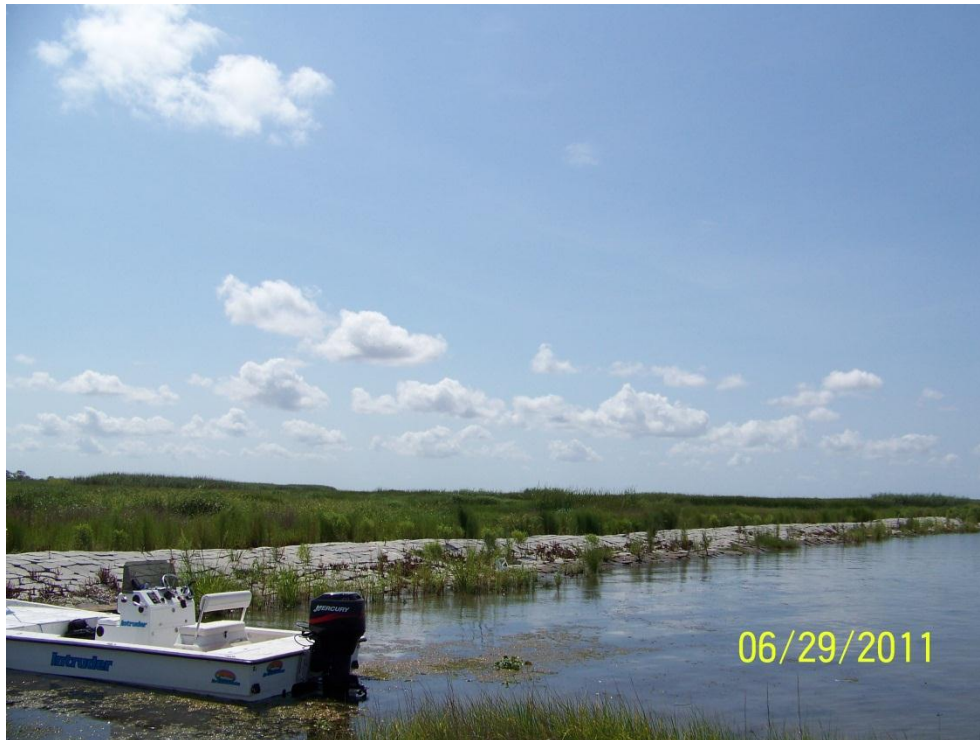
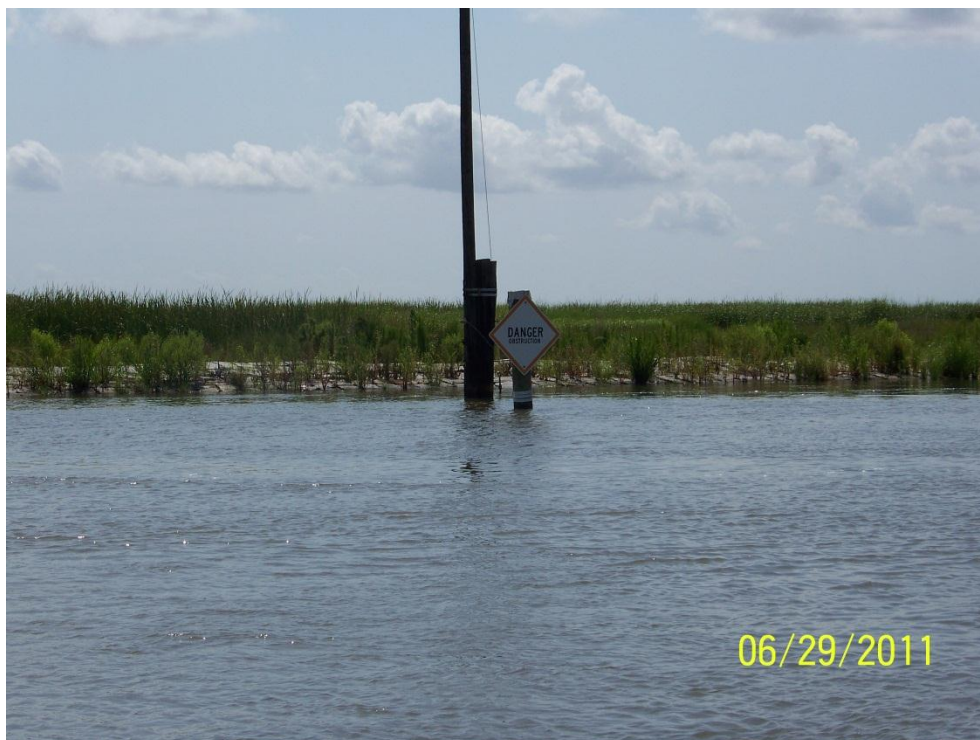
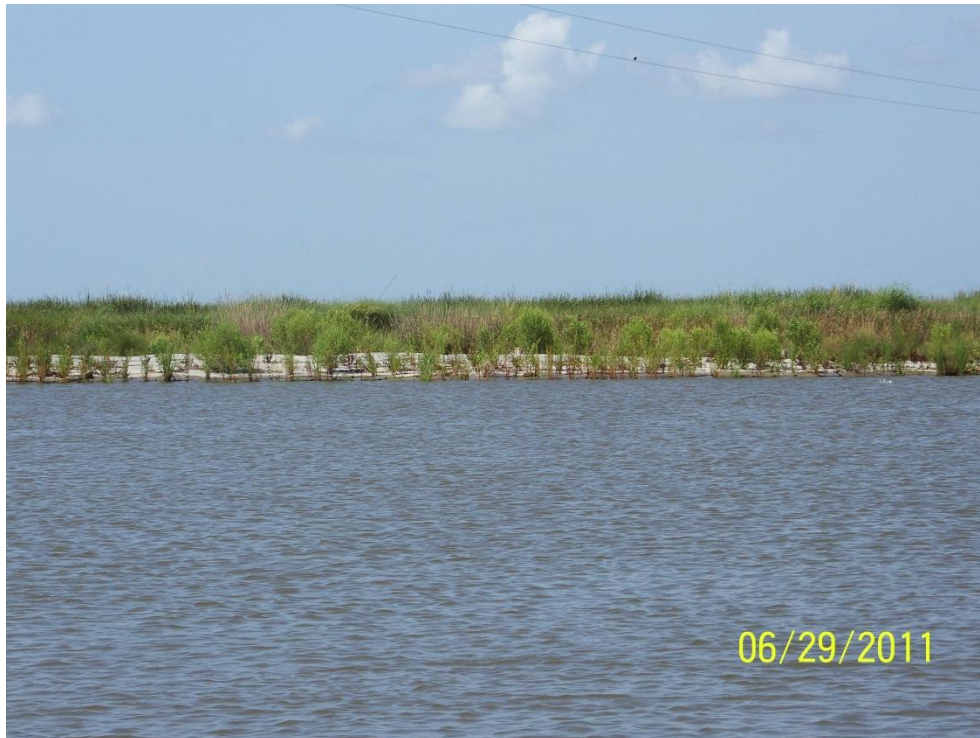
The armored earthen dike on the west bank of Bayou Raccourci appears to be in good overall condition. The warning sign and its support timber show no signs of damage. The articulated concrete mats are still coupled by the copolymer rope with vegetation emerging through the seams. As expected, there is some variation in height along the length of the armored earthen dike. This is believed to be caused by a difference in dredged material settling at different rates under the weight of the articulated concrete mats and placement of the mats on earthen material that was not fully dressed. The armored earthen dike is still performing as designed; therefore, there are no recommendations for corrective actions at this time.

Picture #8: View of Armored Earthen Dike along Raccourci Bayou and Fill Area 6, looking northeast

Picture #9: View of Armored Earthen Dike along Raccourci Bayou and Fill Area 6, looking southeast

Picture #10: View of Armored Earthen Dike along Raccourci Bayou and Fill Area 6, looking southeast

Picture #11: View of Armored Earthen Dike along Raccourci Bayou and Fill Area 6, looking southeast

Picture #12: View of Armored Earthen Dike along Raccourci Bayou and Fill Area 6, looking east

Picture #13: View of Armored Earthen Dike along Raccourci Bayou and Fill Area 6, looking east

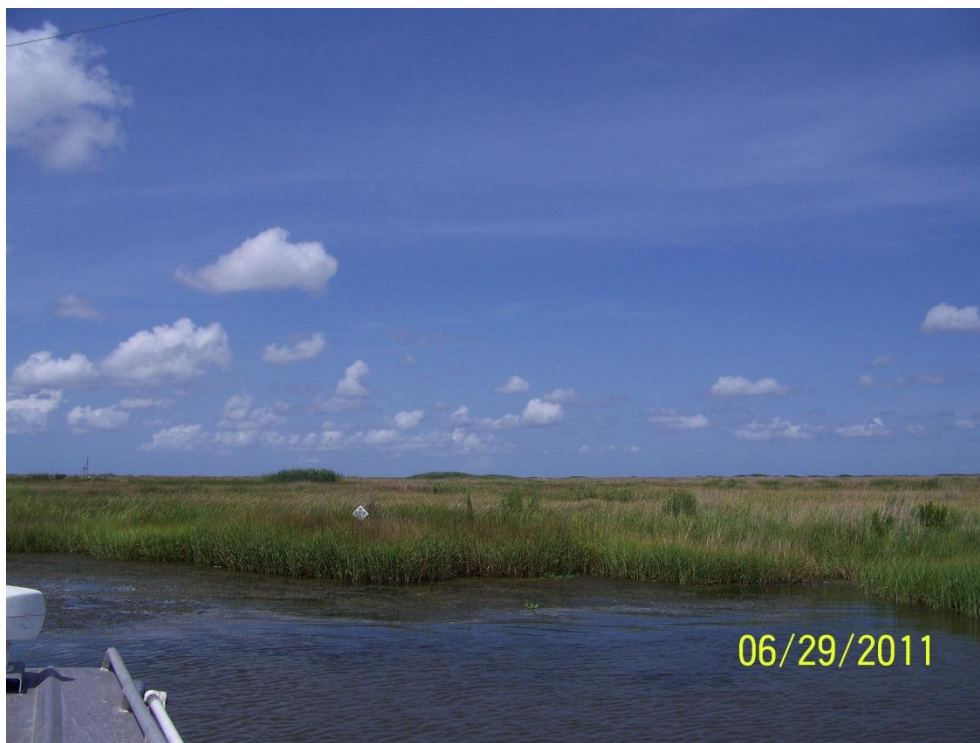
Picture #14: View of Fill Area 5 from Raccourci Bayou, looking west

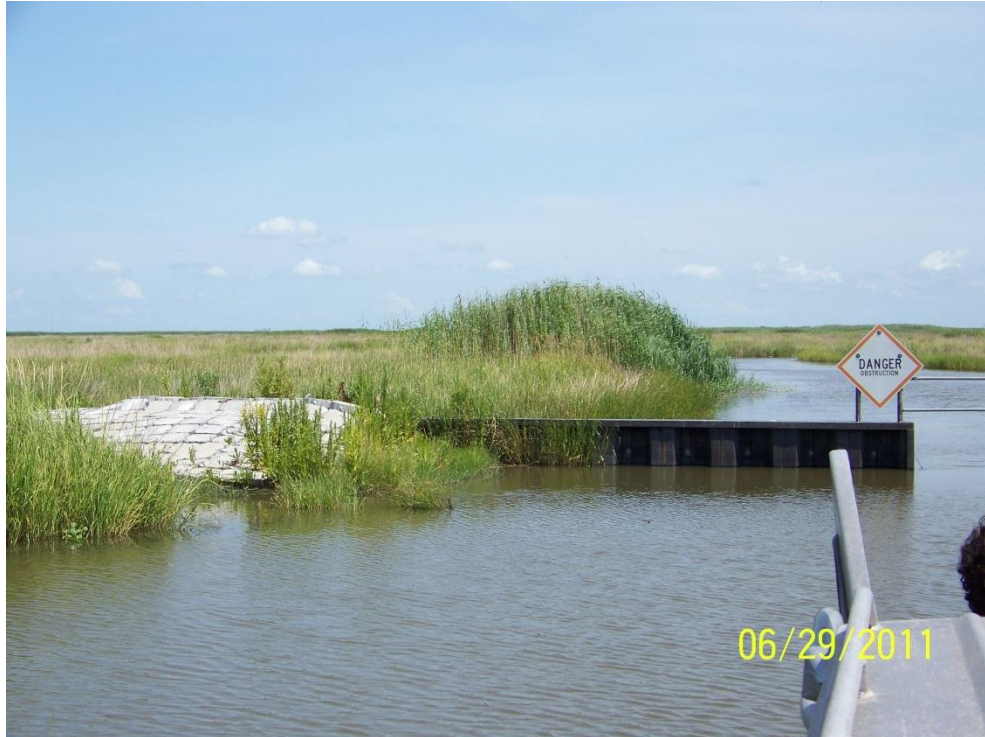
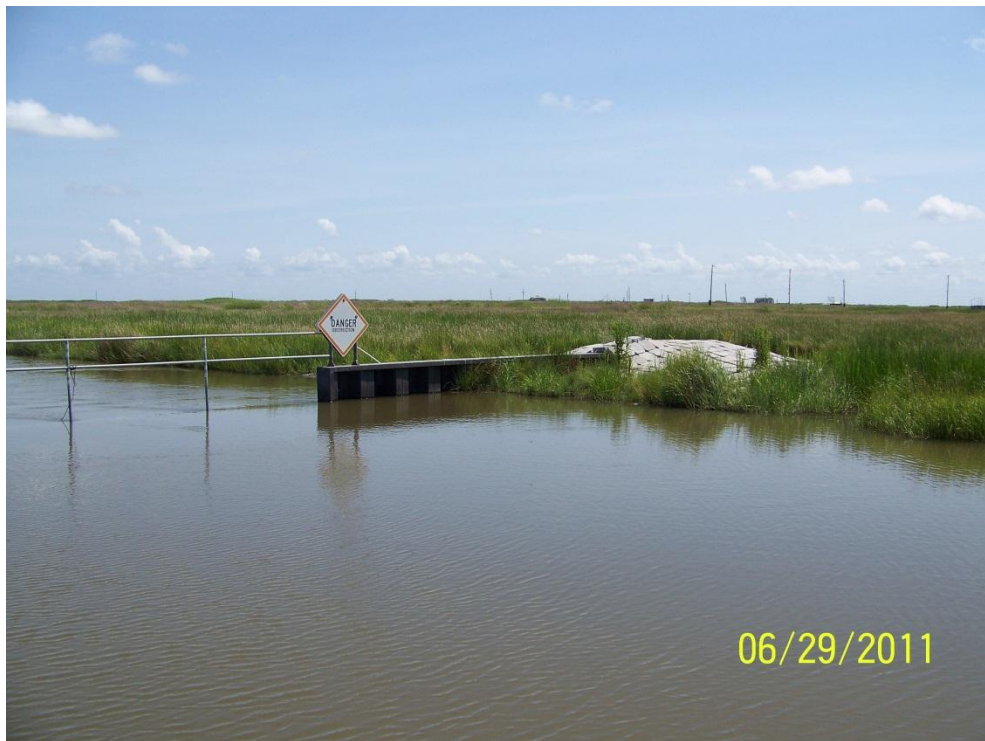
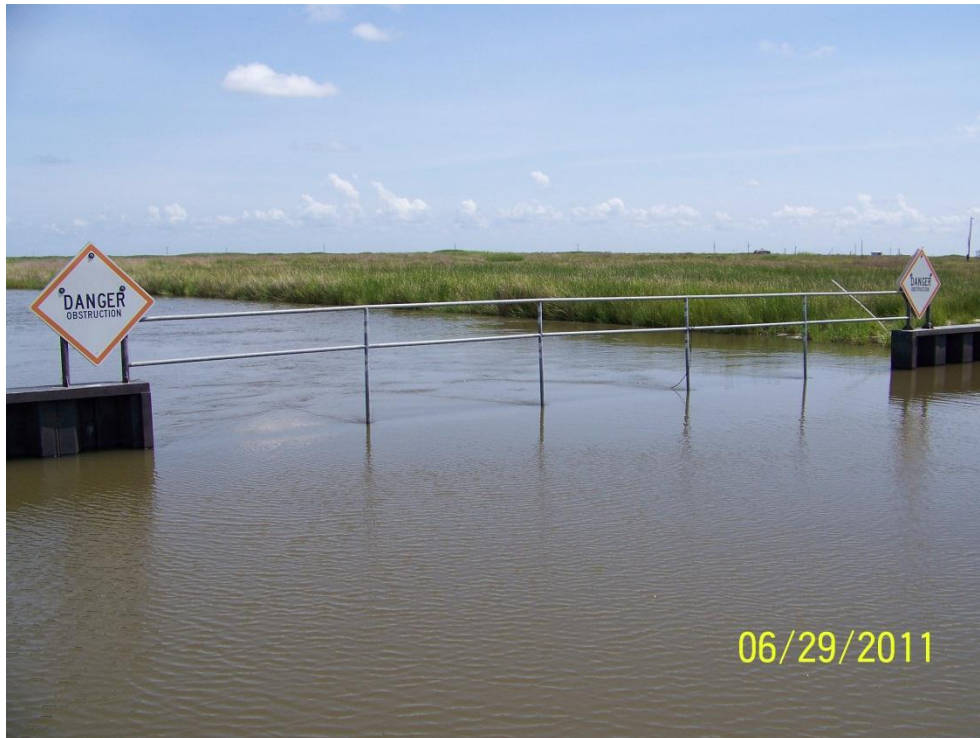
The sheet pile weir appears to be in good overall condition. There are no signs of corrosion or damage to the sheet pile or top cap. There appears to be no erosion or washouts around the embankment tie-ins. The warning signs and supports are also in good condition. There are no recommendations for corrective action at this time.

Picture #15: View of the embankment tie-ins on the west end of Sheetpile Weir, looking northwest

Picture #16: View of the embankment tie-ins on the east end of Sheetpile Weir, looking northeast

Picture #17: View of the 40' opening and warning signs installed on Sheetpile Weir, looking northeast

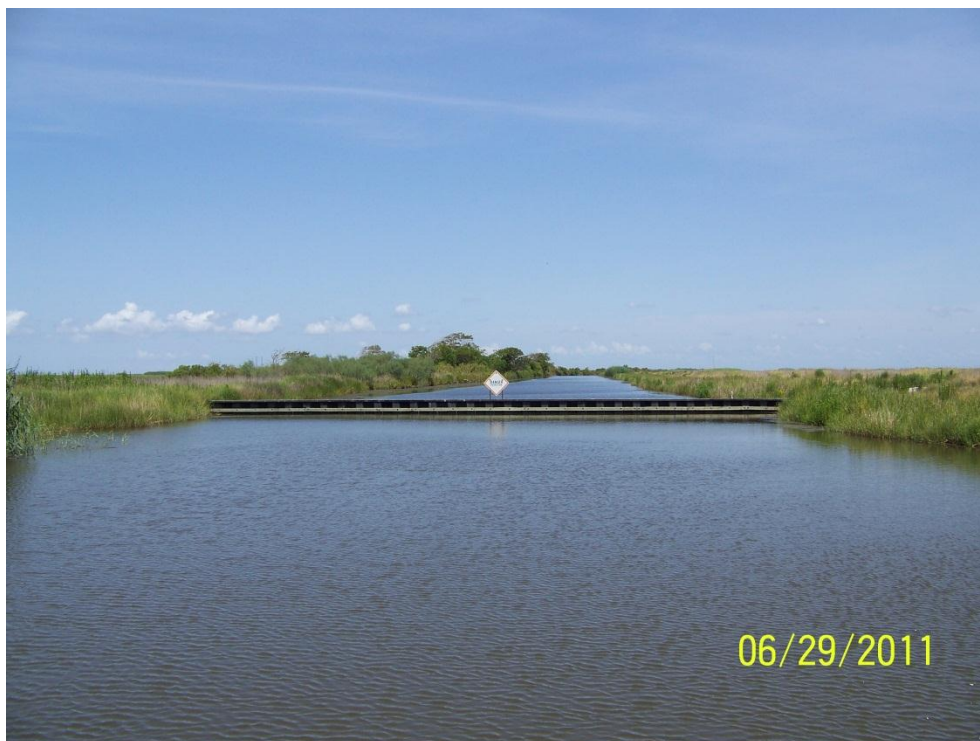
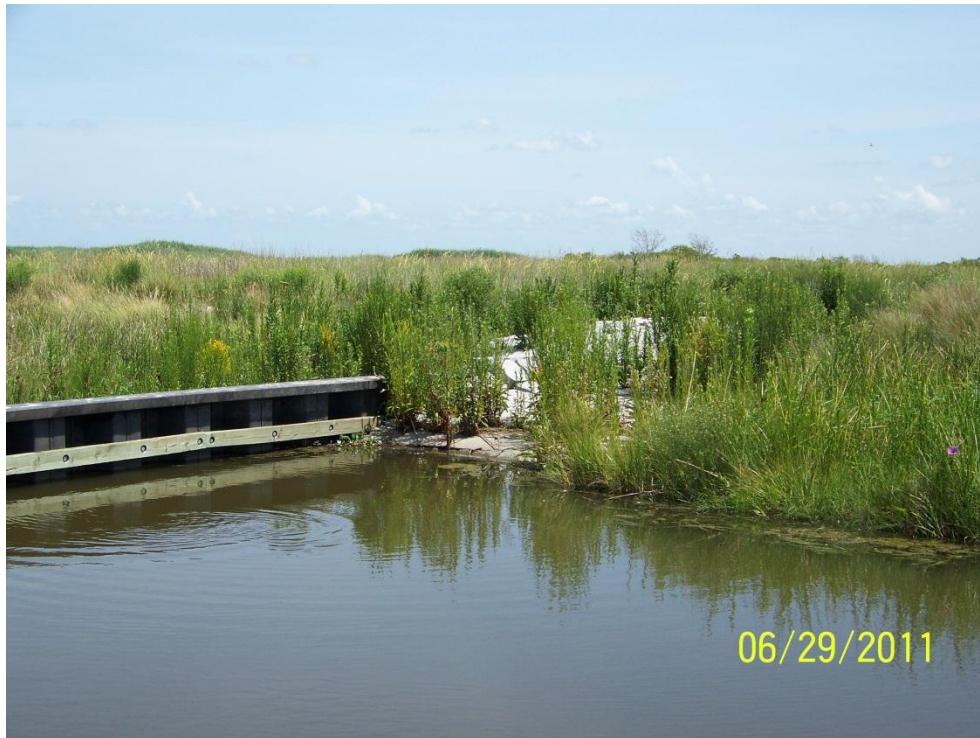
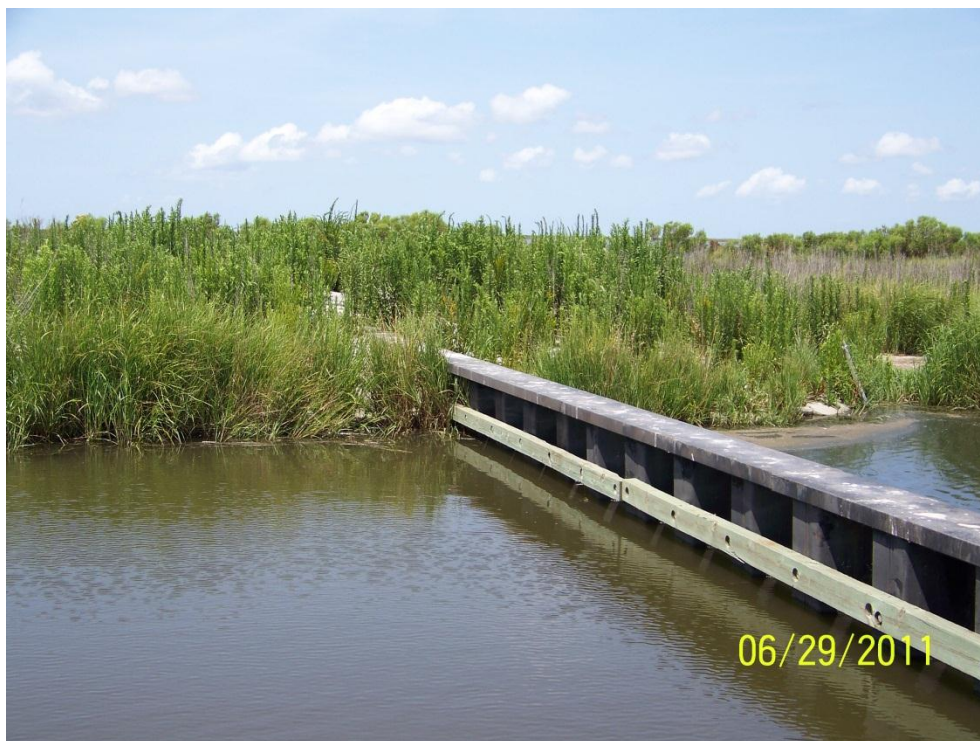
Sheet Pile Plug No. 3 appears to be in good overall condition. The sheet pile and top cap showed no signs of damage or corrosion, and the embankment tie-ins had no signs of erosion or washouts. In addition, the warning signs were intact and visible. There are no recommendations for corrective action at this time.

Picture #18: View of Sheetpile Plug 3 in canal adjacent to Tennessee Gas Pipeline, looking northwest

Picture #19: View of the embankment tie-in on the northeast side of Sheetpile Plug 3, looking north

Picture #20: View of the embankment tie-in on the southwest side of Sheetpile Plug 3, looking west

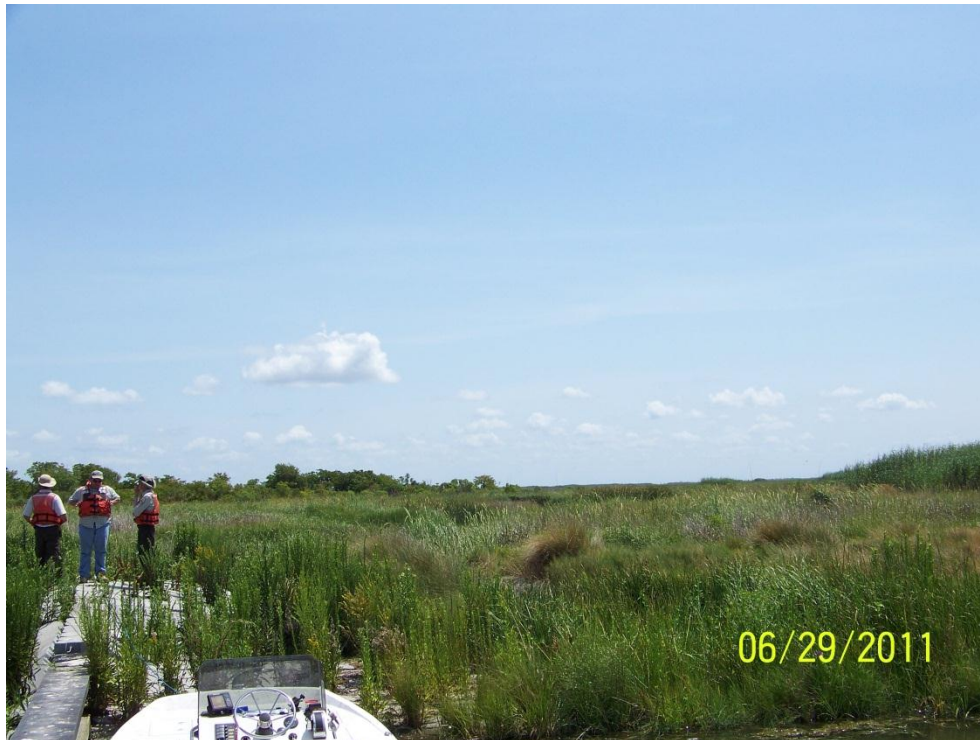
Picture #21: View of Fill Area 7 from on top of Sheetpile Plug 3, looking north east

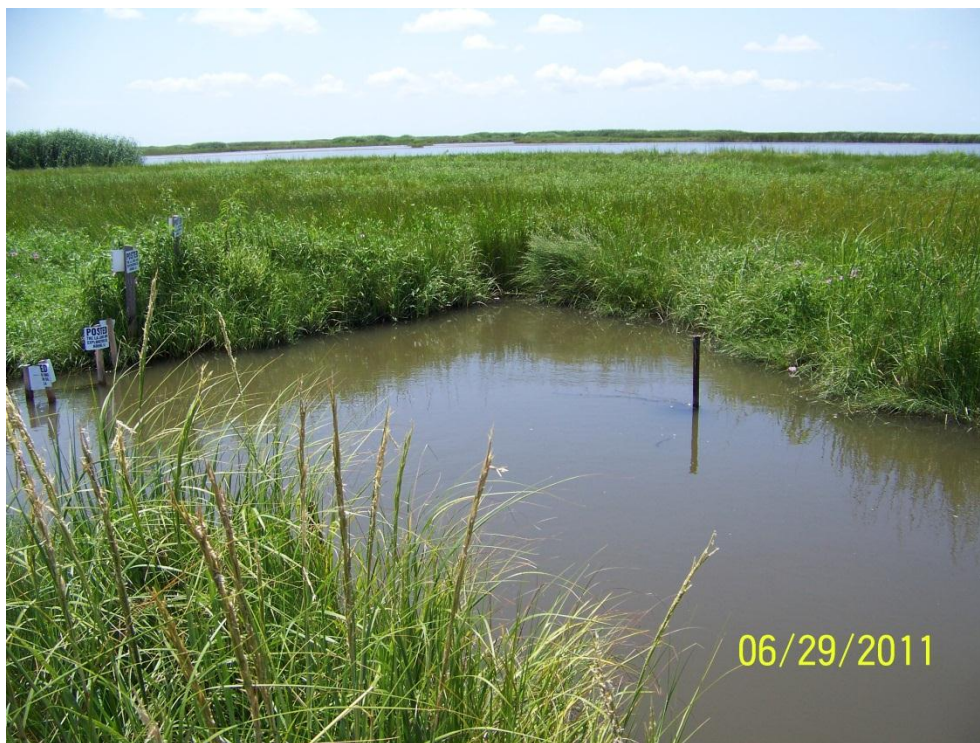
Earthen Plug No. 4 was not included in the original design of the project but was added to the proposed features during construction. Since its construction, this earthen plug has been damaged by vandals and water now passes through the earthen plug. Until there is a cost effective method to replace the feature and prevent the vandalism from reoccurring, there are no recommendations for corrective action.

Picture #22: View of Bayou LaPointe Earthen Plug No. 4, looking south

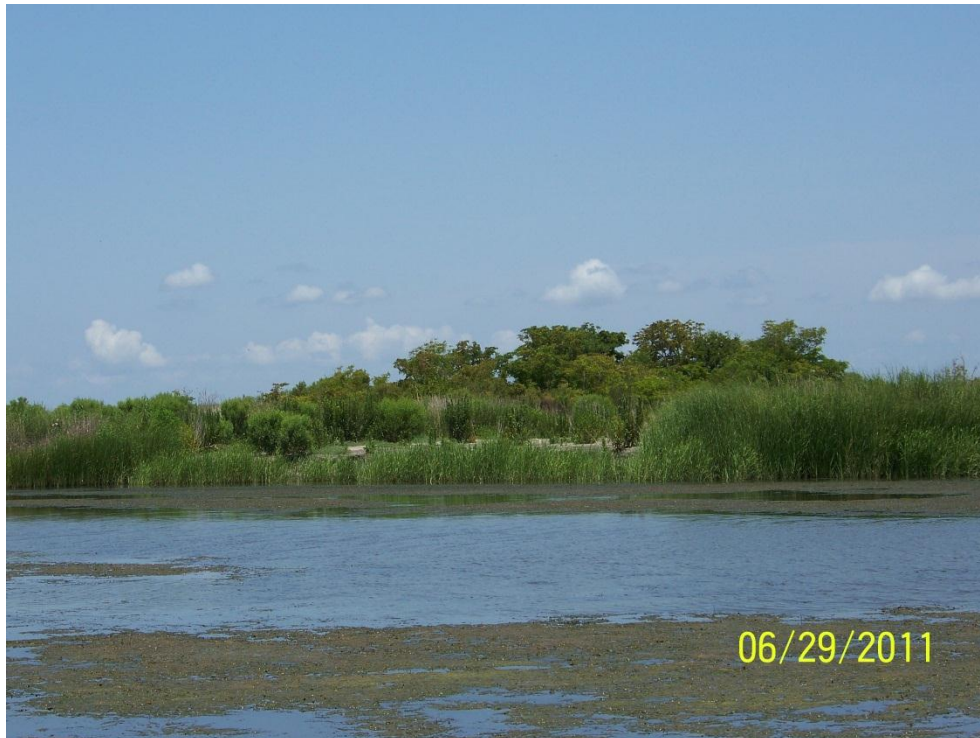
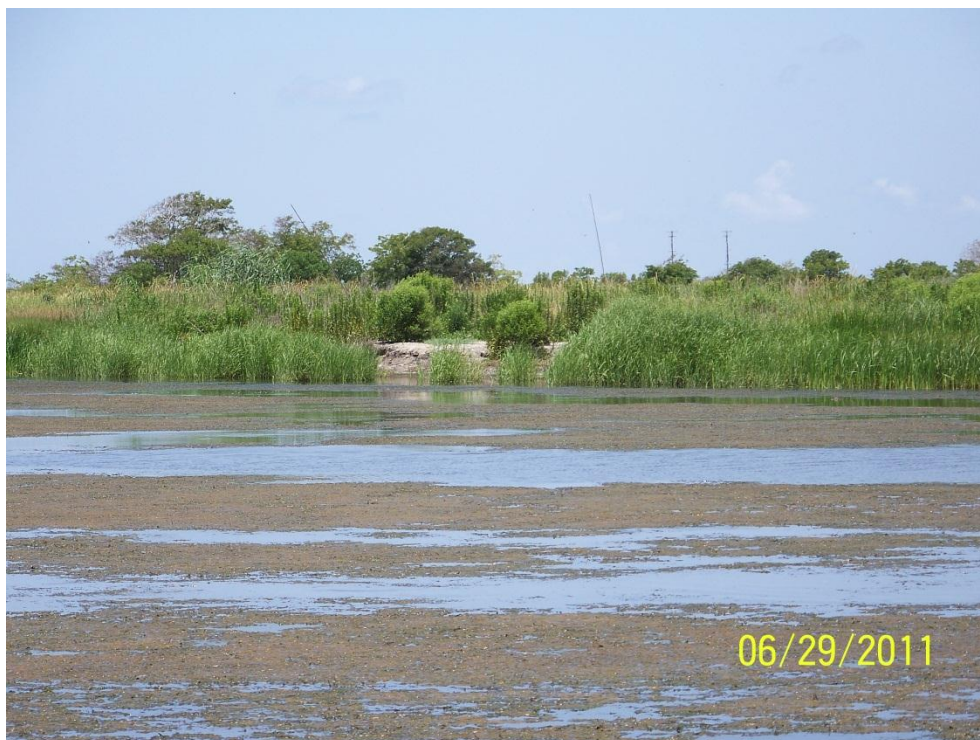
We were unable to access Earthen Plug No.3 during the inspection. It is located in an area that is only accessible by airboat, and this equipment was not available during the time of inspection. There are no recommendations for corrective action at this time, but this site will be monitored on future inspections.

Picture #23: View of Earthen Plug #3 from a distance, aquatic vegetation prevented access, looking northwest

Picture #24: View of Rock Plug #3 from a distance, aquatic vegetation prevented access, looking northwest

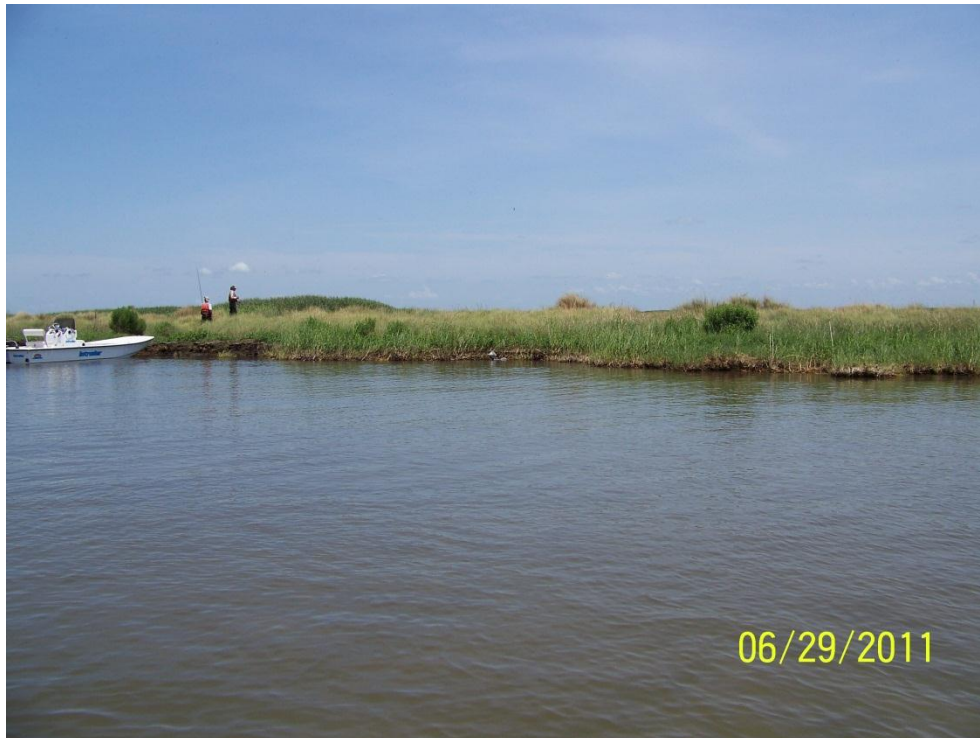
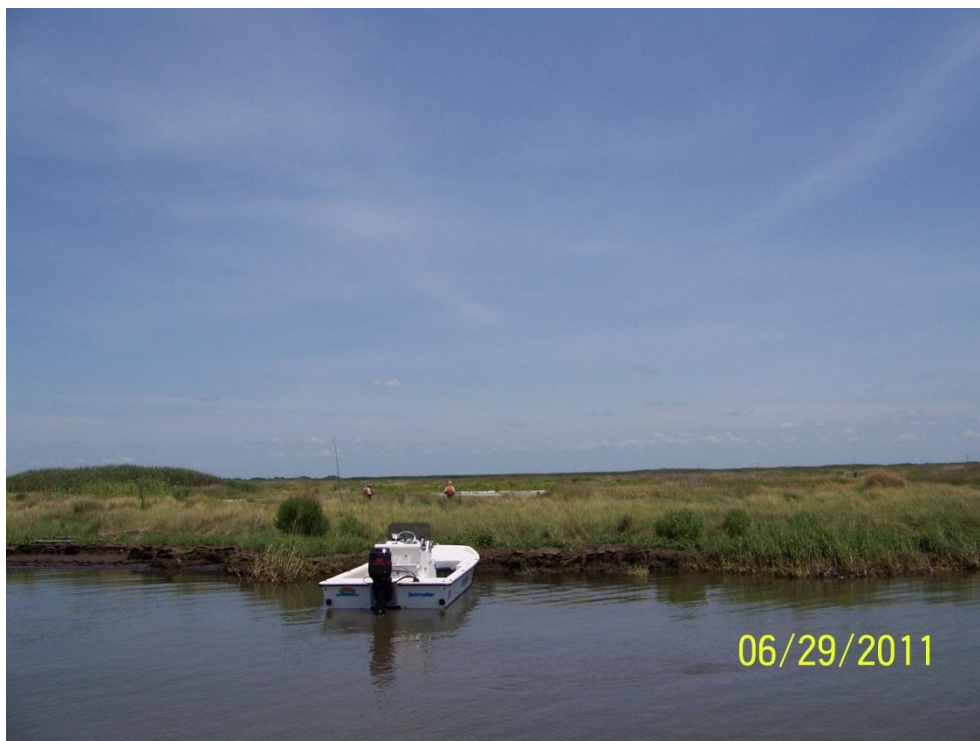
Picture #25: View of Fill Area 4 from north edge of Lake Mechant, looking north

Picture #26: View of Fill Area 4 from north edge of Lake Mechant, looking north

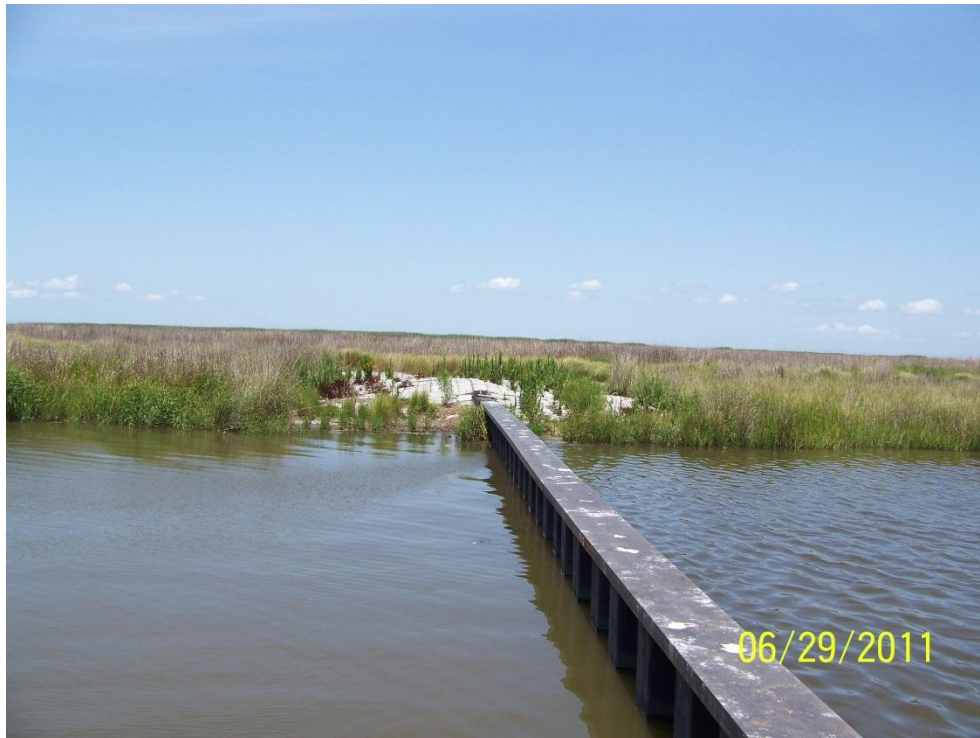
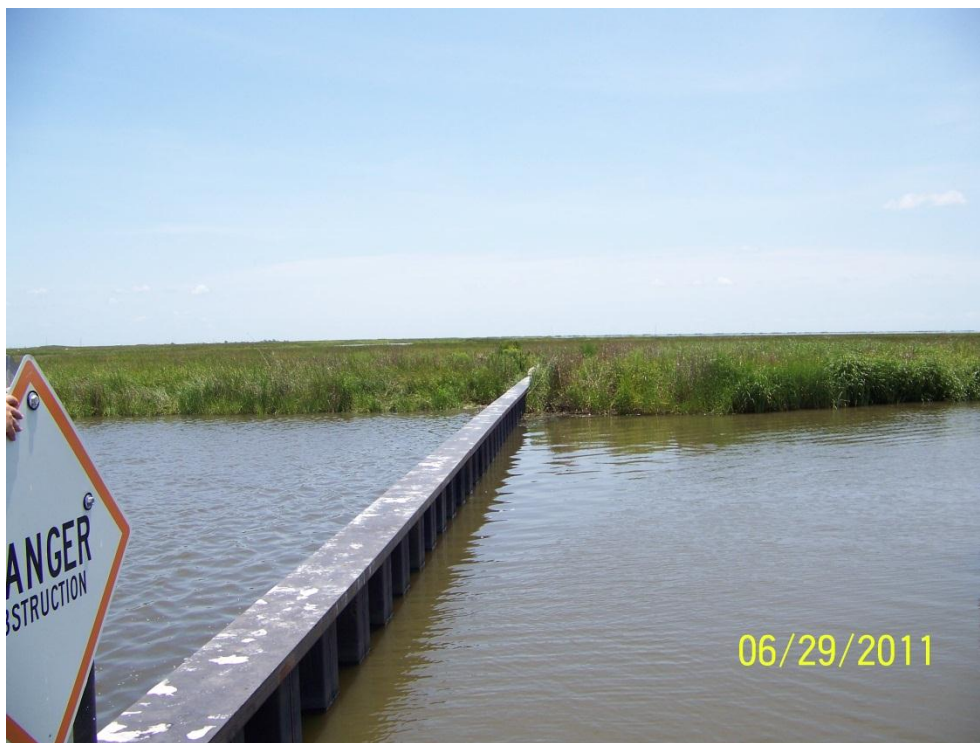
Sheet Pile Plug No. 2 appears to be in good overall condition. The sheet pile and top cap showed no signs of damage or corrosion, and the embankment tie-ins had no signs of erosion or washouts. In addition, the warning signs were intact and visible. There are no recommendations for corrective action at this time.

Picture #27: View from on top of Sheetpile Plug 2, looking west

Picture #28: View from on top of Sheetpile Plug 2, looking east
