**2011 Annual Inspection Report**

**North Lake Mechant Landbridge  
Restoration Project (TE-44)**

State Project Number TE-44  
Priority Project List 10

August 30, 2011  
Terrebonne Parish

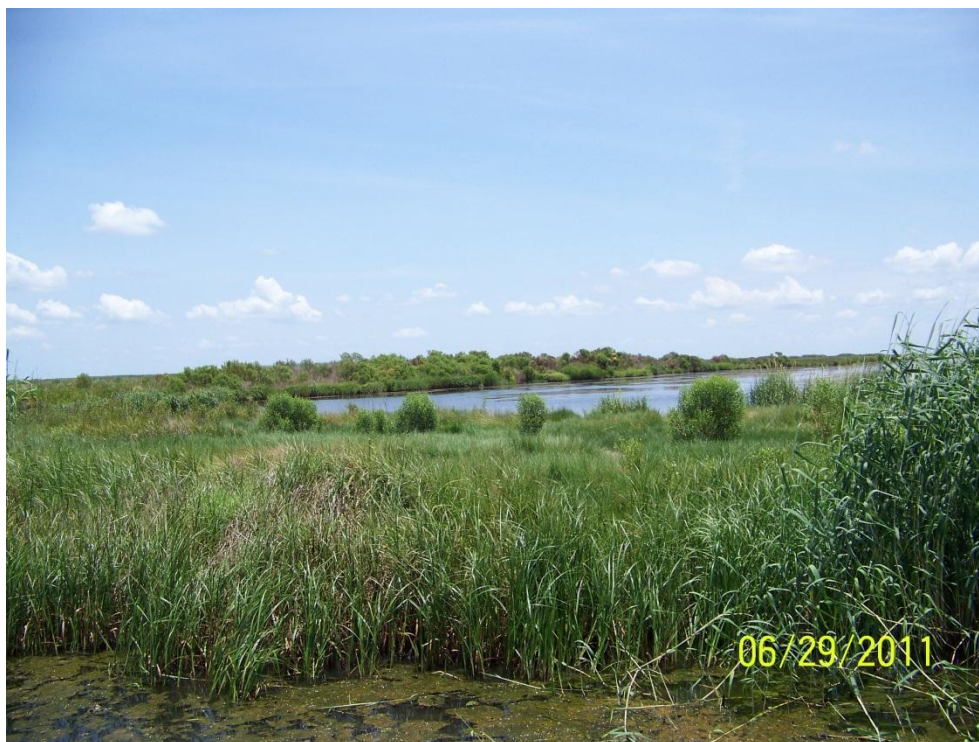
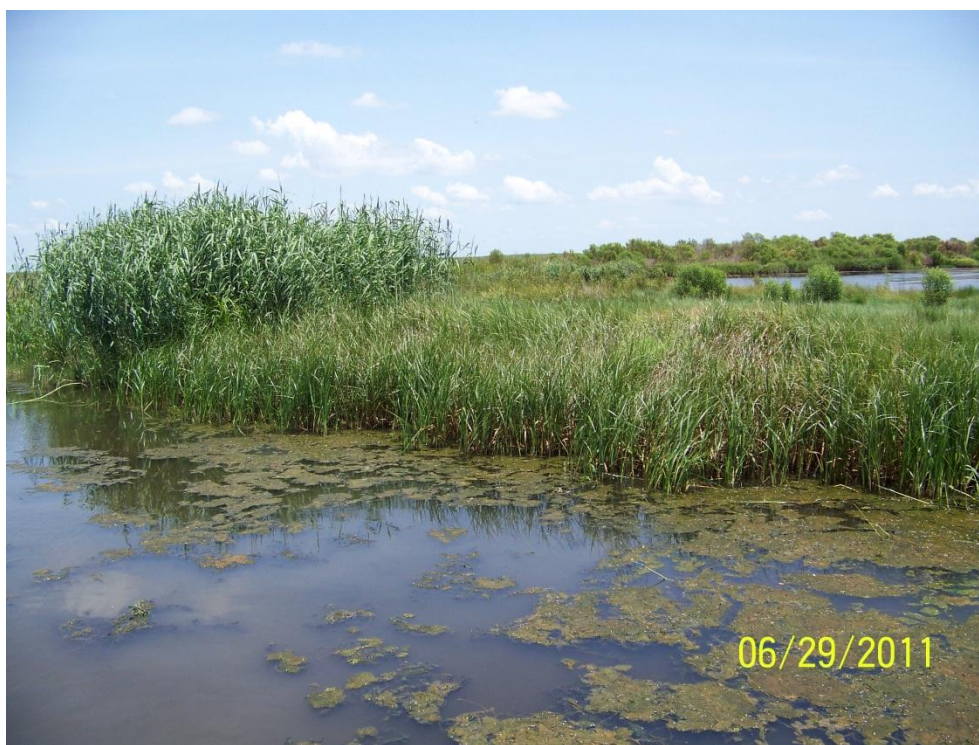
The earthen plug 1 located on the eastern edge of Lake Pagie appeared to be in good overall condition. There was no observed settlement or erosion of the plug. Also, there were no signs of erosion or a washout around the embankment tie-ins. Earthen plug 1 is in good shape and there are no recommendations for corrective action at this time.

Picture #29: View of Earthen Plug 1 from the eastern edge of Lake Pagie, looking east

Picture #30: View of Earthen Plug 1 from the eastern edge of Lake Pagie, looking northeast
